VEHICLE INSPECTION REPORT

LD19FKL

Ford Focus 1.0 EcoBoost 125 Titanium 5dr

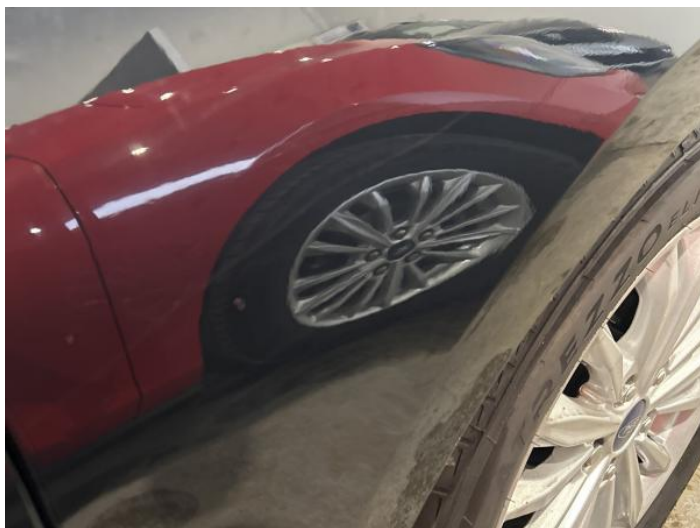
1: Wing osf
Scratched
Over 25mm Not Thru Paint

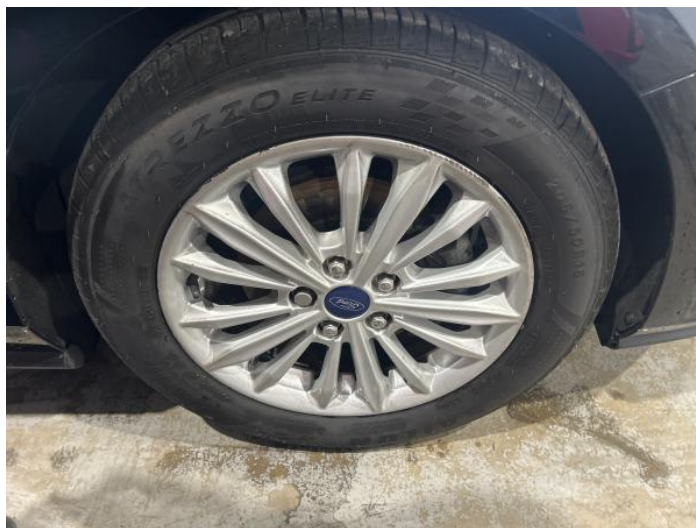
2: Wheel osf
Scratched
Over 50mm

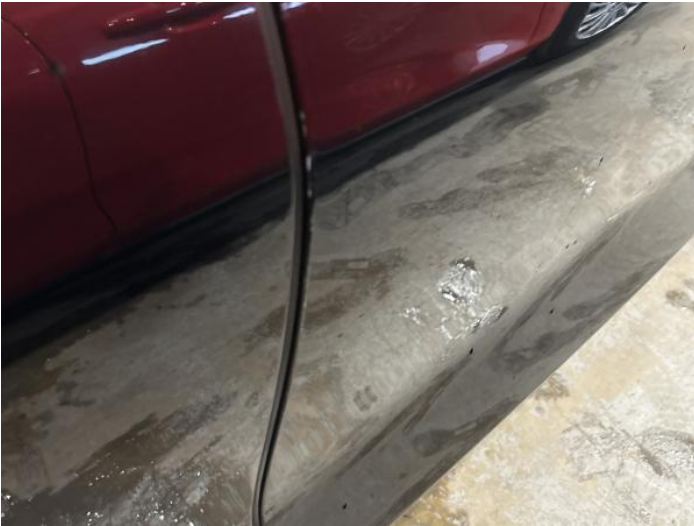
3: Door osf
Chipped
Edge Chip

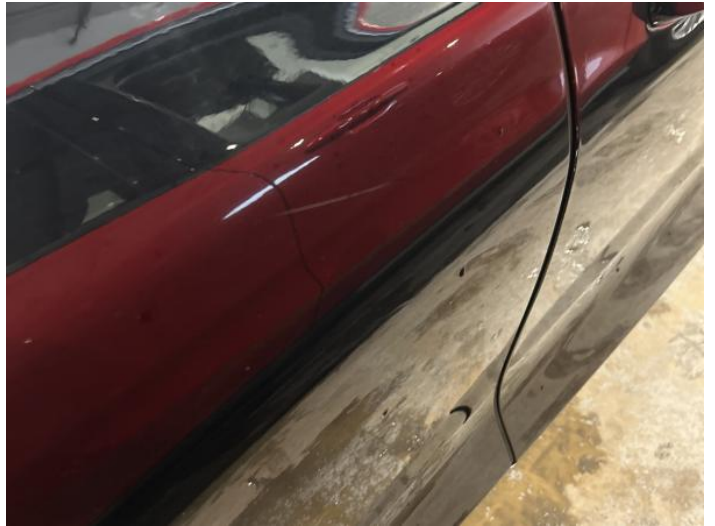
4: Door osr
Scratched
Over 25mm Not Thru Paint

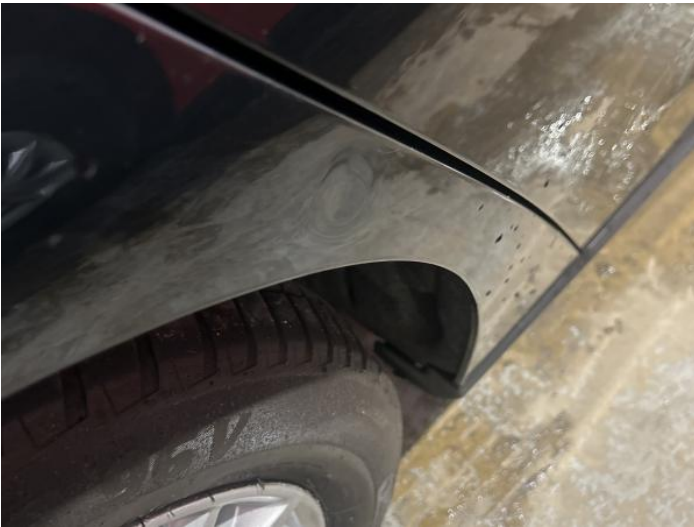
5: Qtr Panel osr
Dented
Between 10mm + 30mm

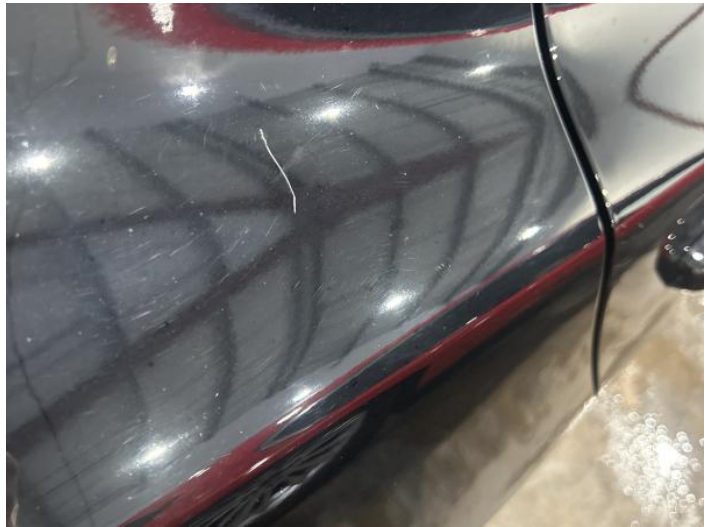
6: Qtr Panel osr
Scratched
UpTo 25mm Thru Paint

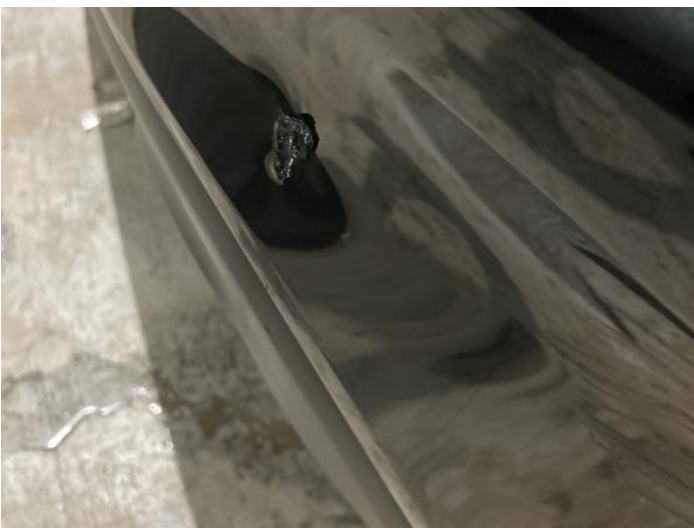
7: Bumper Rear
Hole
UpTo 25mm

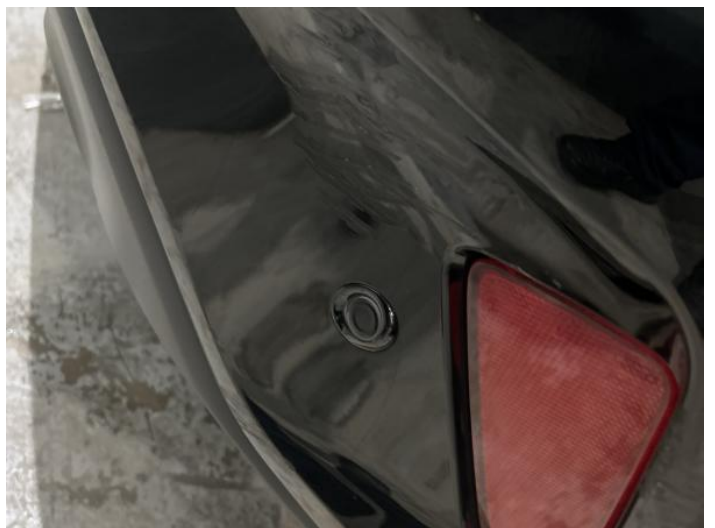
8: Bumper Rear
Scratched
25 to 100mm Thru Paint

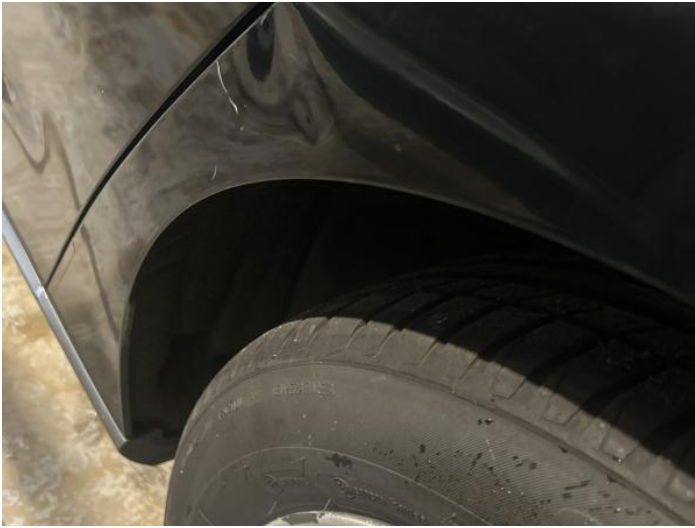
9: Qtr Panel nsr
Dented
Over 30mm

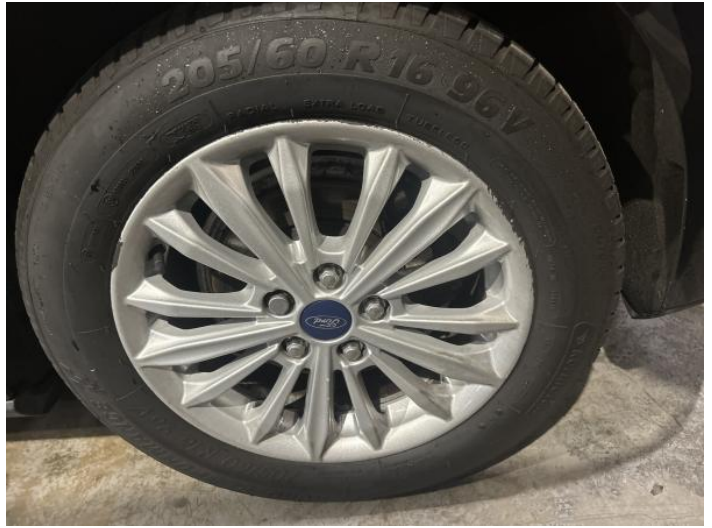
10: Wheel nsr
Scratched
Over 50mm

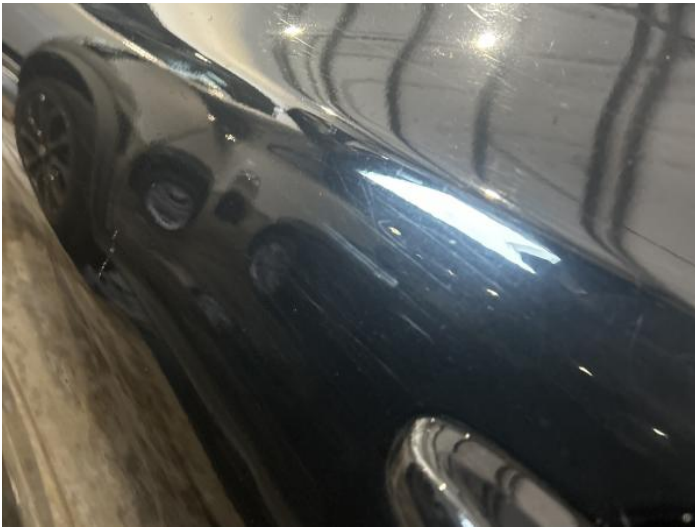
11: Door nsr
Scratched
Over 25mm Not Thru Paint

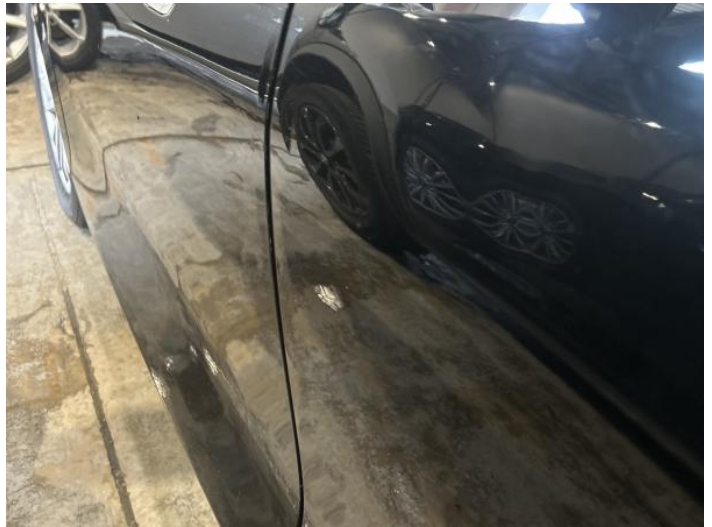
12: Door nsr
Dented
Between 10mm + 30mm

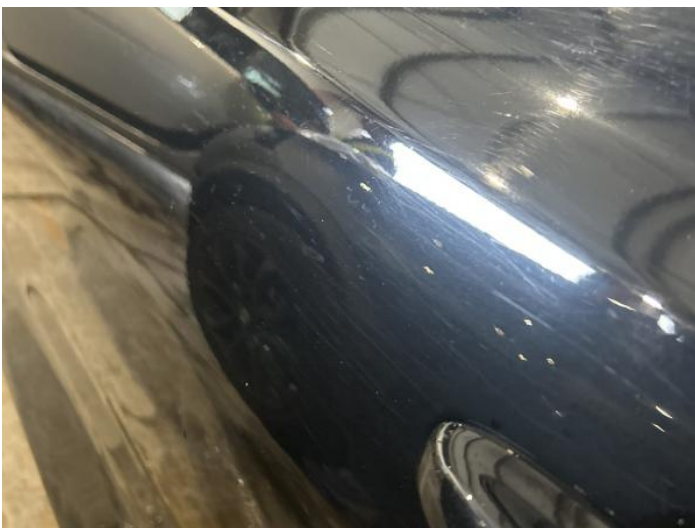
13: Door nsf
Scratched
Over 25mm Not Thru Paint

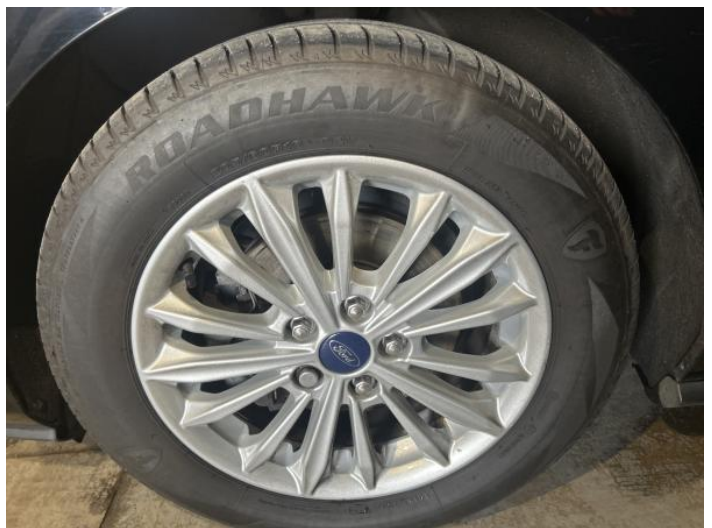
14: Wheel nsf
Scratched
Up To 50mm

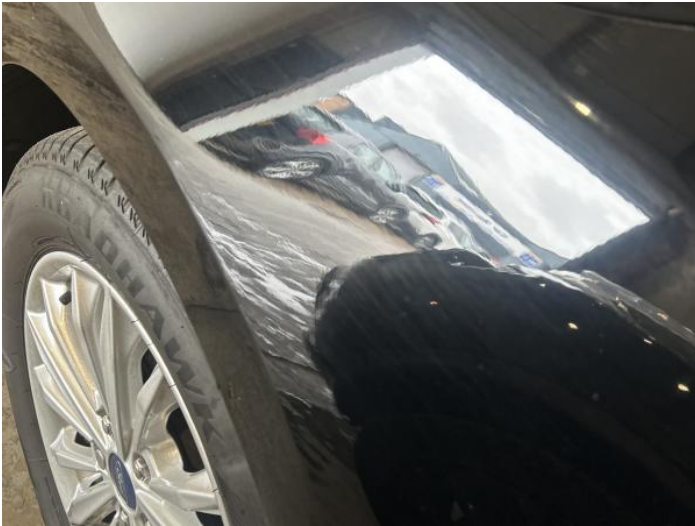
15: Wing nsf
Scratched
Over 25mm Not Thru Paint

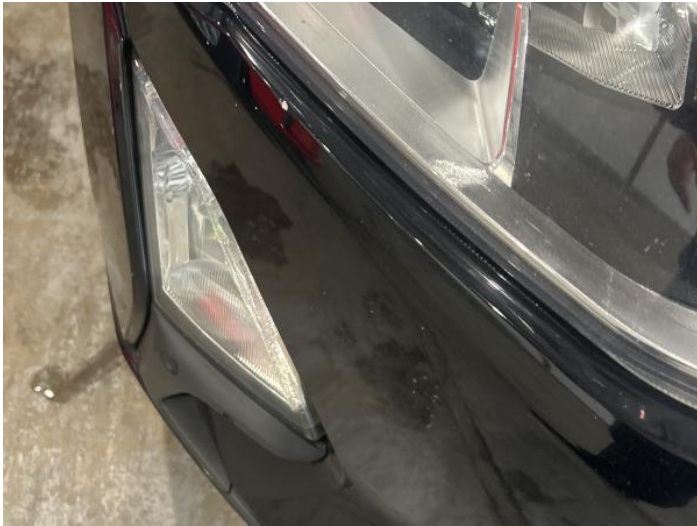
16: Bumper Front
Chipped
Multiple Chips

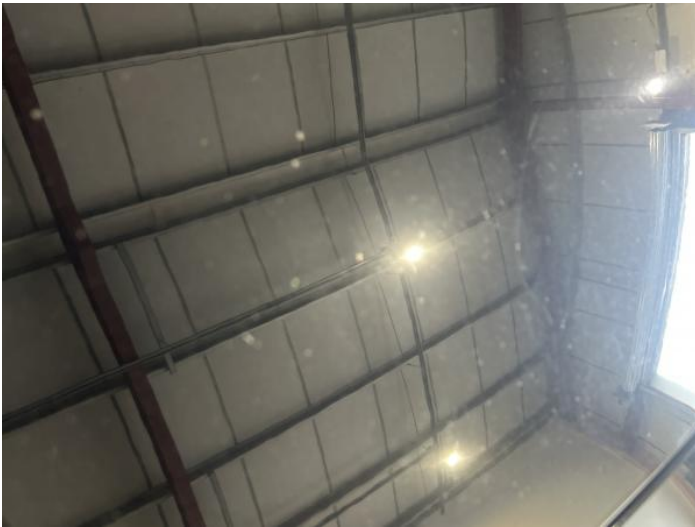
17: Bonnet
Chipped
1 To 5

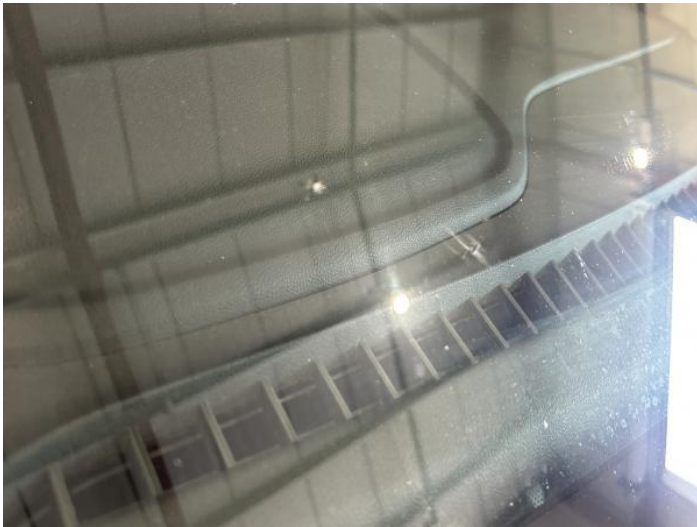
18: Screen Front
Chipped
UpTo 10mm
