VEHICLE INSPECTION REPORT

SM62XLG

Vauxhall Antara 2.2 CDTi Exclusiv 5dr [Start Stop]

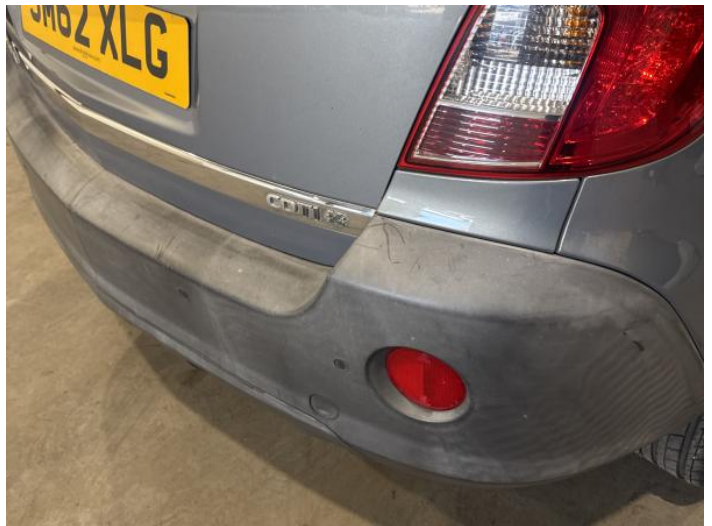
2: Bumper Rear Moulding
Scuffed (Unpainted)
Over 100mm

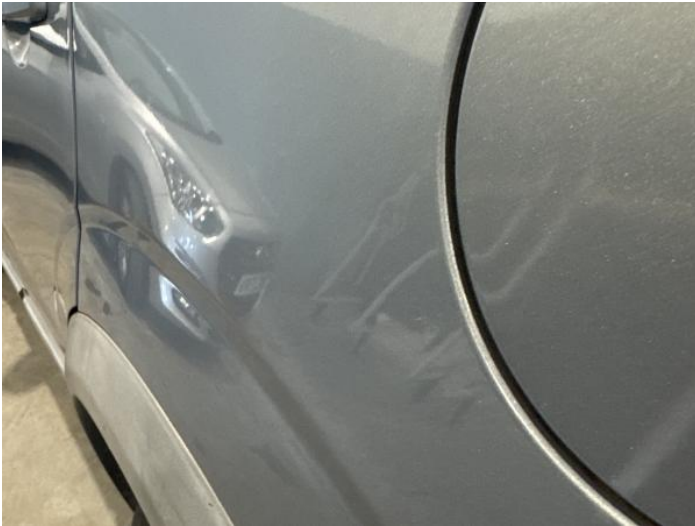
3: Qtr Panel nsr
Dented
Over 2 UpTo 10mm

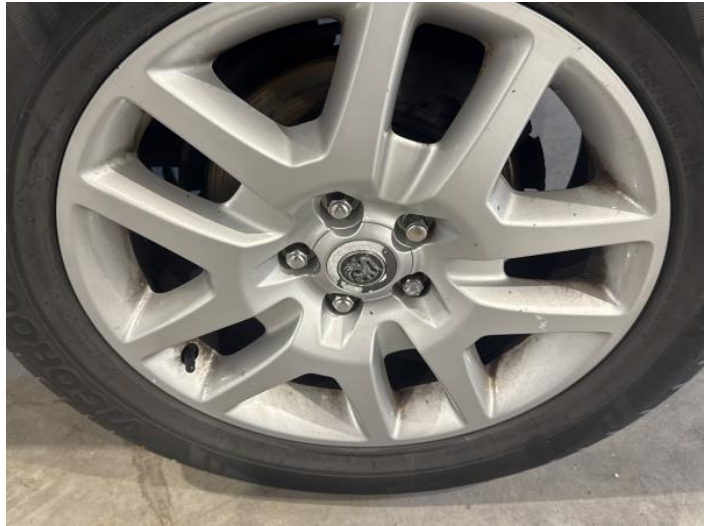
4: Wheel nsr
Scratched
Up To 50mm

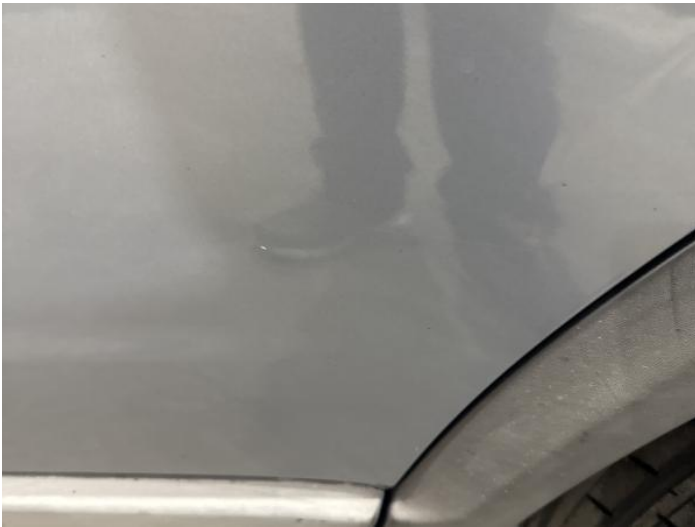
5: Door nsr
Chipped
1 To 5

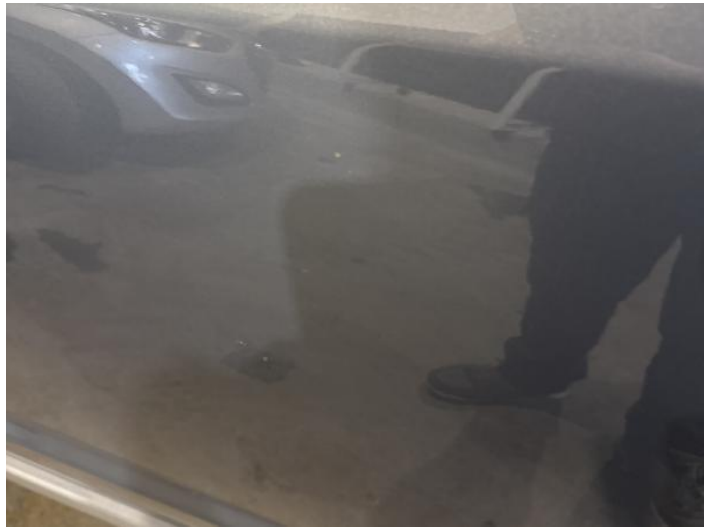
6: Door nsf
Chipped
1 To 5

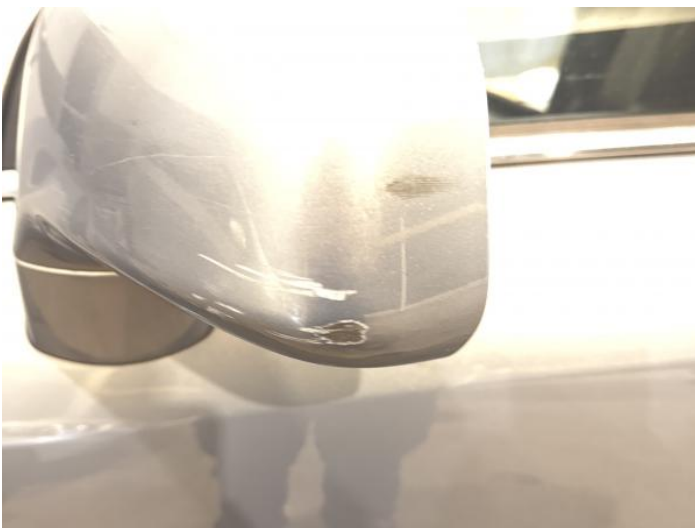
7: Door Mirror Assy nsf
Scratched (Painted)
Over 25mm Thru Paint

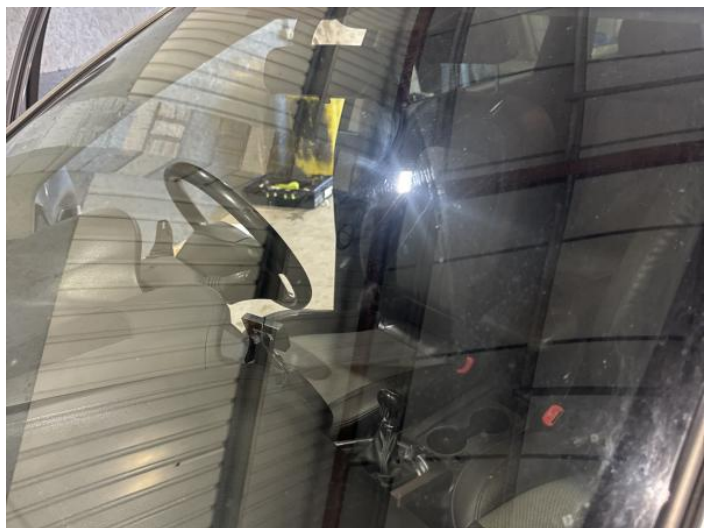
8: Screen Front
Chipped
UpTo 10mm

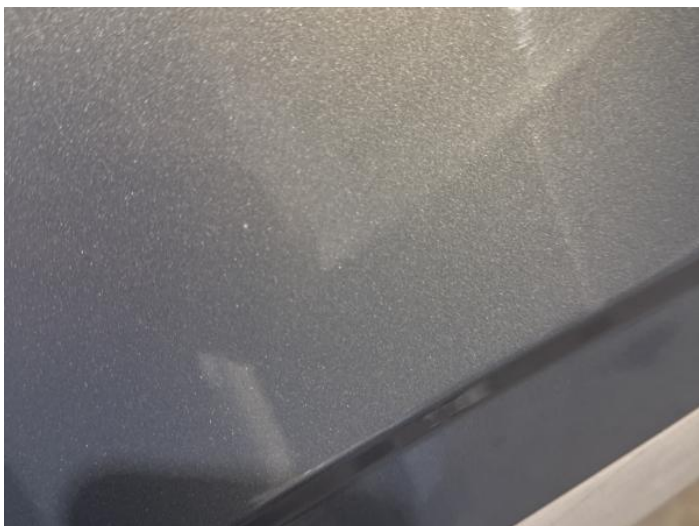
9: Wing nsf
Chipped
1 To 5

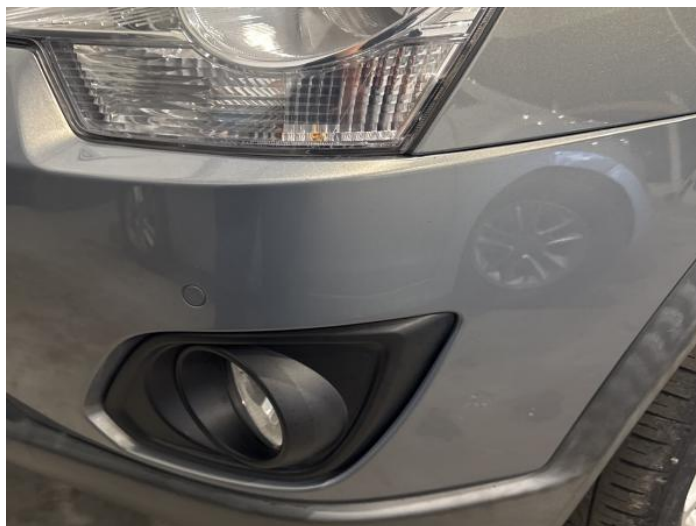
10: Bumper Front
Scratched
25 to 100mm Thru Paint

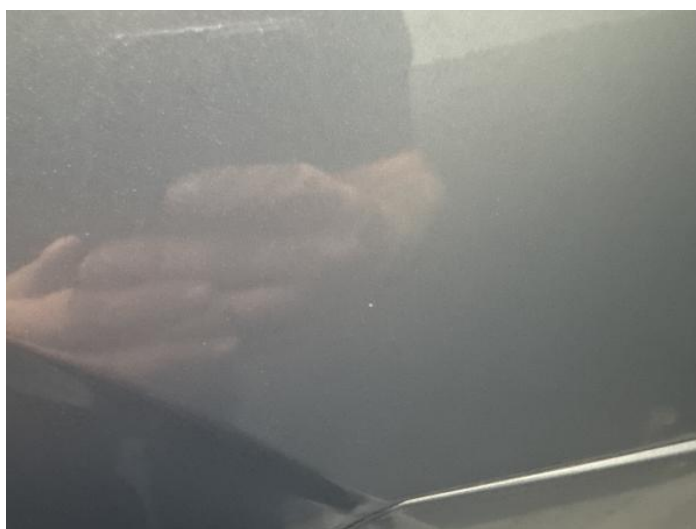
12: Wing osf
Chipped
1 To 5

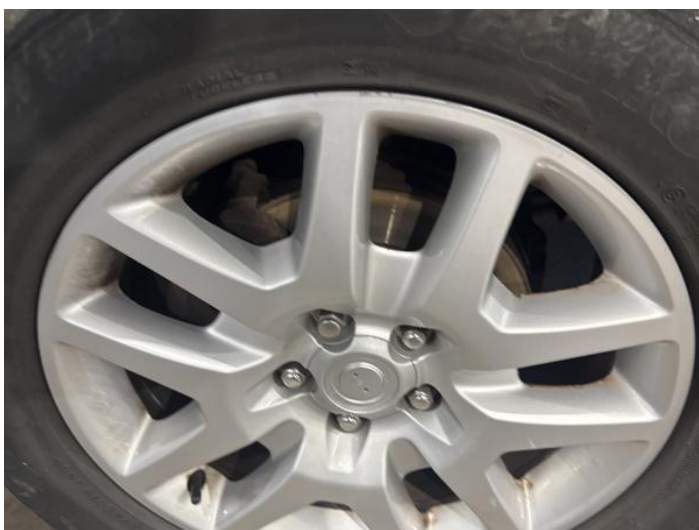
13: Wheel nsf
Scratched
Up To 50mm

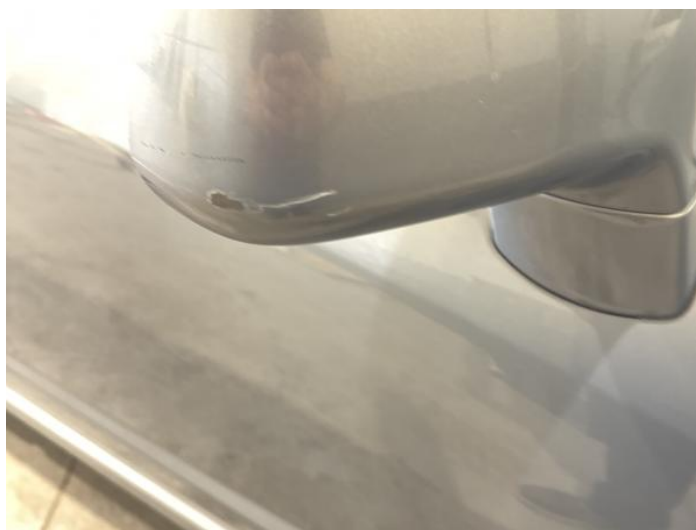
14: Door Mirror Assy osf
Scratched (Painted)
Over 25mm Thru Paint

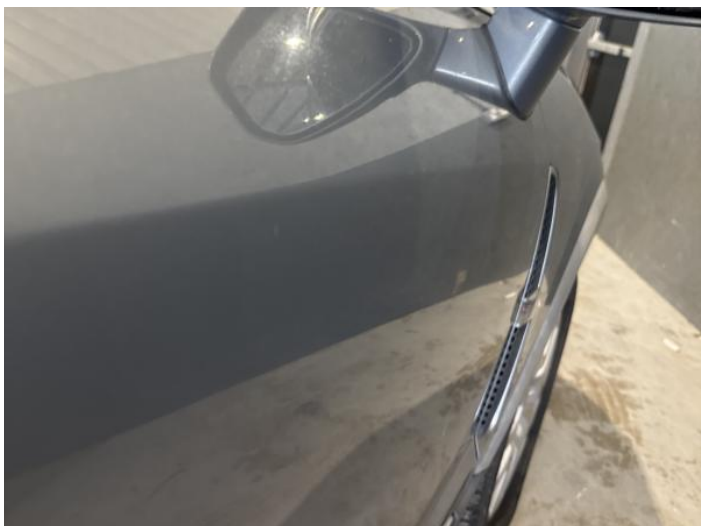
15: Door osf
Dented
Over 2 UpTo 10mm

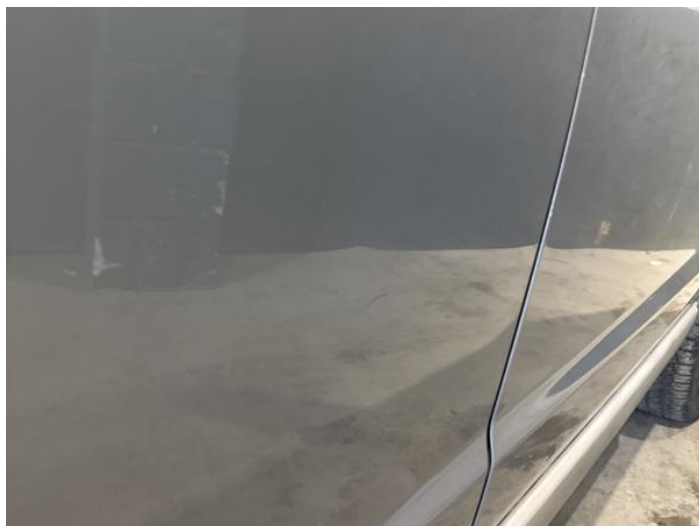
16: Door osr
Dented
Between 10mm + 30mm

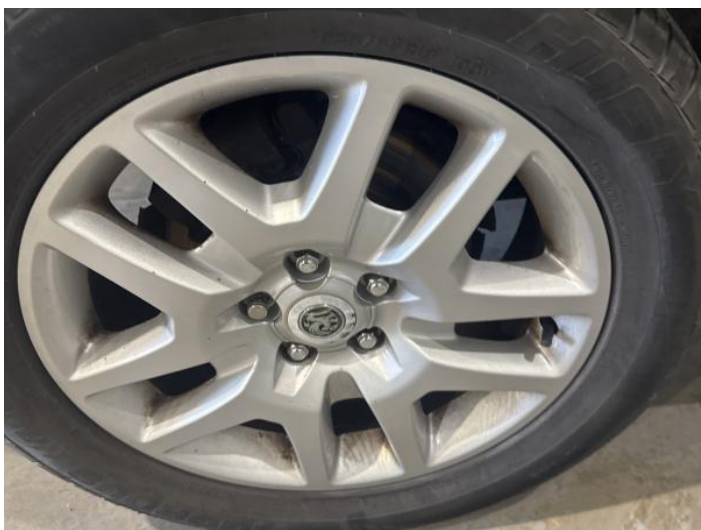
17: Wheel osr
Scratched
Up To 50mm

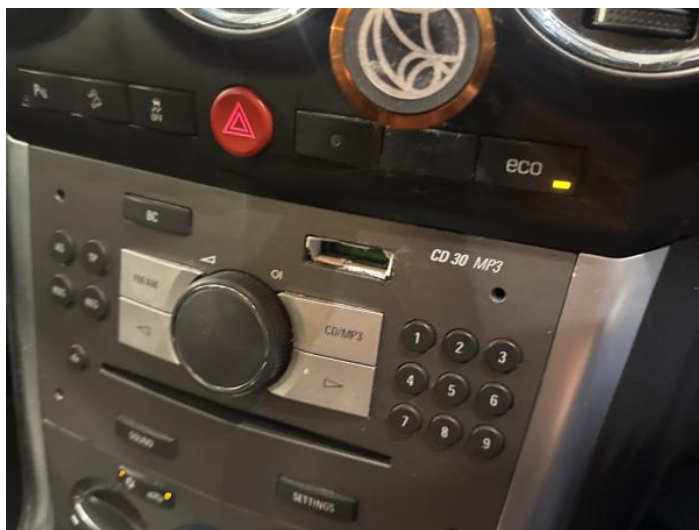
18: Switches And Controls
Broken
Replace

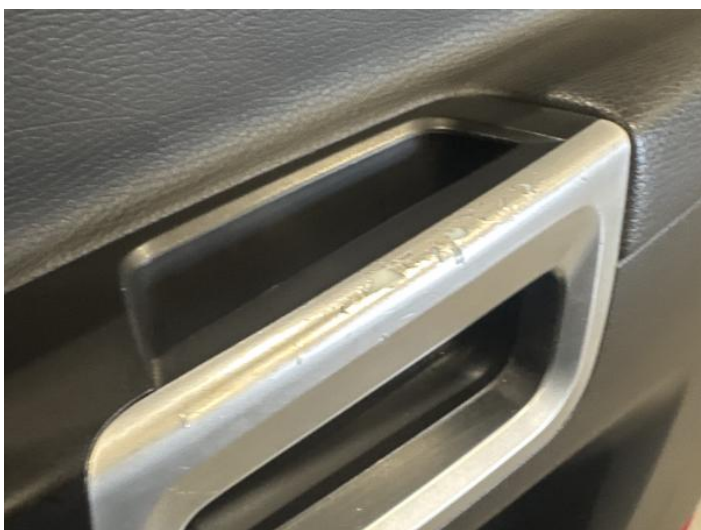
19: Door Pad osf
Scuffed
Over 25mm

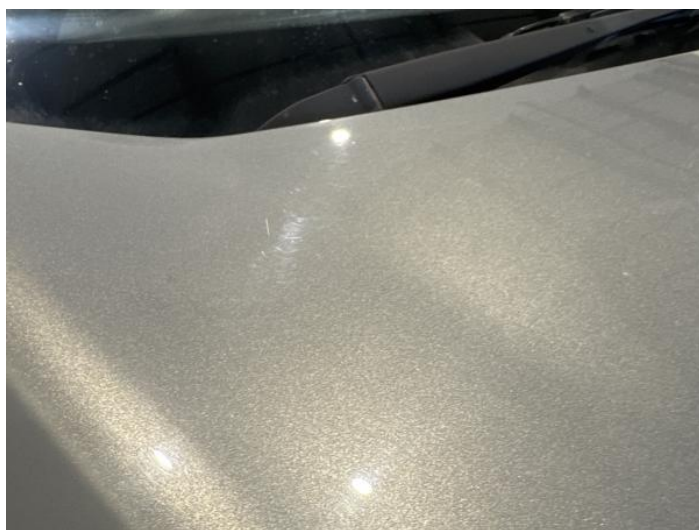
20: Bonnet
Dented
Over 30mm
