VEHICLE INSPECTION REPORT

FV65NWX

Nissan Juke 1.5 dCi N-Connecta 5dr

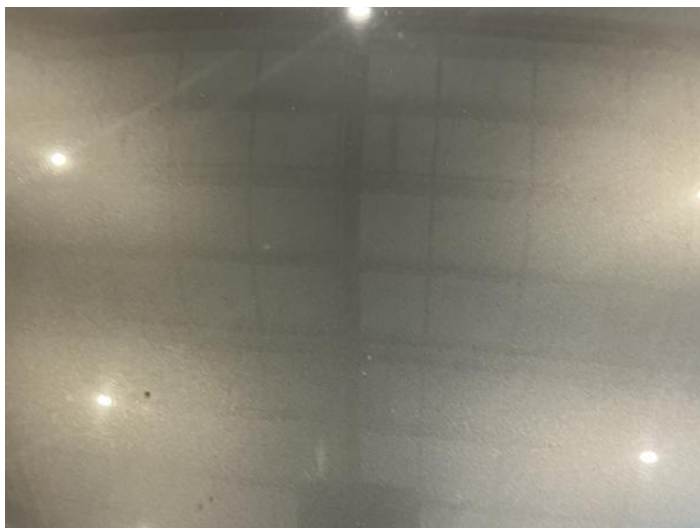
1: Bonnet
Chipped
Multiple Chips

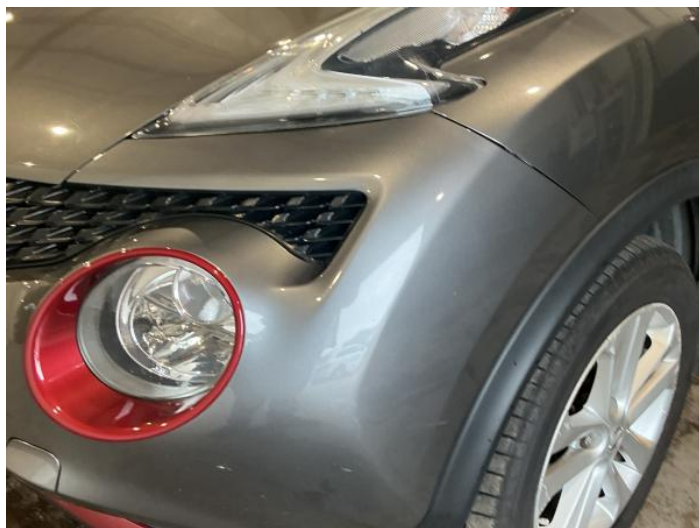
2: Bumper Front
Scratched
25 to 100mm Thru Paint

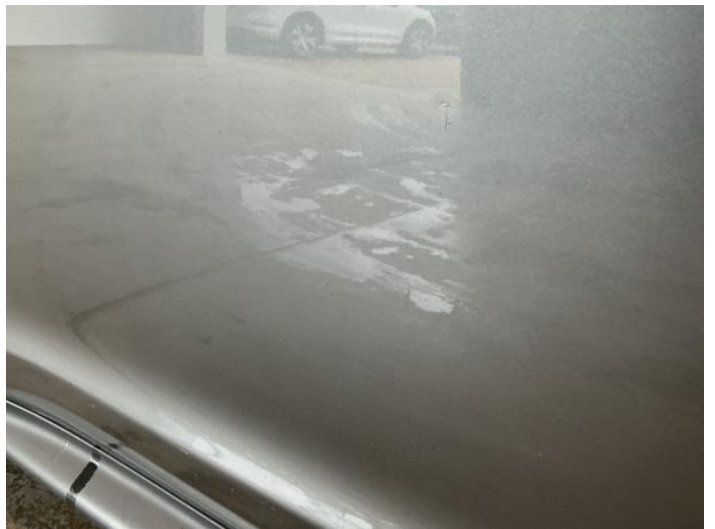
5: Wing nsf
Scratched
Over 25mm Not Thru Paint

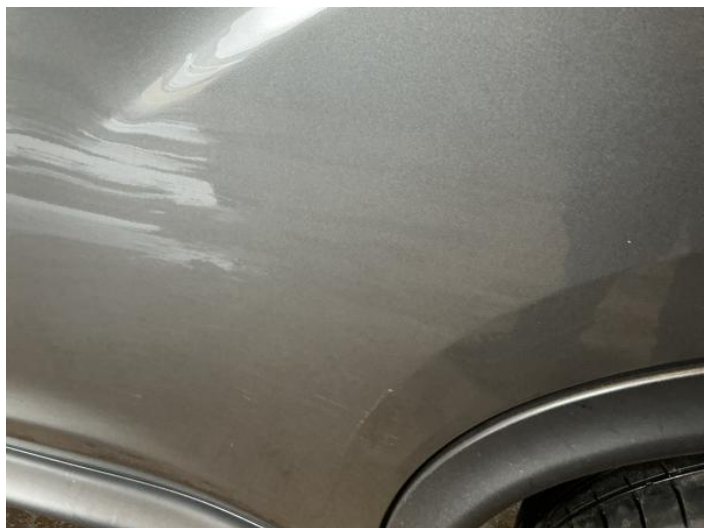
7: Door nsf
Scratched
Over 25mm Not Thru Paint

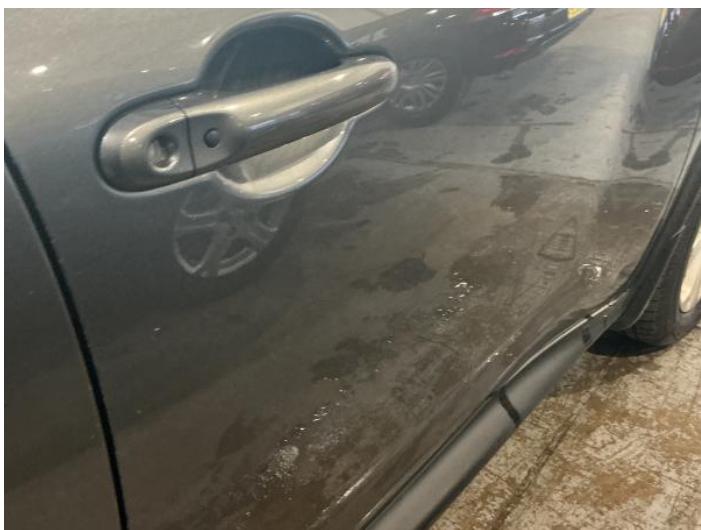
16: Door osr
Scratched
Over 25mm Not Thru Paint
