VEHICLE INSPECTION REPORT

HV14WLK

Nissan Note 1.2 Acenta Premium 5dr [Comfort Pack]

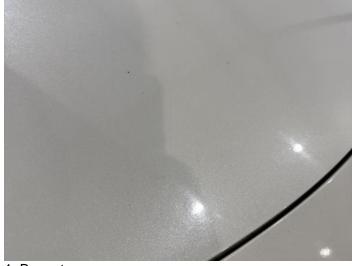
1: Bonnet Chipped 1 To 5

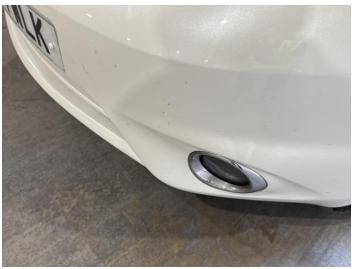
2: Bumper Front Chipped Multiple Chips

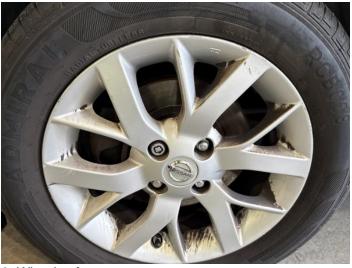
3: Wheel osf Scratched Over 50mm

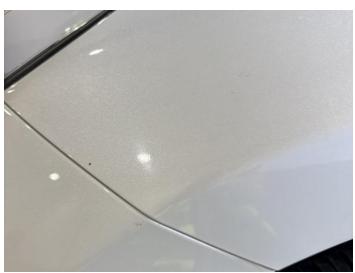
4: Wing nsf Chipped 1 To 5

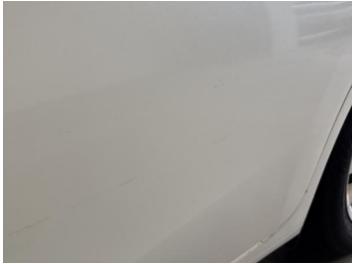
6: Door nsr Scratched Over 25mm Thru Paint

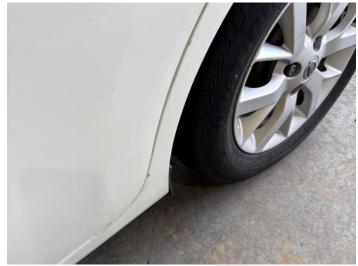
7: Qtr Panel nsr Chipped Edge Chip

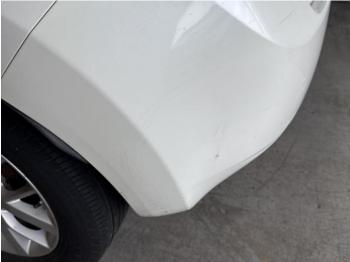
8: Bumper Rear Dented With Paint Damage

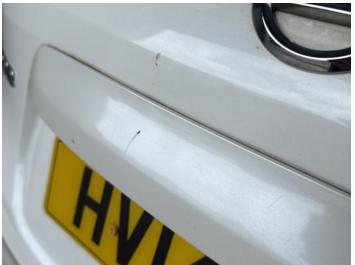
9: Tailgate Chipped 1 To 5

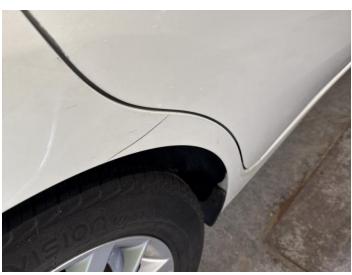
10: Qtr Panel osr Dented Between 10mm + 30mm

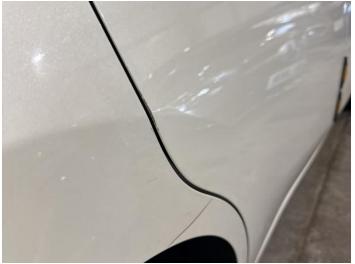
11: Door osr Chipped Edge Chip

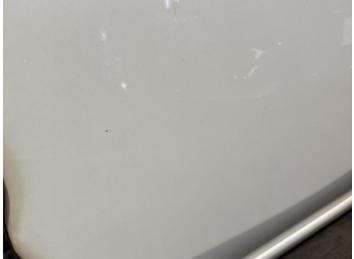
12: Door osf Chipped 1 To 5

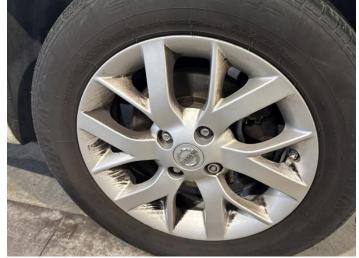
13: Wheel osf Scratched Up To 50mm
