VEHICLE INSPECTION REPORT

AF70CWJ

MG Mg Zs EXCLUSIVE

nama
GRADE
4

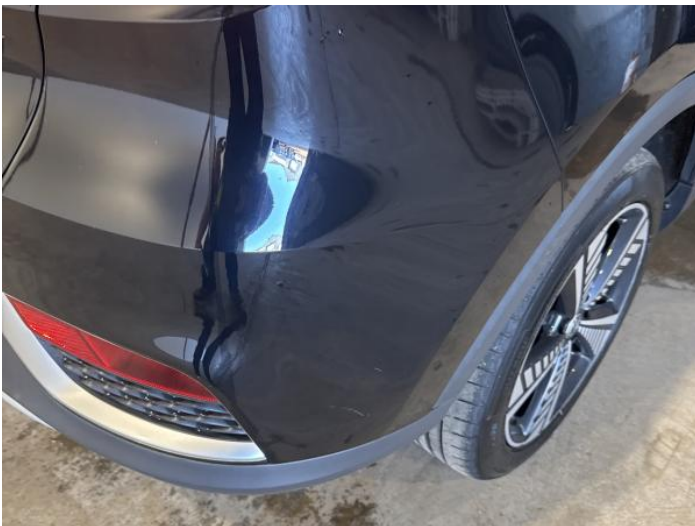
1: Bumper Rear
Scratched
25 to 100mm Thru Paint

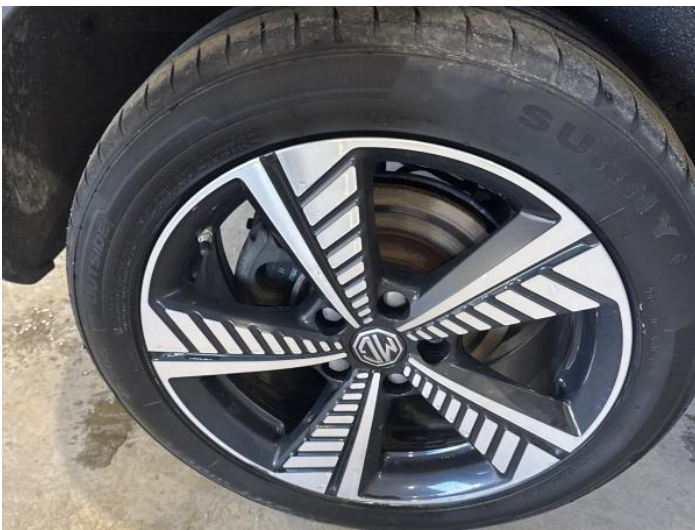
5: Wheel osr
Scratched
Up To 50mm

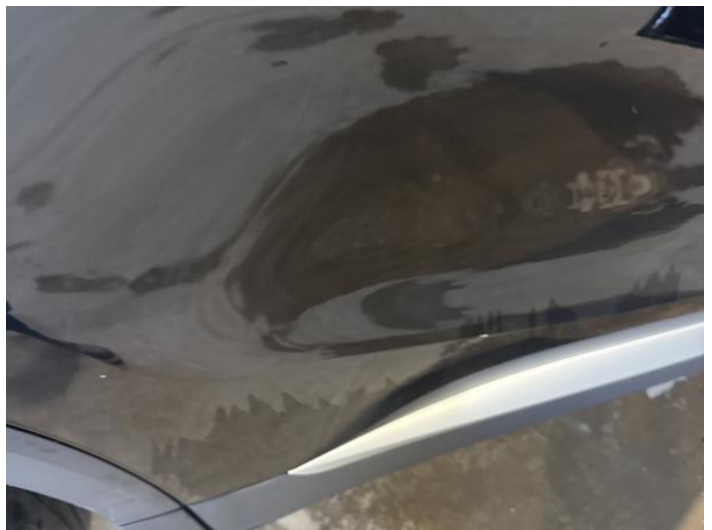
6: Door osr
Chipped
1 To 5

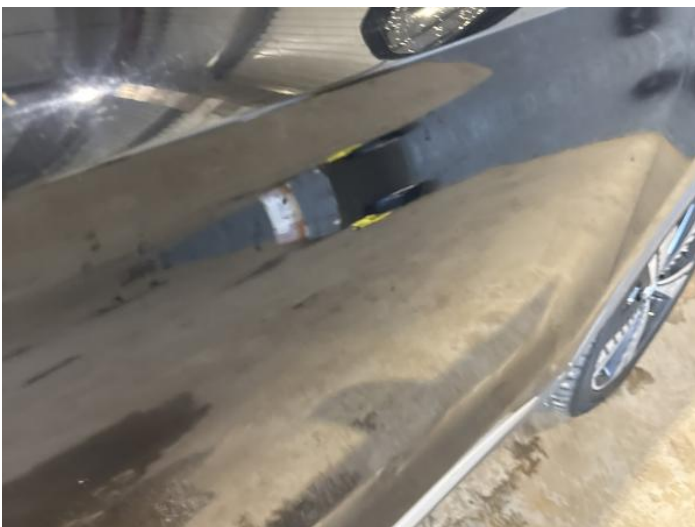
7: Door osf
Dented
Over 30mm

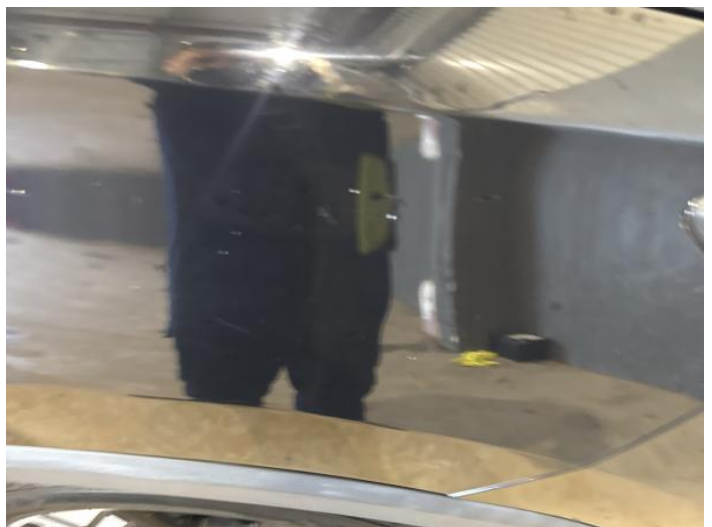
8: Wing osf
Chipped
1 To 5

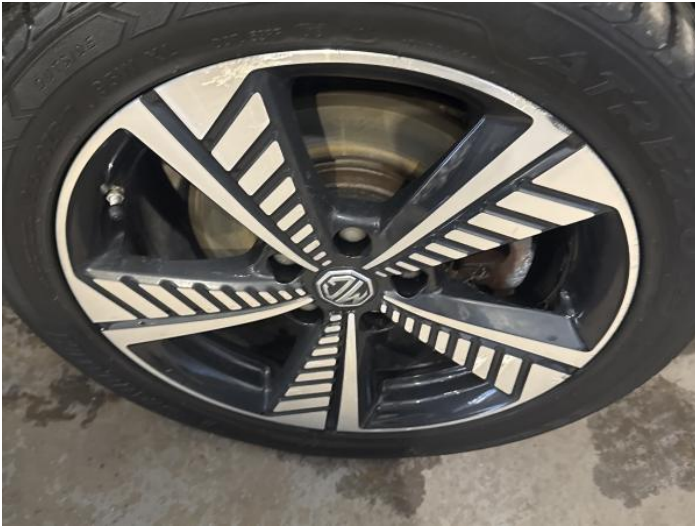
9: Wheel osf
Scratched
Over 50mm

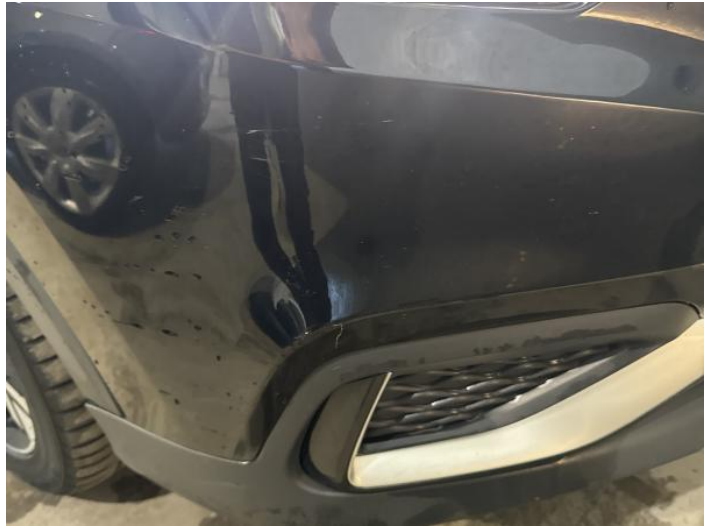
10: Bumper Front
Scratched
25 to 100mm Thru Paint

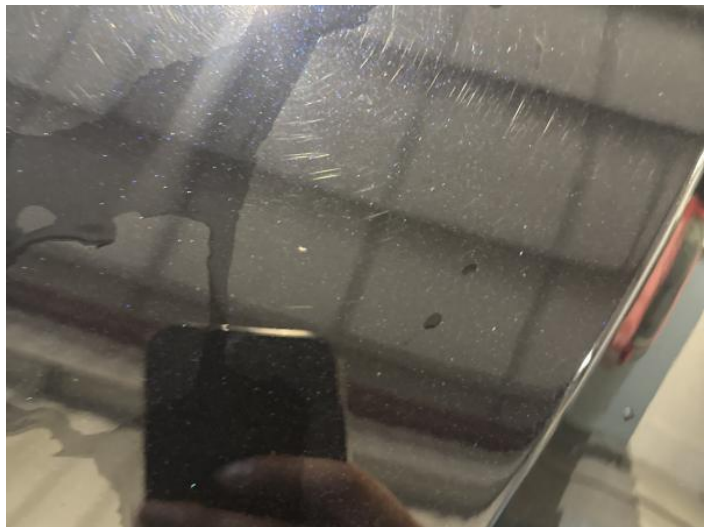
12: Bonnet
Chipped
1 To 5

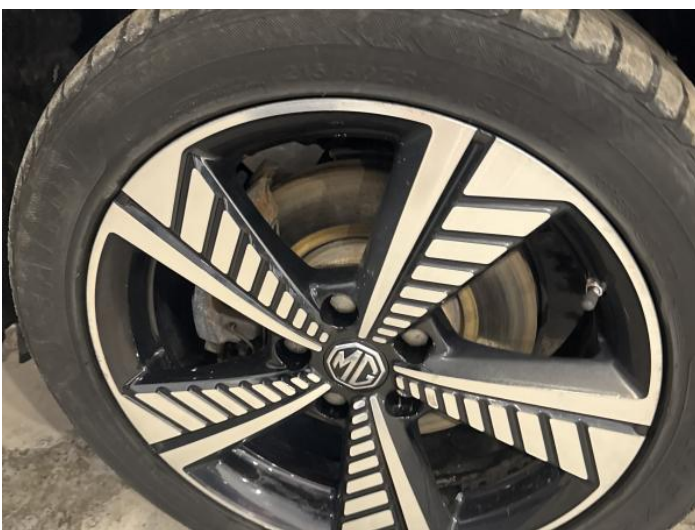
13: Wheel nsf
Scratched
Up To 50mm

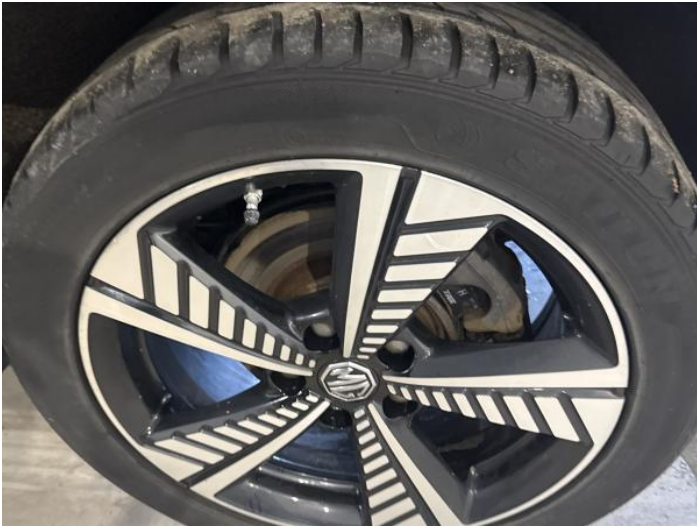
15: Wheel nsr
Scratched
Up To 50mm

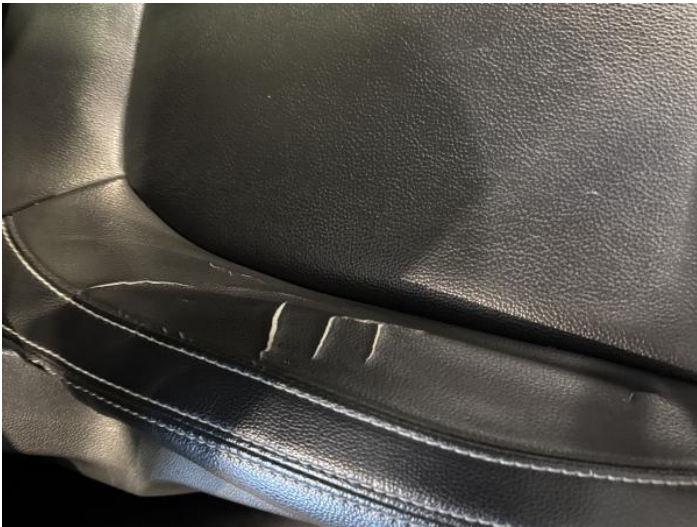
17: Seat Base Cover osf
Torn
Over 3mm

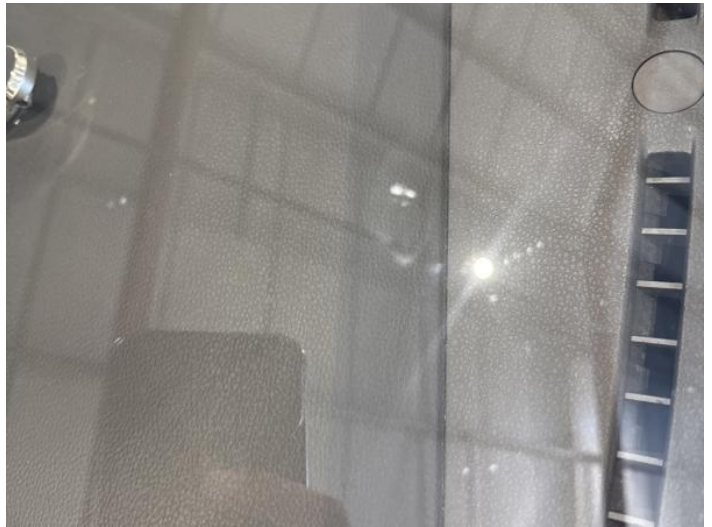
18: Screen Front
Chipped
UpTo 10mm

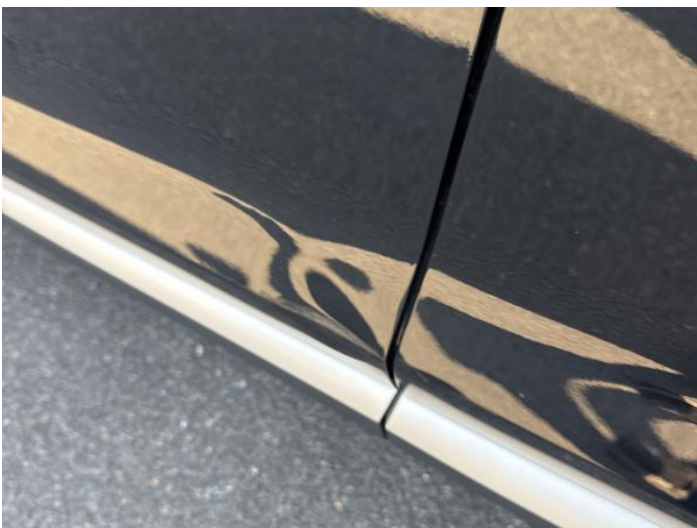
19: Door nsf
Dented
With Paint Damage

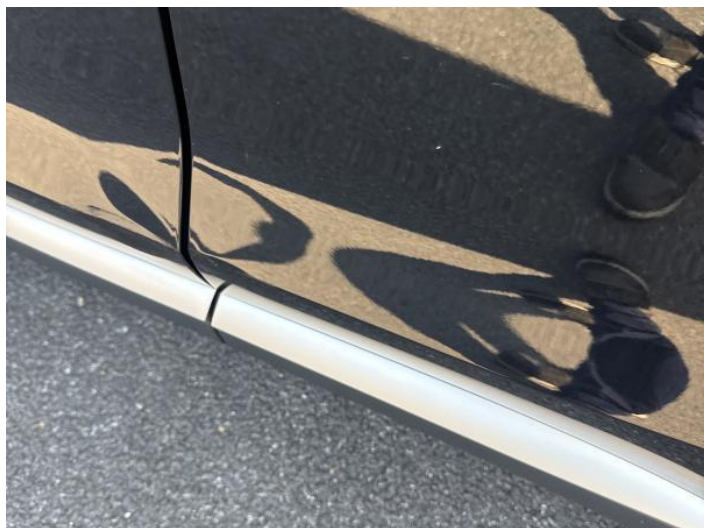
20: Door nsr
Dented
Over 30mm
