# VEHICLE INSPECTION REPORT

**RE10DMU**

## Citroen DS3 1.6 VTi 16V DStyle 3dr

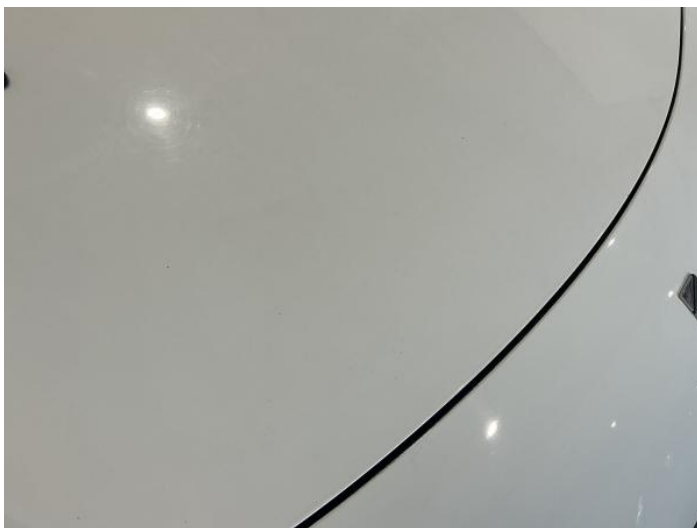
1: Bonnet  
Chipped  
1 To 5

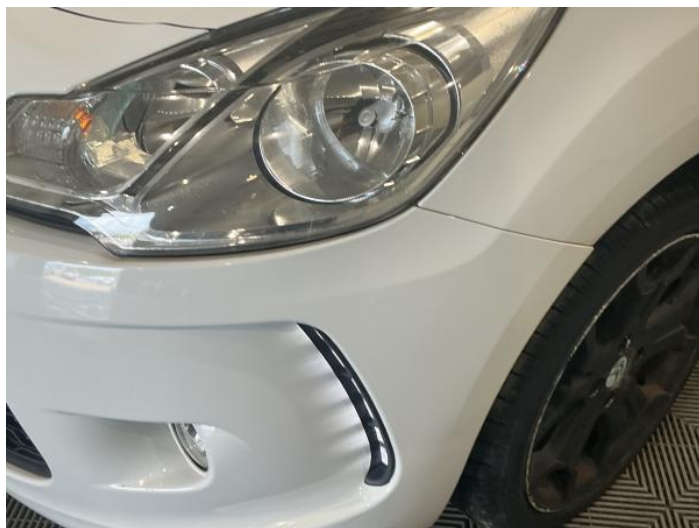
2: Bumper Front  
Chipped  
Multiple Chips

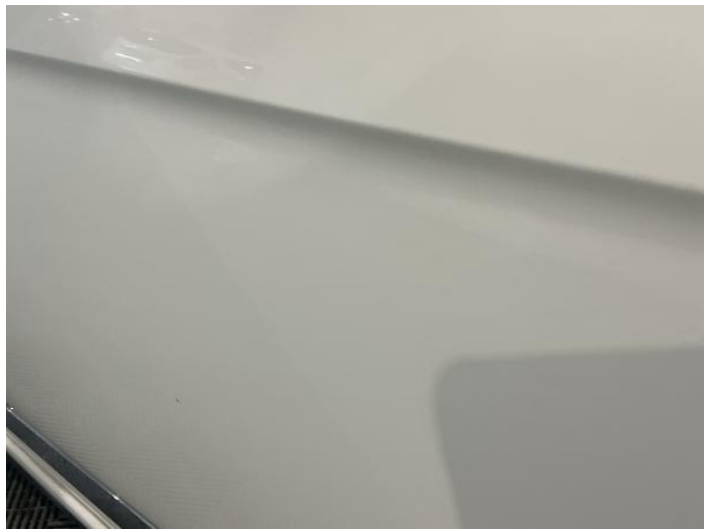
5: Wing nsf  
Scratched  
Over 25mm Not Thru Paint

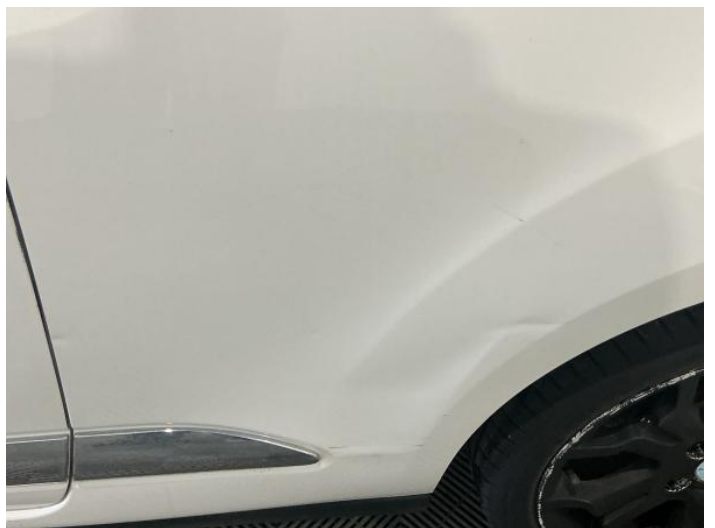
7: Door nsf  
Scratched  
Over 25mm Not Thru Paint

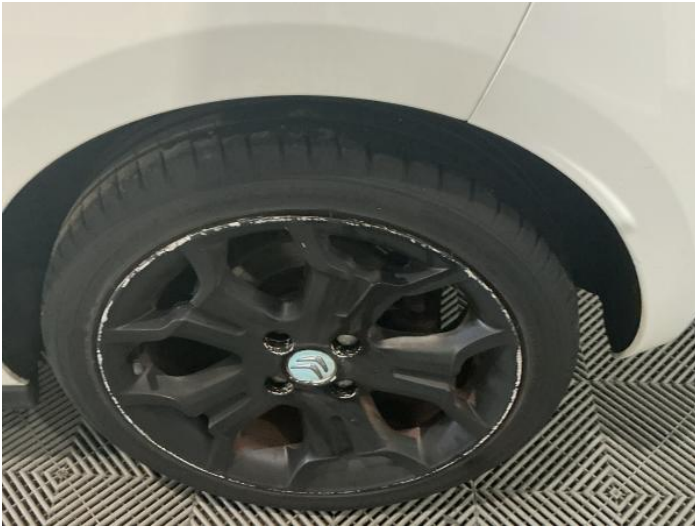
9: Wheel nsr  
Scratched  
Over 50mm

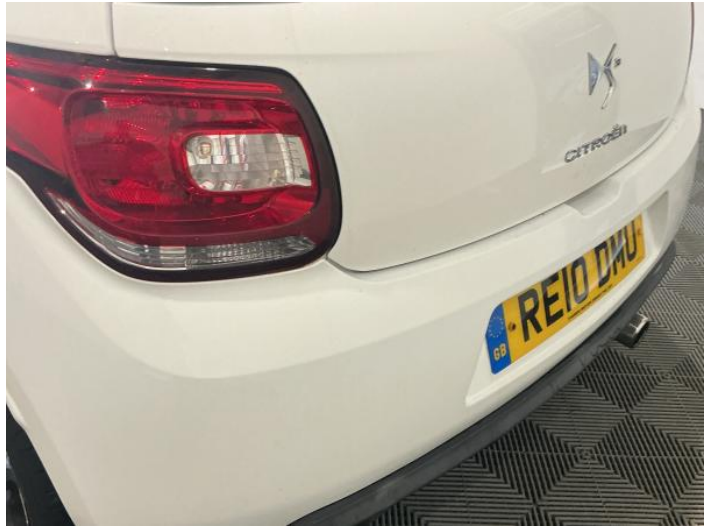
10: Bumper Rear  
Poor Previous Repair  
Poor Colour

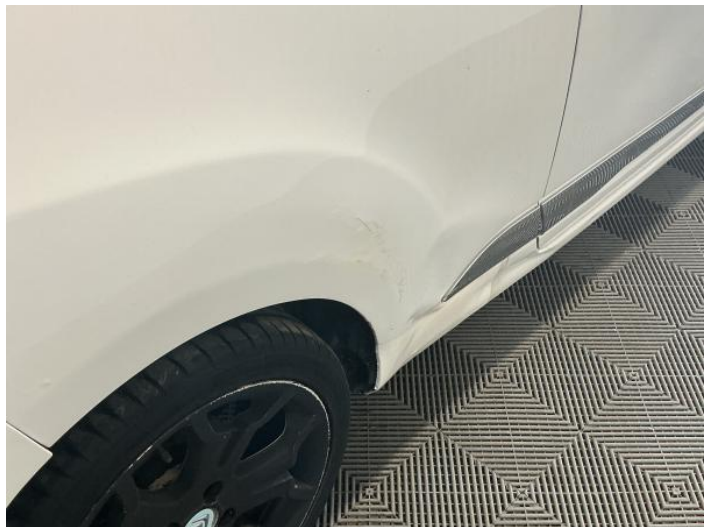
12: Qtr Panel osr  
Dented  
With Paint Damage

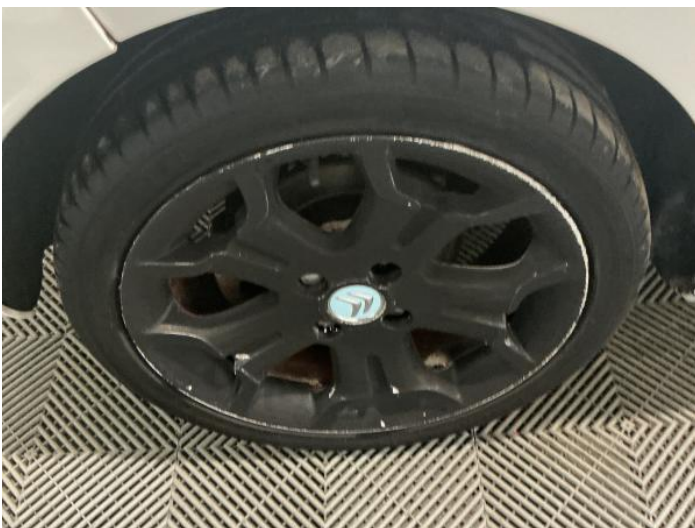
13: Wheel osr  
Scratched  
Over 50mm

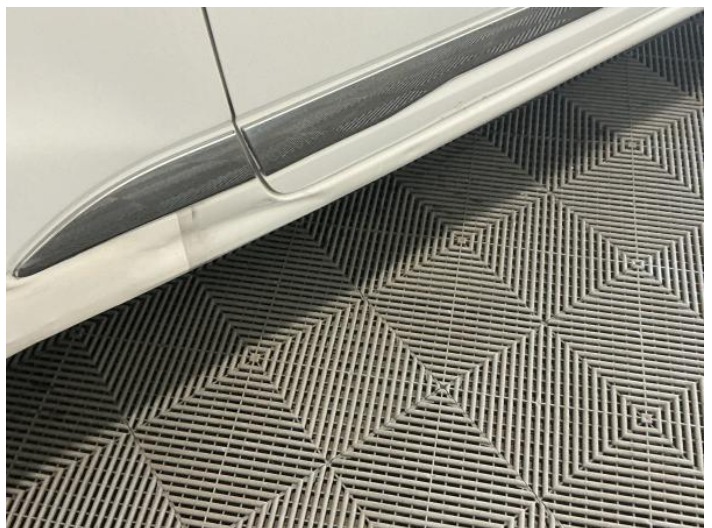
14: Sill os  
Dented  
With Paint Damage

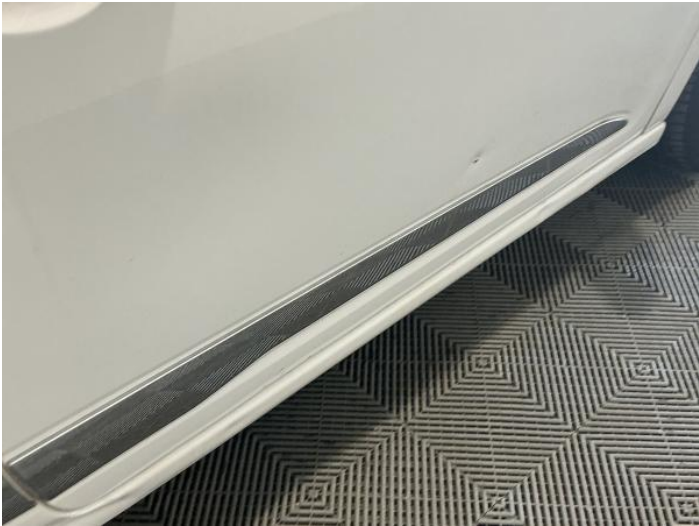
15: Door osf  
Dented  
With Paint Damage

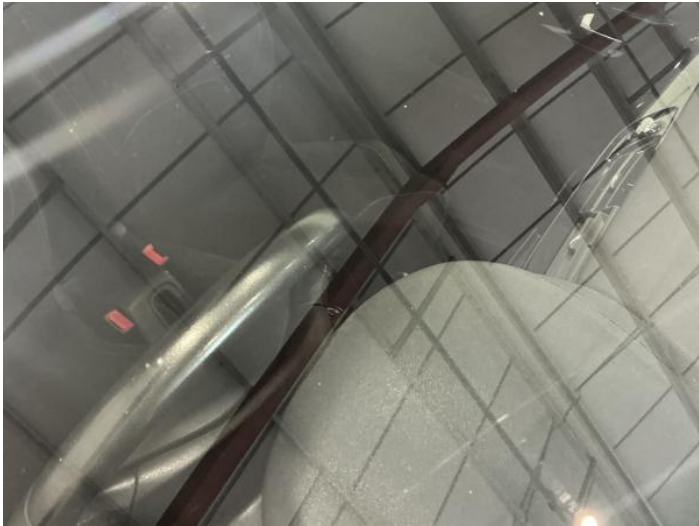
16: Screen Front  
Chipped  
UpTo 10mm

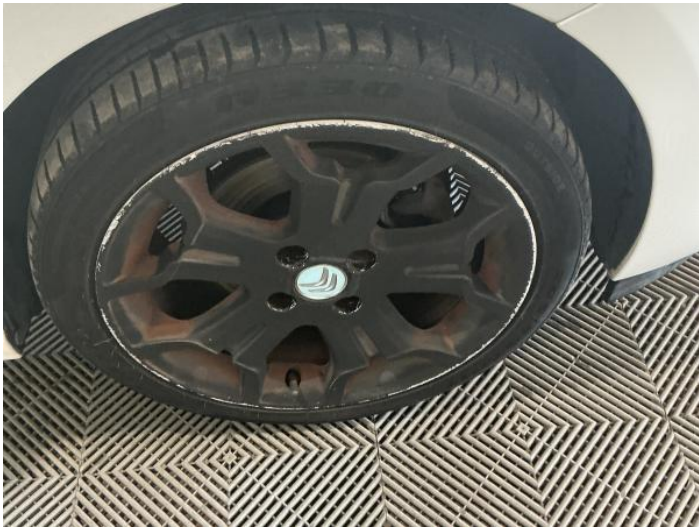
18: Wheel osf  
Scratched  
Over 50mm
