### **VEHICLE INSPECTION REPORT**

### **Renault ZOE DYNAMIQUE INTENS**

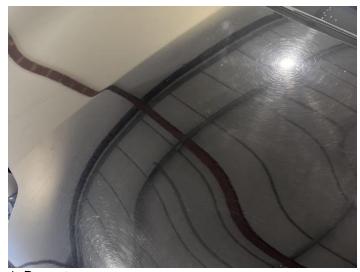
1: Bonnet Dented With Paint Damage

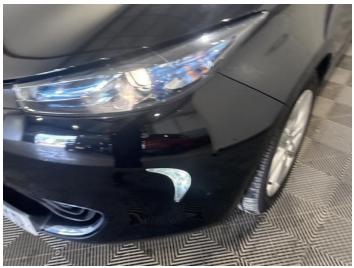
2: Bumper Front Chipped Multiple Chips

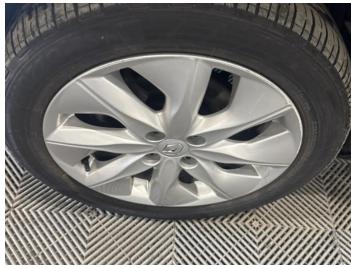
4: Wheel nsf Scratched Over 50mm

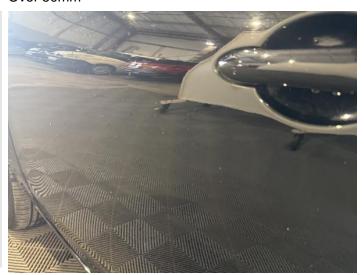
6: Door nsf Chipped 1 To 5

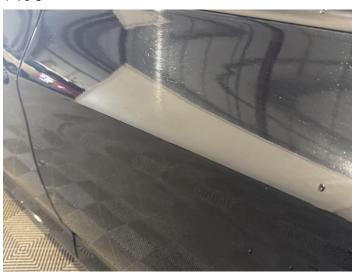
8: Door nsr Dented 2 Or Less UpTo 10mm

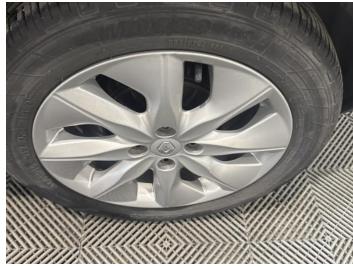
10: Wheel nsrScratchedUp To 50mm

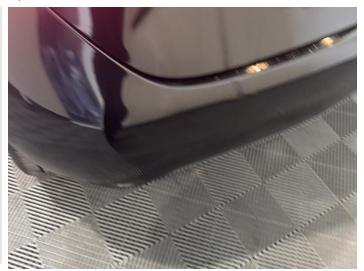
12: Bumper Rear Poor Previous Repair Poor Paint

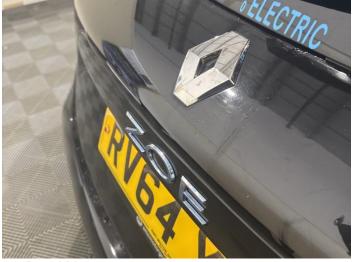
13: Boot Lid Dented 2 Or Less UpTo 10mm

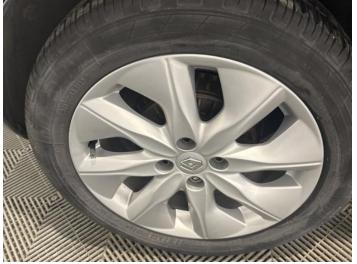
15: Wheel osr Scratched Up To 50mm

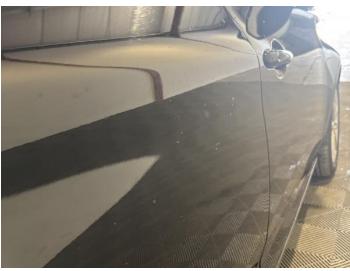
16: Door osr Dented Over 2 UpTo 10mm

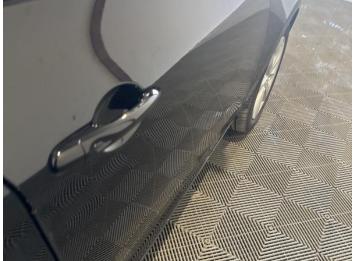
17: Door osf Dented With Paint Damage

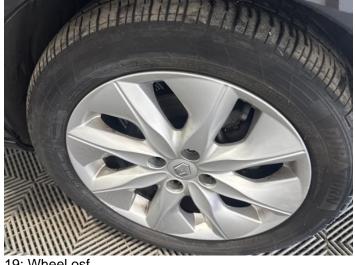
19: Wheel osf Scratched Up To 50mm
