VEHICLE INSPECTION REPORT

MC14NRZ

Peugeot 108 1.2 VTi Allure 5dr

nama
GRADE
2

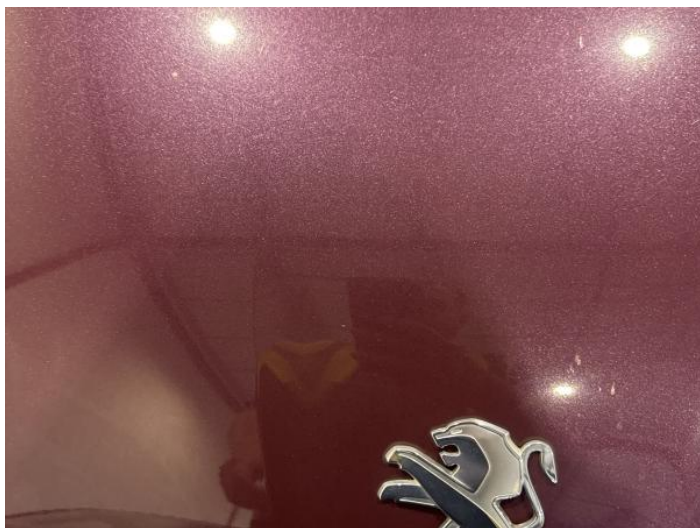
1: Bonnet
Chipped
1 To 5

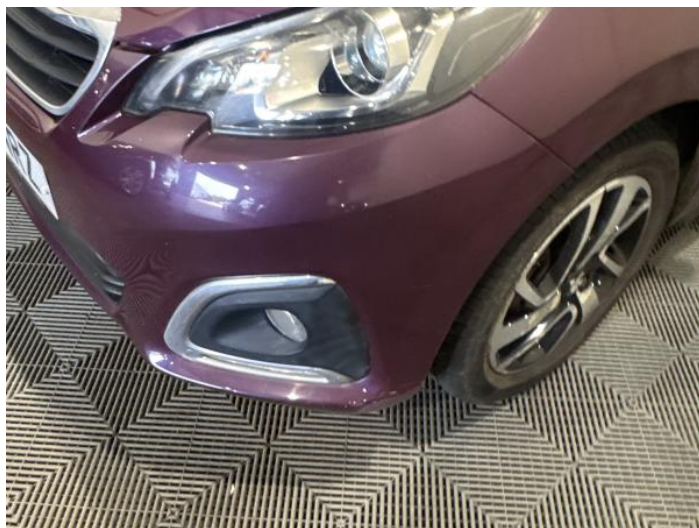
2: Bumper Front
Scratched
25 to 100mm Thru Paint

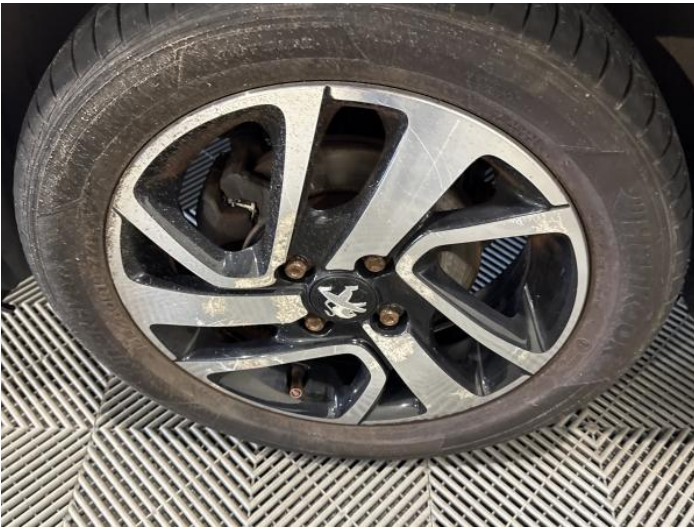
5: Wheel nsf
Scratched
Over 50mm

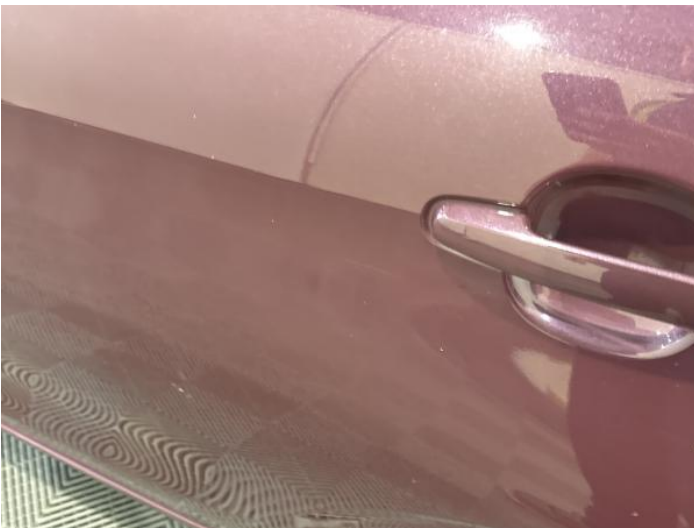
7: Door nsr
Chipped
1 To 5

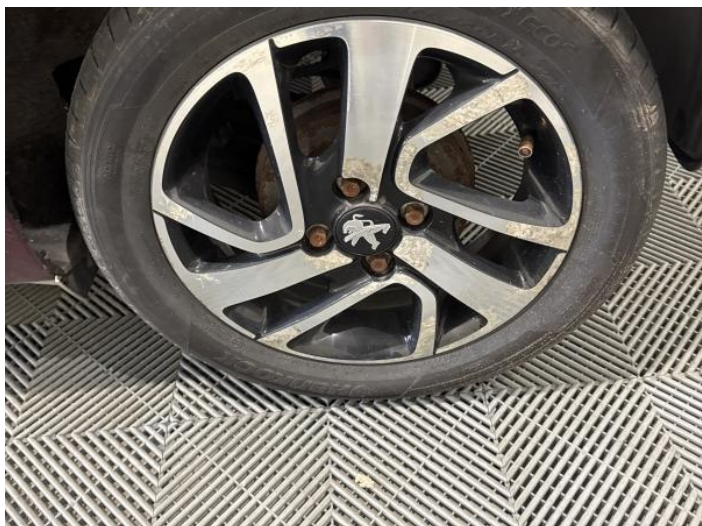
9: Wheel nsr
Scratched
Over 50mm

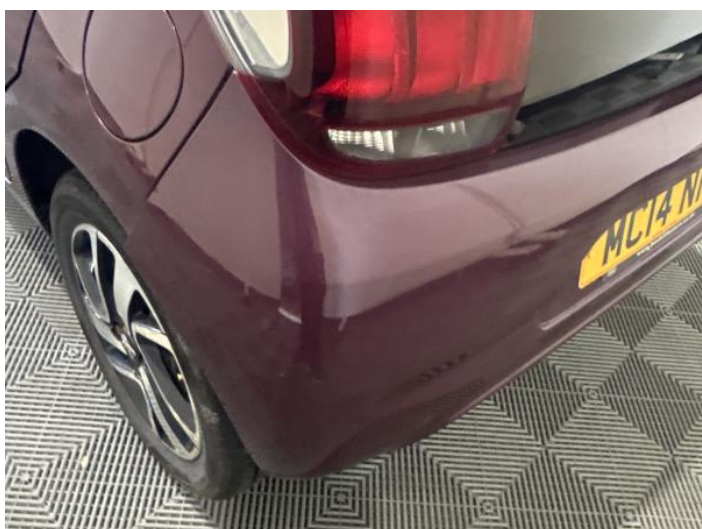
11: Bumper Rear
Scratched
Over 100mm Thru Paint

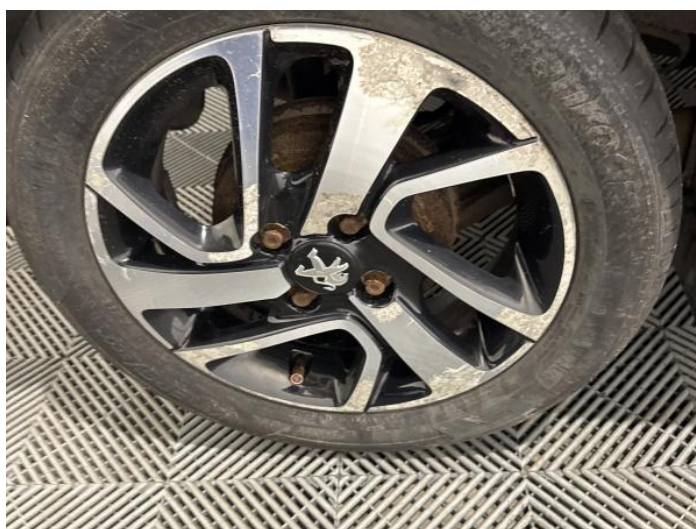
12: Wheel osr
Scratched
Over 50mm

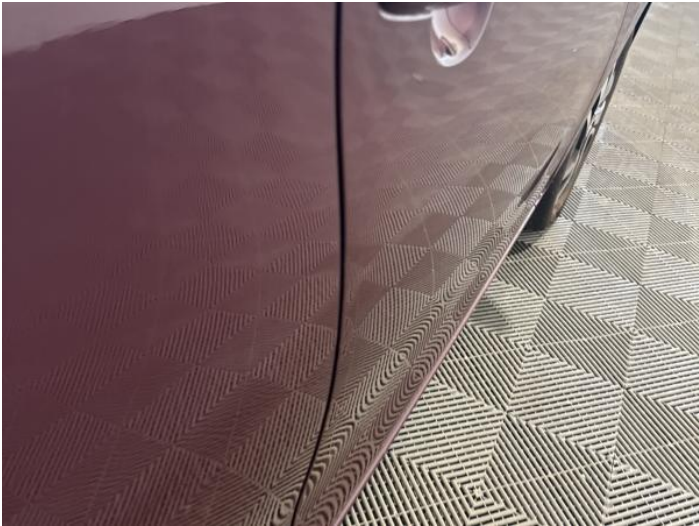
15: Door osf
Dented
Between 10mm + 30mm

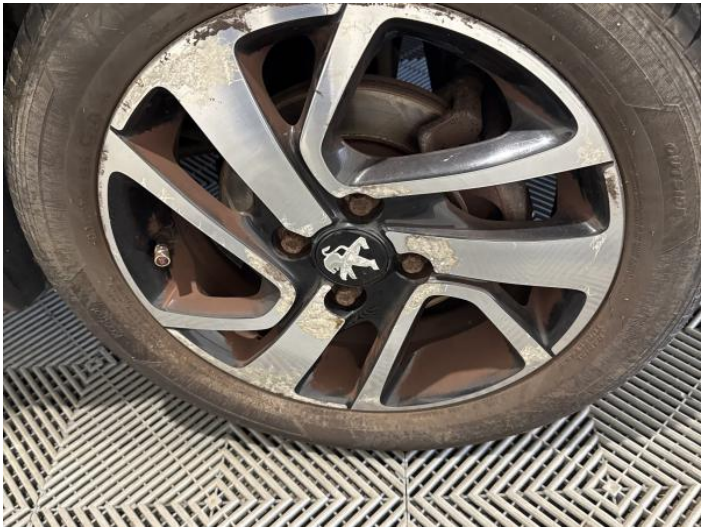
18: Wheel osf
Scratched
Over 50mm
