VEHICLE INSPECTION REPORT

SA15UZP

Peugeot 108 1.0 Active 5dr

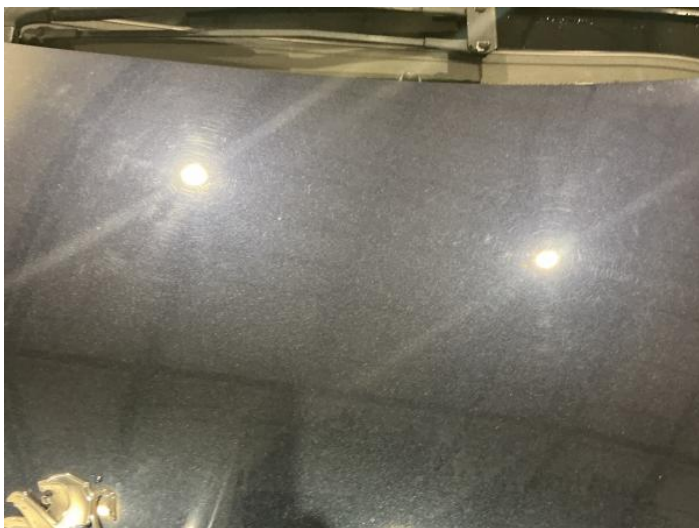
1: Bonnet
Chipped
1 To 5

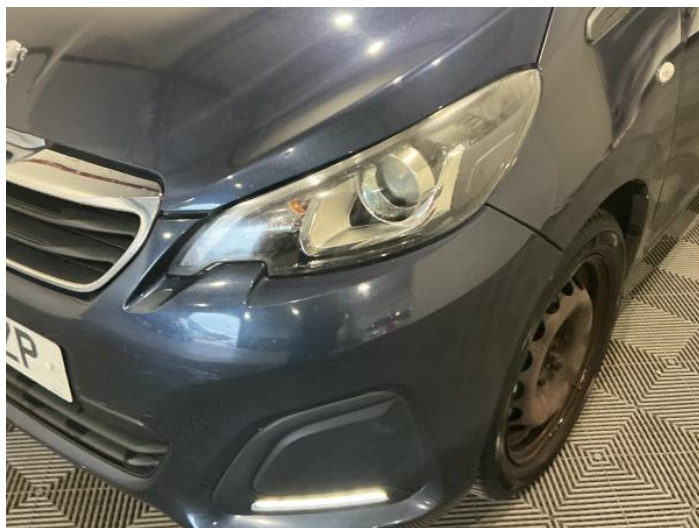
2: Bumper Front
Poor Previous Repair
Poor Paint

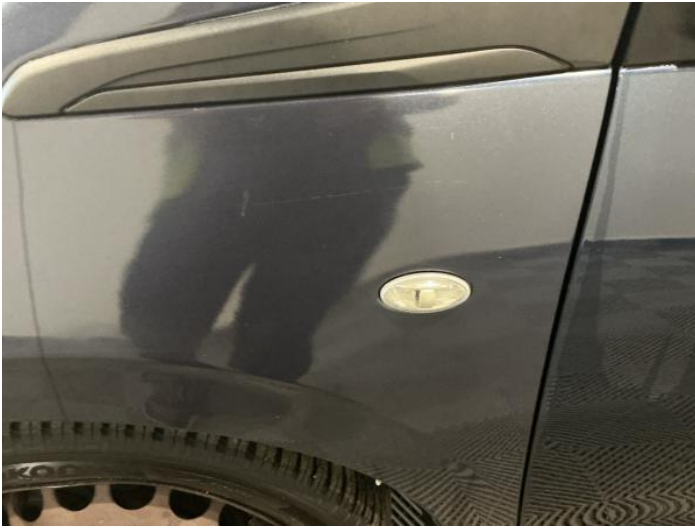
3: Wing nsf
Poor Previous Repair
Poor Paint

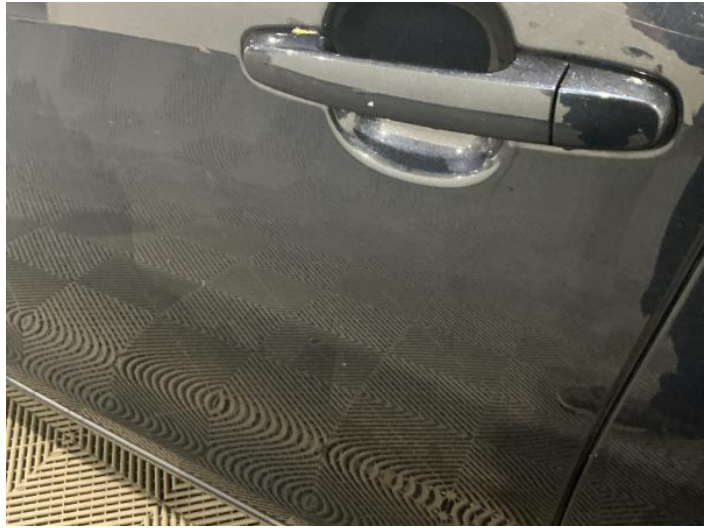
4: Door nsf
Chipped
1 To 5

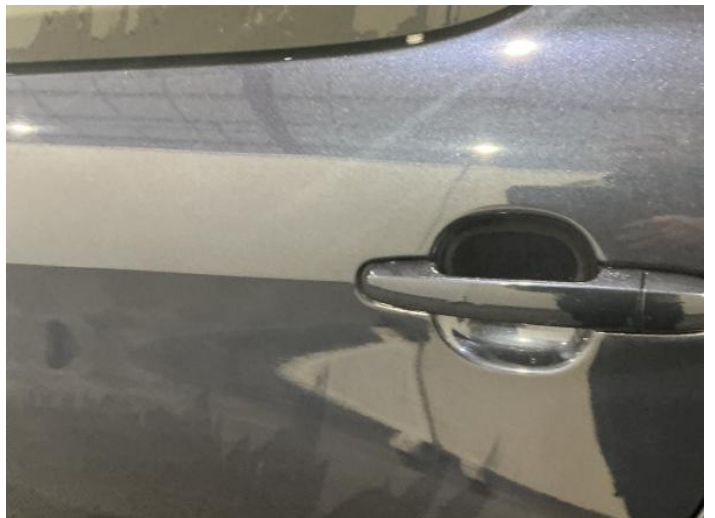
6: Door nsr
Chipped
1 To 5

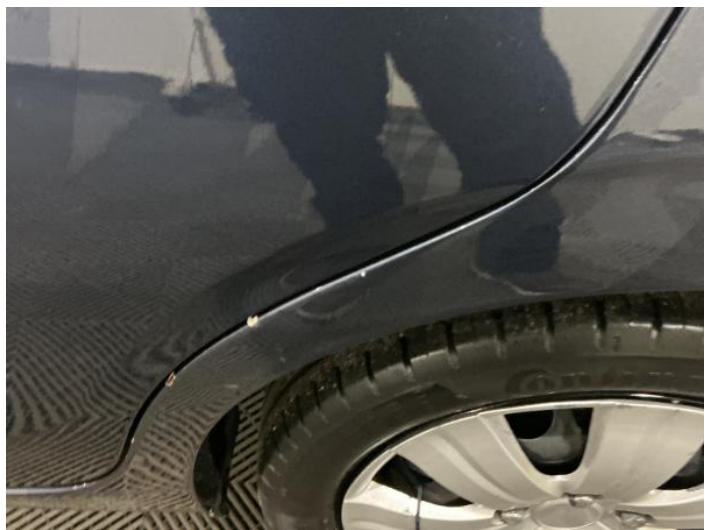
8: Qtr Panel nsr
Rusted
UpTo 5mm

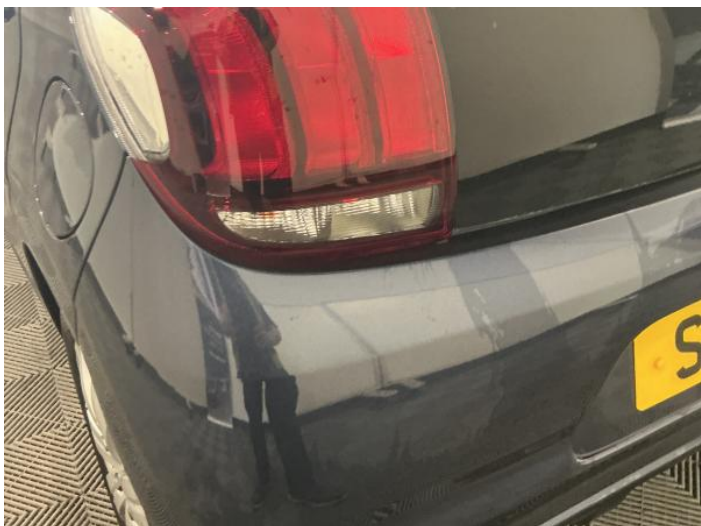
9: Bumper Rear
Scratched
25 to 100mm Thru Paint

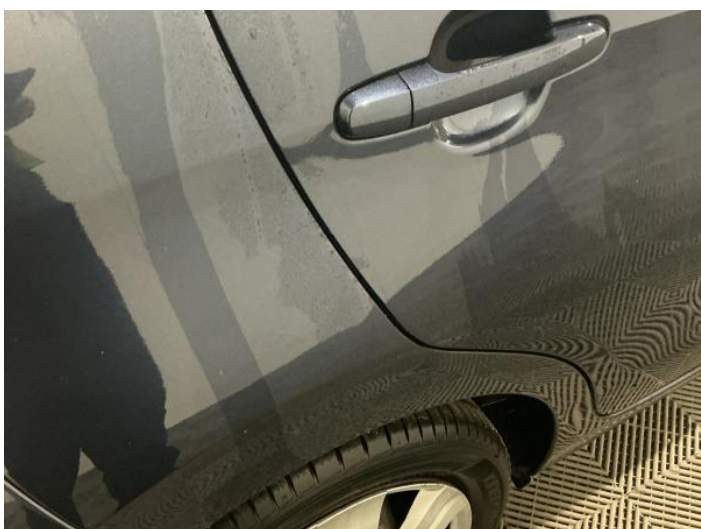
11: Qtr Panel osr
Dented
2 Or Less UpTo 10mm

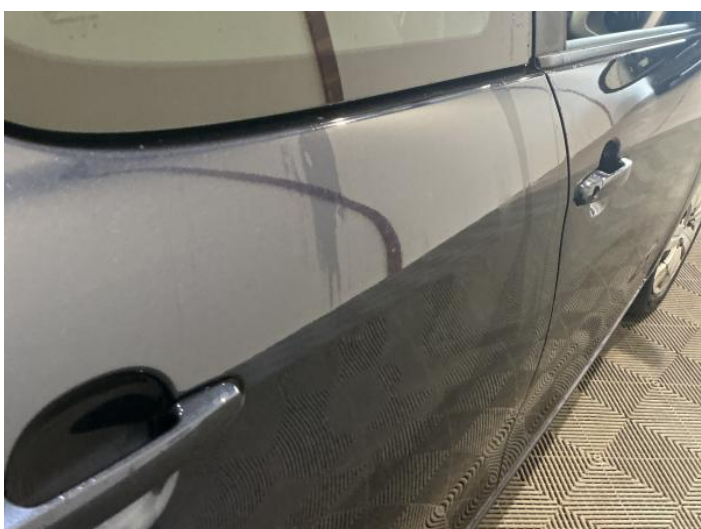
13: Door osr
Dented
Between 10mm + 30mm

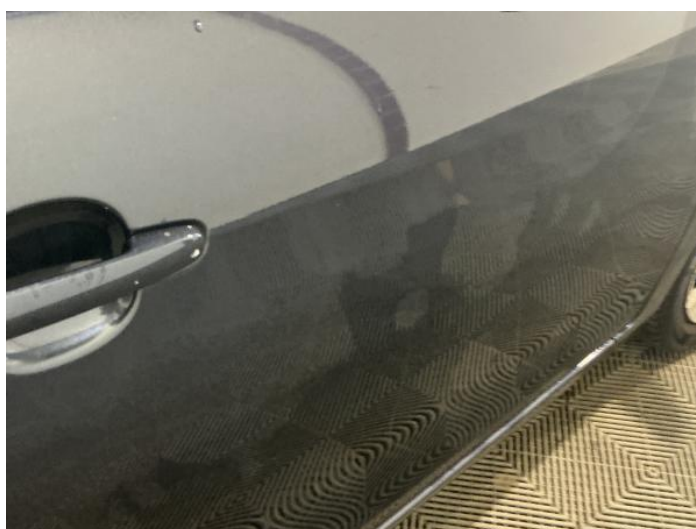
14: Door osf
Dented
Over 2 UpTo 10mm

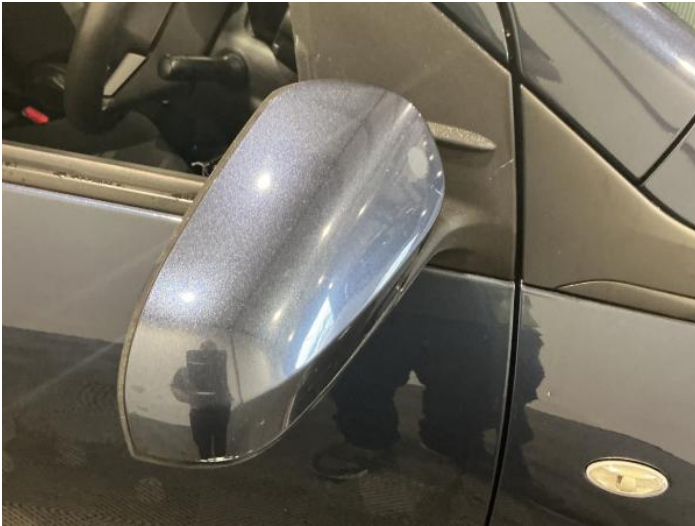
15: Door Mirror Assy osf
Scratched (Painted)
UpTo 25mm Thru Paint

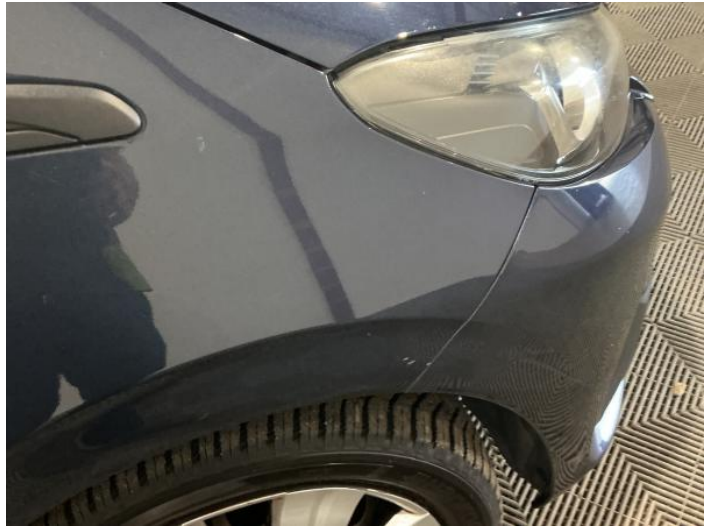
16: Wing osf
Chipped
1 To 5

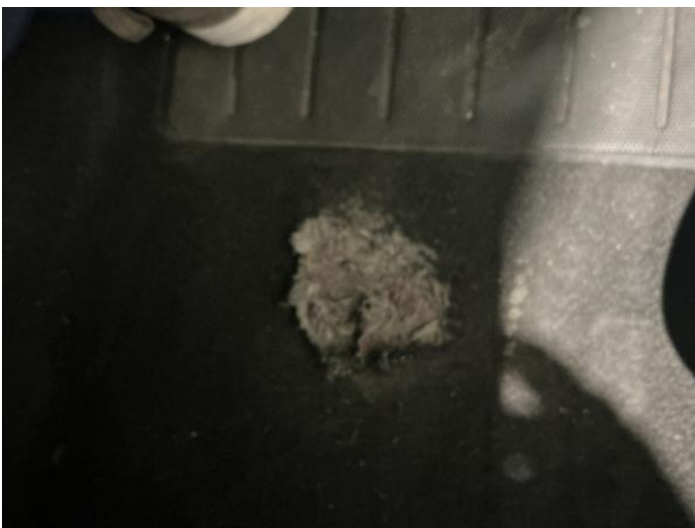
19: Carpets Front
Torn
Over 10mm
