# VEHICLE INSPECTION REPORT

**GV61NPE**

## Peugeot 207 1.4 VTi 95 Active 5dr

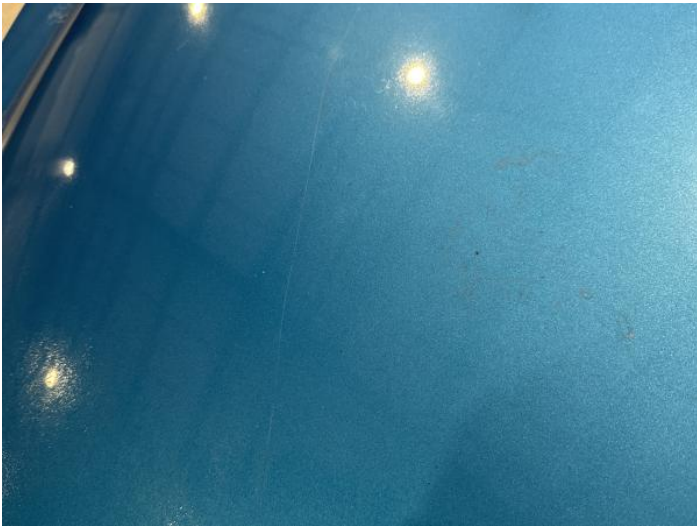
1: Bonnet  
Scratched  
Over 25mm Thru Paint

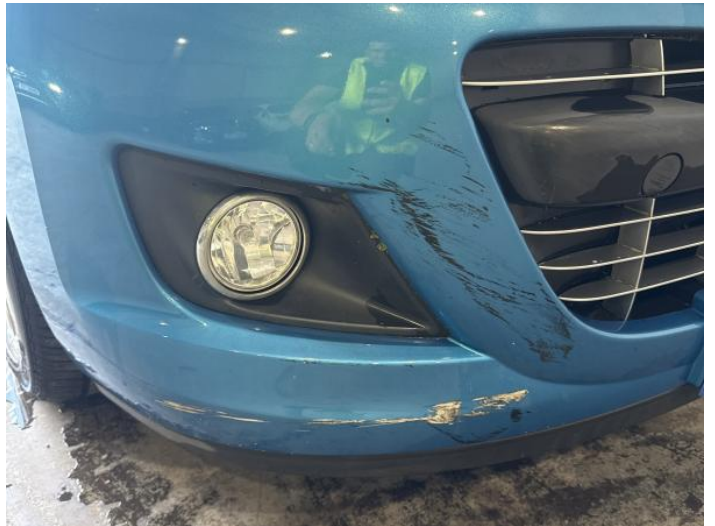
2: Bumper Front  
Scratched  
Over 100mm Thru Paint

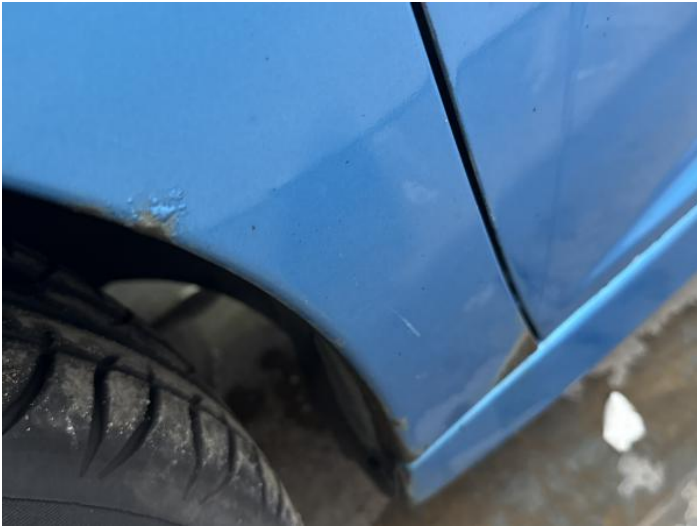
3: Wing nsf  
Rusted  
Over 5mm

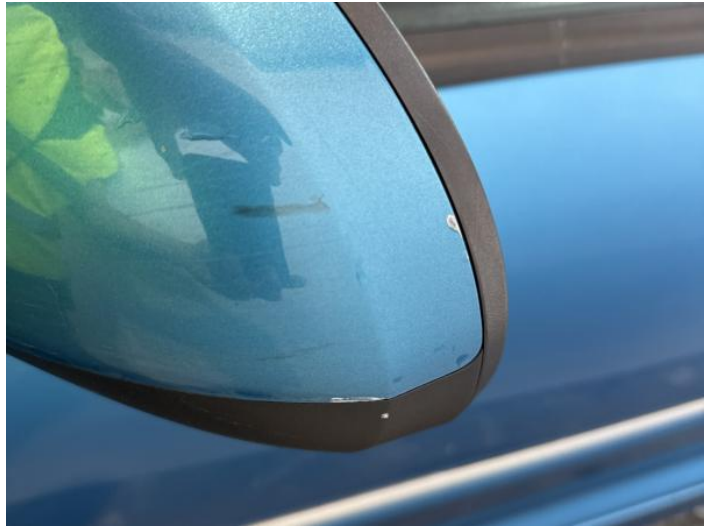
4: Door Mirror Assy nsf  
Scratched (Painted)  
Over 25mm Thru Paint

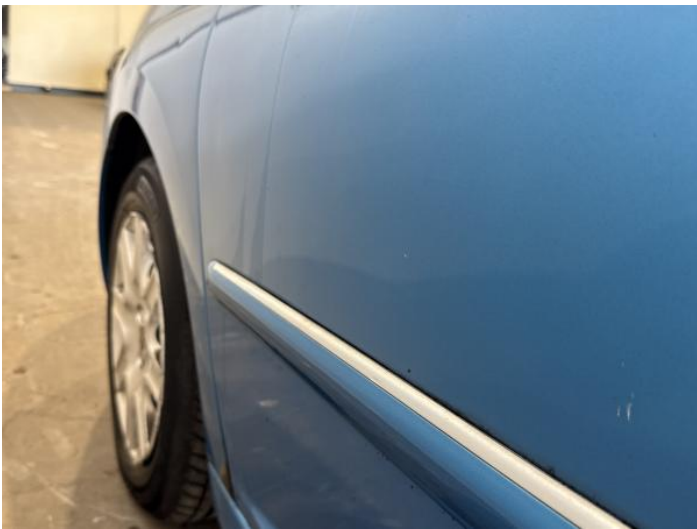
5: Door nsf  
Dented  
Over 30mm

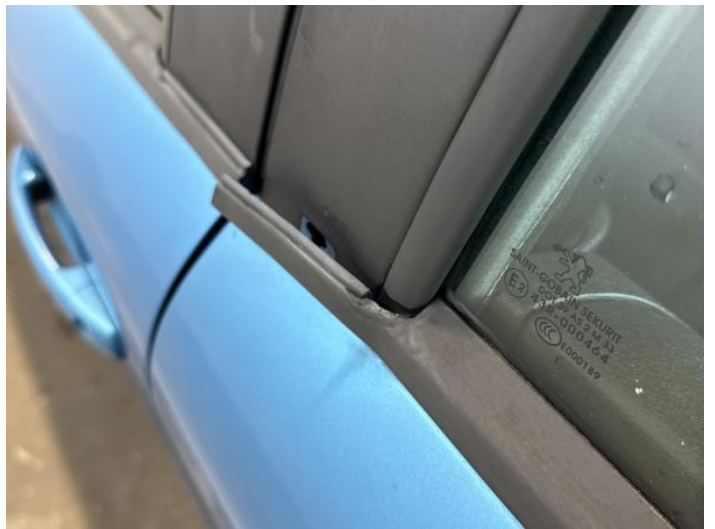
6: Aperture Seal nsr  
Broken  
Replace

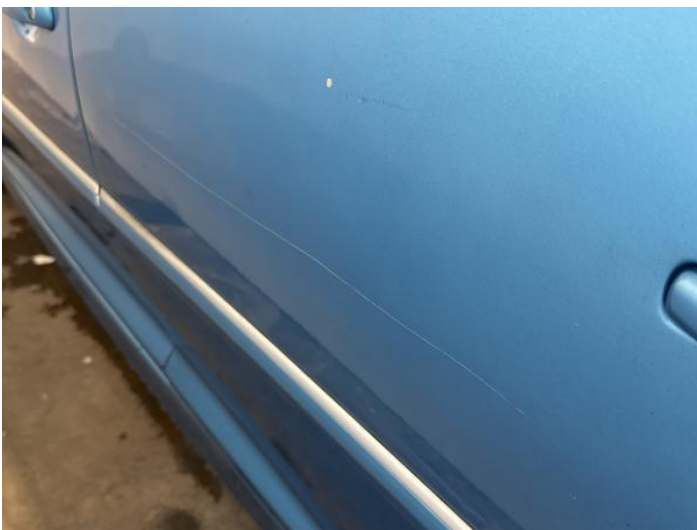
7: Door nsr  
Scratched  
Over 25mm Thru Paint

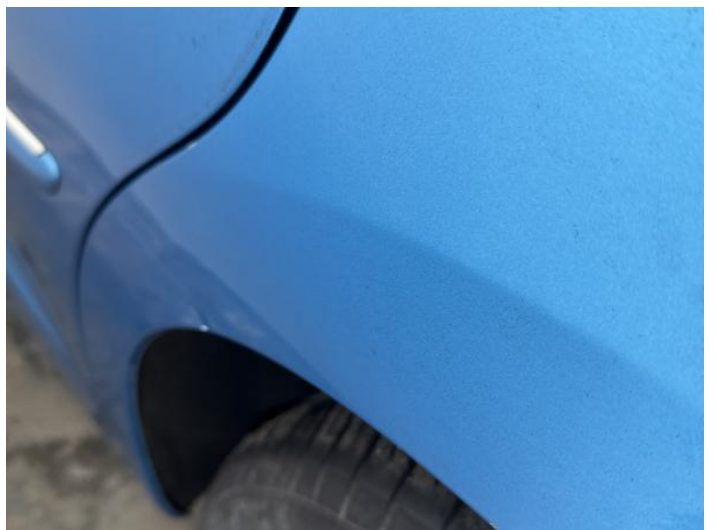
8: Qtr Panel nsr  
Dented  
With Paint Damage

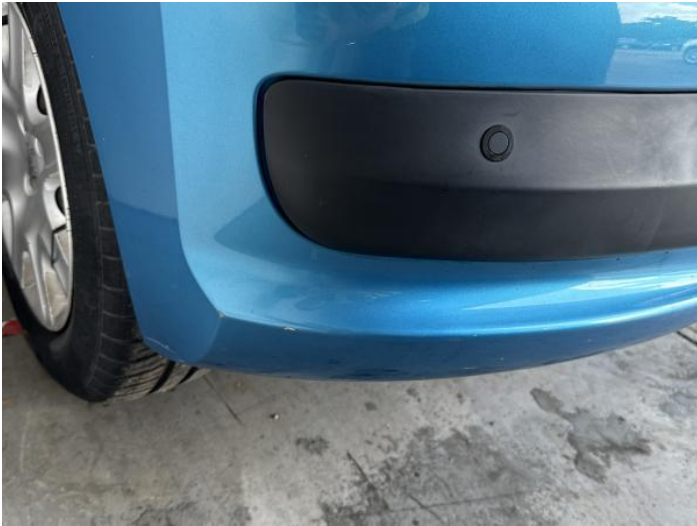
9: Bumper Rear  
Scratched  
Over 100mm Thru Paint

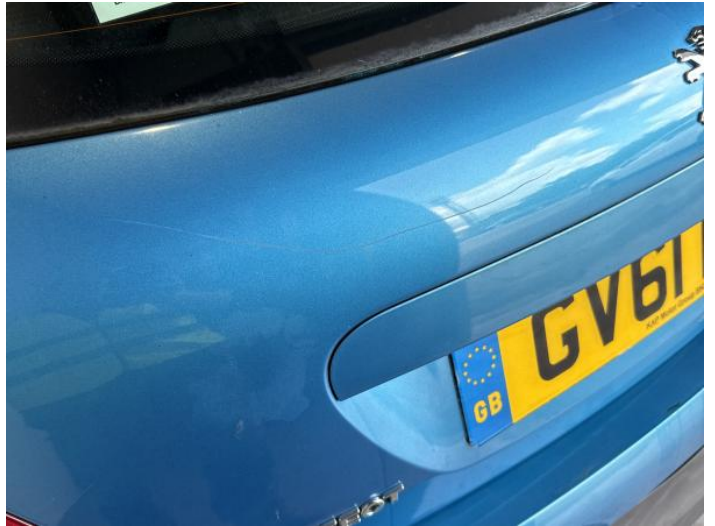
10: Tailgate  
Scratched  
Over 25mm Thru Paint

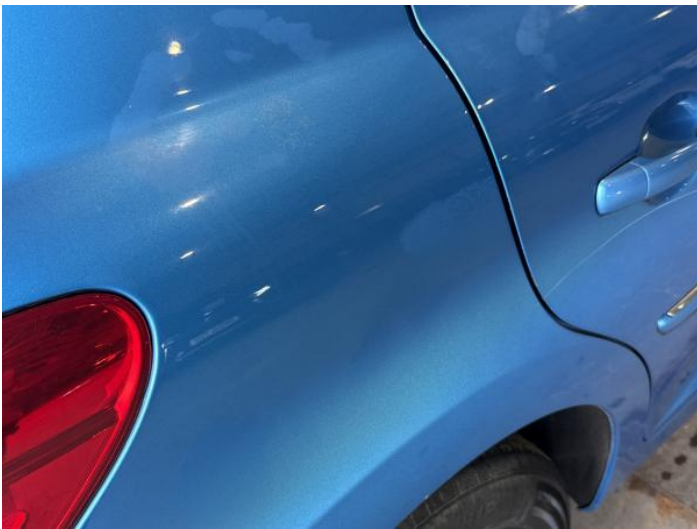
11: Qtr Panel osr  
Scratched  
Over 25mm Thru Paint

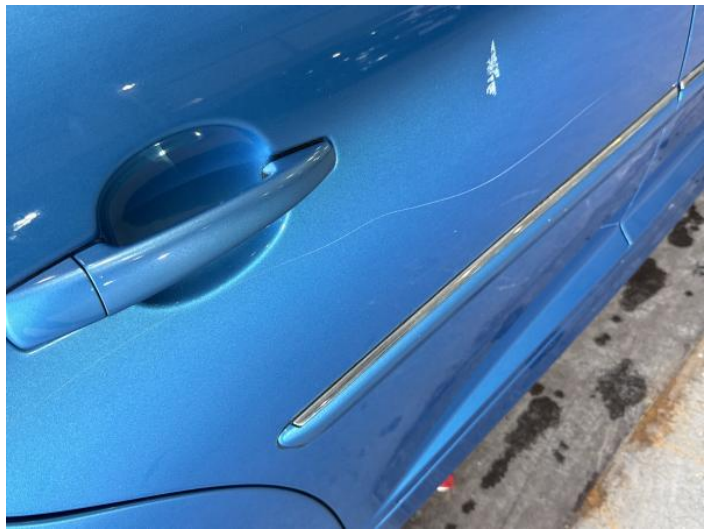
12: Door osr  
Dented  
With Paint Damage

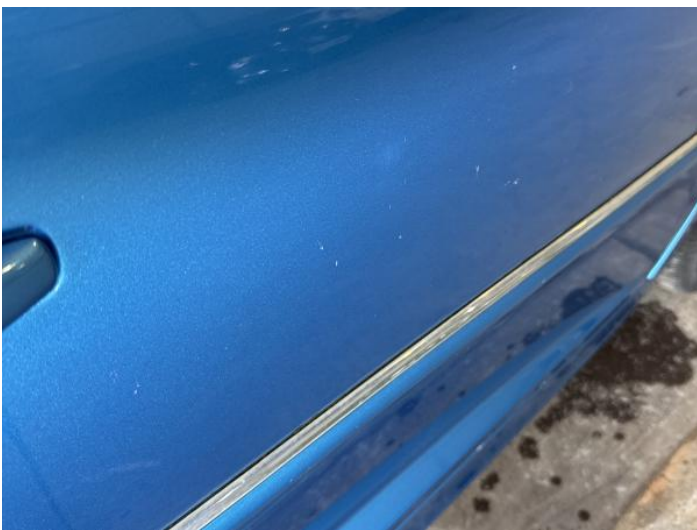
13: Door osf  
Chipped  
Multiple Chips

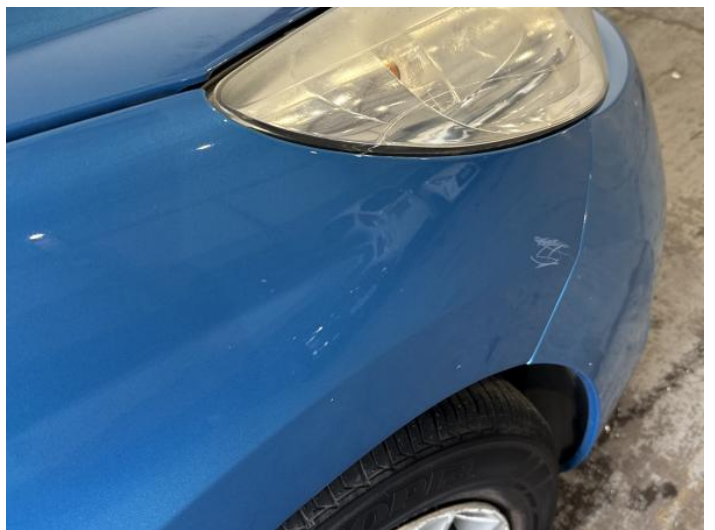
14: Wing osf  
Dented  
With Paint Damage

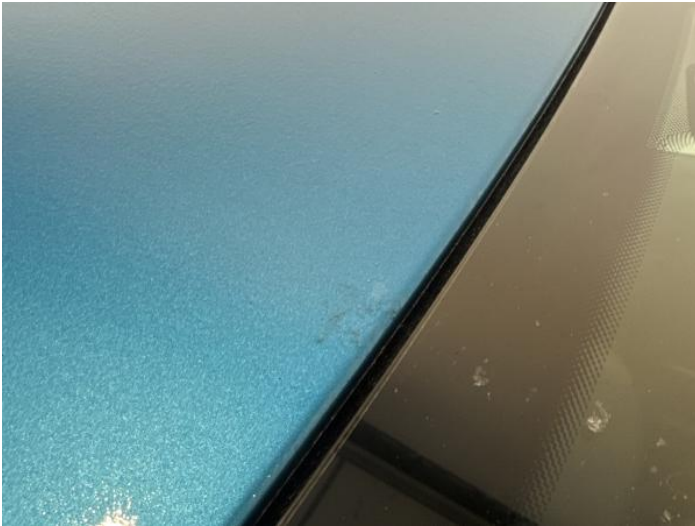
15: Roof  
Rusted  
Over 5mm
