VEHICLE INSPECTION REPORT

SY60RZJ

Audi A3 2.0 TDI 170 Sport 5dr S Tronic

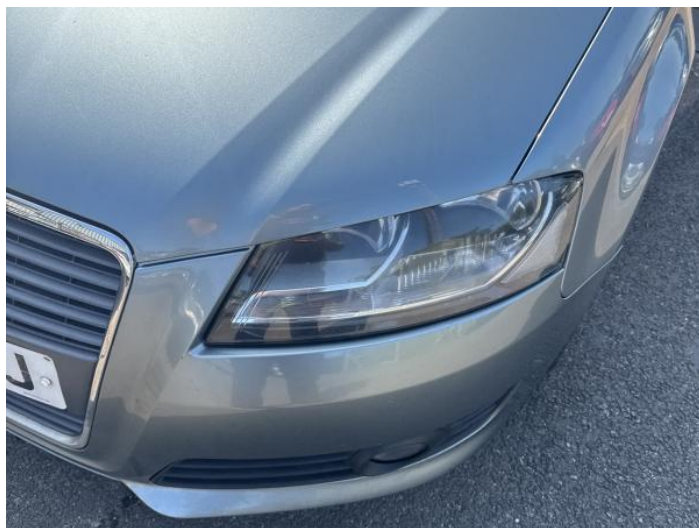
2: Bumper Front
Poor Previous Repair
Poor Paint

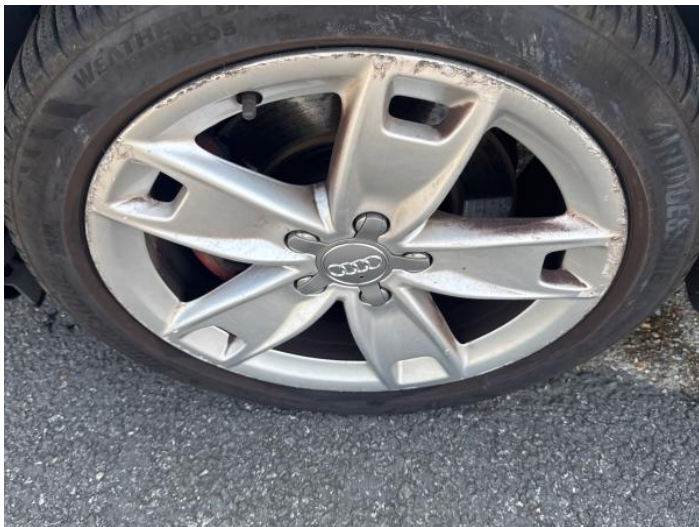
3: Wheel nsf
Scratched
Over 50mm

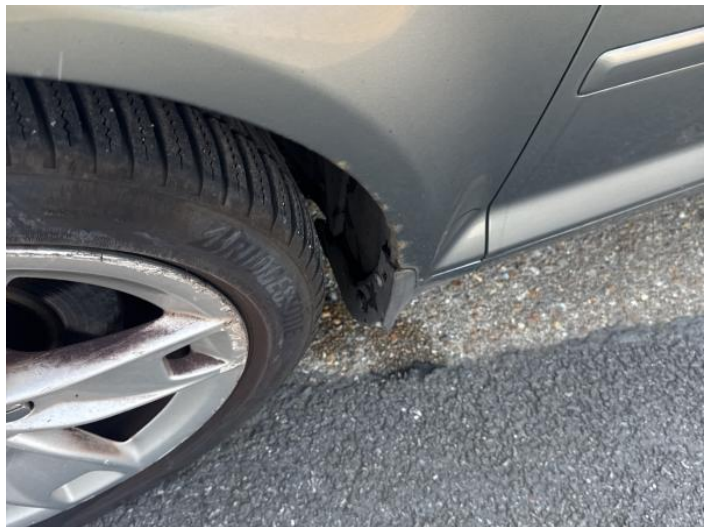
4: Wing nsf
Rusted
Over 5mm

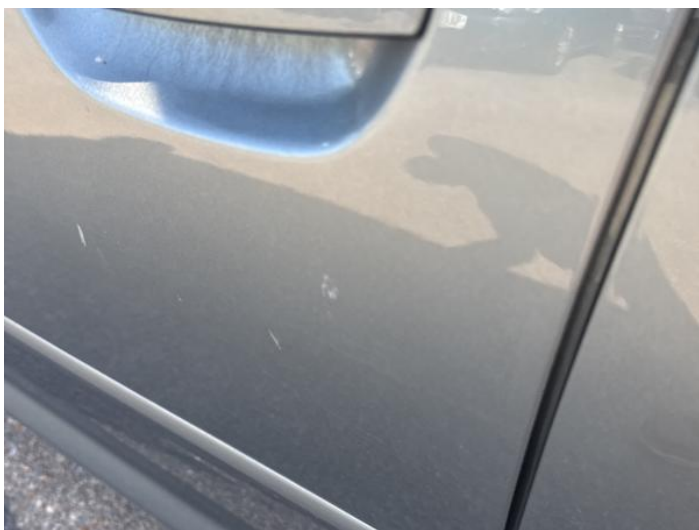
5: Door nsf
Chipped
1 To 5

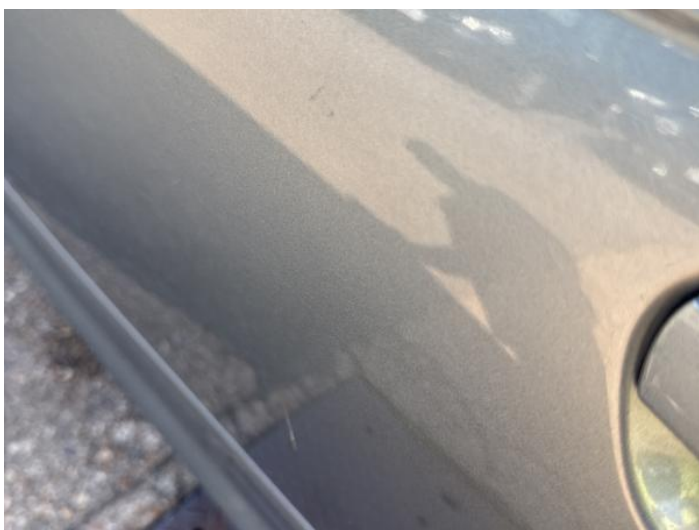
7: Door nsr
Dented
2 Or Less UpTo 10mm

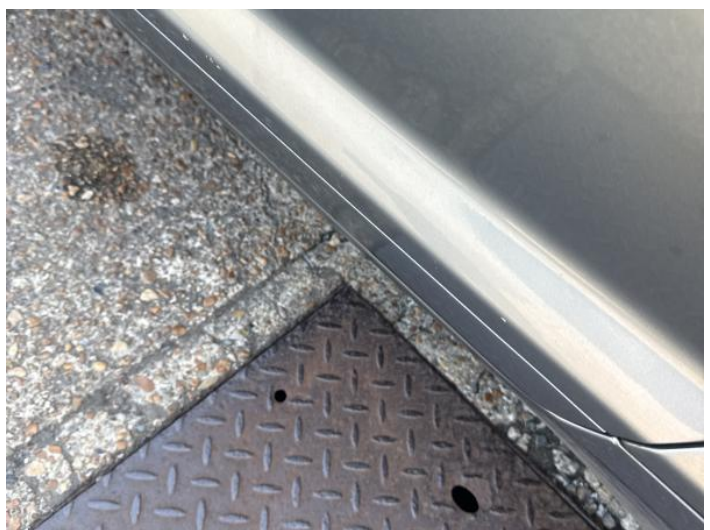
8: Door nsr
Chipped
1 To 5

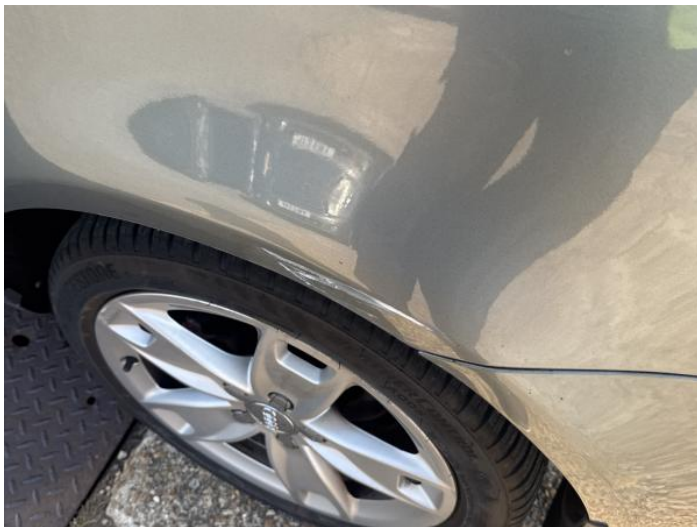
9: Qtr Panel nsr
Dented
With Paint Damage

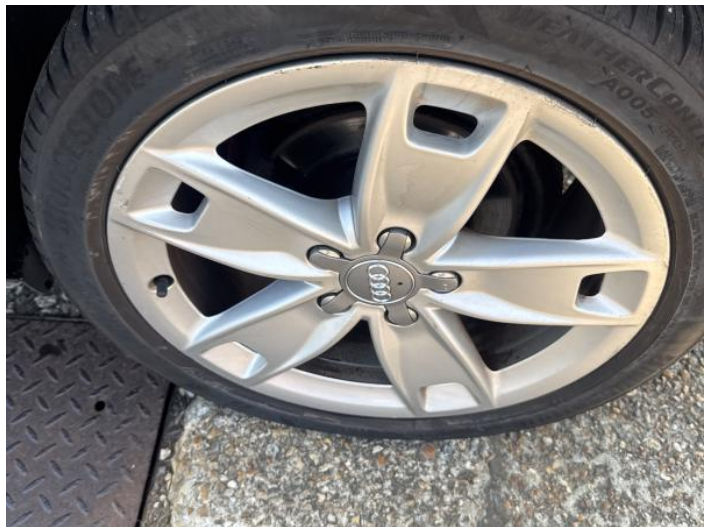
10: Wheel nsr
Scratched
Over 50mm

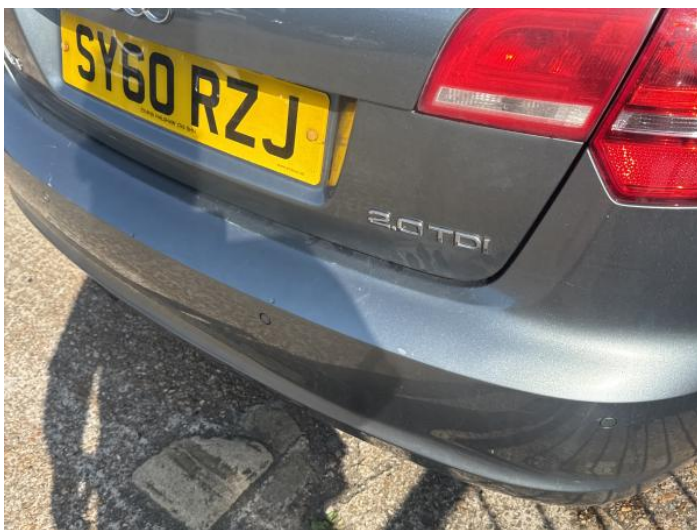
11: Bumper Rear
Scratched
25 to 100mm Thru Paint

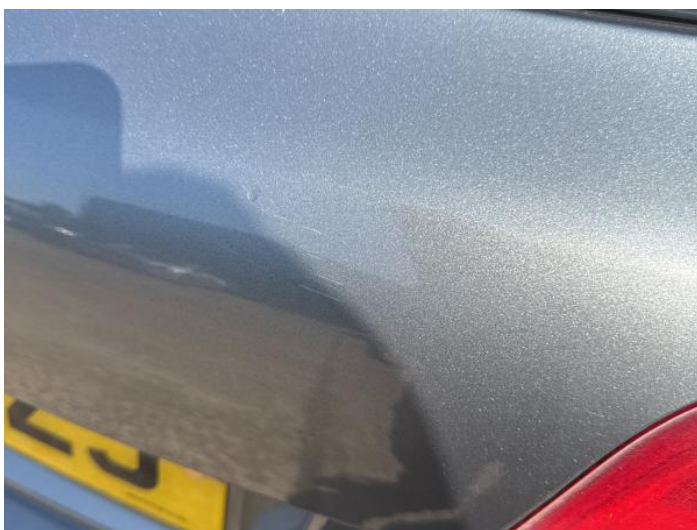
13: Boot Lid
Scratched
UpTo 25mm Thru Paint

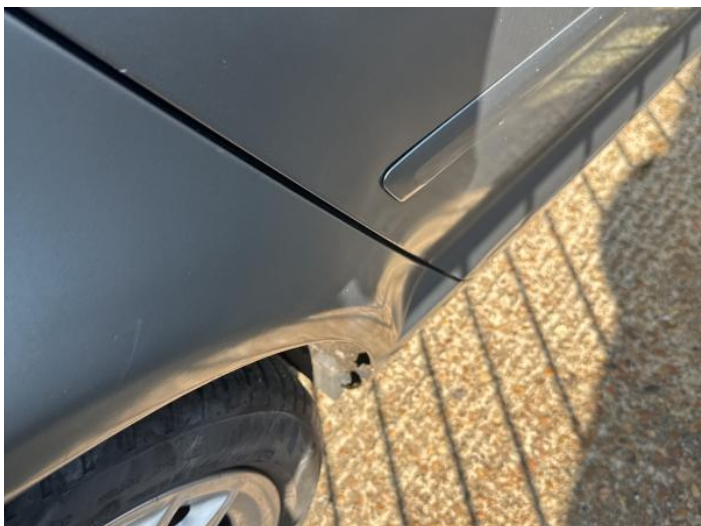
15: Qtr Panel osr
Poor Previous Repair
Poor Paint

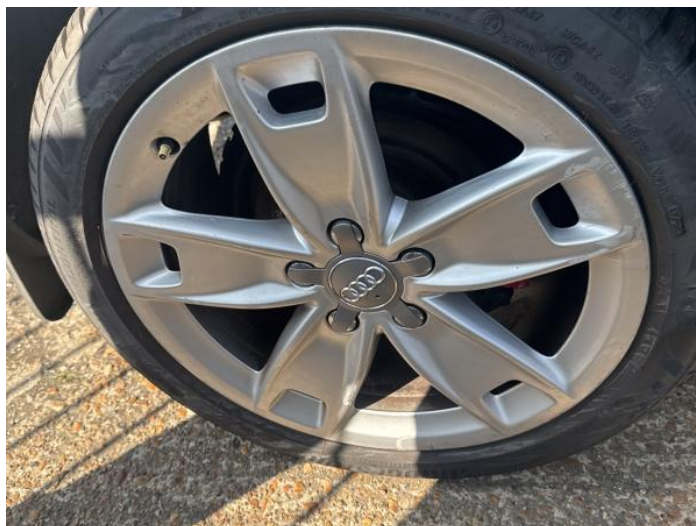
16: Wheel osr
Scratched
Over 50mm

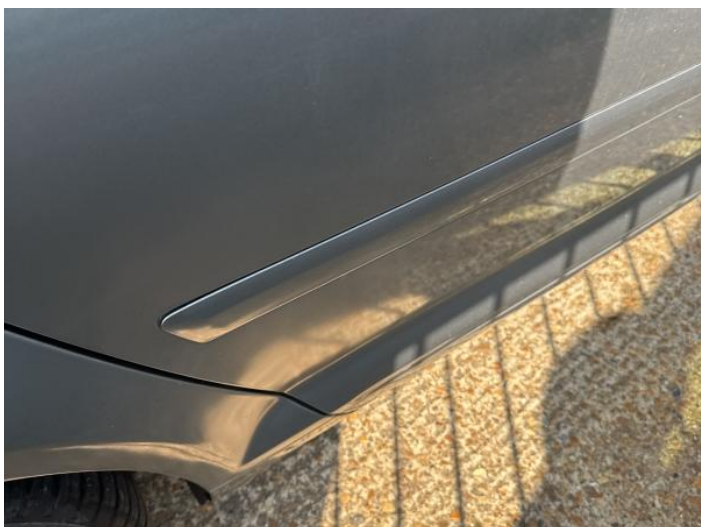
17: Door osr
Poor Previous Repair
Poor Paint

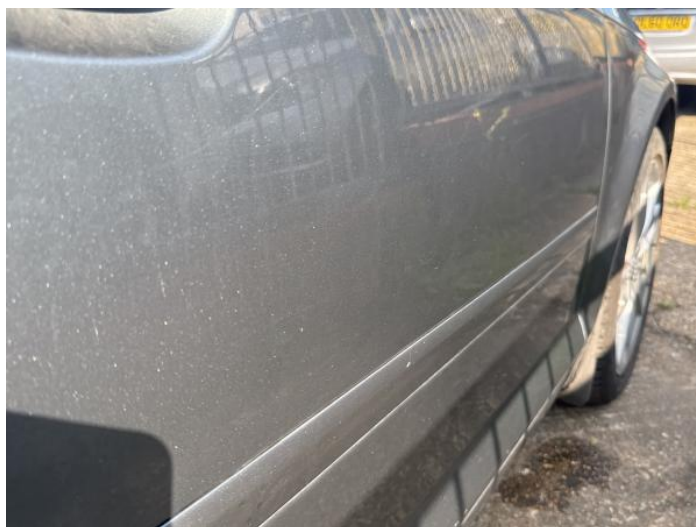
18: Door osf
Chipped
1 To 5

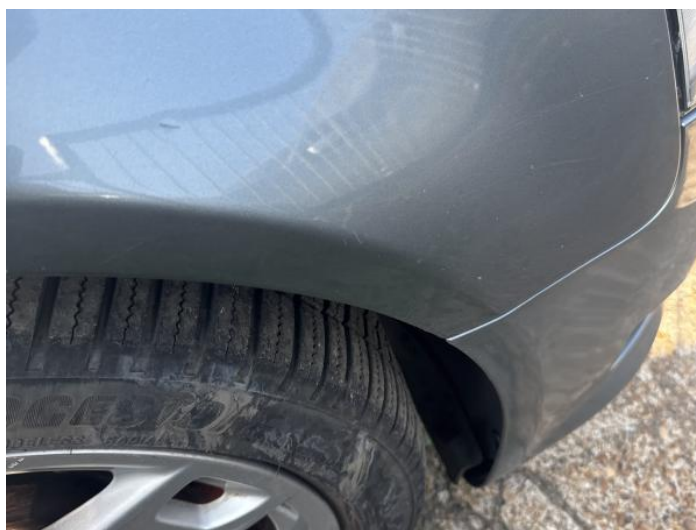
20: Wing osf
Rusted
Over 5mm

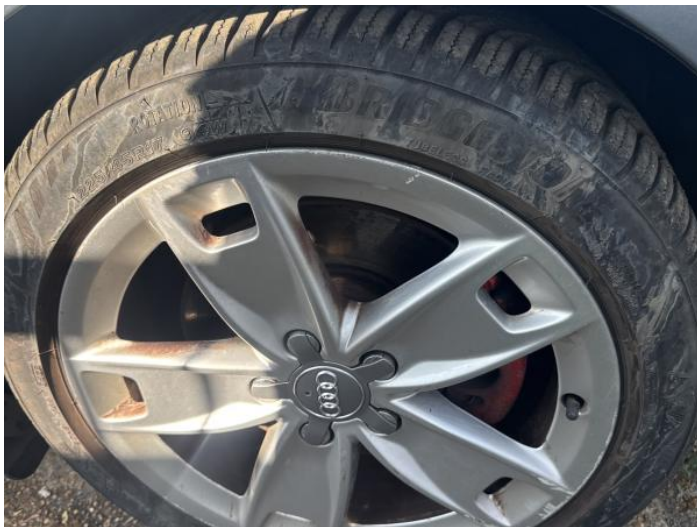
21: Wheel of
Scratched
Over 50mm

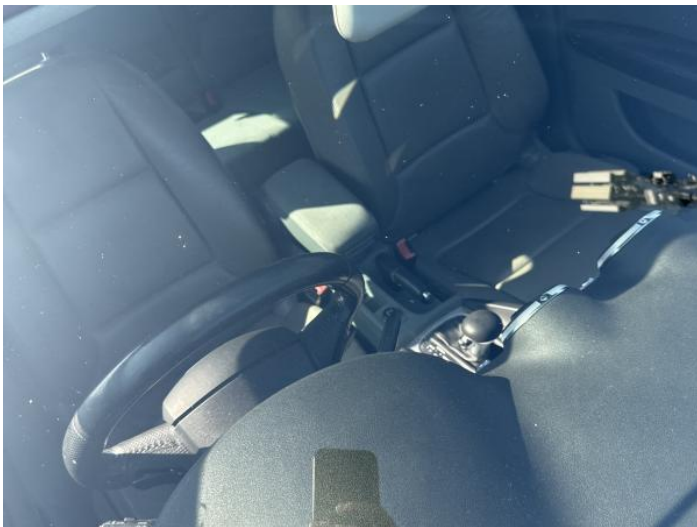
22: Screen Front
Chipped
UpTo 10mm
