VEHICLE INSPECTION REPORT

YC60BSX

Nissan Qashqai 1.6 [117] N-Tec 5dr

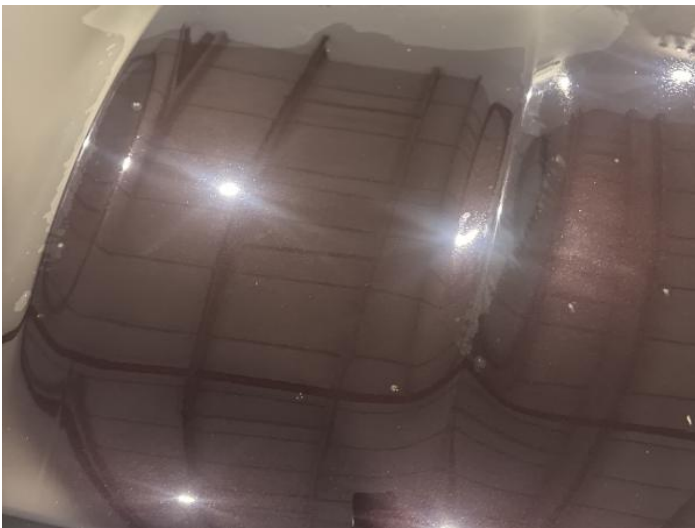
1: Bonnet
Chipped
1 To 5

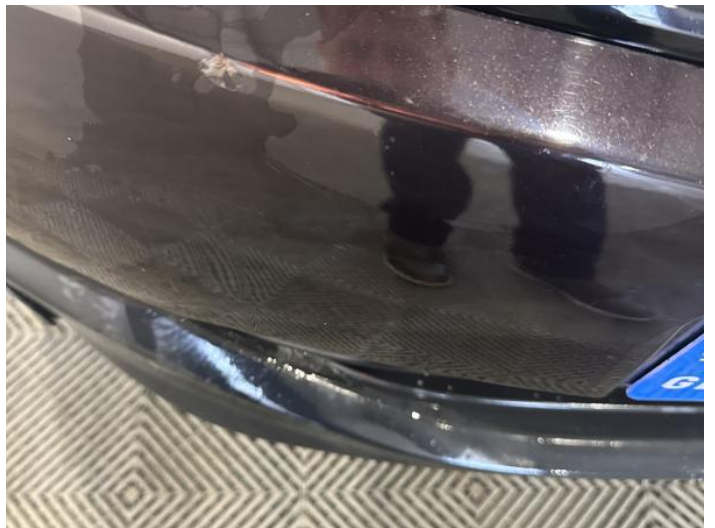
2: Bumper Front
Poor Previous Repair
Paint Flake

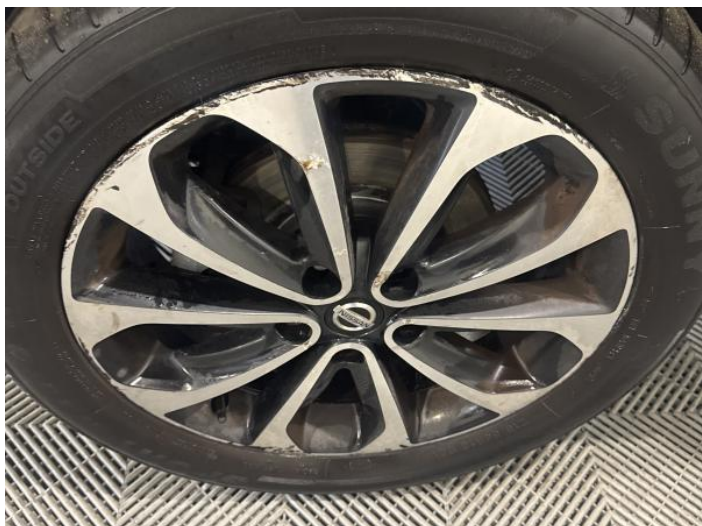
3: Wheel nsf
Scratched
Over 50mm

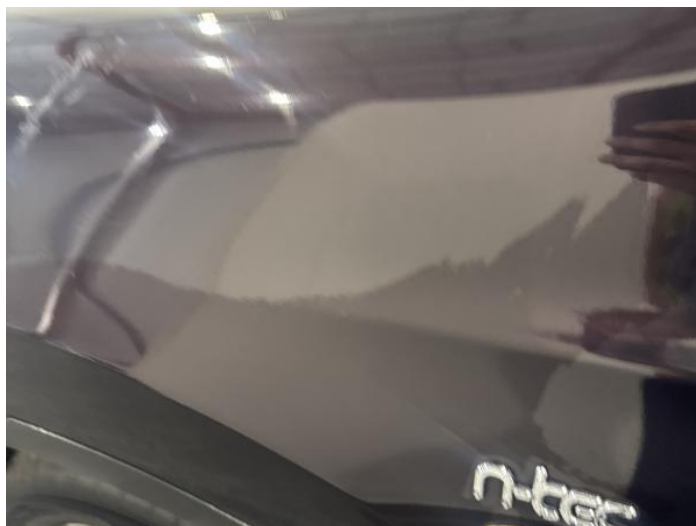
4: Wing nsf
Chipped
1 To 5

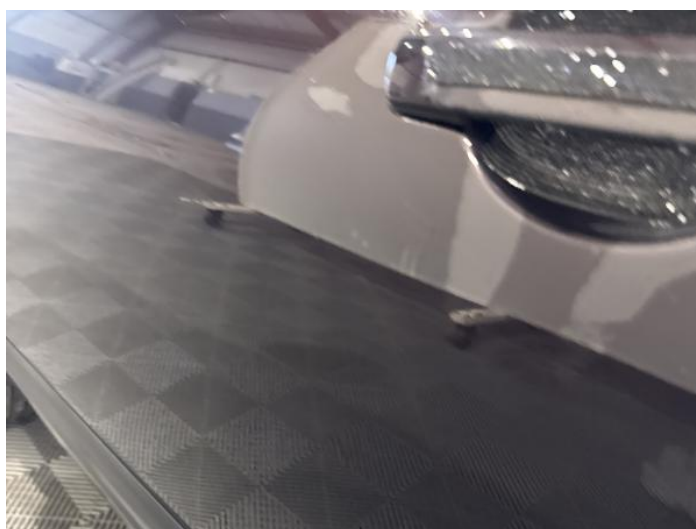
6: Door nsf
Chipped
1 To 5

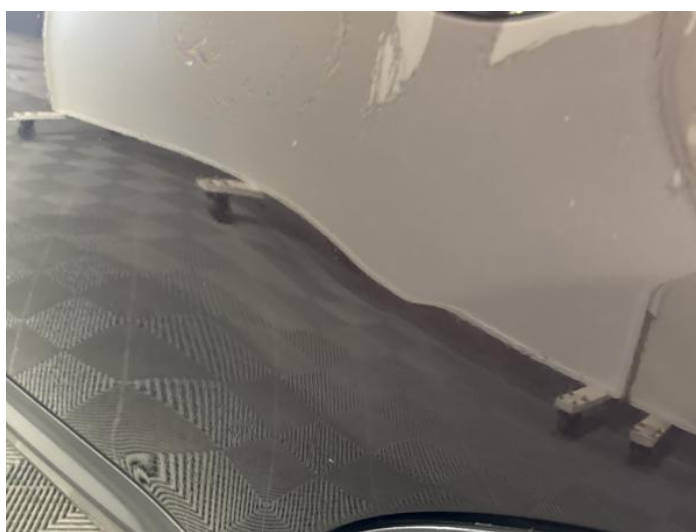
8: Door nsr
Chipped
1 To 5

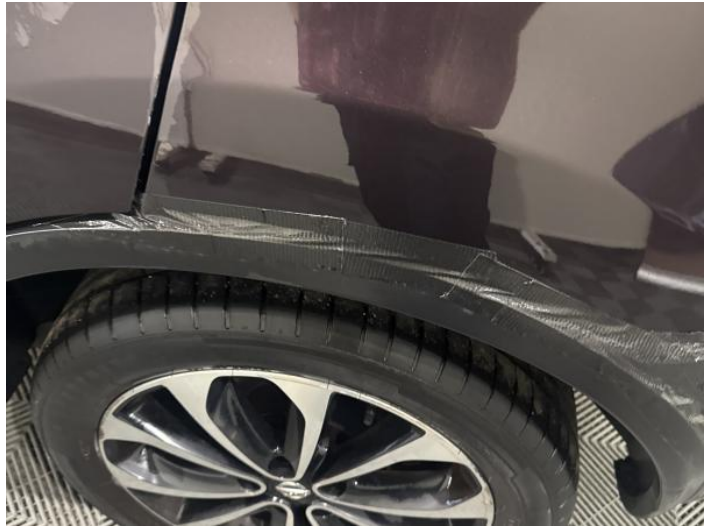
10: Qtr Panel Arch Extension ns
Broken
Replace

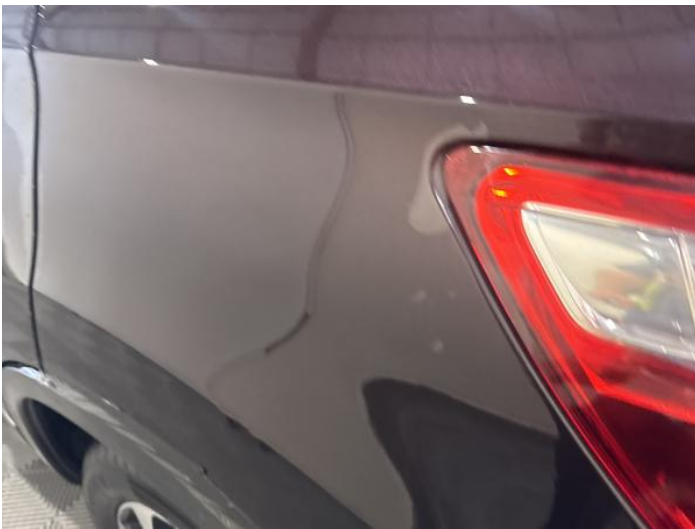
11: Qtr Panel nsr
Chipped
1 To 5

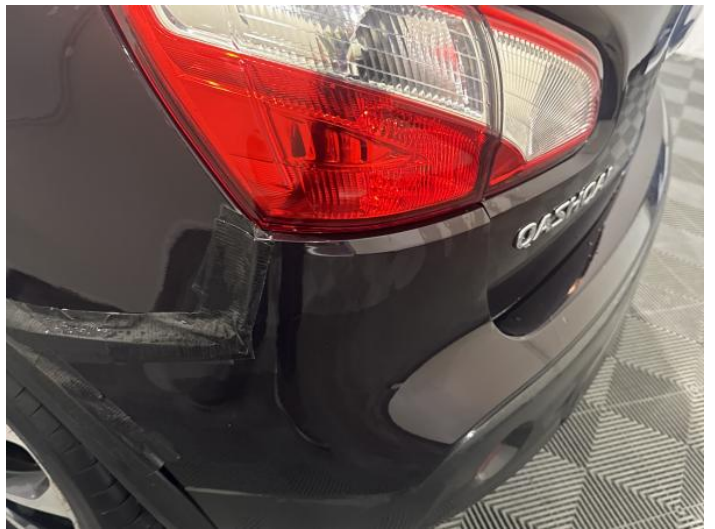
12: Bumper Rear
Cracked
Over 25mm

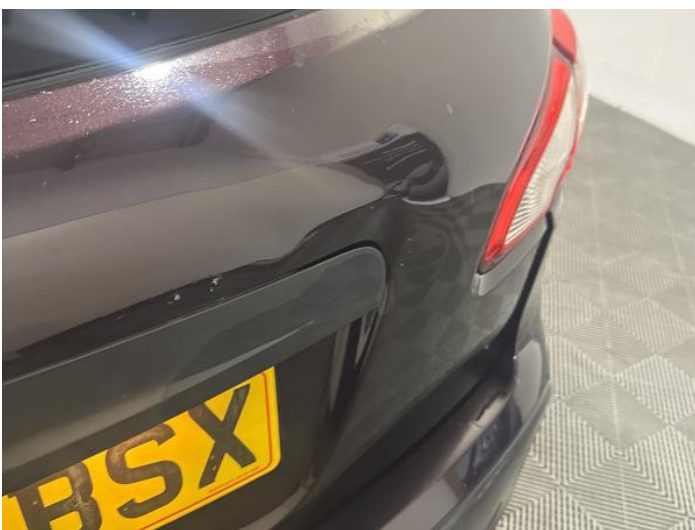
13: Boot Lid
Dented
Over 30mm

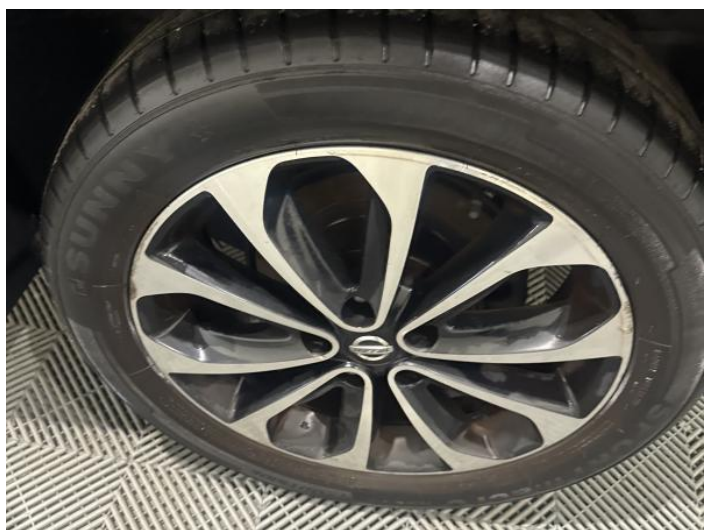
14: Wheel nsr
Scratched
Over 50mm

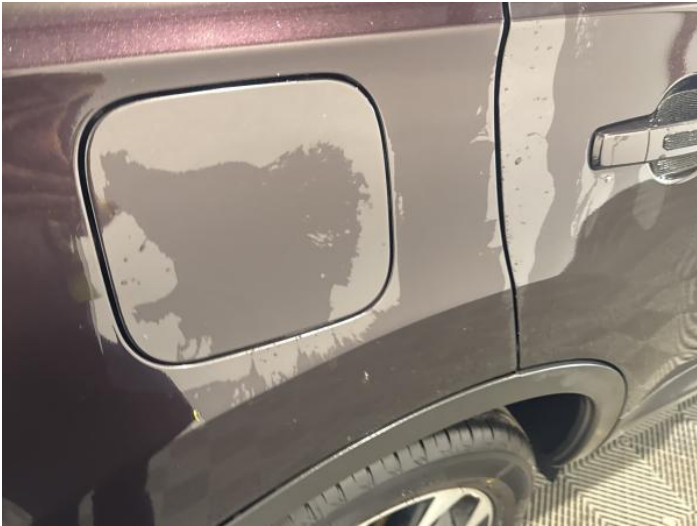
15: Qtr Panel osr
Chipped
1 To 5

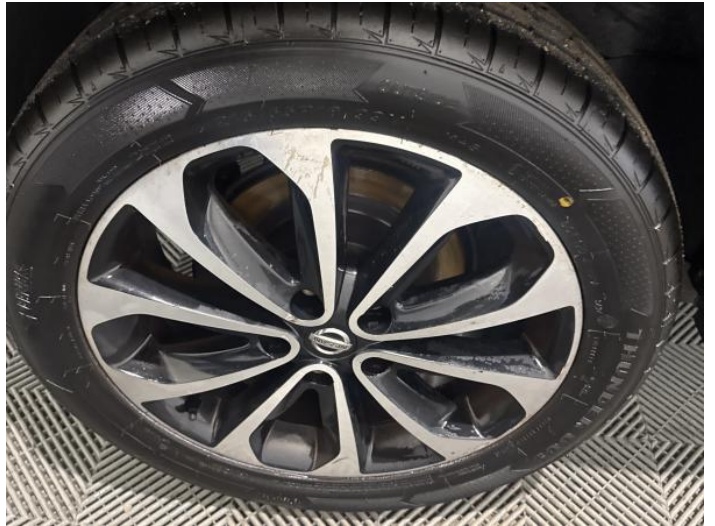
16: Wheel osr
Scratched
Over 50mm

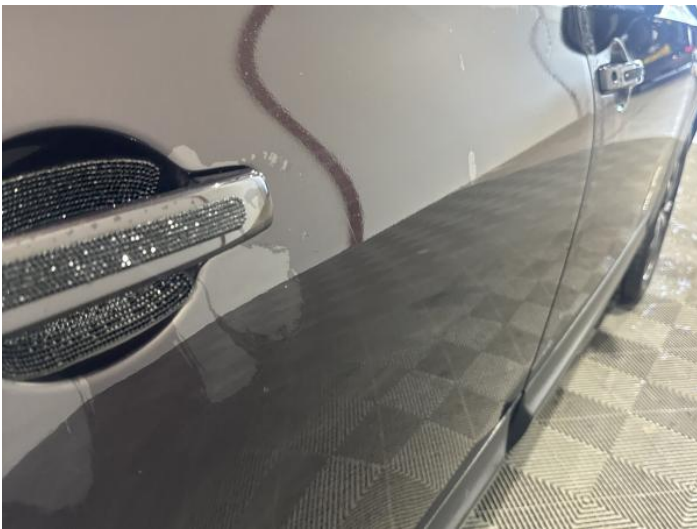
17: Door osr
Chipped
1 To 5

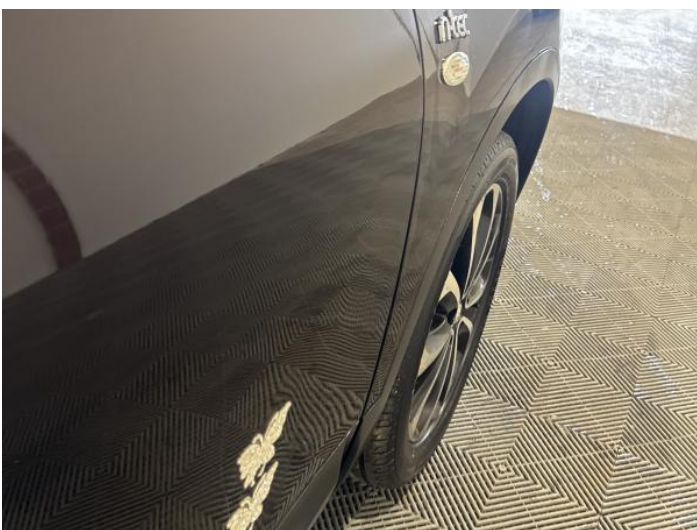
19: Door osf
Dented
Between 10mm + 30mm

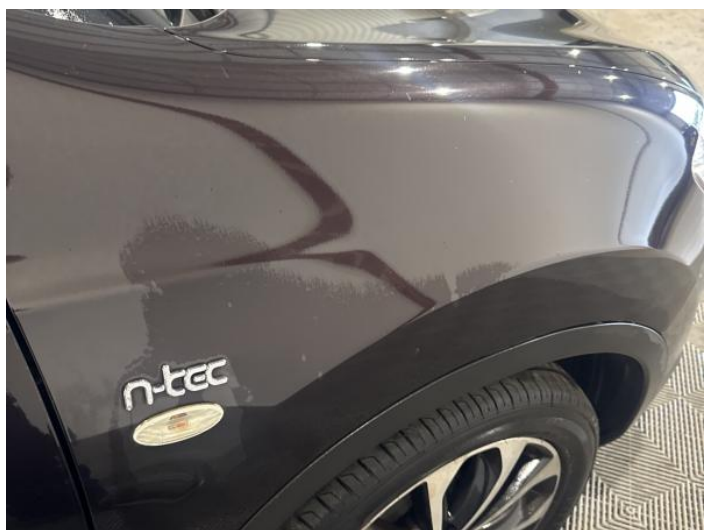
20: Wing osf
Chipped
1 To 5

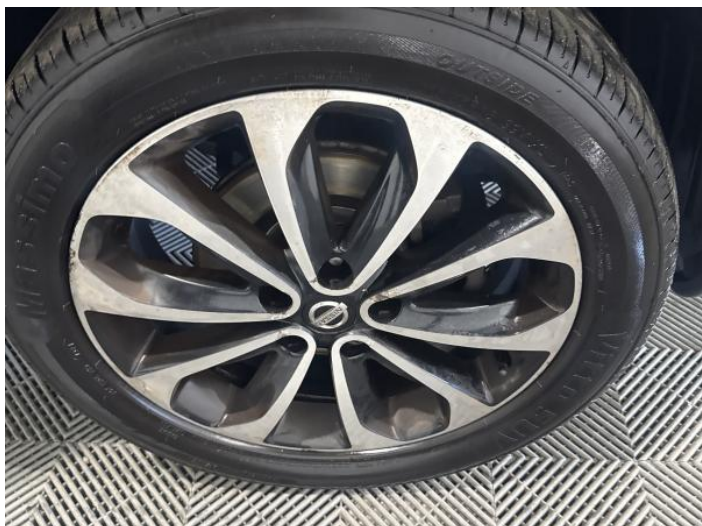
21: Wheel of
Scratched
Over 50mm
