VEHICLE INSPECTION REPORT

GV12LOJ

Ford Fiesta 1.25 Zetec 5dr [82]

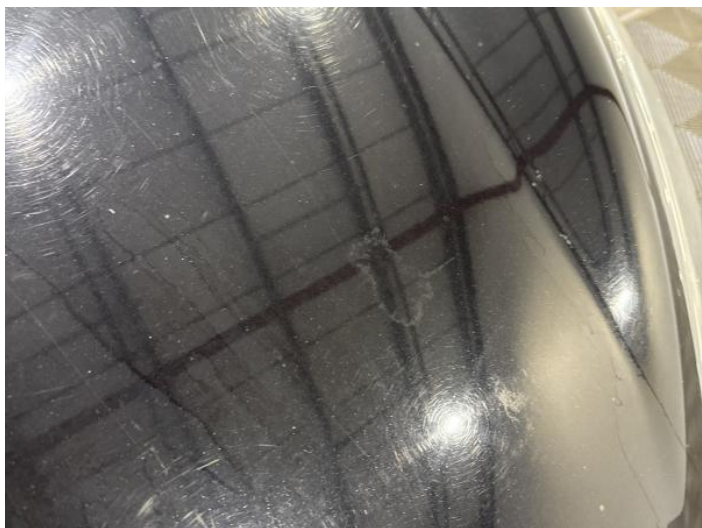
1: Bonnet
Scratched
Over 25mm Thru Paint

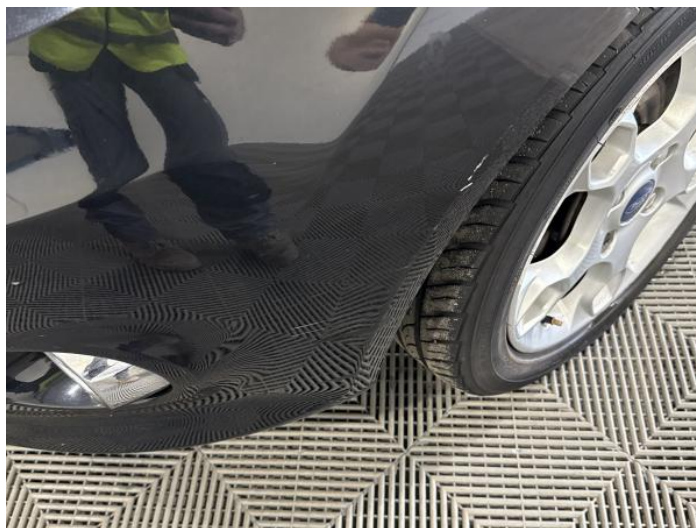
2: Bumper Front
Scratched
Over 100mm Thru Paint

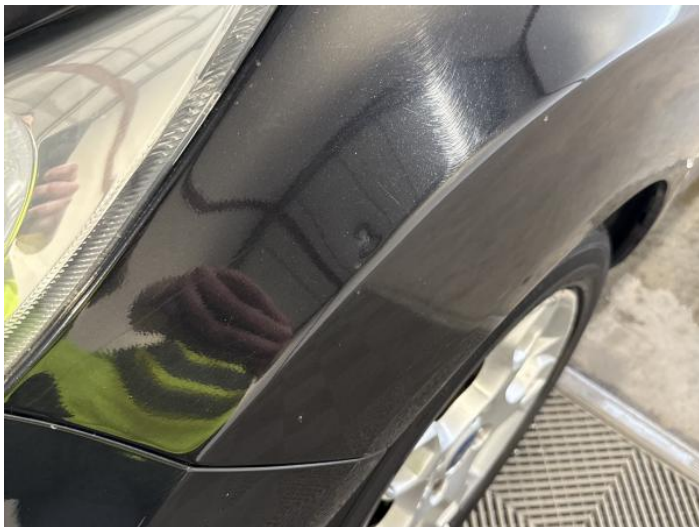
3: Wing nsf
Dented
With Paint Damage

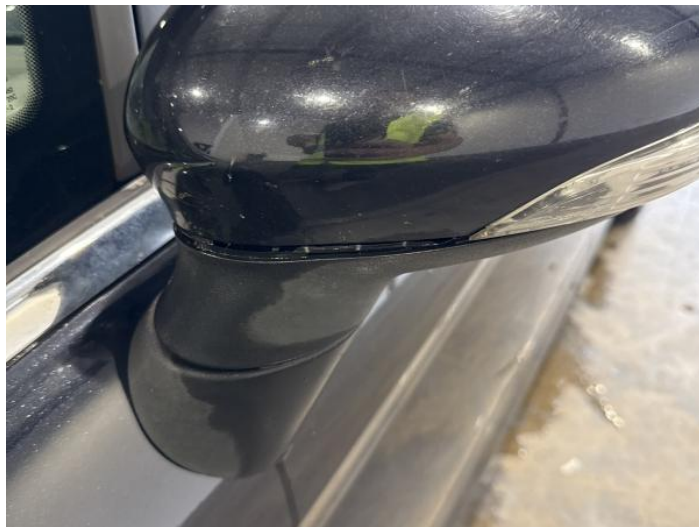
4: Door Mirror Assy nsf
Scuffed (Unpainted)
Over 100mm

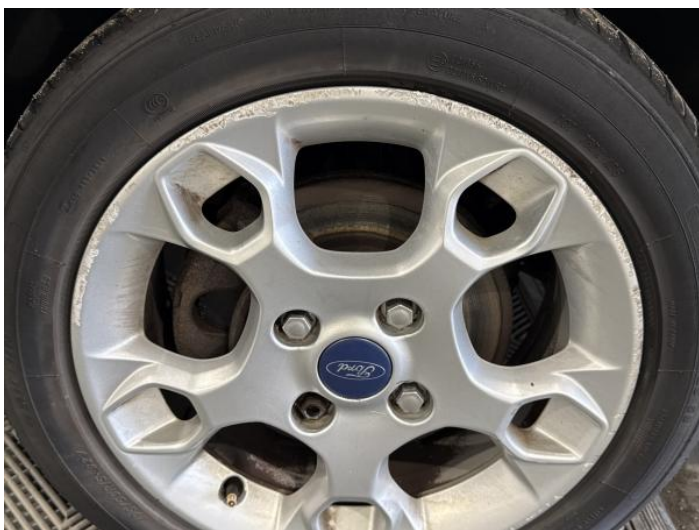
5: Wheel nsf
Scratched
Over 50mm

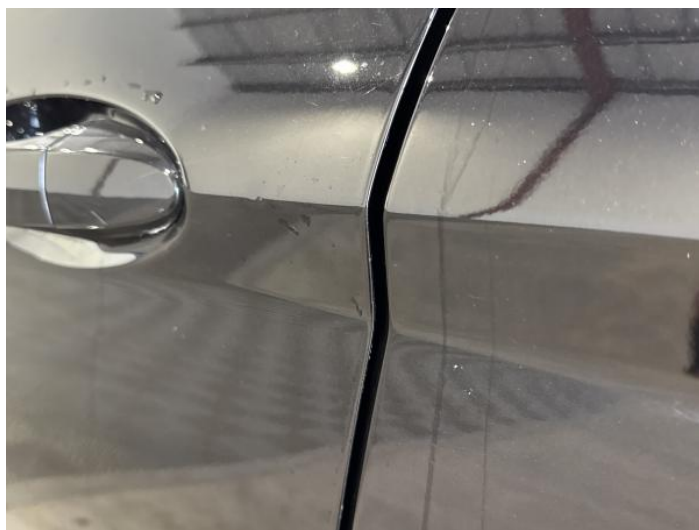
6: Door nsf
Dented
Between 10mm + 30mm

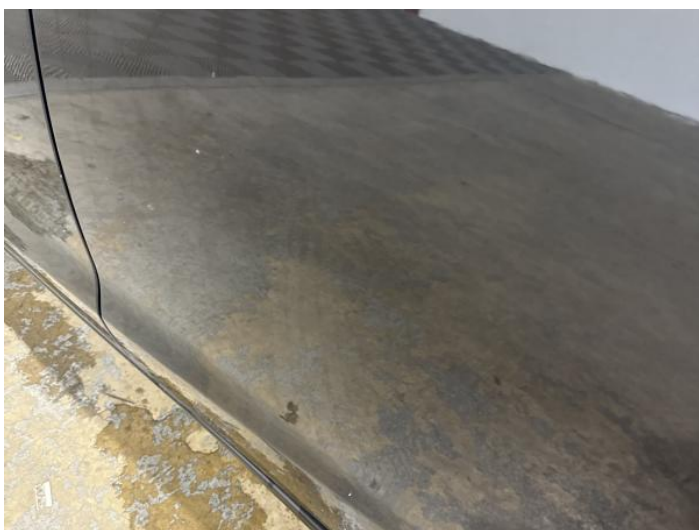
7: Door nsr
Chipped
1 To 5

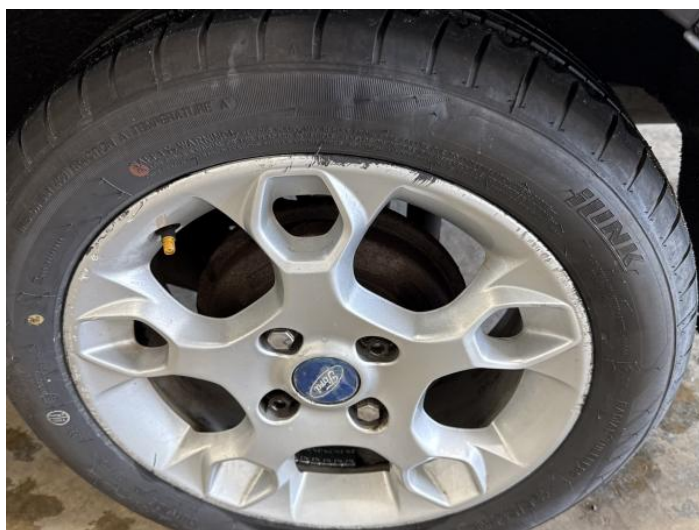
8: Wheel nsr
Scratched
Over 50mm

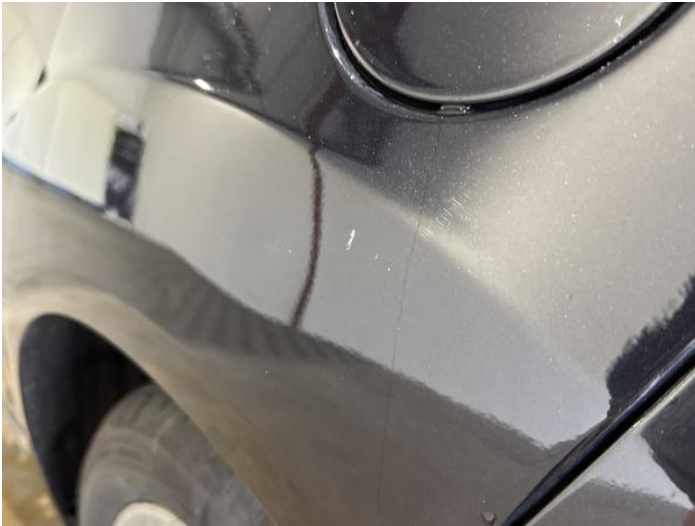
9: Qtr Panel nsr
Dented
Between 10mm + 30mm

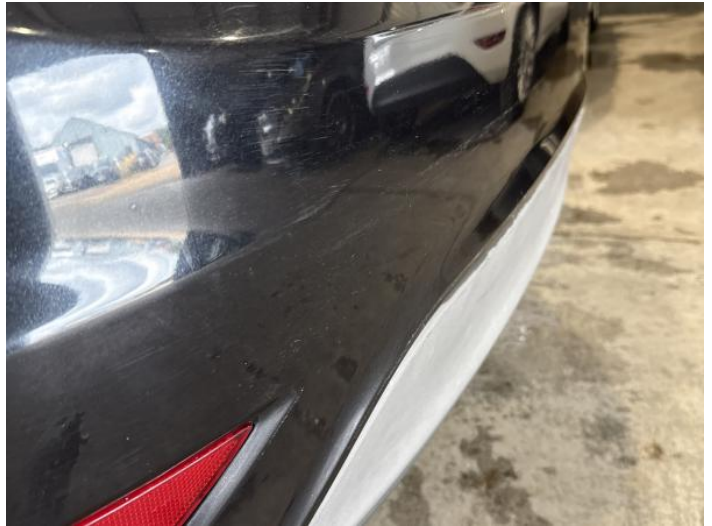
10: Bumper Rear
Scratched
Over 100mm Thru Paint

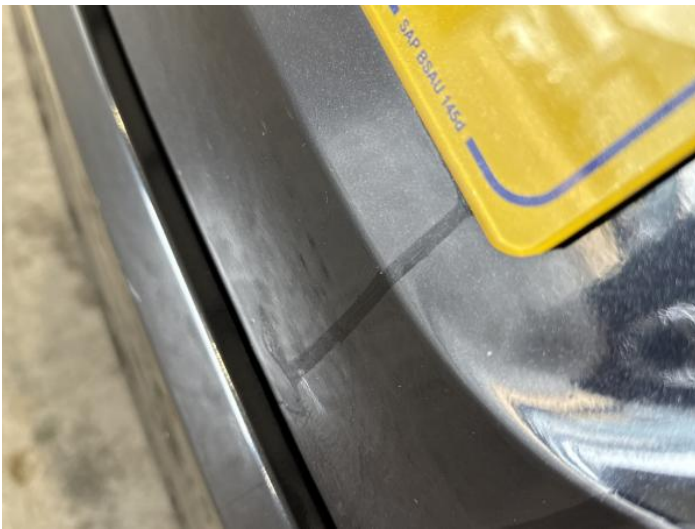
11: Tailgate
Chipped
1 To 5

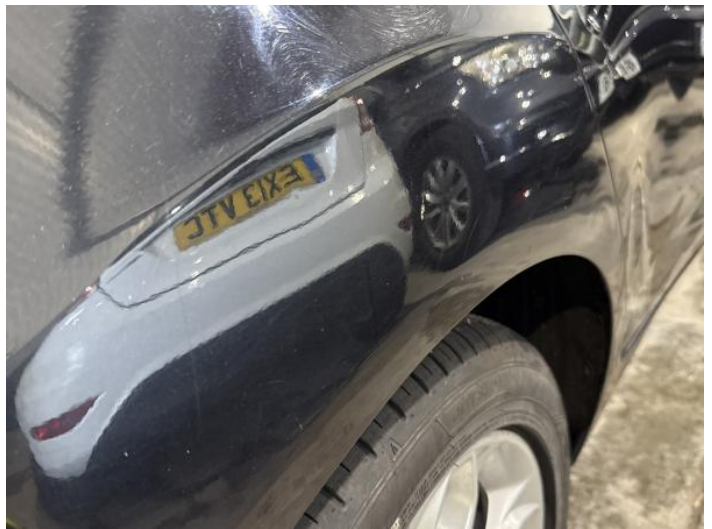
12: Qtr Panel osr
Dented
Between 10mm + 30mm

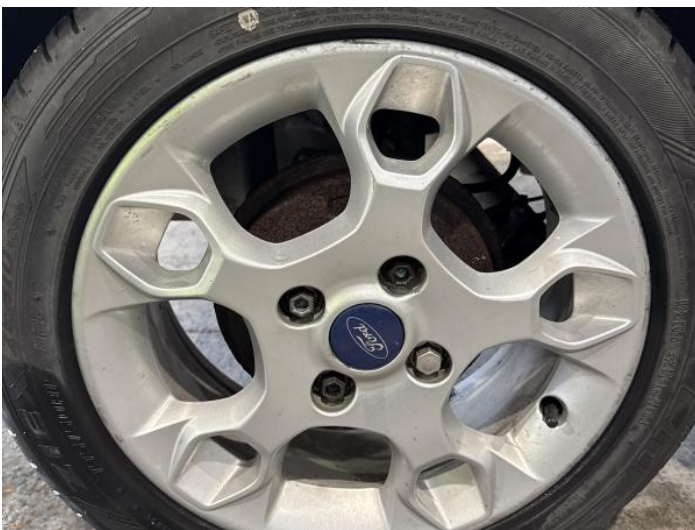
13: Wheel osr
Scratched
Up To 50mm

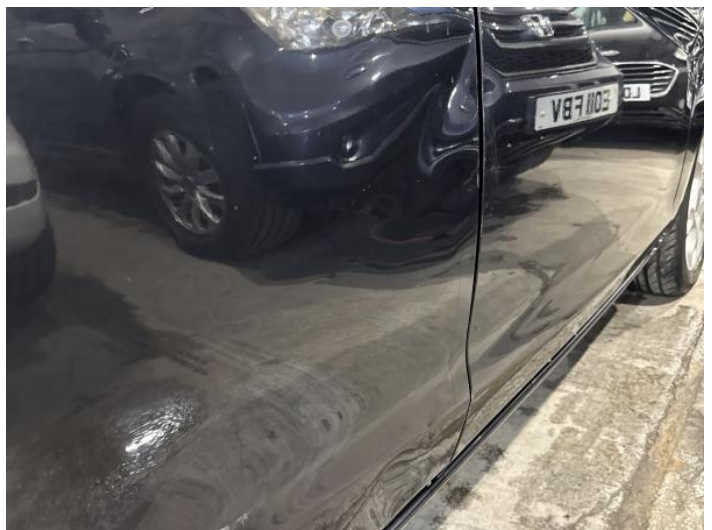
14: Door osr
Dented
Over 30mm

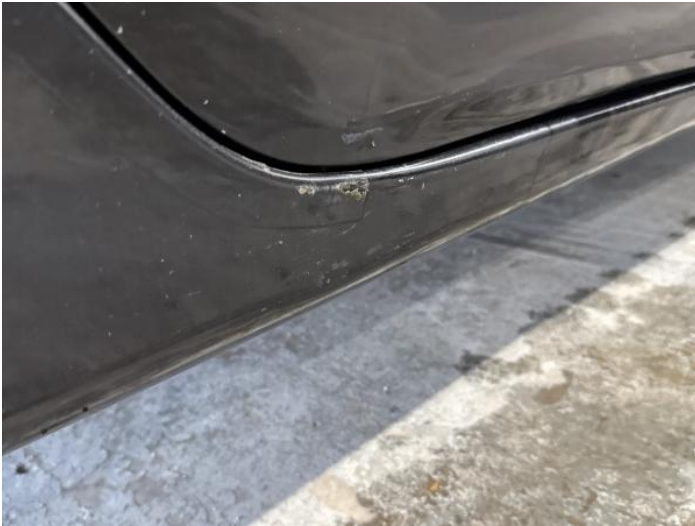
15: Sill os
Scratched
Over 25mm Thru Paint

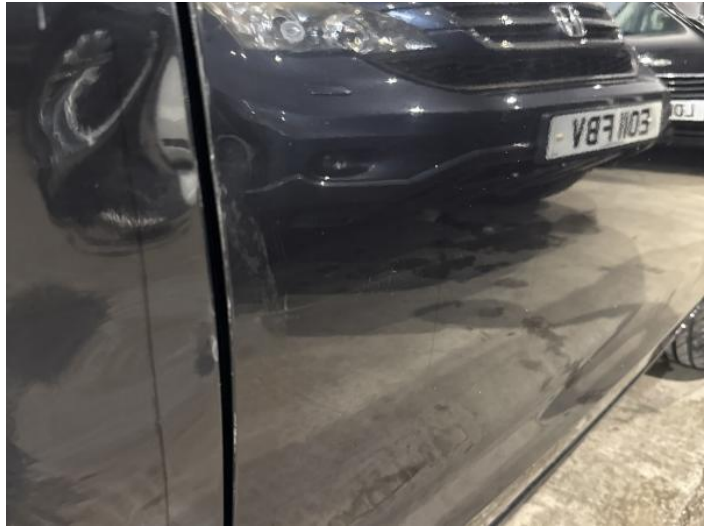
16: Door osf
Dented
Over 30mm

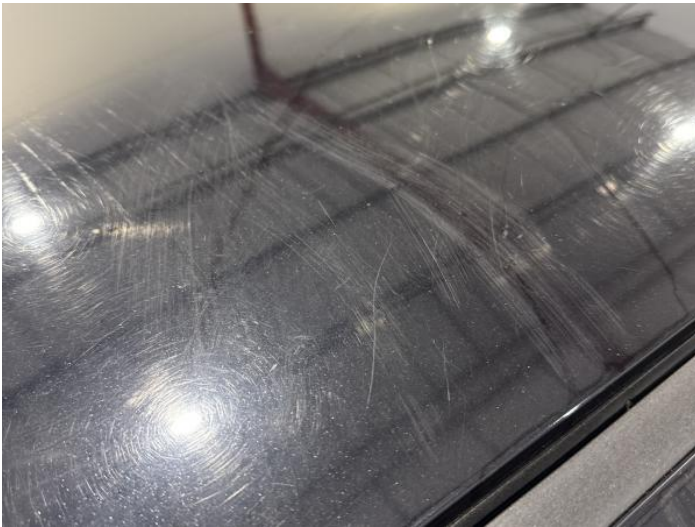
17: Roof
Scratched
Over 25mm Thru Paint

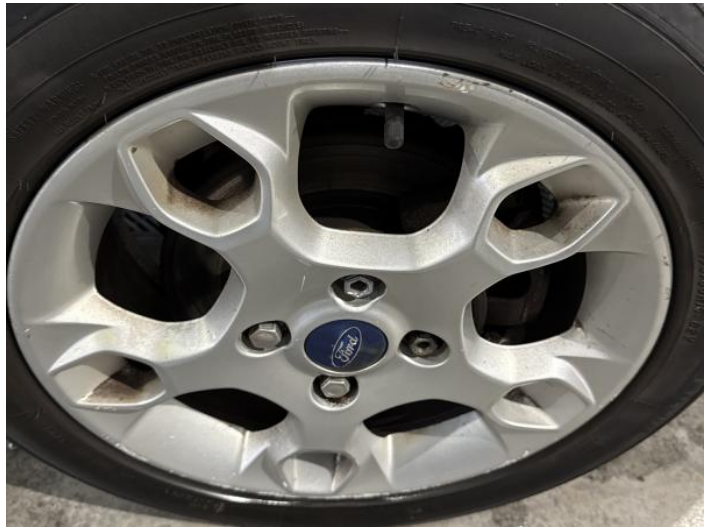
18: Wheel osf
Scratched
Over 50mm

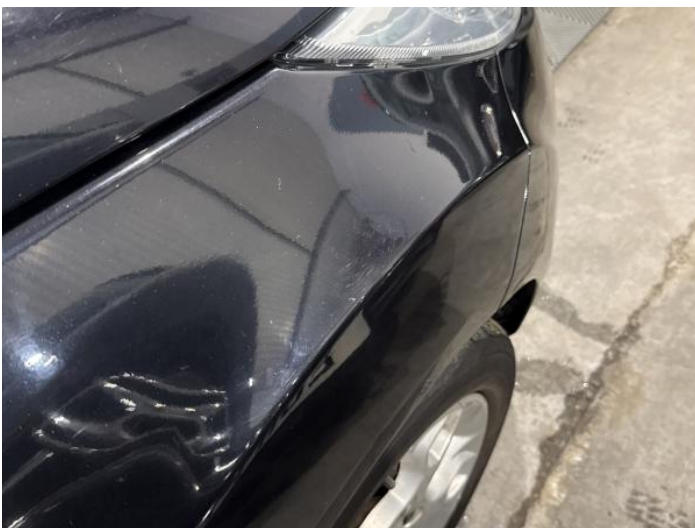
19: Wing nsf
Chipped
1 To 5

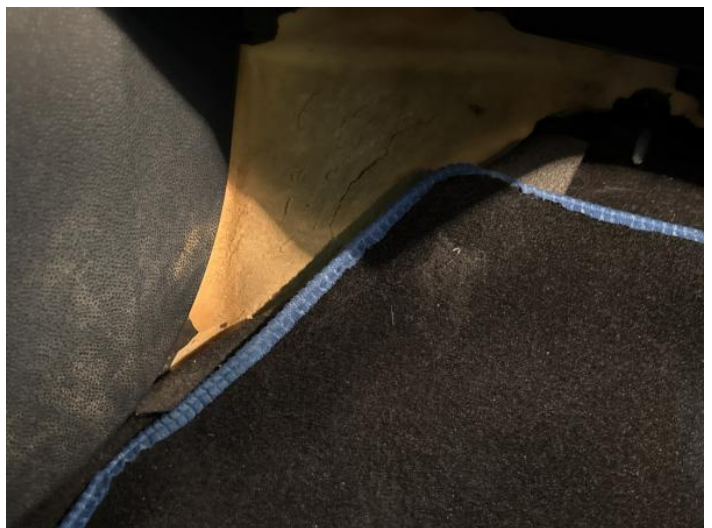
20: Carpets Front
Scuffed
Over 25mm
