VEHICLE INSPECTION REPORT

AO15MXE

Smart Forfour 0.9 Turbo Prime Premium 5dr

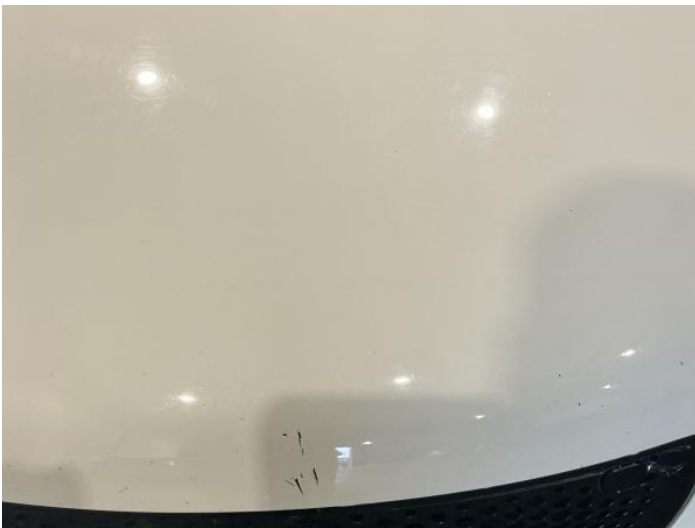
1: Bonnet
Scratched
Over 25mm Thru Paint

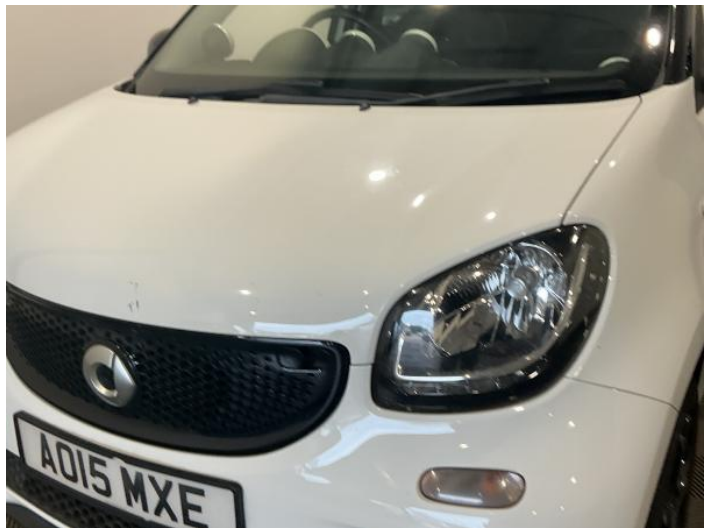
2: Bumper Front
Chipped
Multiple Chips

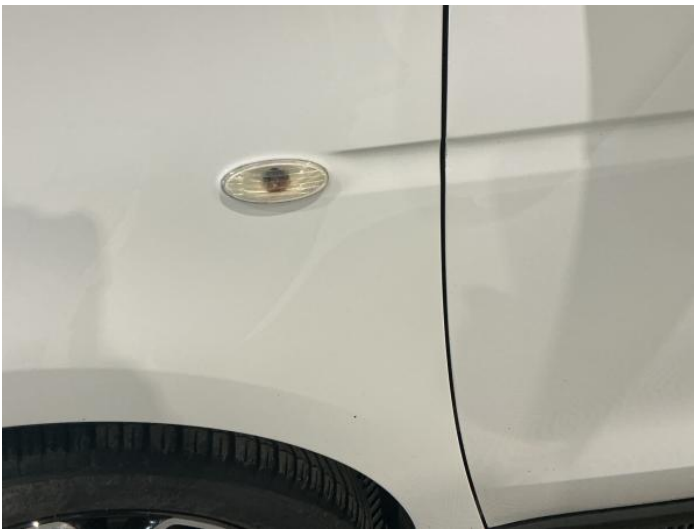
5: Wing nsf
Chipped
1 To 5

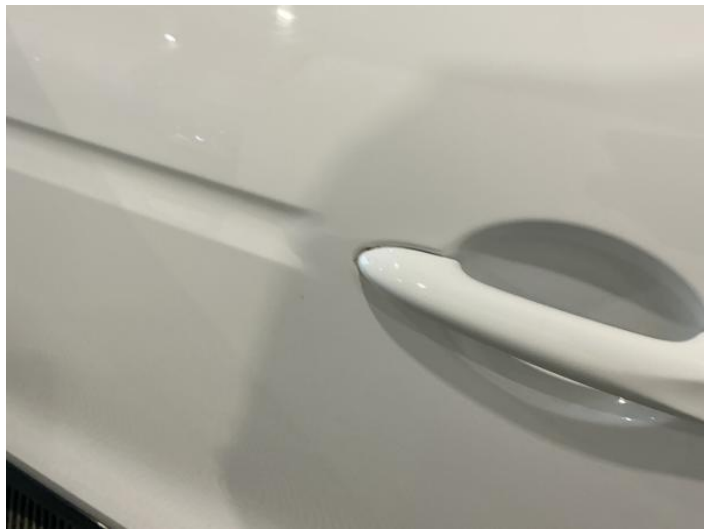
6: Door nsf
Dented
Over 2 UpTo 10mm

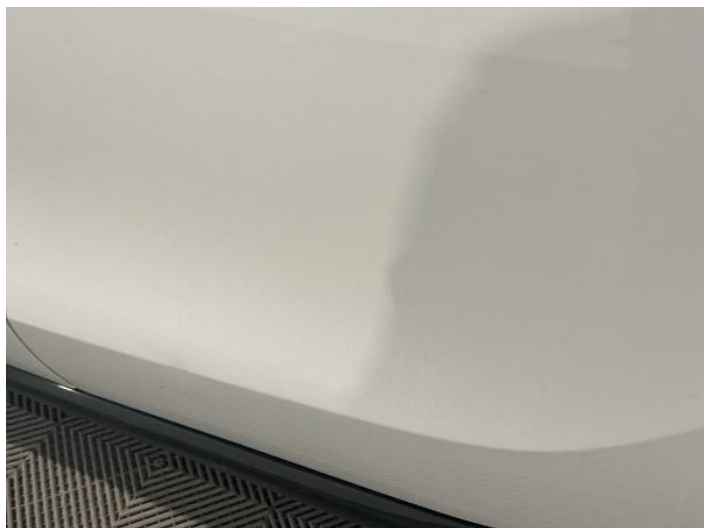
7: Door nsf
Scratched
Over 25mm Not Thru Paint

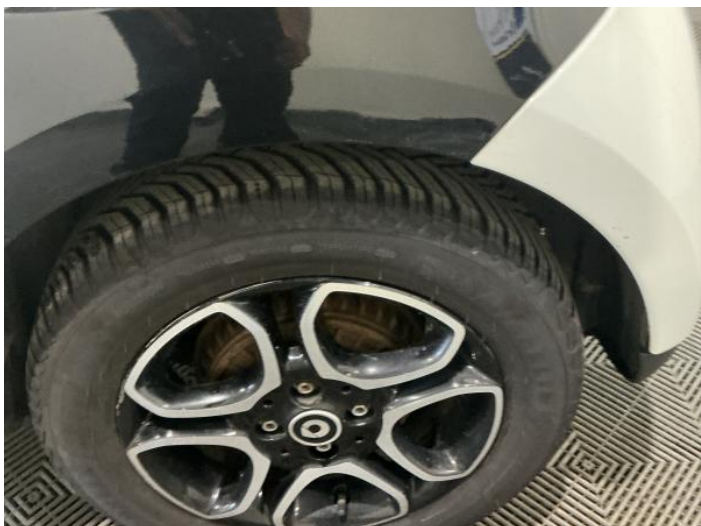
9: Wheel nsr
Scratched
Over 50mm

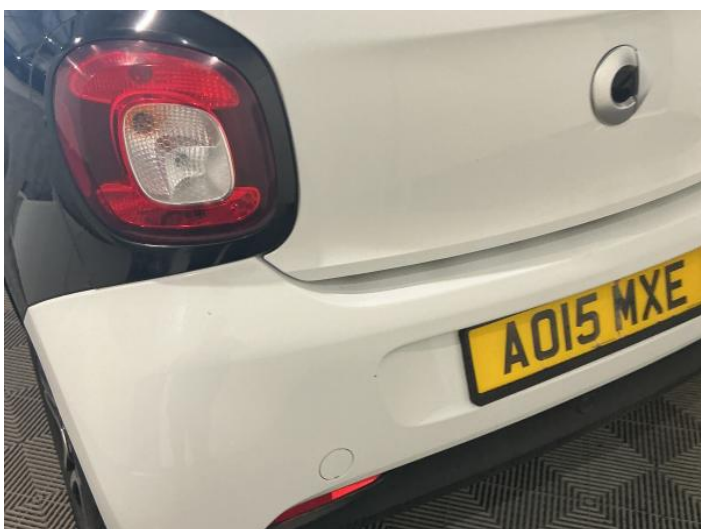
11: Bumper Rear
Scratched
25 to 100mm Thru Paint

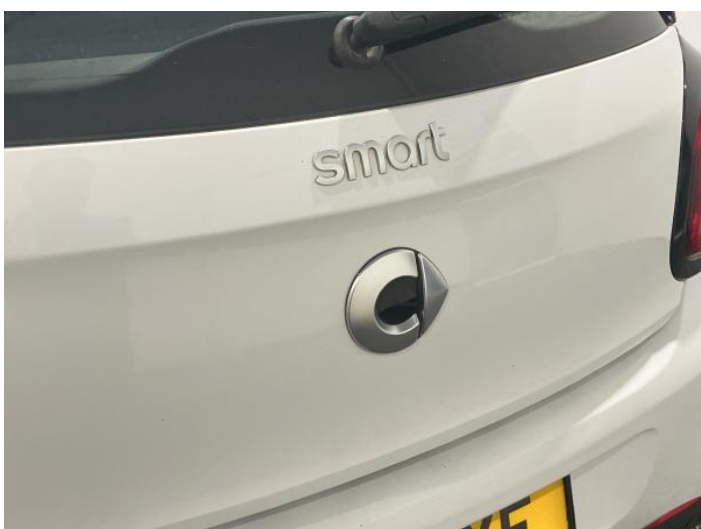
13: Boot Lid
Chipped
1 To 5

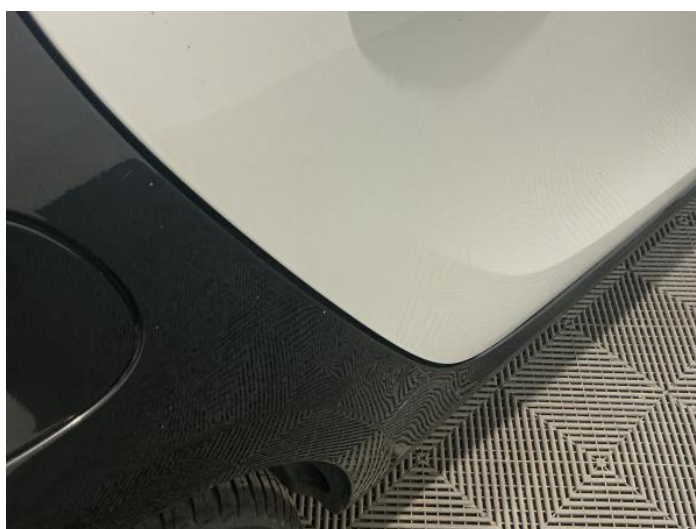
14: Qtr Panel osr
Dented
Over 30mm

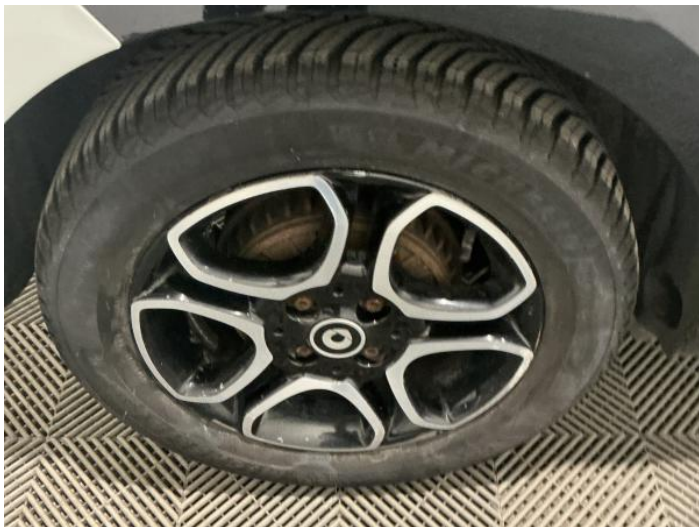
15: Wheel osr
Scratched
Over 50mm

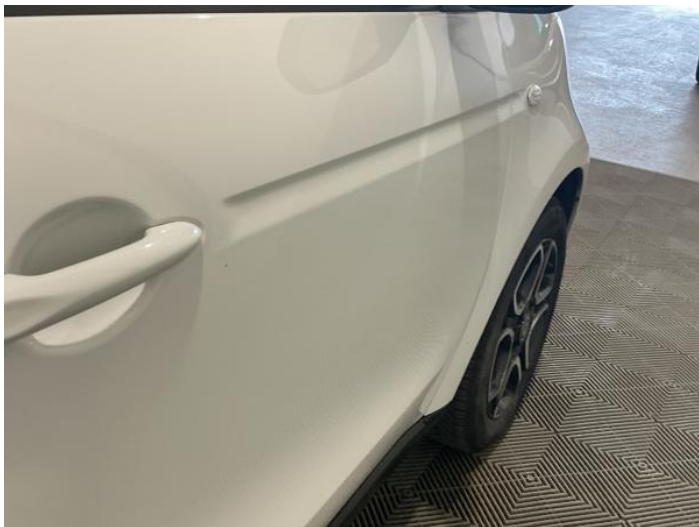
17: Door osf
Dented
2 Or Less UpTo 10mm

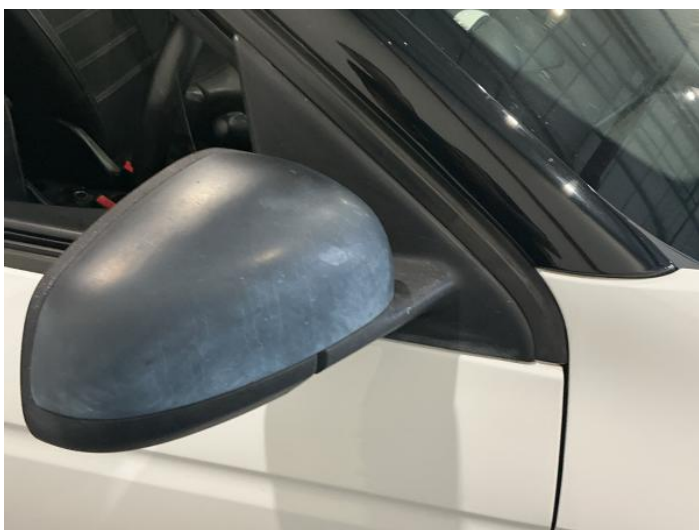
19: Door Mirror Assy osf
Scratched (Painted)
Over 25mm Thru Paint

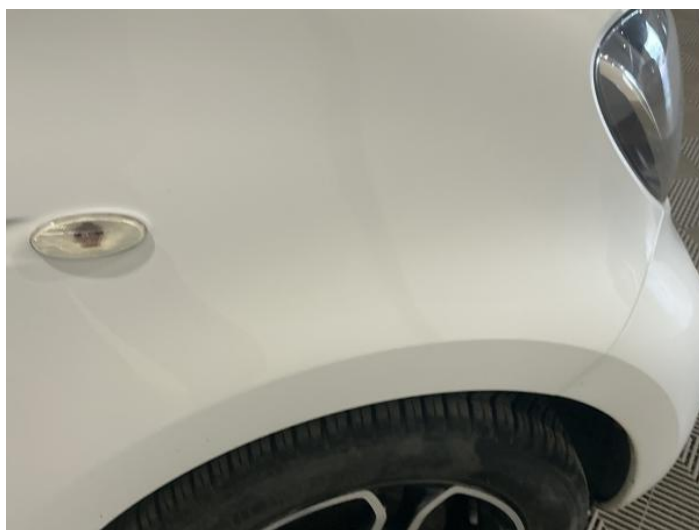
20: Wing osf
Chipped
1 To 5

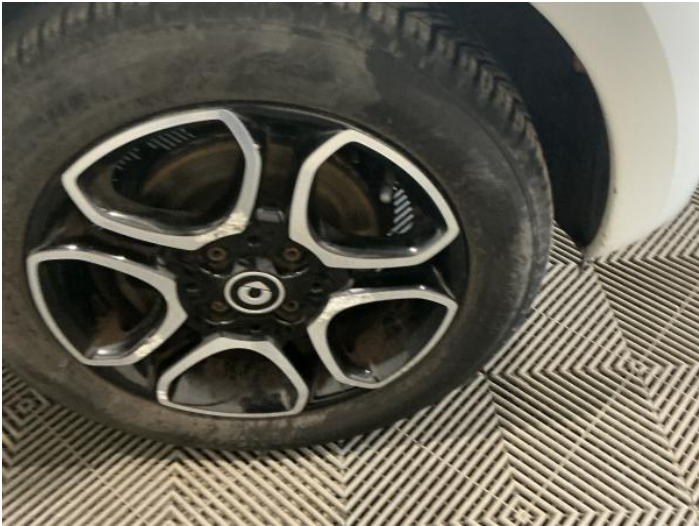
21: Wheel osf
Scratched
Over 50mm

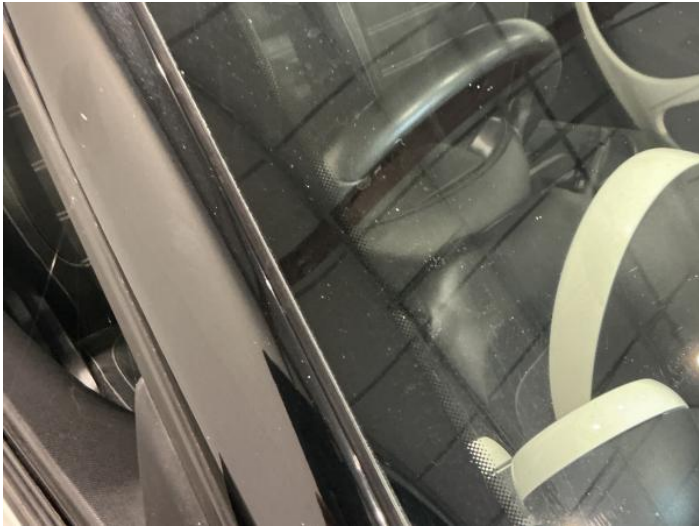
22: A Post os
Chipped
Multiple Chips

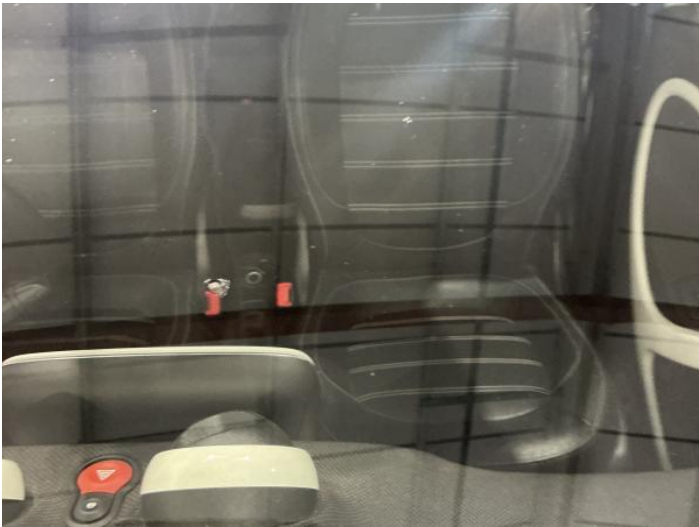
23: Screen Front
Chipped
Over 10mm
