VEHICLE INSPECTION REPORT

BV14MHJ

Skoda Superb 2.0 TDI CR 140 Elegance 5dr DSG

nama
 GRADE
4

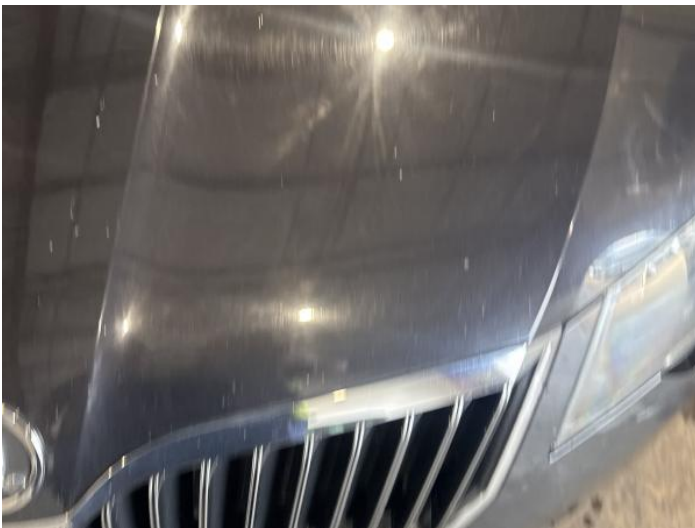
1: Bonnet
Chipped
Multiple Chips

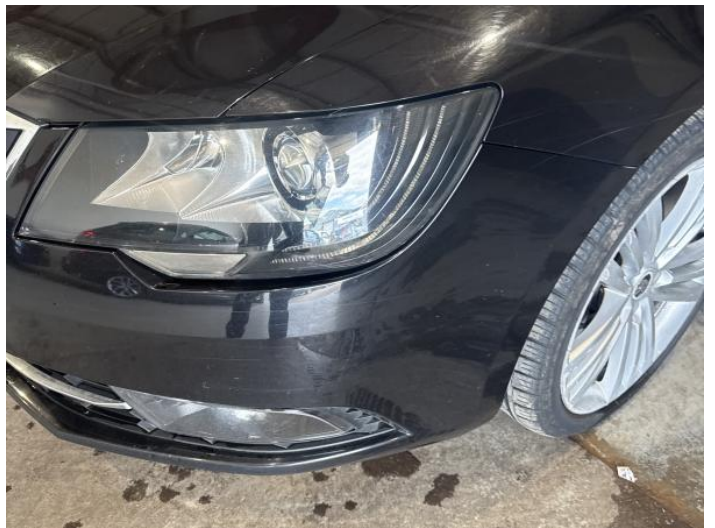
2: Bumper Front
Scratched
25 to 100mm Thru Paint

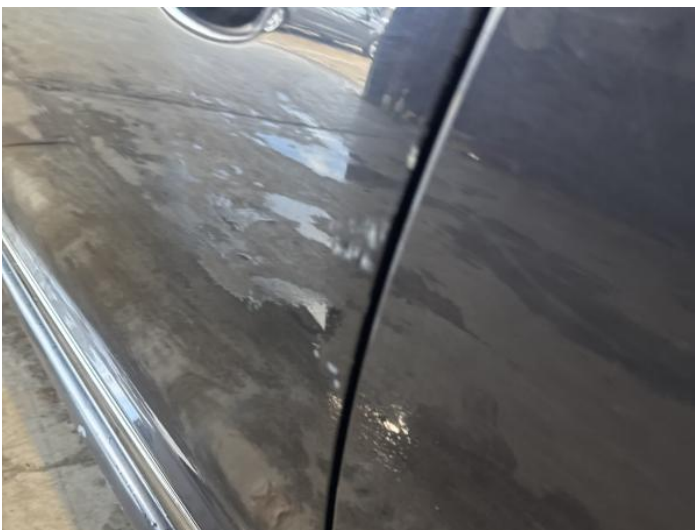
7: Door nsf
Scratched
UpTo 25mm Thru Paint

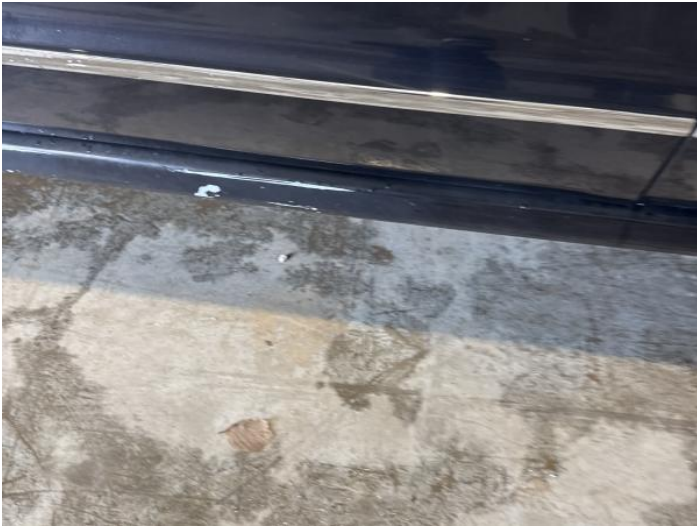
9: Sill ns
Scratched
Over 25mm Thru Paint

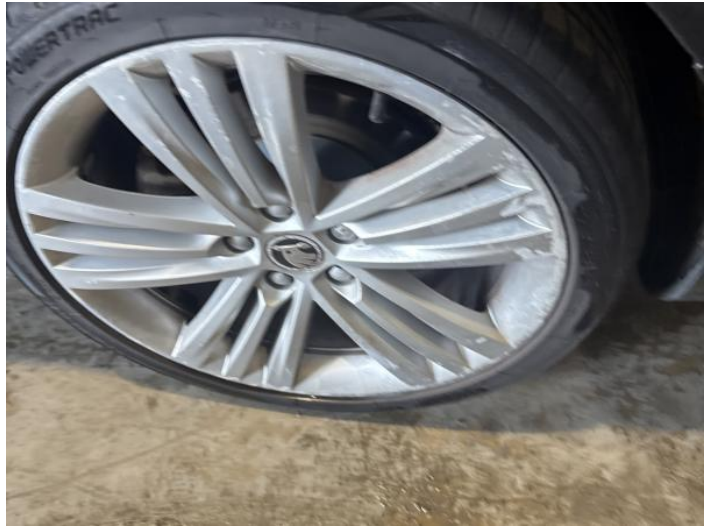
10: Wheel nsr
Scratched
Over 50mm

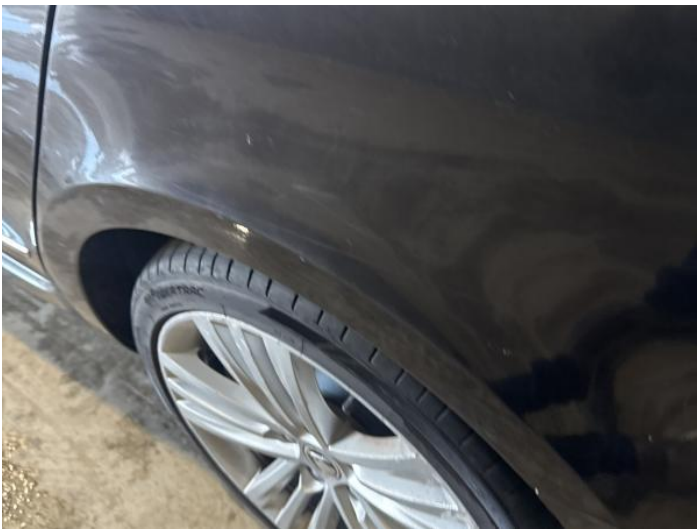
11: Qtr Panel nsr
Chipped
1 To 5

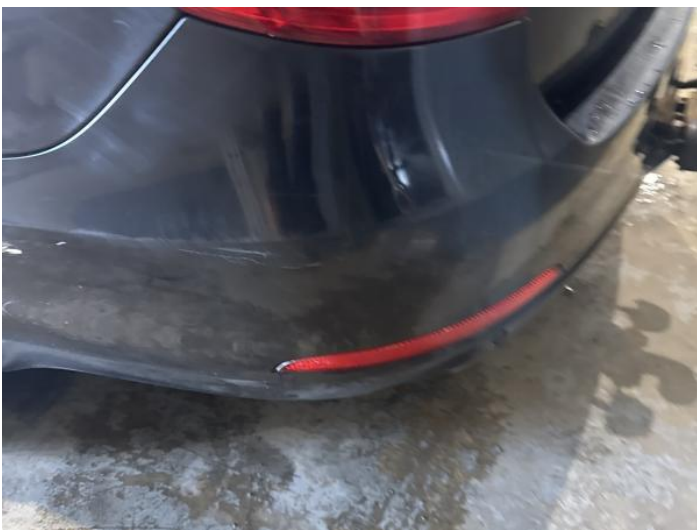
13: Bumper Rear
Scratched
Over 100mm Thru Paint

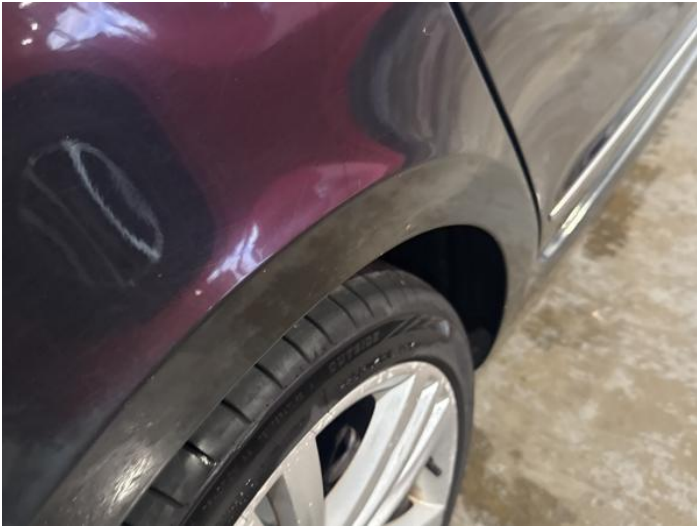
15: Qtr Panel osr
Chipped
1 To 5

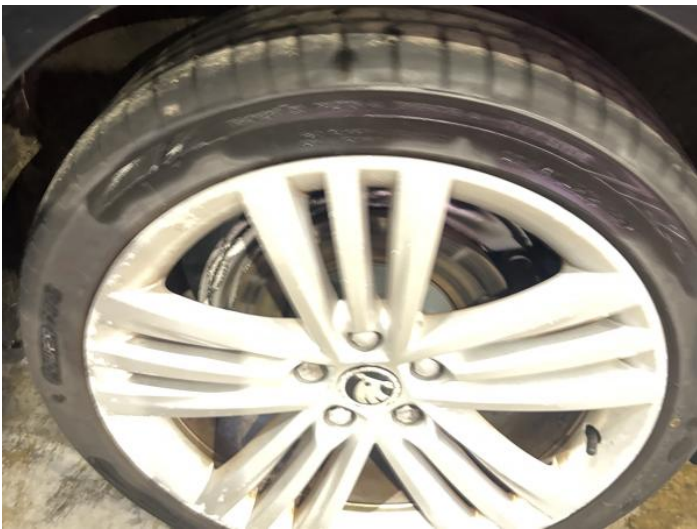
17: Wheel osr
Scratched
Over 50mm

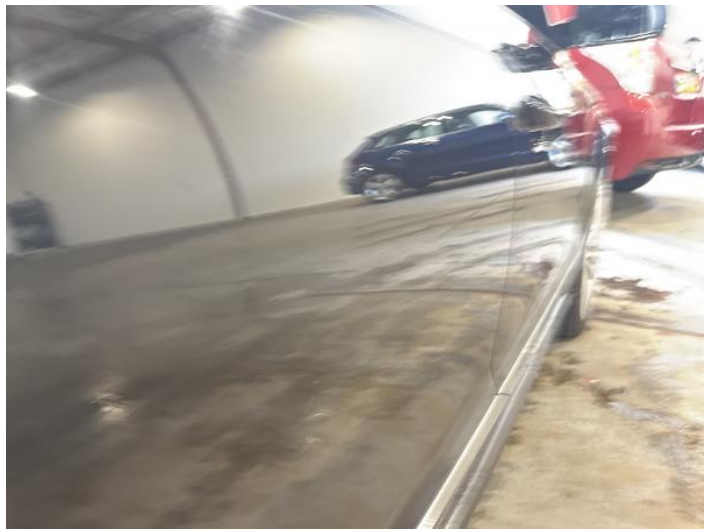
18: Door osr
Dented
Over 2 UpTo 10mm

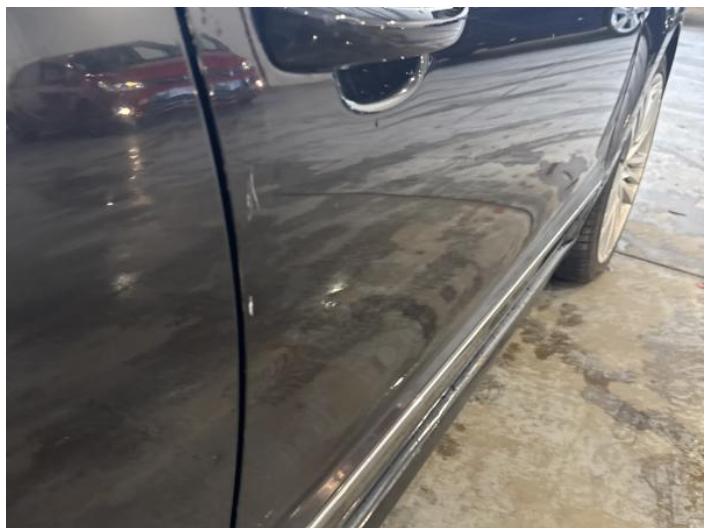
20: Door osf
Chipped
1 To 5

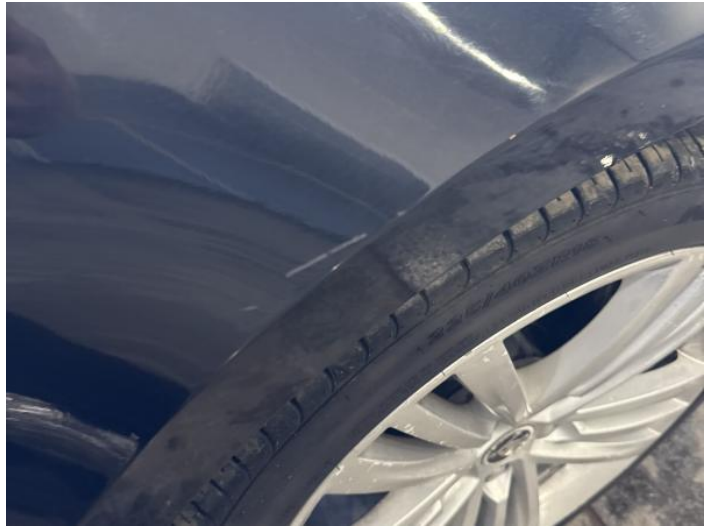
21: Door osf
Scratched
Over 25mm Not Thru Paint

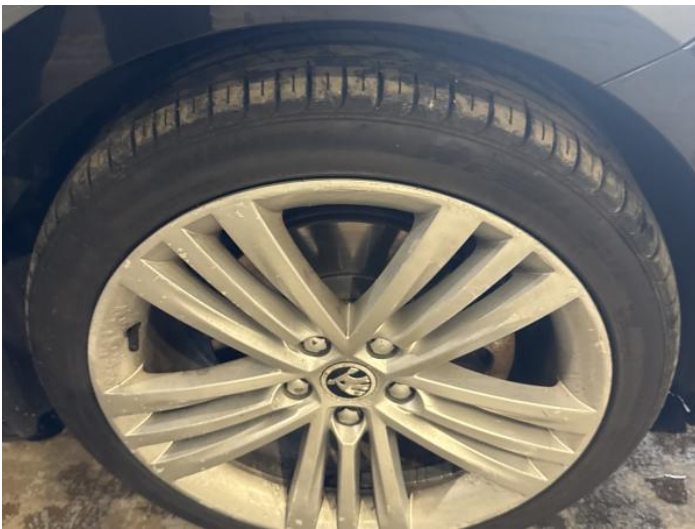
23: Wheel osf
Scratched
Over 50mm

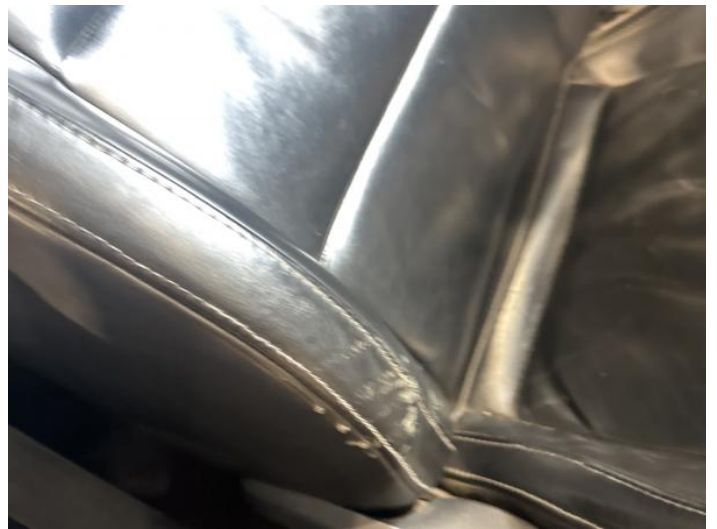
24: Seat Back Cover osf
Torn
UpTo 3mm

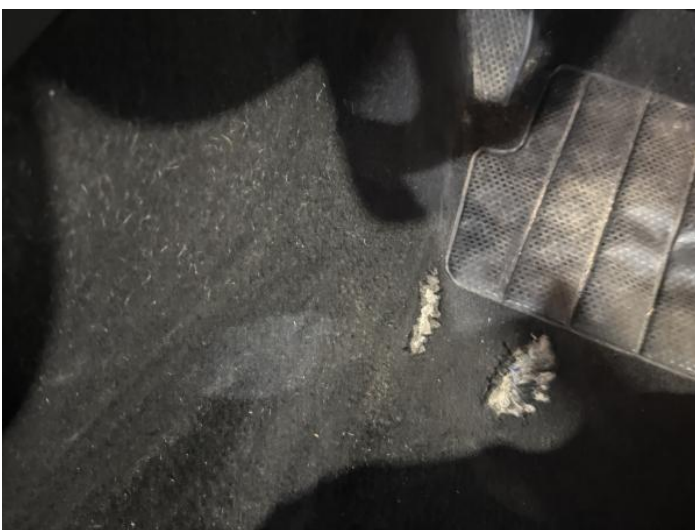
25: Carpets Front
Torn
Over 10mm
