VEHICLE INSPECTION REPORT

VO65MVX

Vauxhall Insignia 1.6 CDTi SRi Vx-line Nav 5dr [Start Stop]

nama
GRADE
4

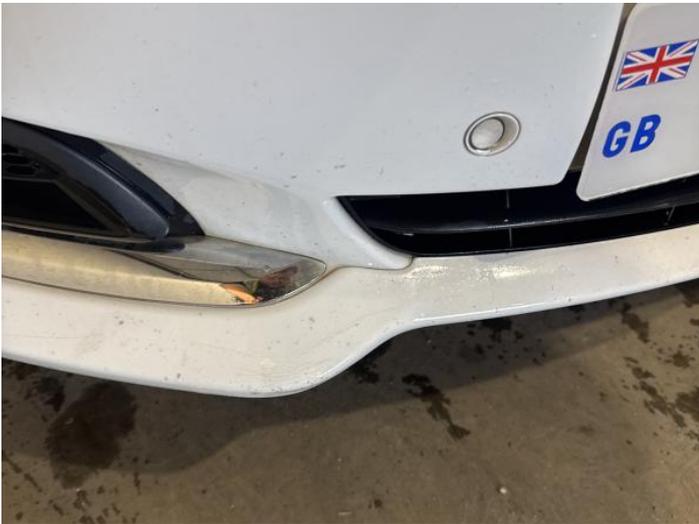
1: Bumper Front
Poor Previous Repair
Rippled Over 30%

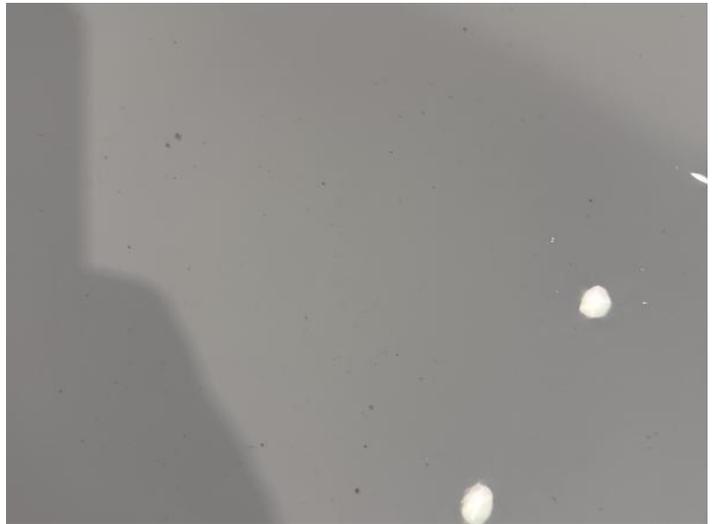
2: Bonnet
Chipped
Multiple Chips

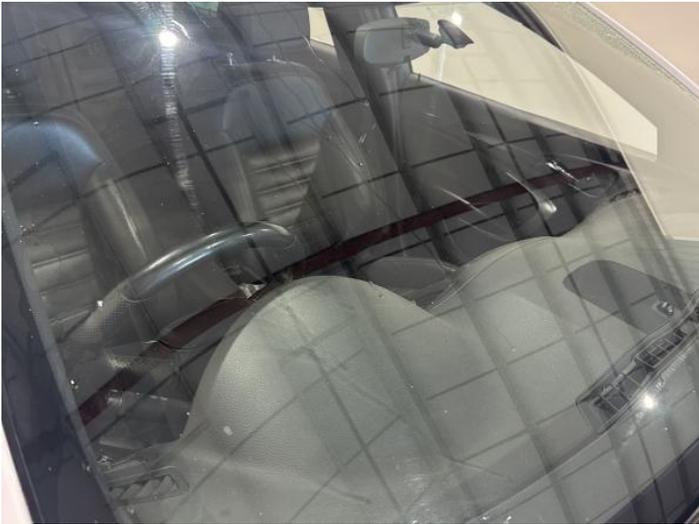
3: Screen Front
Chipped
UpTo 10mm

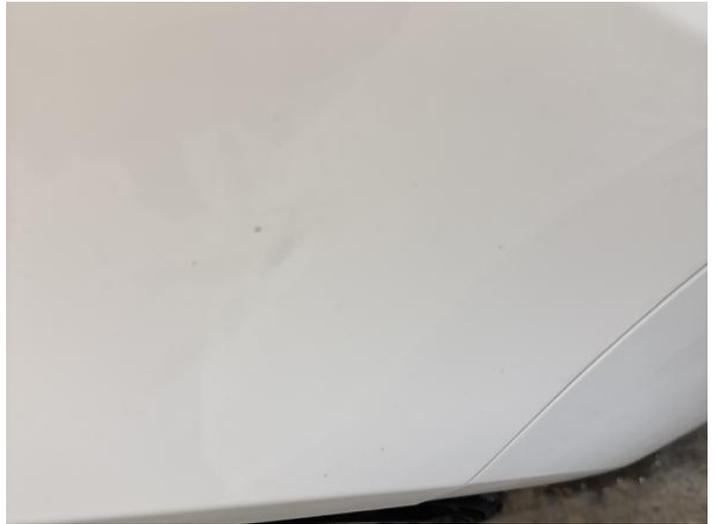
4: Wing osf
Chipped
1 To 5

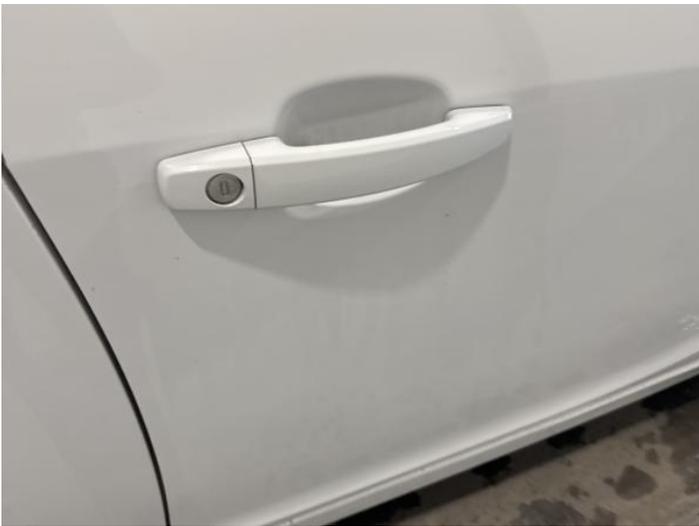
5: Door osf
Chipped
1 To 5

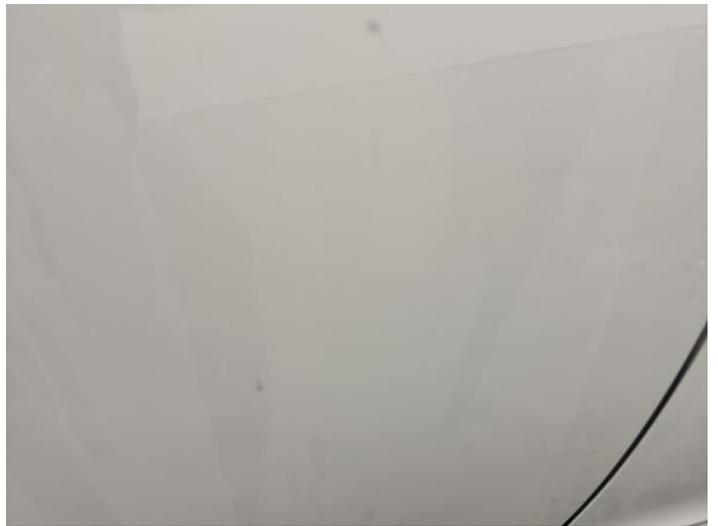
6: Door osr
Chipped
1 To 5

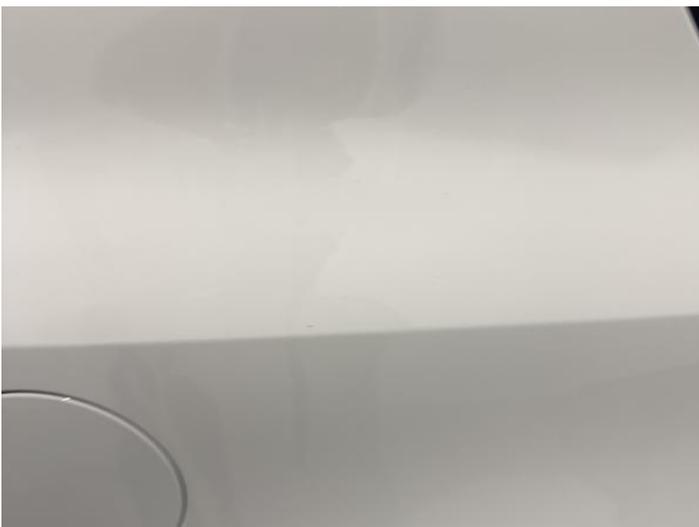
7: Qtr Panel osr
Scratched
Over 25mm Not Thru Paint

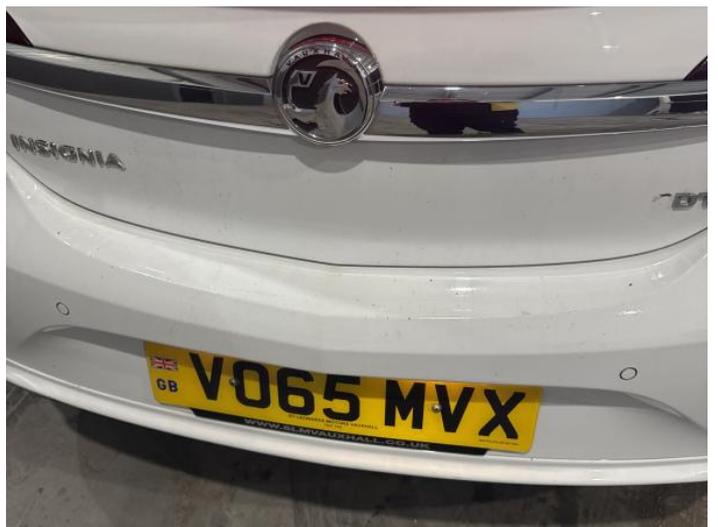
8: Bumper Rear
Scratched
25 to 100mm Thru Paint

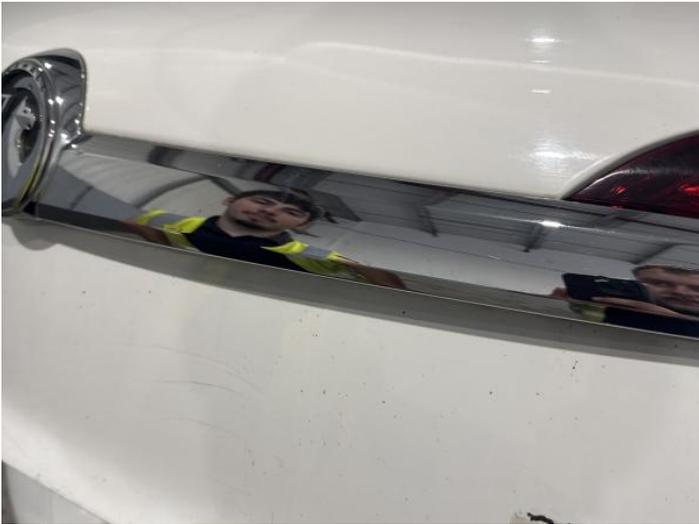
9: Boot Lid
Scratched
Over 25mm Not Thru Paint

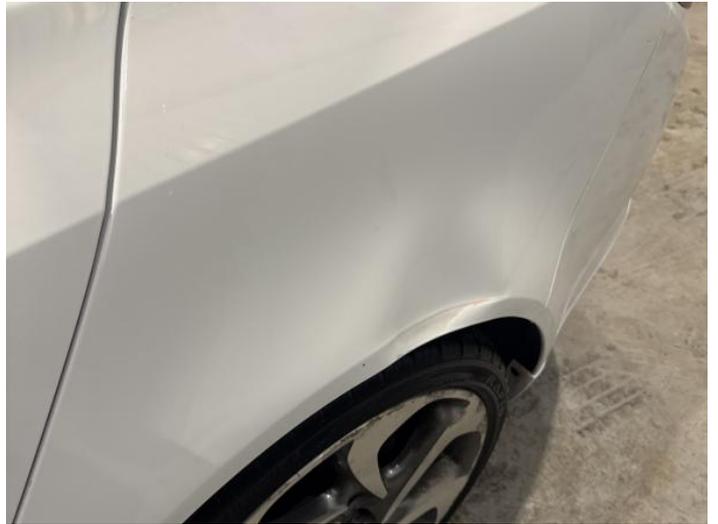
10: Qtr Panel nsr
Dented
Over 30mm

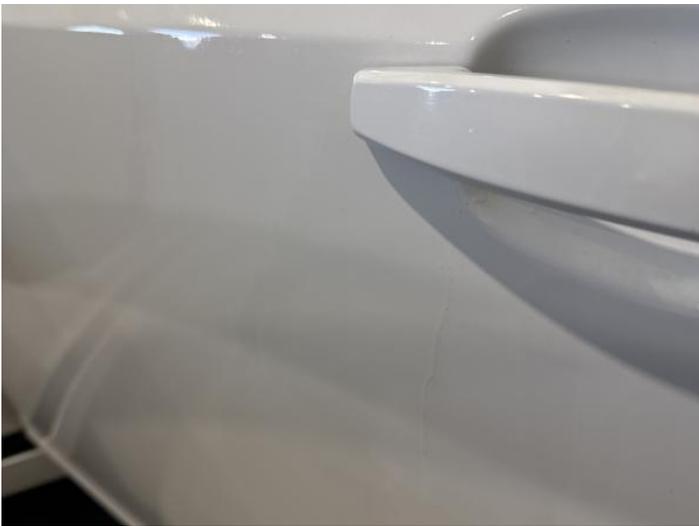
11: Door nsr
Scratched
Over 25mm Not Thru Paint

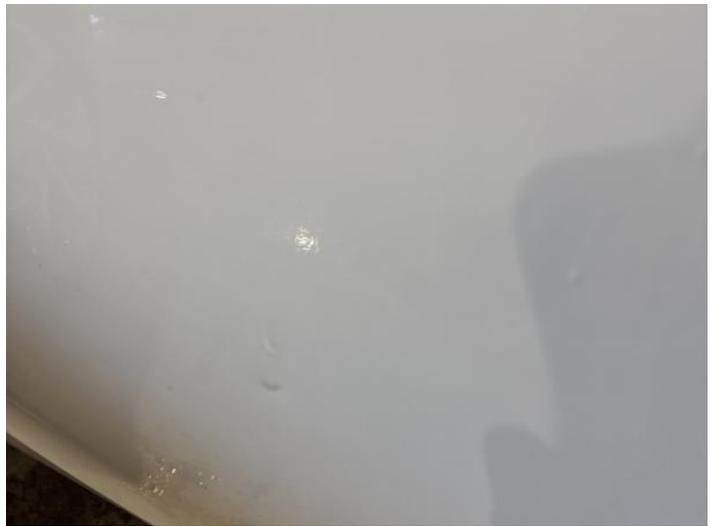
12: Door nsf
Dented
Between 10mm + 30mm

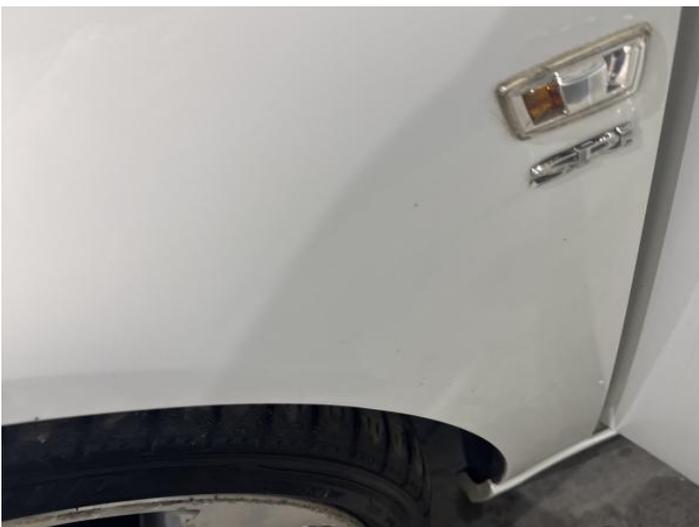
13: Wing nsf
Chipped
1 To 5

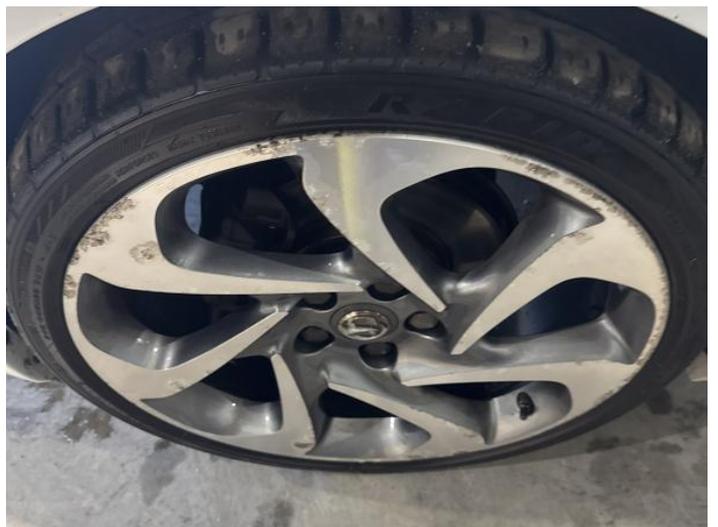
14: Wheel nsf
Scratched
Over 50mm

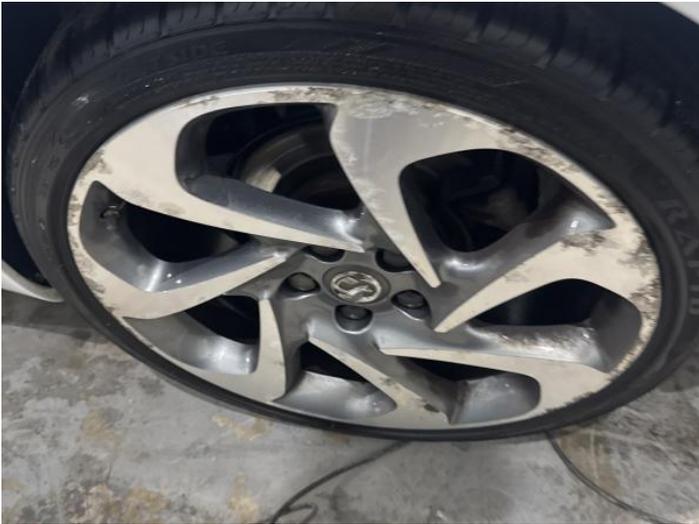
15: Wheel nsr
Scratched
Over 50mm

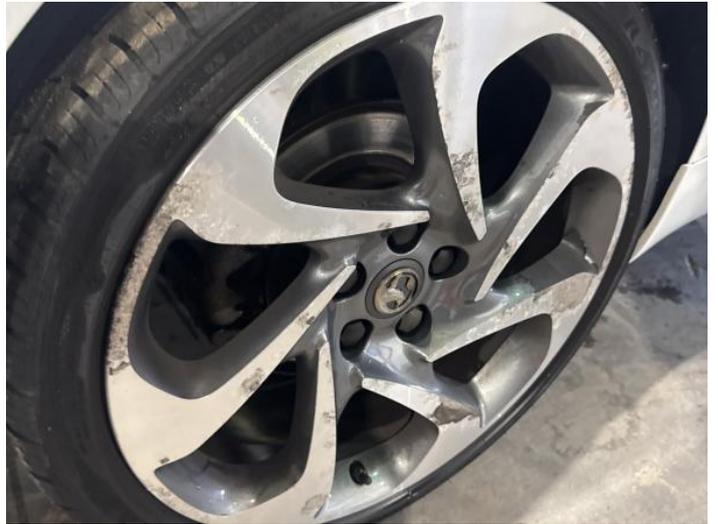
16: Wheel osr
Scratched
Over 50mm

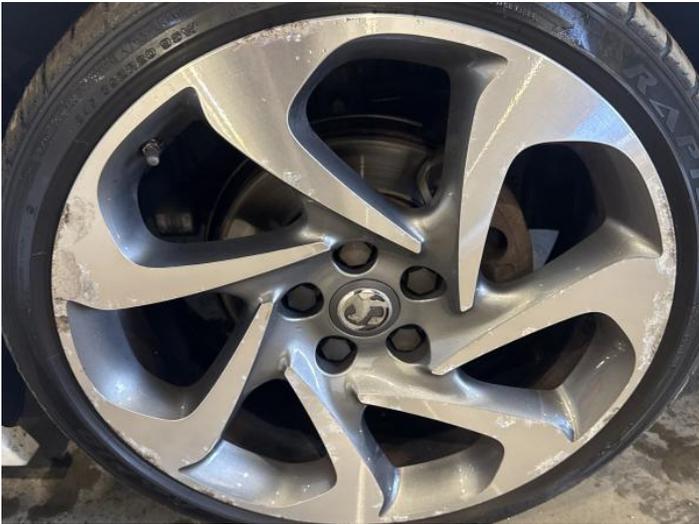
17: Wheel osf
Scratched
Over 50mm

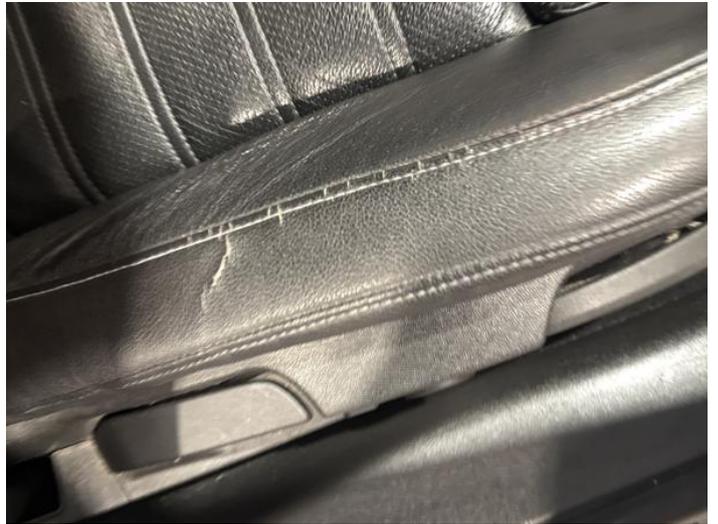
18: Seat Base Cover osf
Torn
Over 3mm

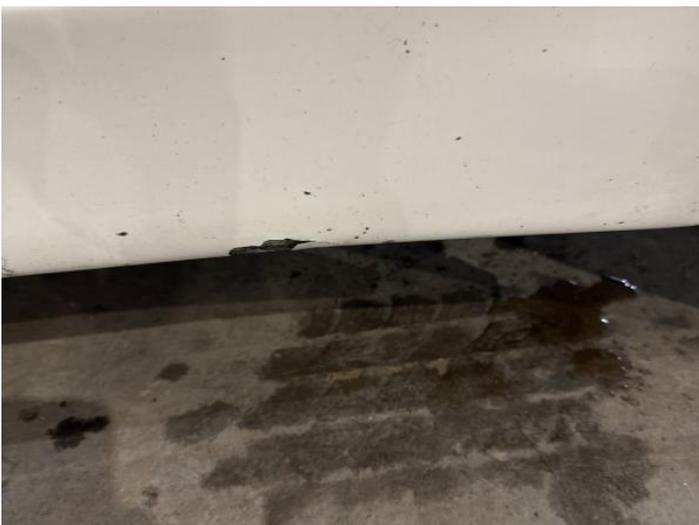
19: Sill os
Scratched
Over 25mm Thru Paint
