VEHICLE INSPECTION REPORT

GU61CZN

Ford Focus 1.6 EcoBoost Titanium X 5dr

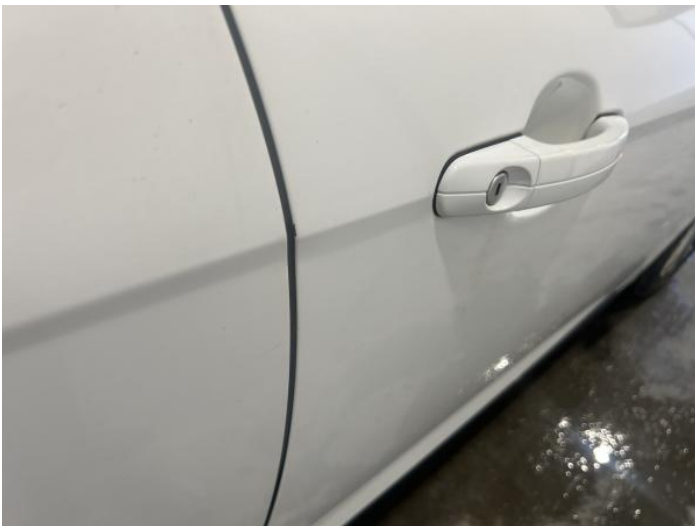
1: Door osf
Chipped
Edge Chip

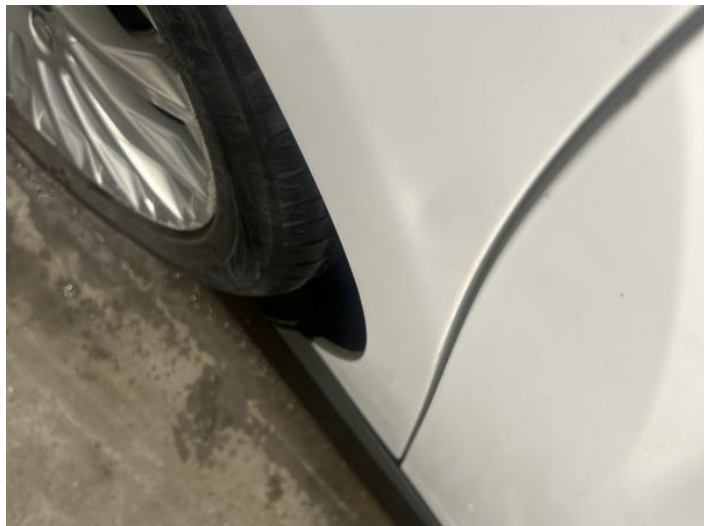
2: Qtr Panel osr
Dented
Between 10mm + 30mm

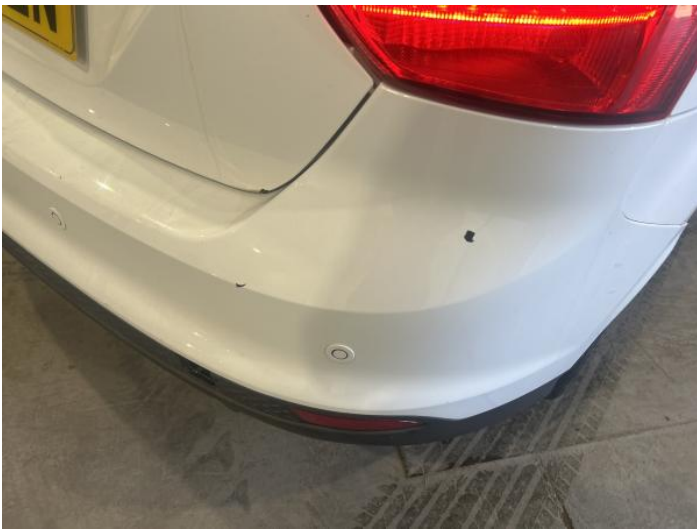
3: Bumper Rear
Scratched
Over 100mm Thru Paint

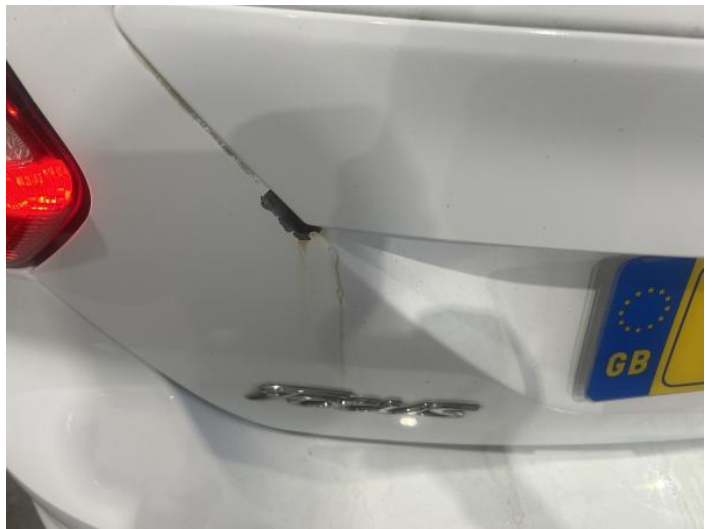
4: Tailgate
Chipped
Over 5mm

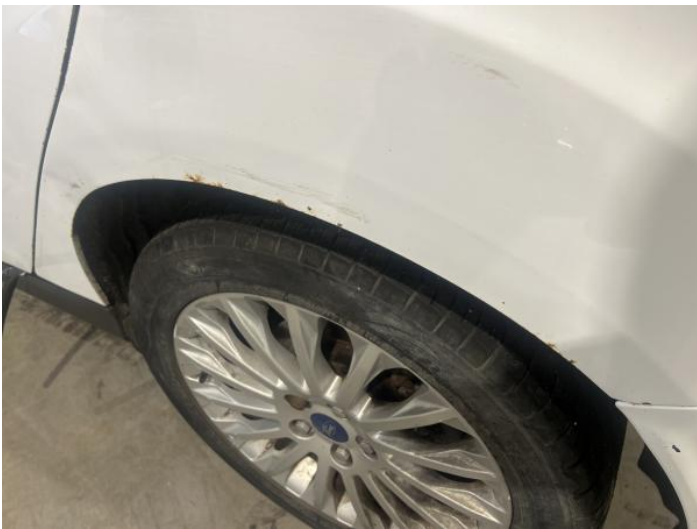
5: Qtr Panel nsr
Dented
With Paint Damage

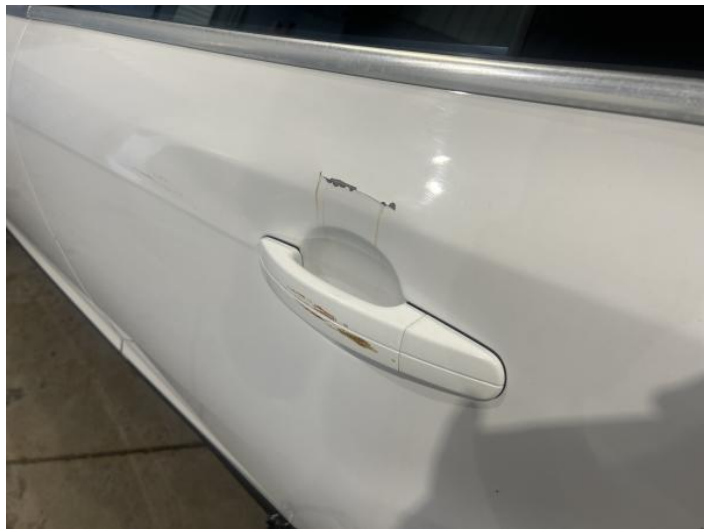
6: Door nsr
Dented
With Paint Damage

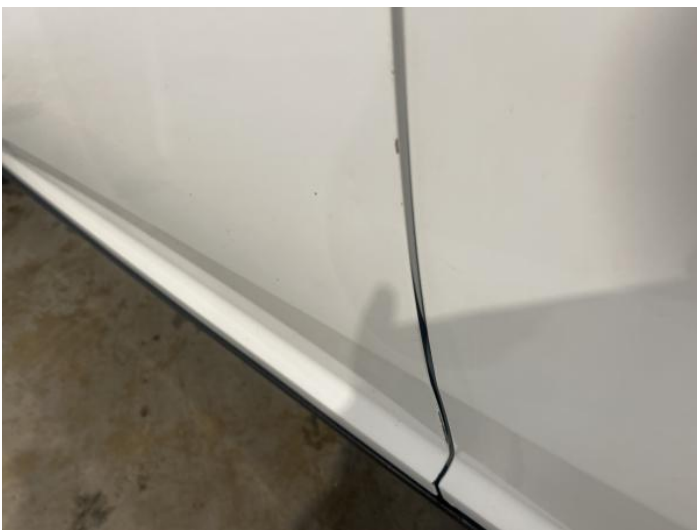
7: Door nsf
Dented
Between 10mm + 30mm

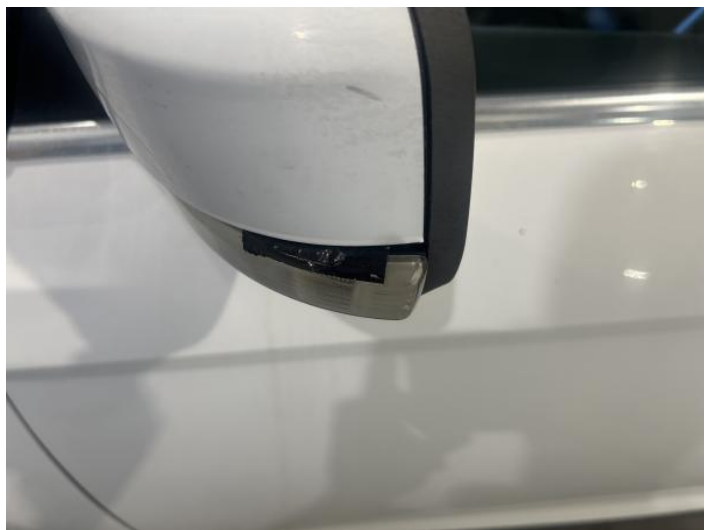
8: Door Mirror Assy nsf
Broken
Replace

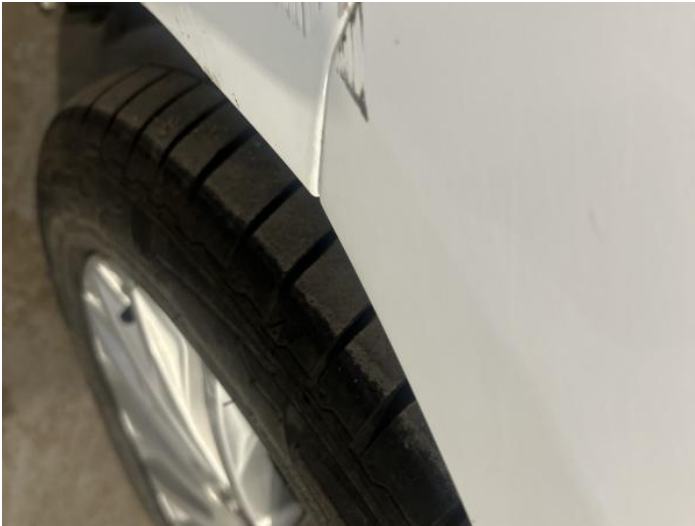
9: Wing nsf
Scratched
UpTo 25mm Thru Paint

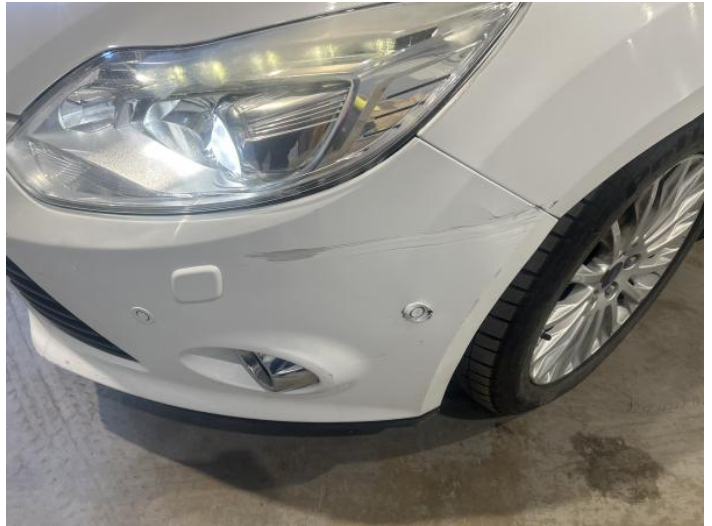
10: Bumper Front
Scratched
Over 100mm Thru Paint

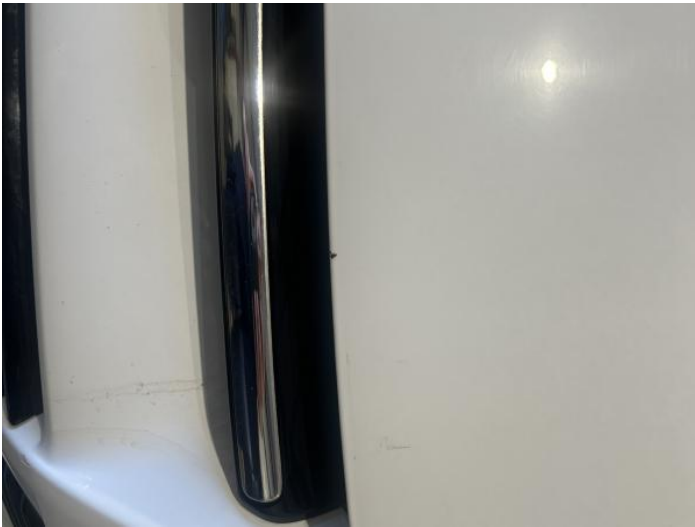
11: Bonnet
Chipped
1 To 5

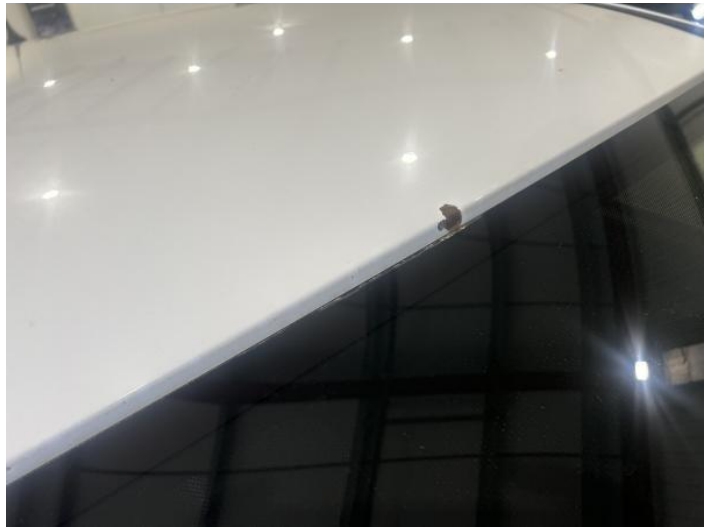
12: Roof
Chipped
Over 5mm

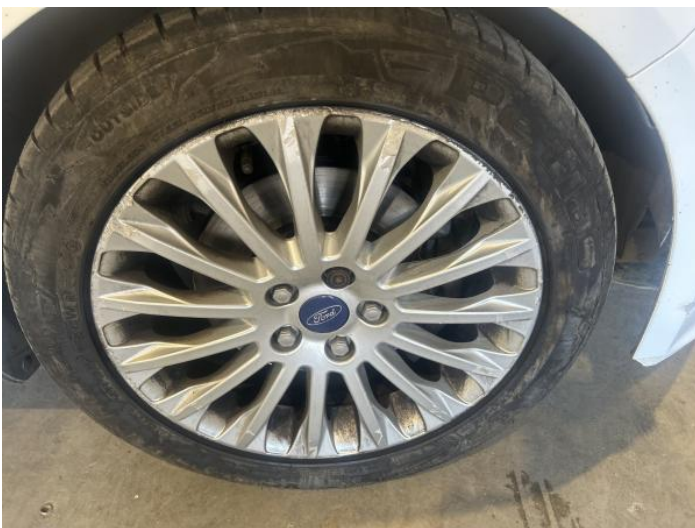
13: Wheel osf
Scratched
Over 50mm

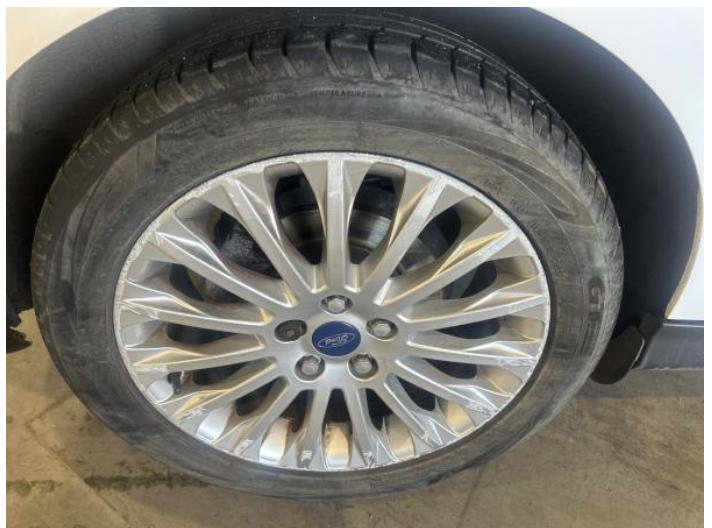
14: Wheel osr
Scratched
Over 50mm

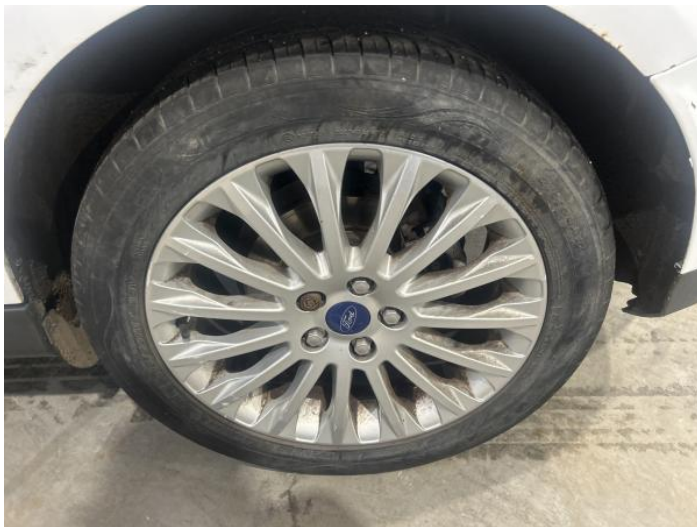
15: Wheel nsr
Scratched
Over 50mm

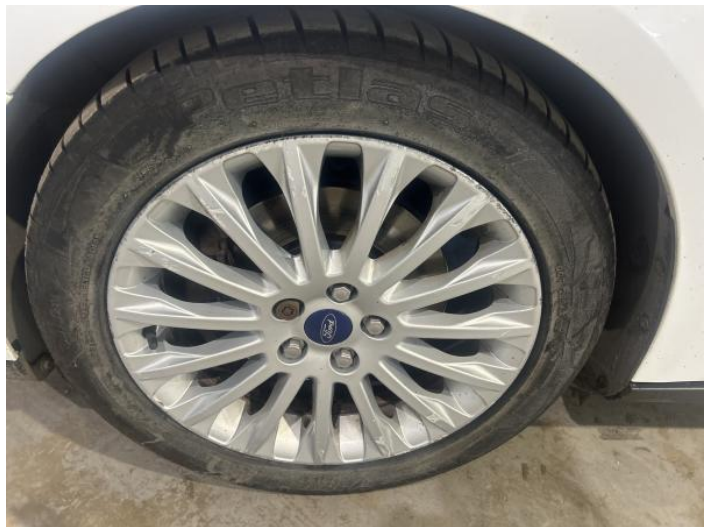
Clutch pedal stiff and low, nsf wheel looks bent, front end of car knocking when driving

16: Wheel nsf
Scratched
Over 50mm
