VEHICLE INSPECTION REPORT

GU13YLB

Nissan Juke 1.6 Tekna 5dr

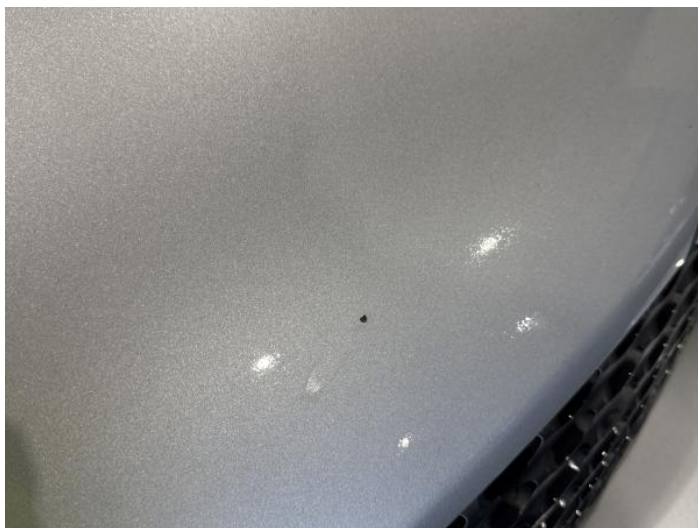
1: Bonnet
Chipped
1 To 5

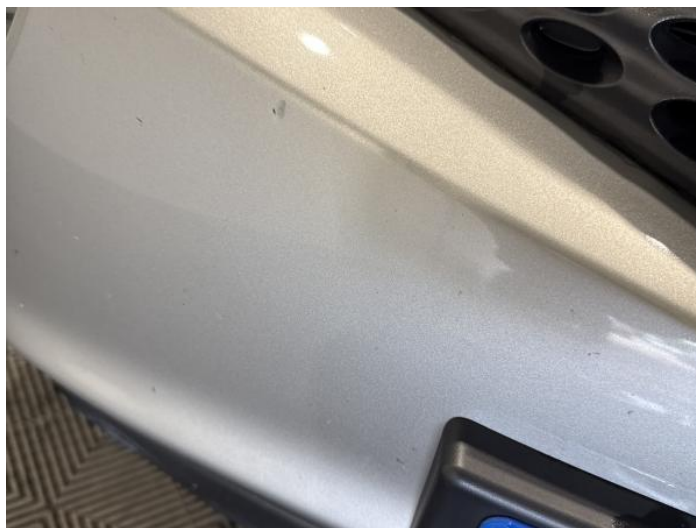
2: Bumper Front
Chipped
Multiple Chips

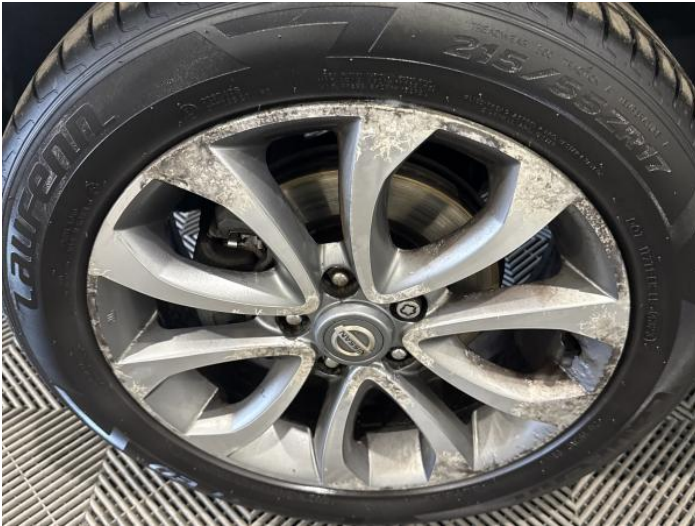
3: Wheel nsf
Scratched
Over 50mm

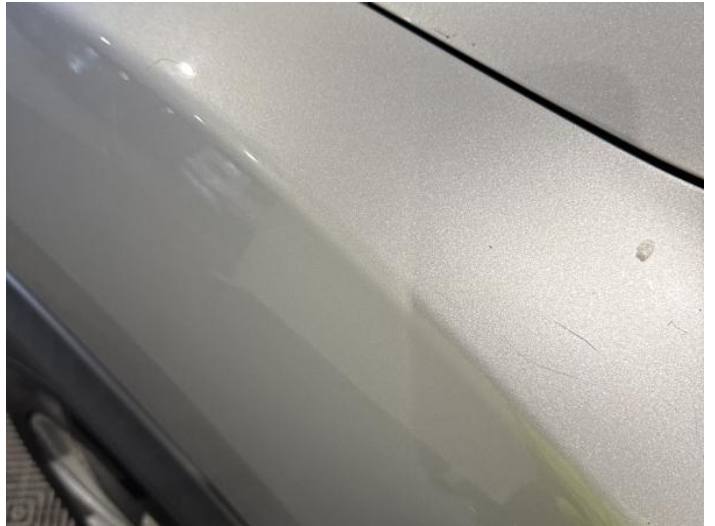
4: Wing nsf
Scratched
Over 25mm Thru Paint

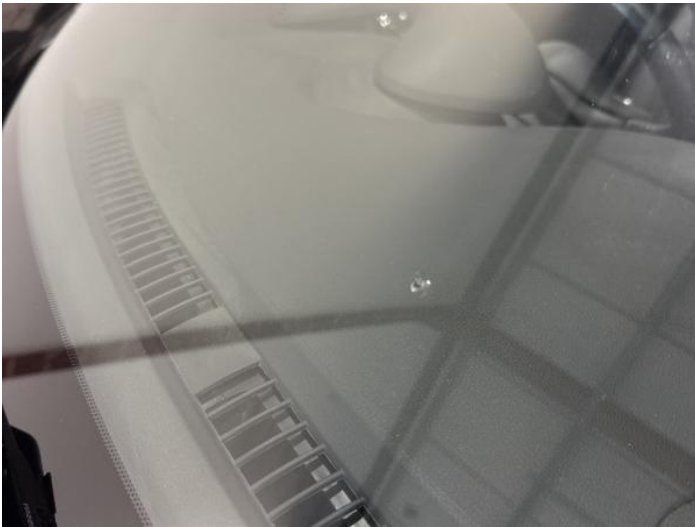
5: Screen Front
Chipped
Over 10mm

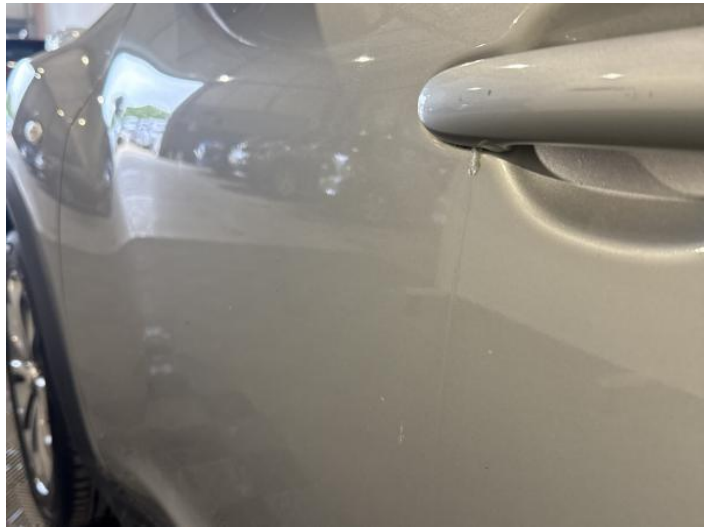
6: Door nsf
Dented
Over 30mm

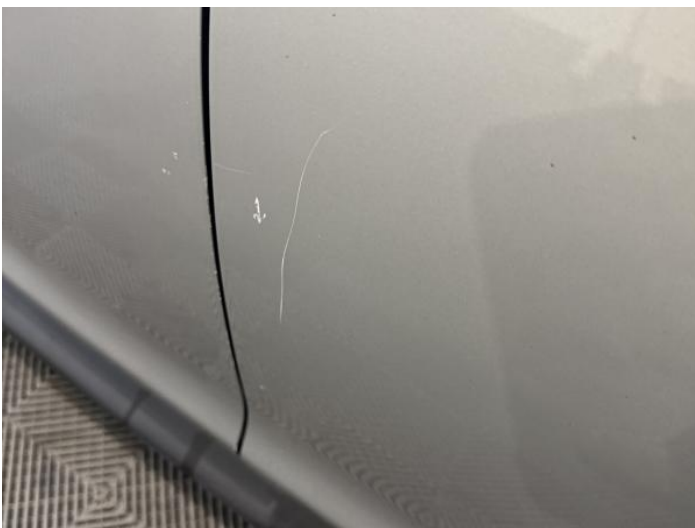
7: Door osr
Scratched
Over 25mm Thru Paint

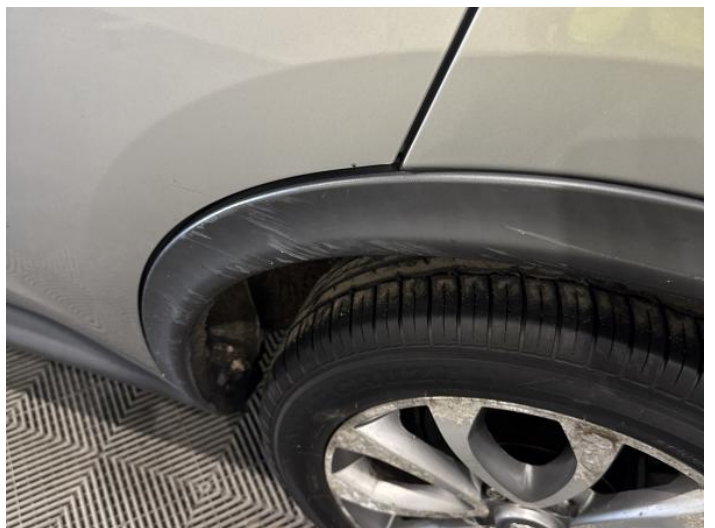
8: Qtr Panel Arch Extension ns
Scuffed (Unpainted)
Over 100mm

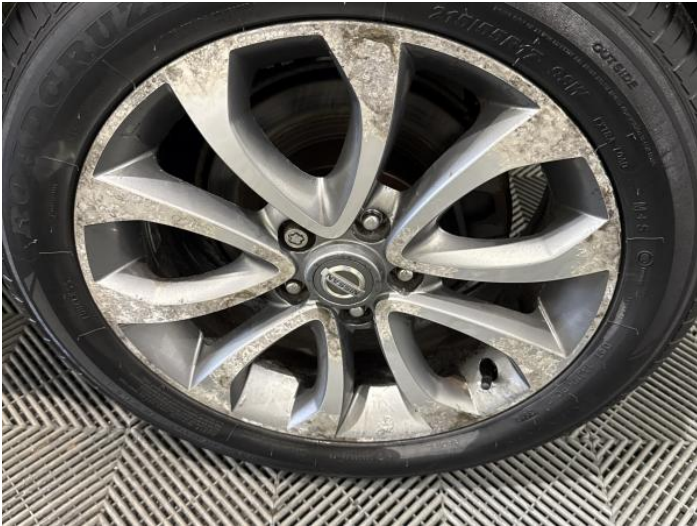
9: Wheel nsr
Scratched
Over 50mm

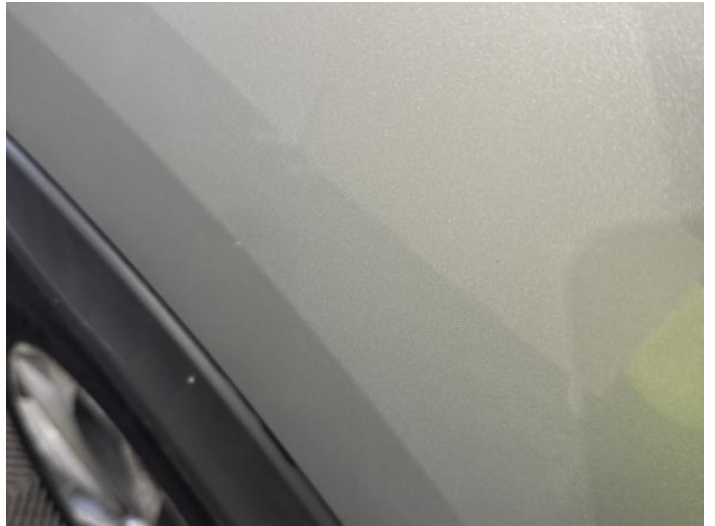
10: Qtr Panel nsr
Dented
Between 10mm + 30mm

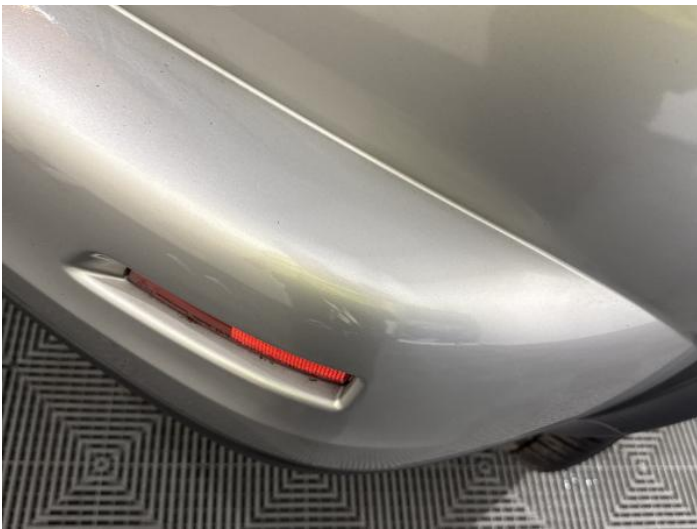
11: Bumper Rear
Scratched
25 to 100mm Thru Paint

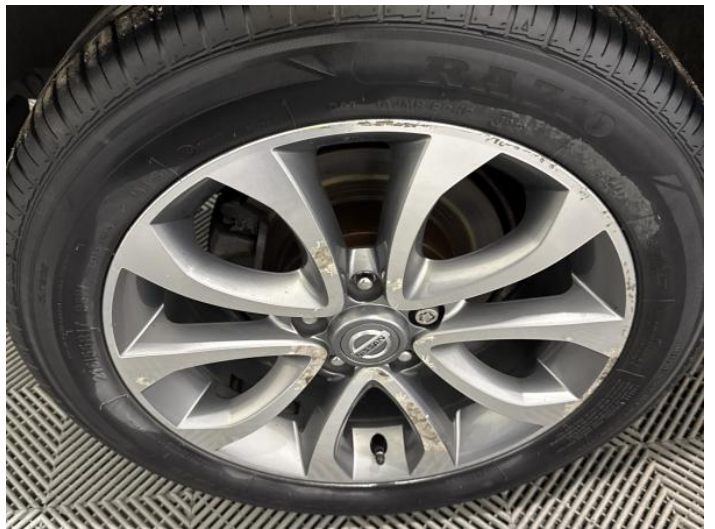
12: Wheel osr
Scratched
Over 50mm

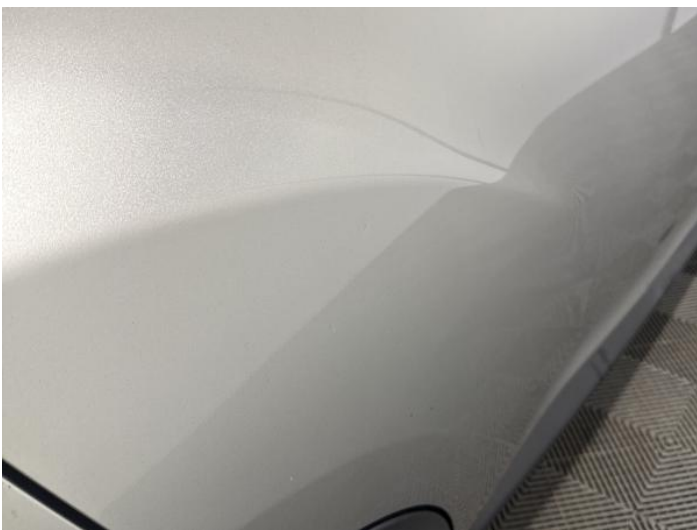
13: Door osr
Dented
2 Or Less UpTo 10mm

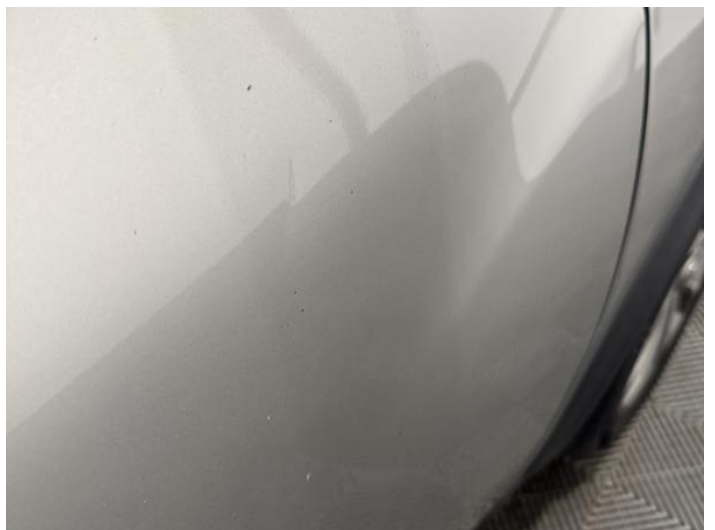
14: Door osf
Dented
With Paint Damage

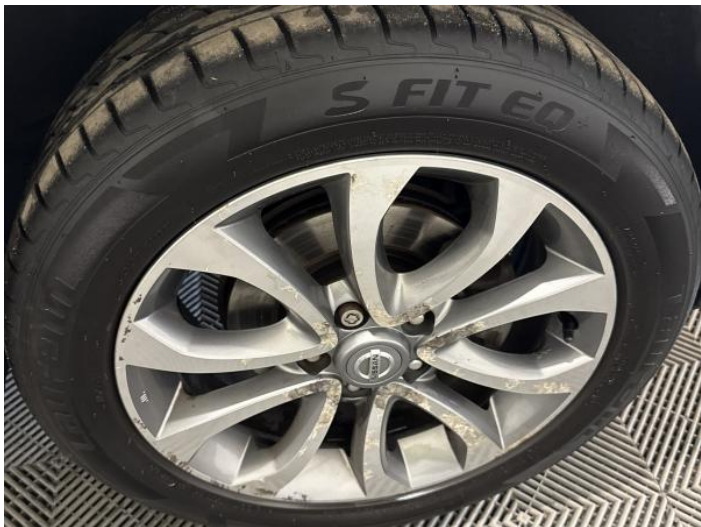
15: Wheel osf
Scratched
Over 50mm
