VEHICLE INSPECTION REPORT

LV09DHC

Renault Clio 1.5 dCi 86 Dynamique S 5dr [AC]

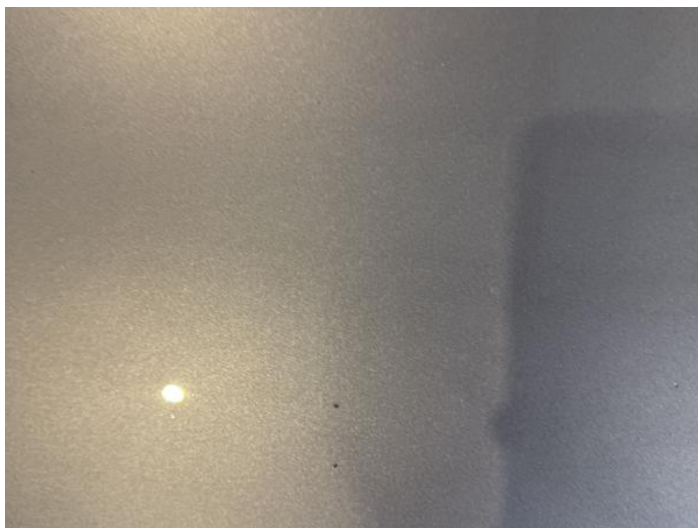
1: Bonnet
Chipped
1 To 5

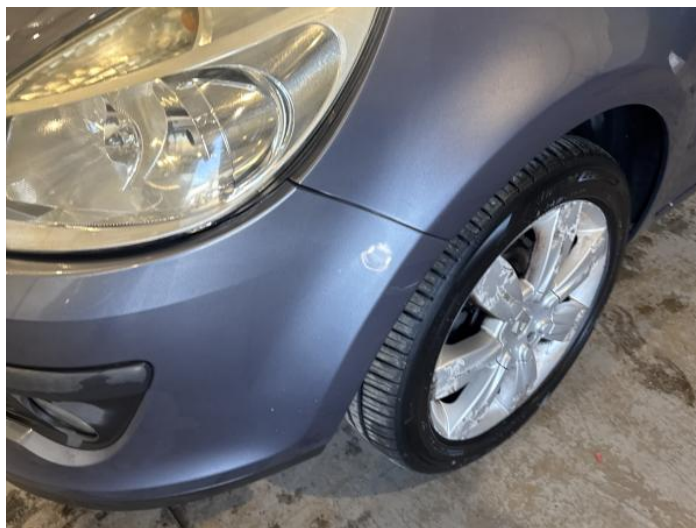
2: Bumper Front
Scratched
25 to 100mm Thru Paint

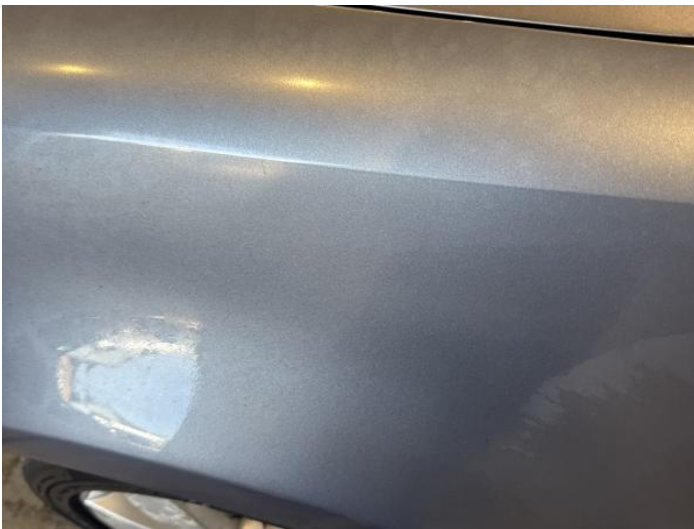
5: Wing nsf
Poor Previous Repair
Poor Paint

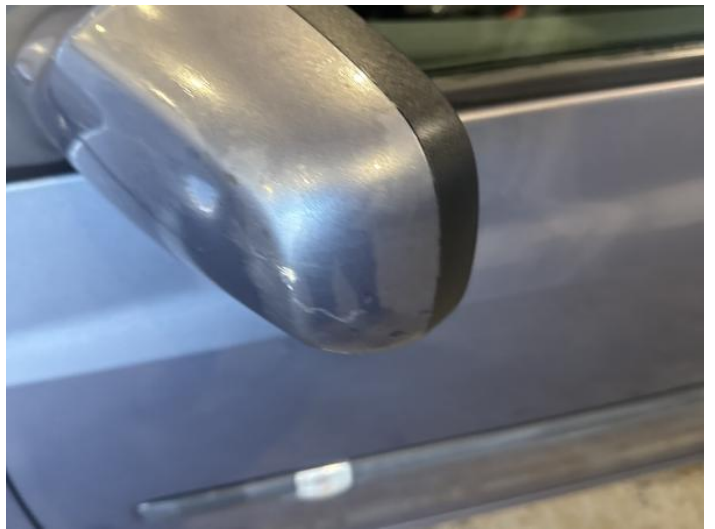
6: Door Mirror Assy nsf
Scratched (Painted)
UpTo 25mm Thru Paint

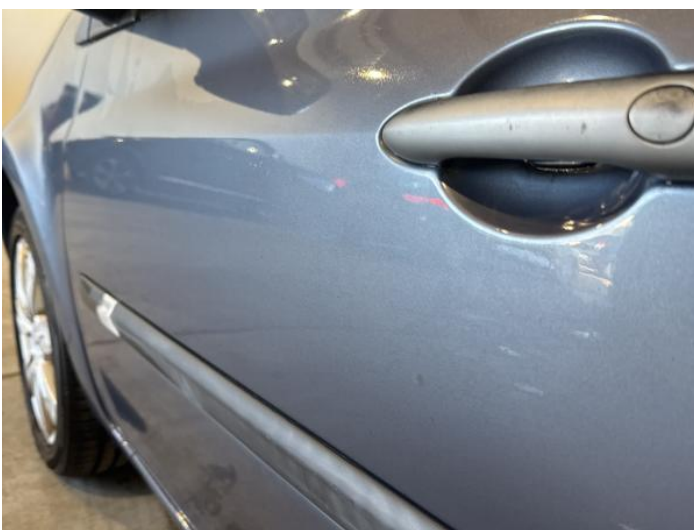
7: Door nsf
Chipped
1 To 5

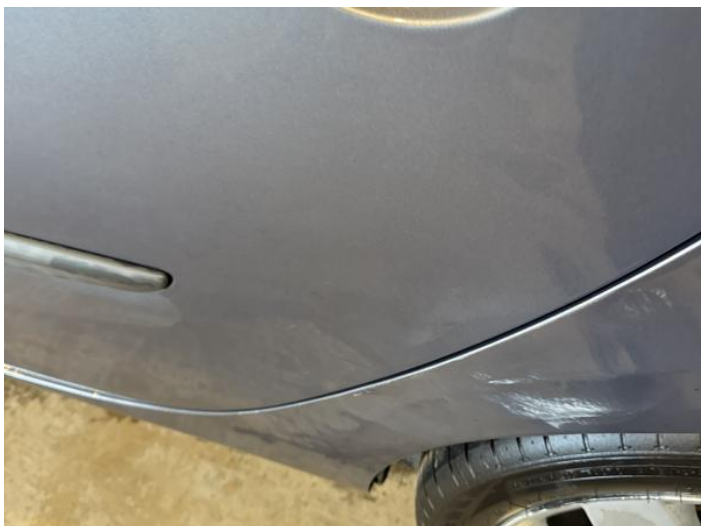
9: Door nsr
Dented
Over 30mm

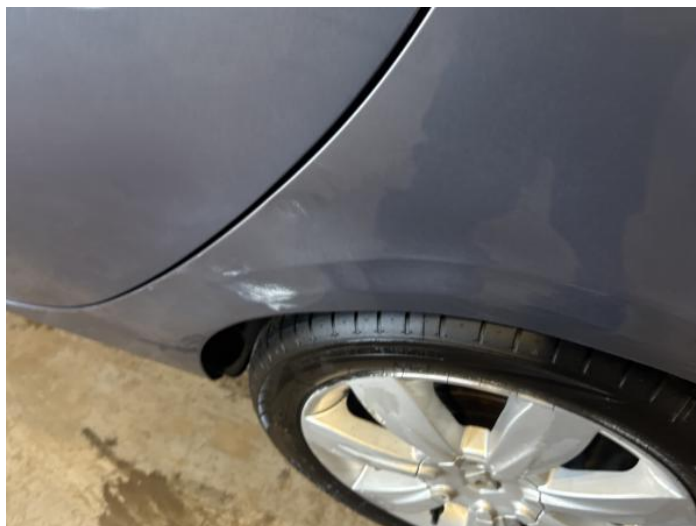
10: Qtr Panel nsr
Dented
With Paint Damage

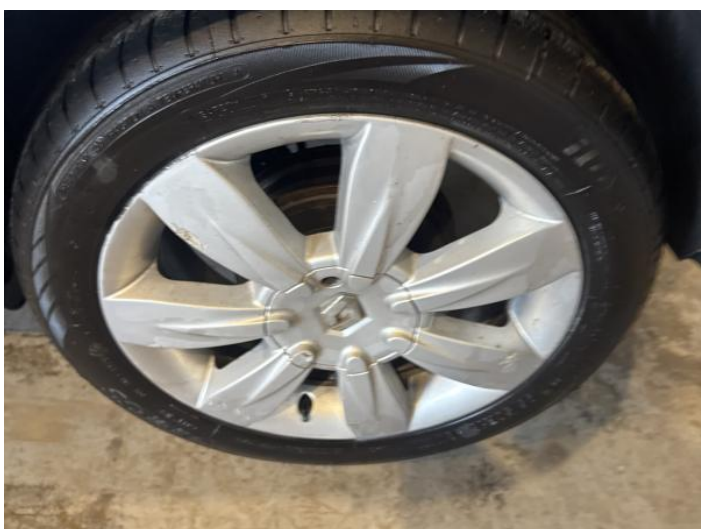
11: Wheel nsr
Scratched
Over 50mm

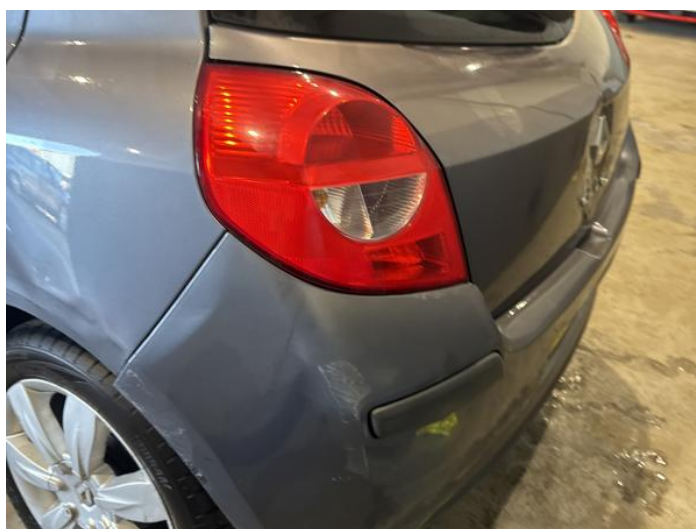
12: Bumper Rear
Poor Previous Repair
Poor Paint

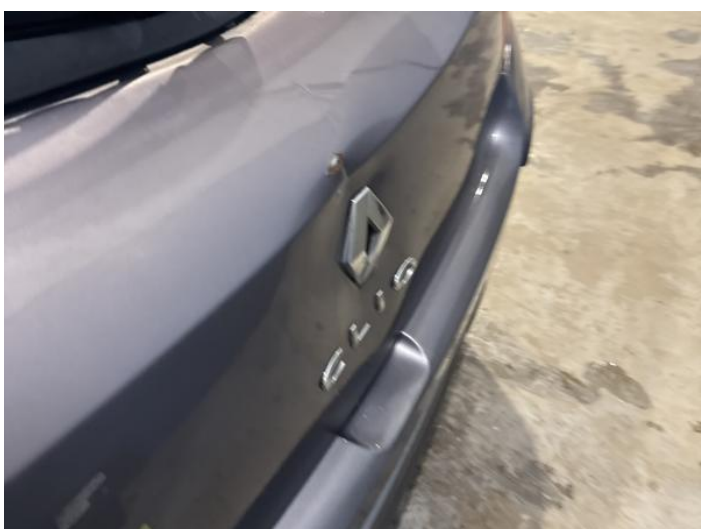
13: Boot Lid
Dented
With Paint Damage

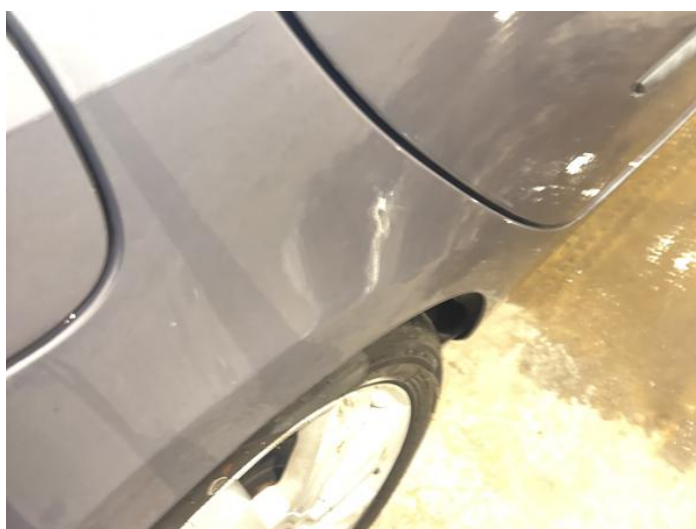
14: Qtr Panel osr
Dented
Between 10mm + 30mm

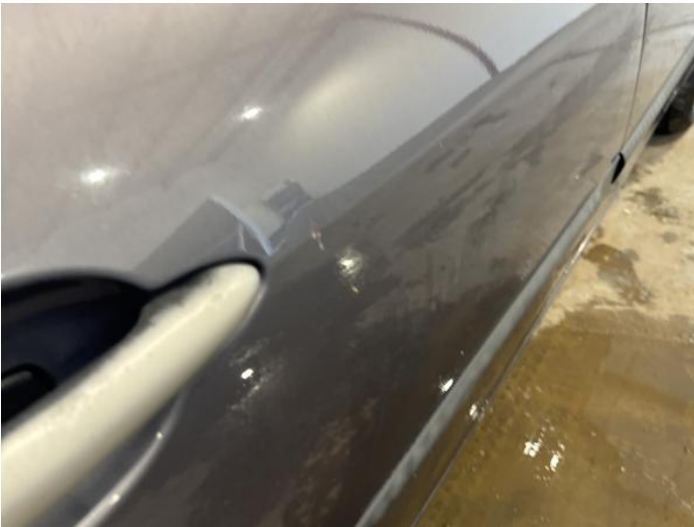
17: Door osr
Dented
With Paint Damage

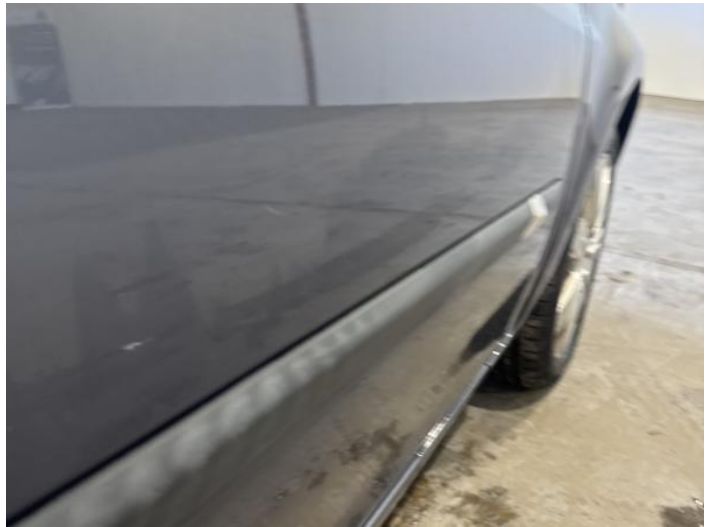
18: Door osf
Chipped
1 To 5

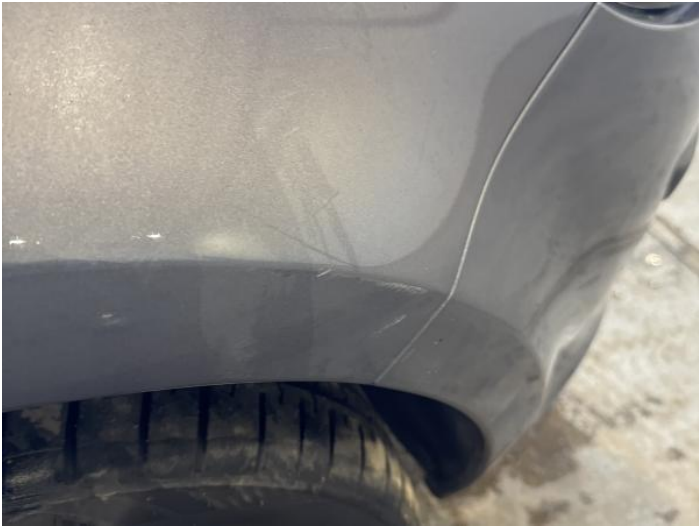
21: Wing osf
Scratched
UpTo 25mm Thru Paint

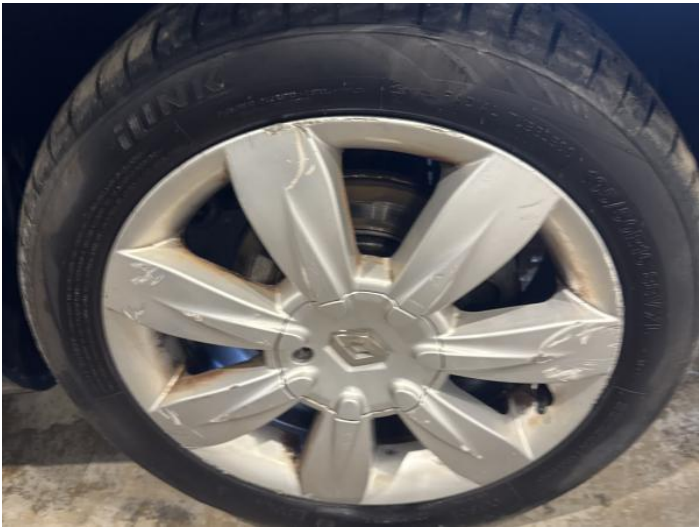
23: Wheel osf
Scratched
Over 50mm

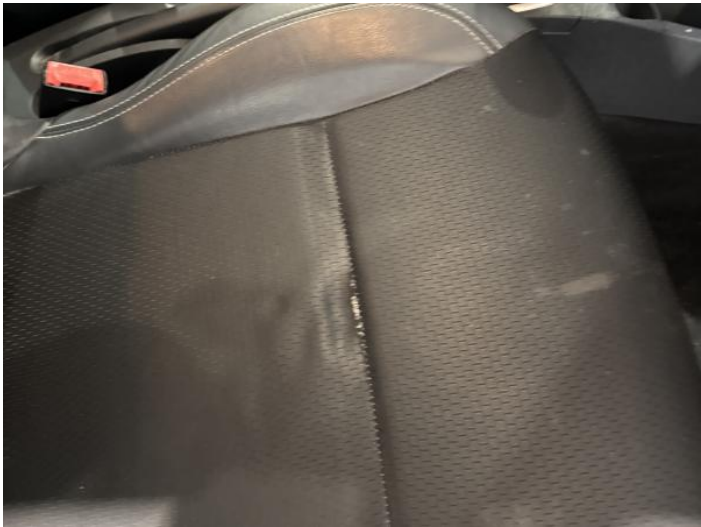
24: Seat Base Cover osf
Torn
UpTo 3mm
