VEHICLE INSPECTION REPORT

GU59YLA

Toyota IQ 1.0 VVT-i 3dr

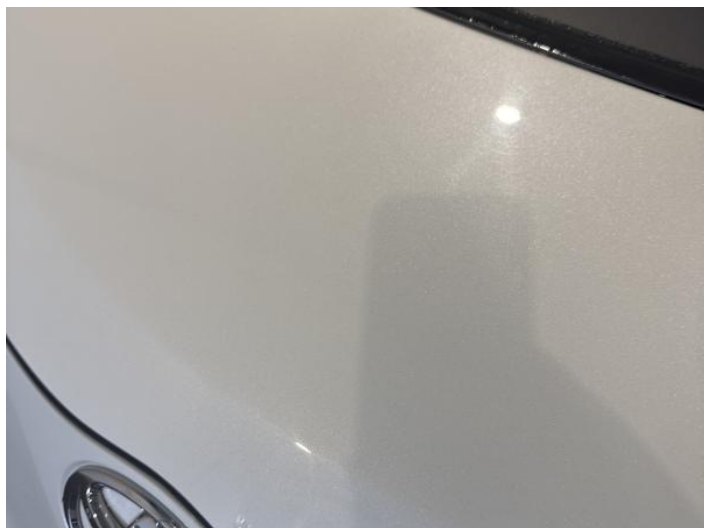
2: Bonnet
Chipped
1 To 5

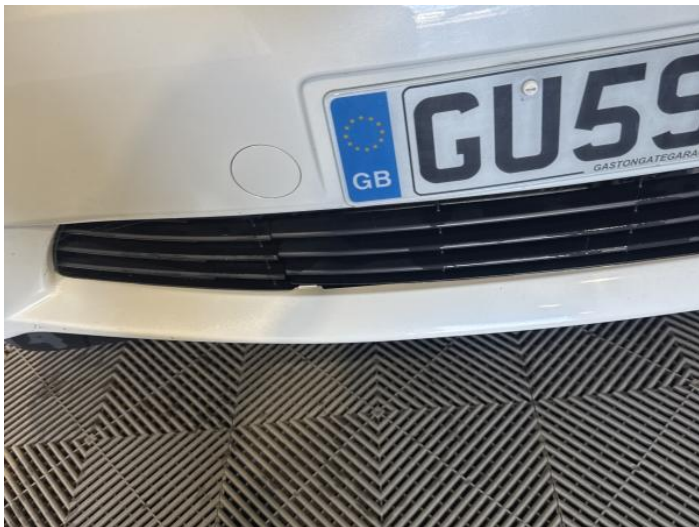
3: Bumper Front Moulding
Broken
Replace

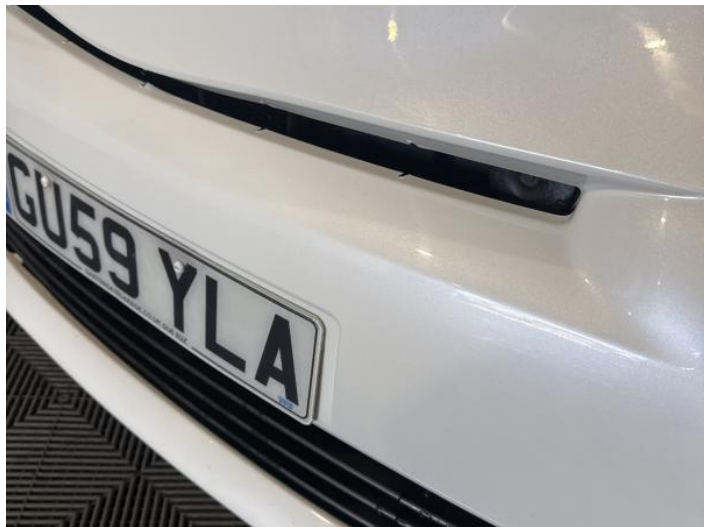
4: Bumper Front
Cracked
Over 25mm

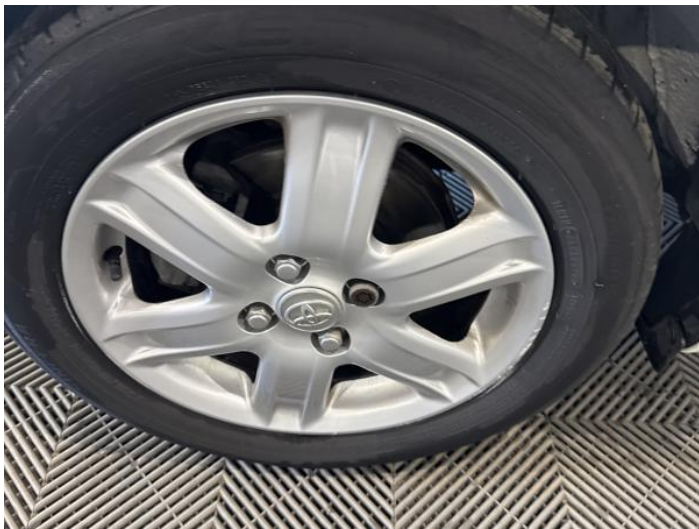
5: Wheel nsf
Scratched
Over 50mm

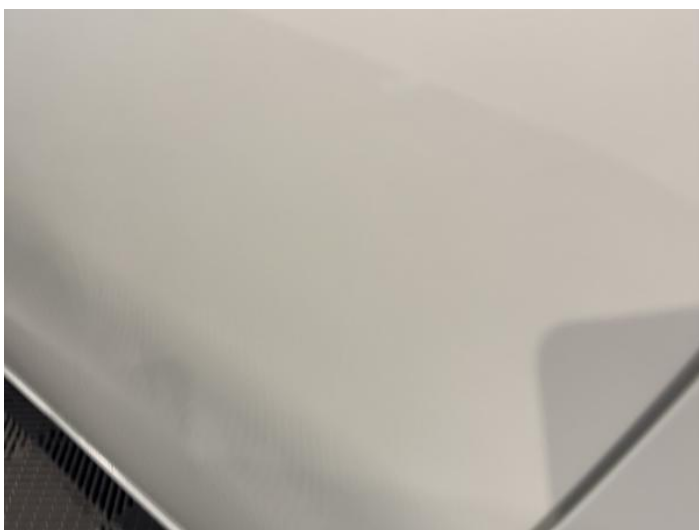
7: Door nsf
Chipped
1 To 5

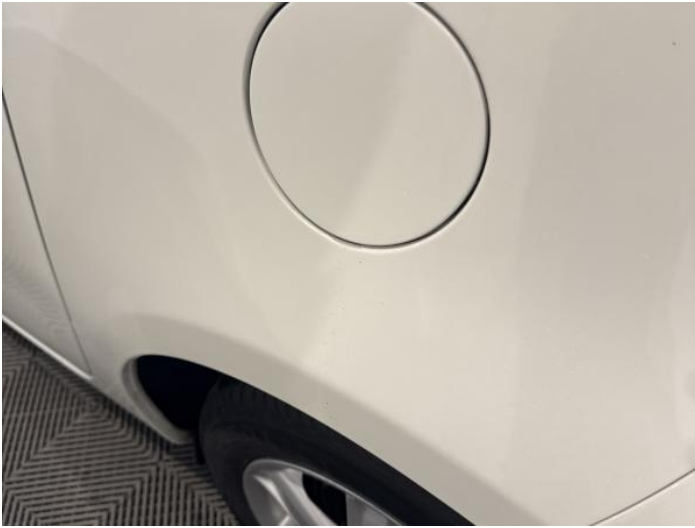
9: Qtr Panel nsr
Dented
2 Or Less UpTo 10mm

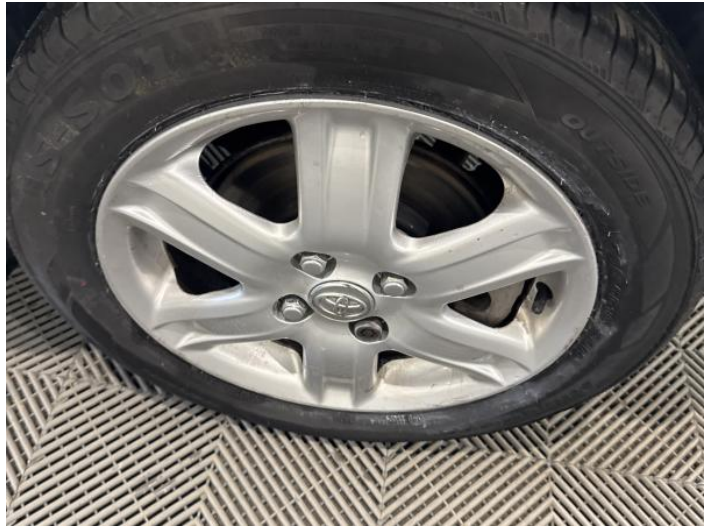
10: Wheel nsr
Scratched
Over 50mm

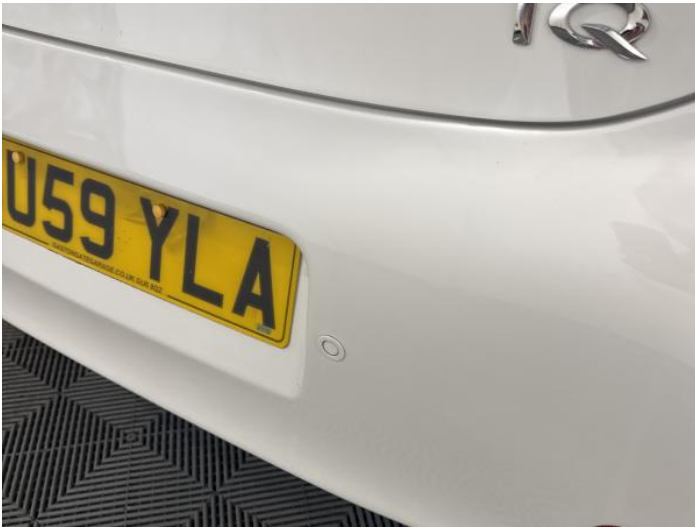
11: Bumper Rear
Chipped
Multiple Chips

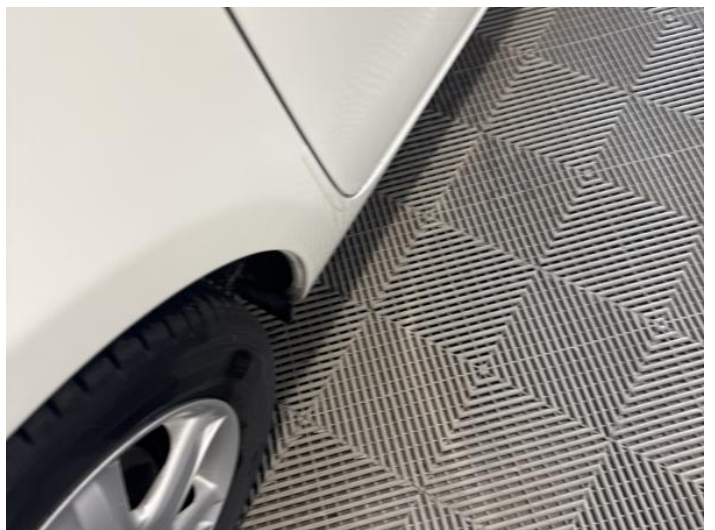
14: Qtr Panel osr
Dented
2 Or Less UpTo 10mm

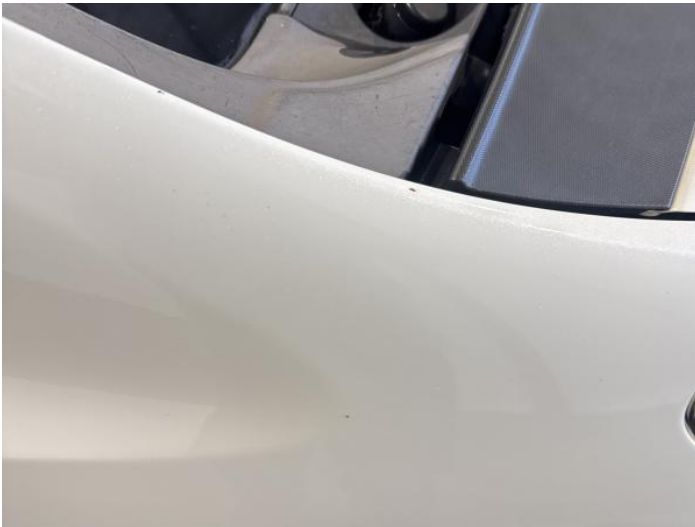
16: Door osf
Scratched
Over 25mm Not Thru Paint

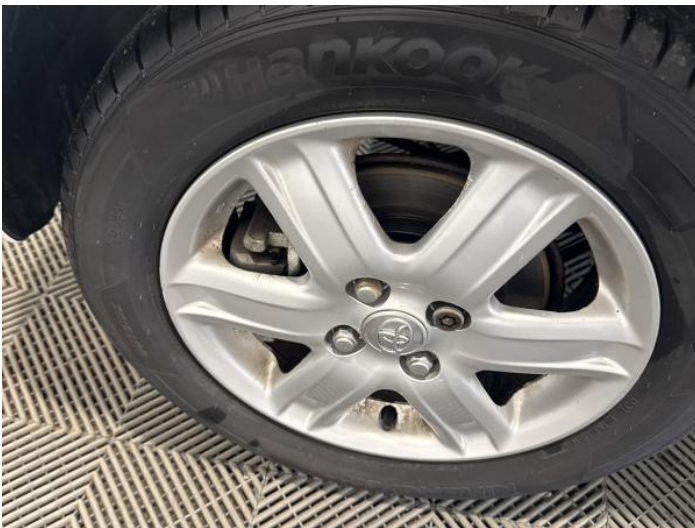
18: Wheel osf
Scratched
Up To 50mm
