# VEHICLE INSPECTION REPORT

EO66TKJ

## Volkswagen UP 1.0 High Up 3dr

nama  
GRADE  
3

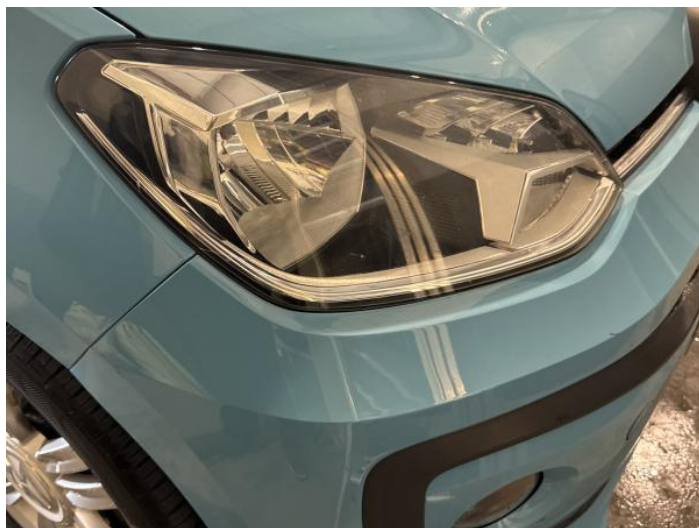
2: Bumper Front  
Chipped  
Multiple Chips

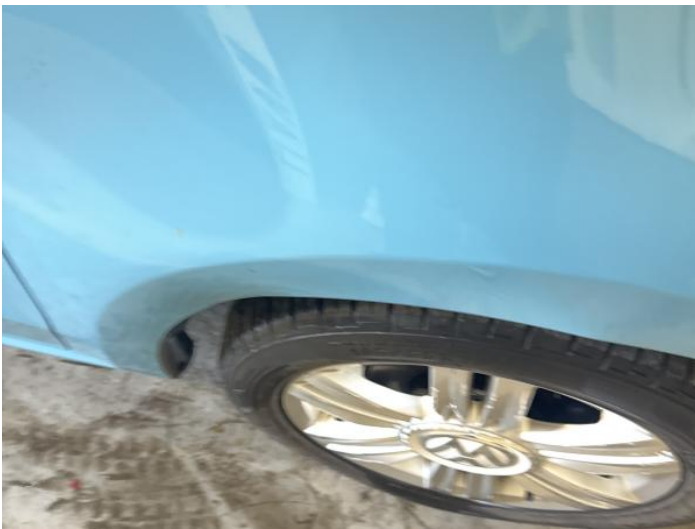
5: Wing osf  
Dented  
Over 30mm

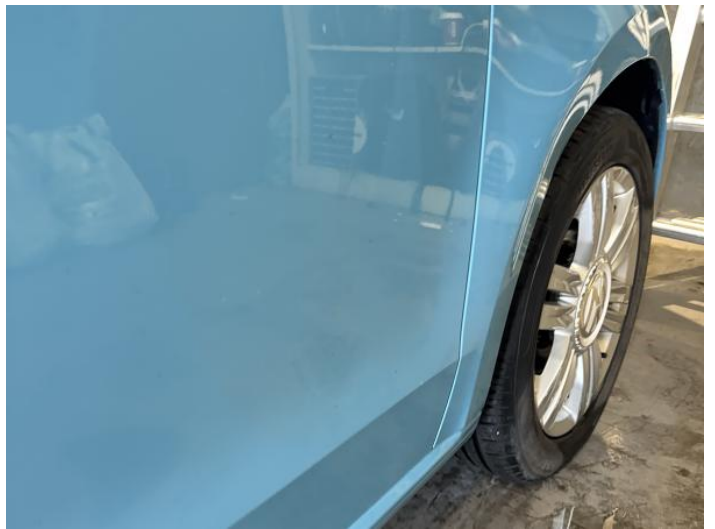
6: Door osf  
Chipped  
1 To 5

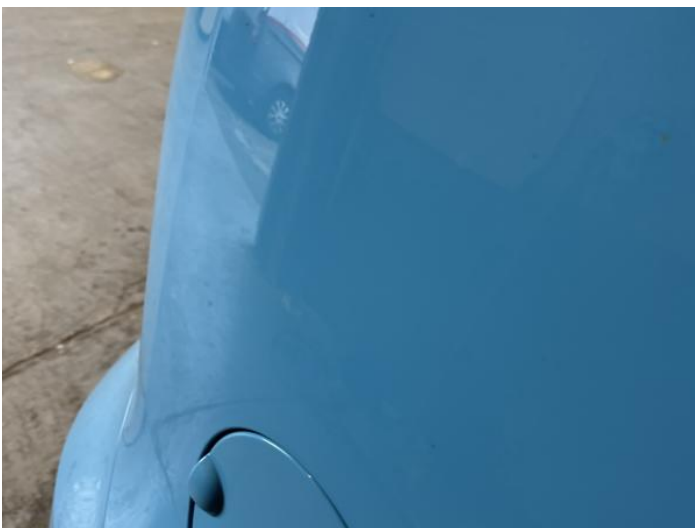
7: Qtr Panel osr  
Dented  
Between 10mm + 30mm

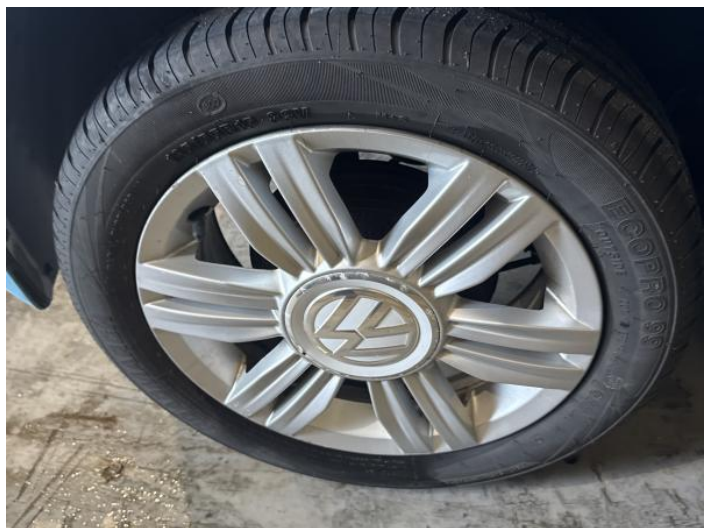
8: Wheel osr  
Scratched  
Over 50mm

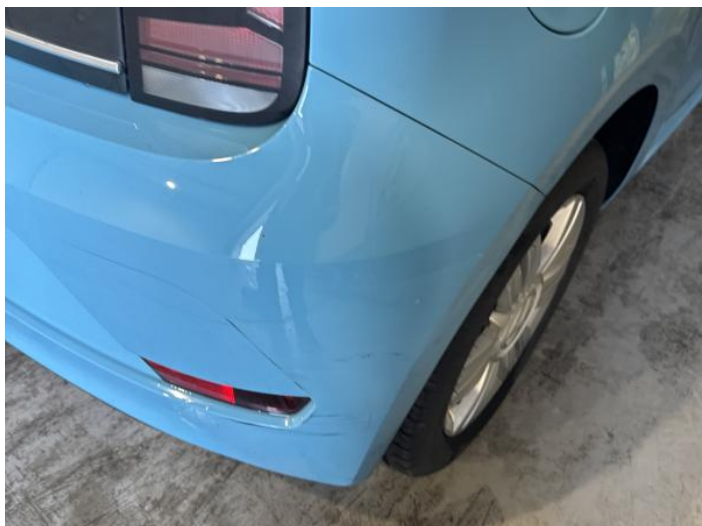
9: Bumper Rear  
Scratched  
25 to 100mm Thru Paint

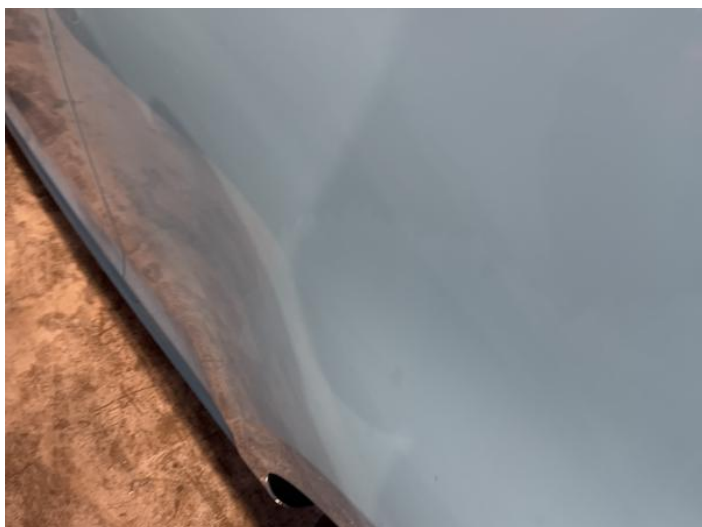
11: Qtr Panel nsr  
Dented  
Over 2 UpTo 10mm

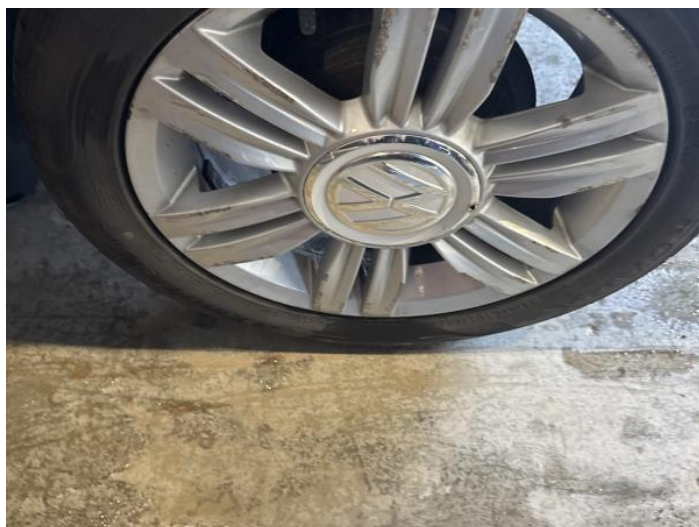
12: Wheel nsr  
Scratched  
Over 50mm

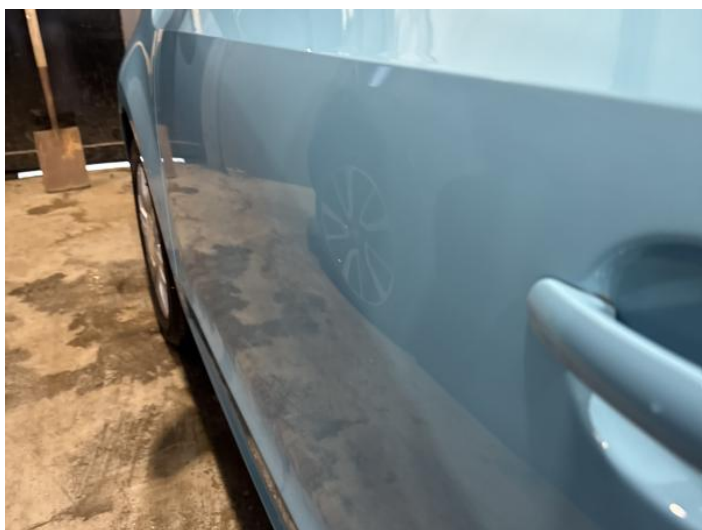
13: Door nsf  
Dented  
Over 2 UpTo 10mm

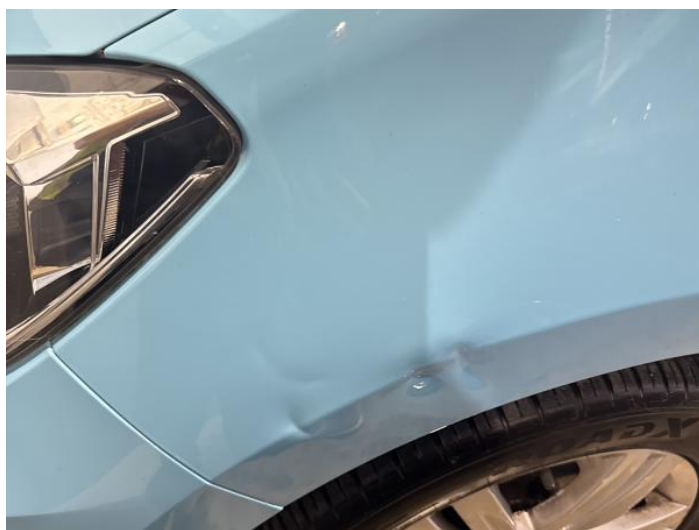
14: Wing nsf  
Dented  
With Paint Damage

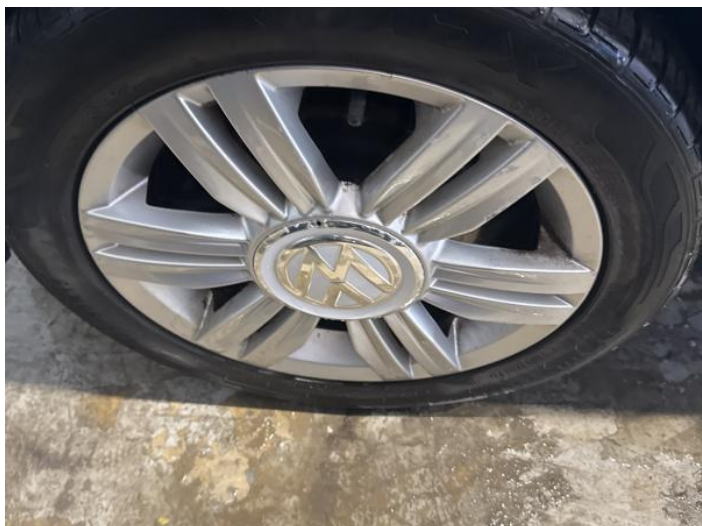
15: Wheel nsf  
Scratched  
Over 50mm
