VEHICLE INSPECTION REPORT

HF65RXC

Nissan Note 1.2 Acenta 5dr

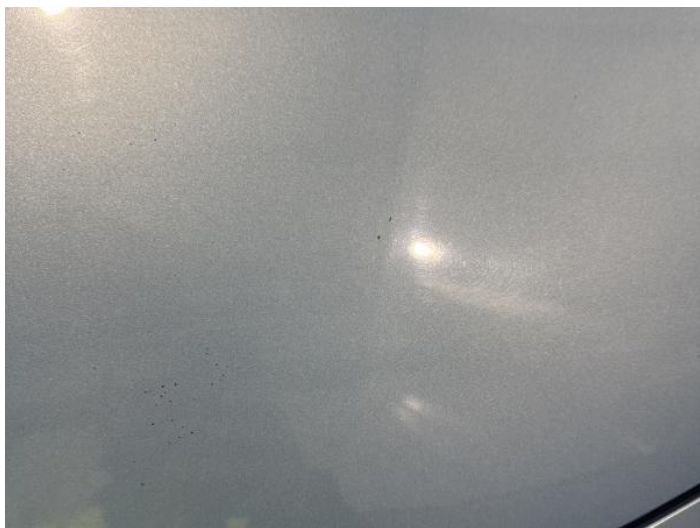
1: Bonnet
Chipped
1 To 5

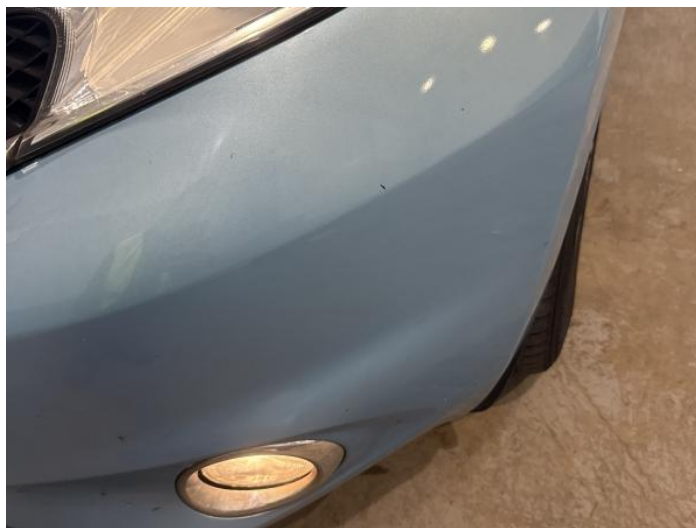
2: Bumper Front
Chipped
Multiple Chips

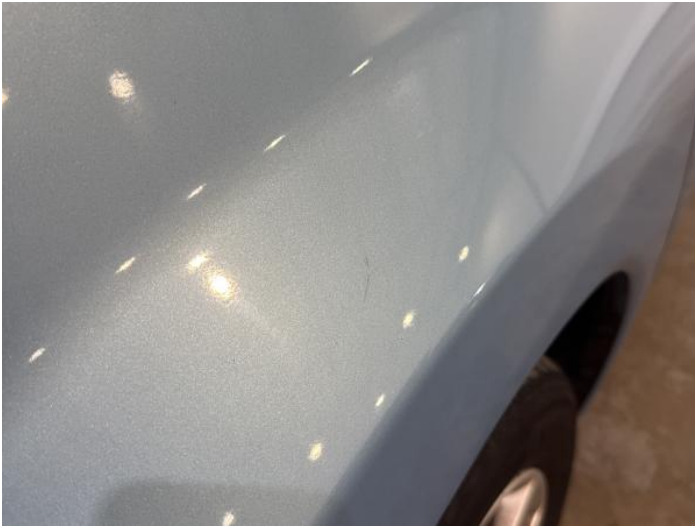
3: Wing nsf
Scratched
UpTo 25mm Thru Paint

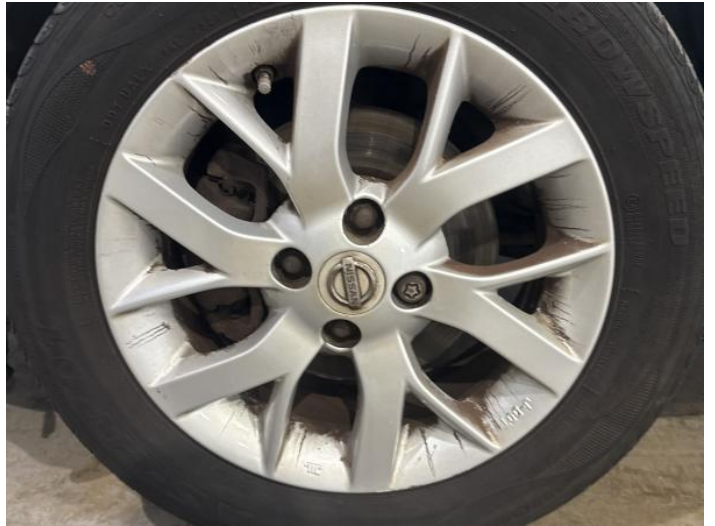
4: Wheel nsf
Scratched
Over 50mm

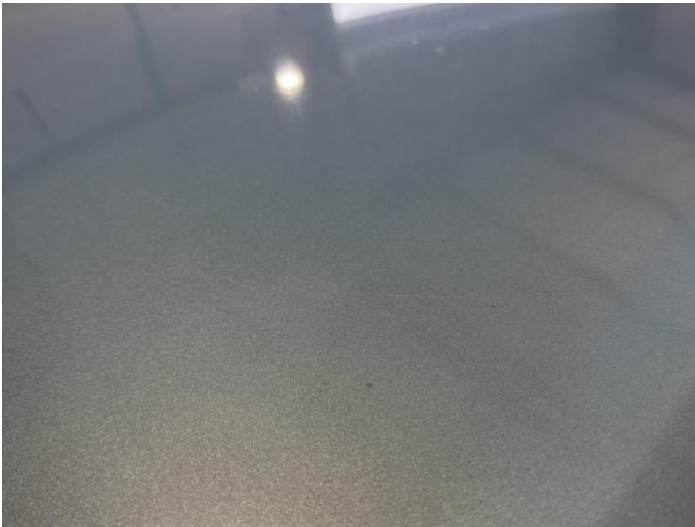
5: Roof
Scratched
Over 25mm Thru Paint

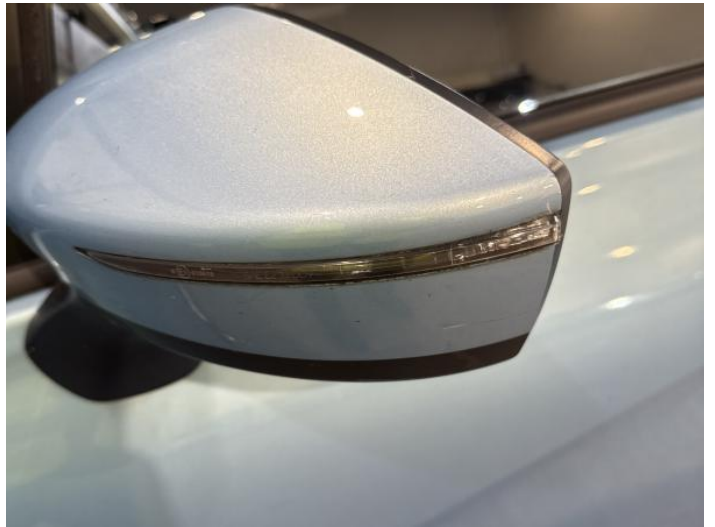
6: Door Mirror Assy nsf
Scratched (Painted)
UpTo 25mm Thru Paint

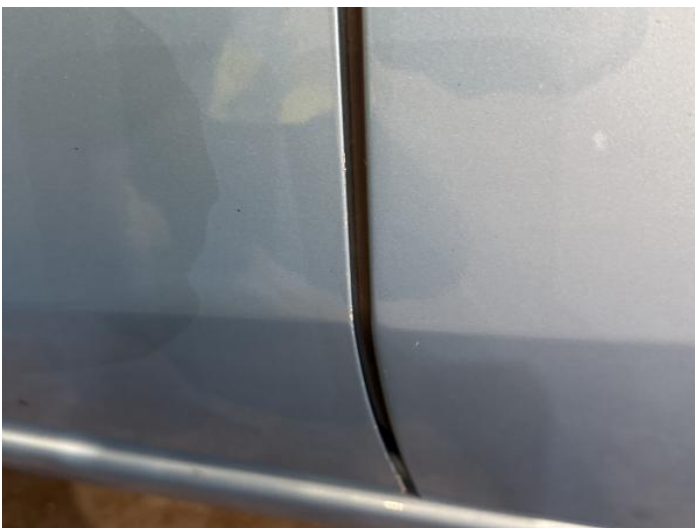
7: Door nsf
Chipped
Edge Chip

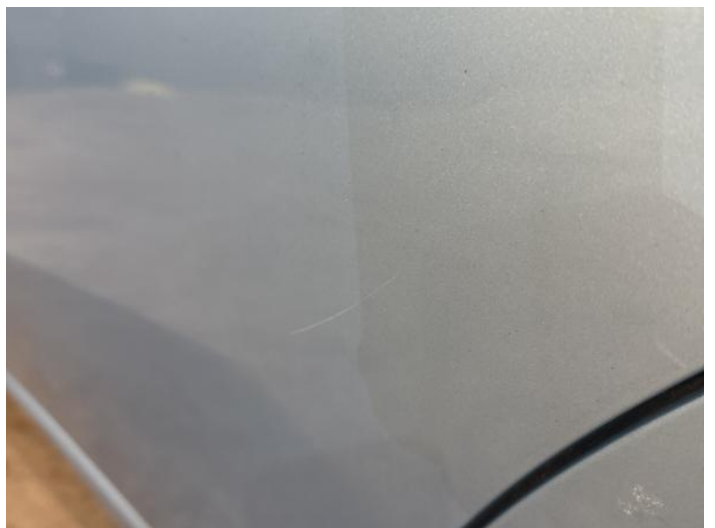
8: Door nsr
Scratched
Over 25mm Thru Paint

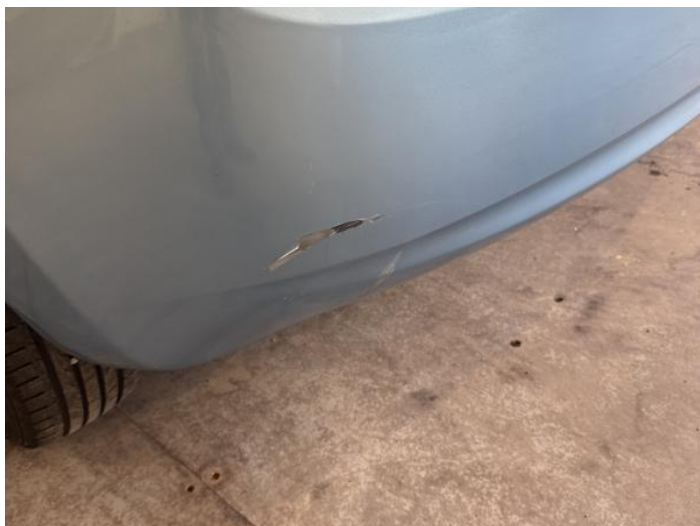
9: Bumper Rear
Scratched
Over 100mm Thru Paint

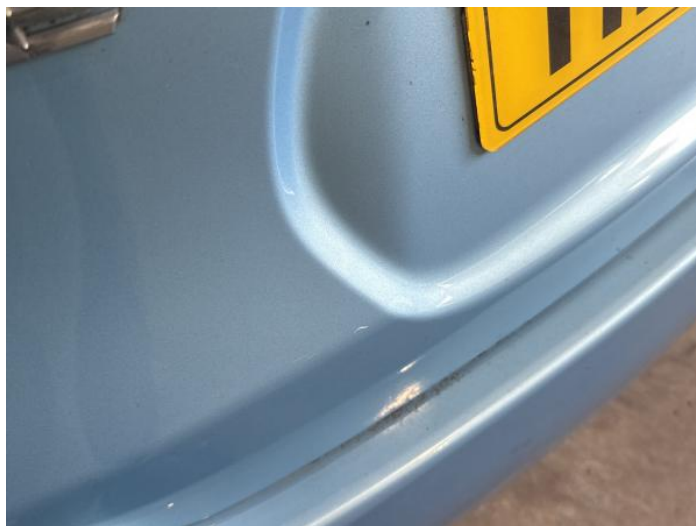
10: Tailgate
Scratched
UpTo 25mm Thru Paint

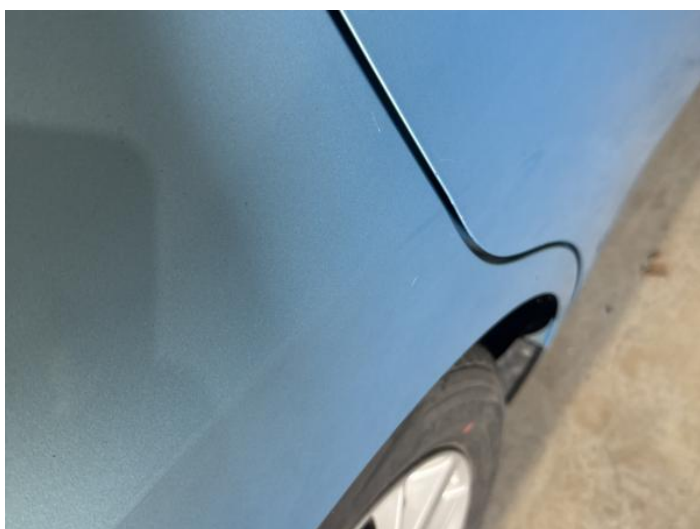
11: Qtr Panel osr
Scratched
Over 25mm Thru Paint

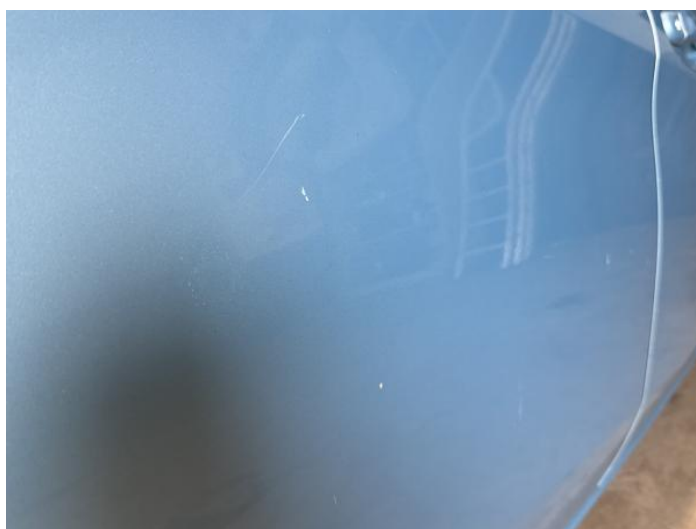
12: Door osr
Scratched
Over 25mm Thru Paint

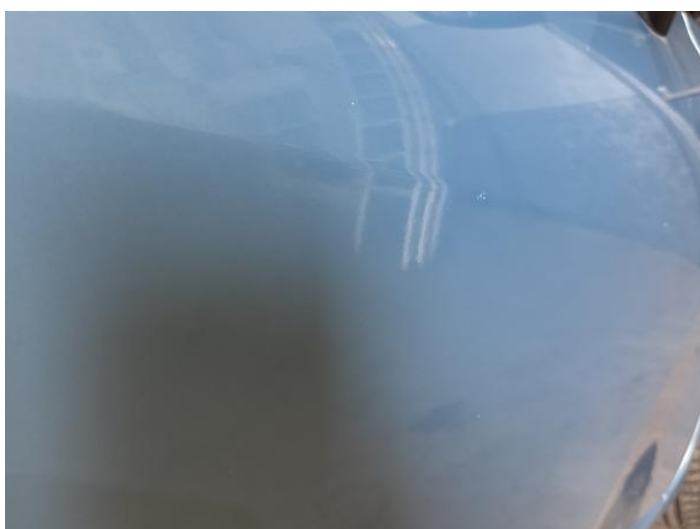
13: Door osf
Dented
With Paint Damage

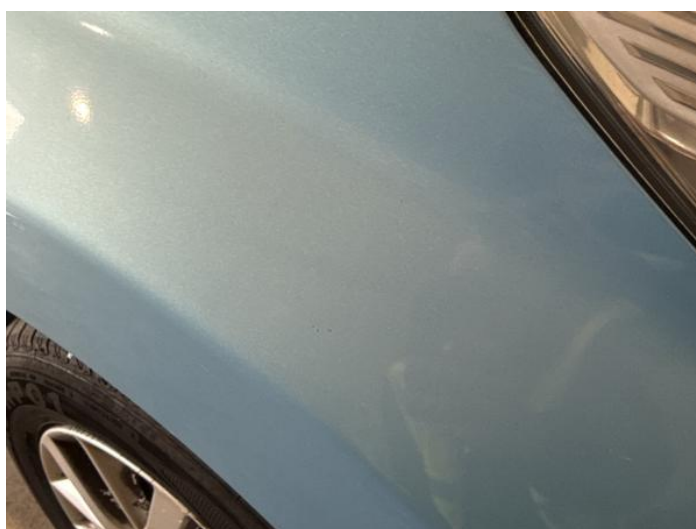
14: Wing osf
Chipped
1 To 5

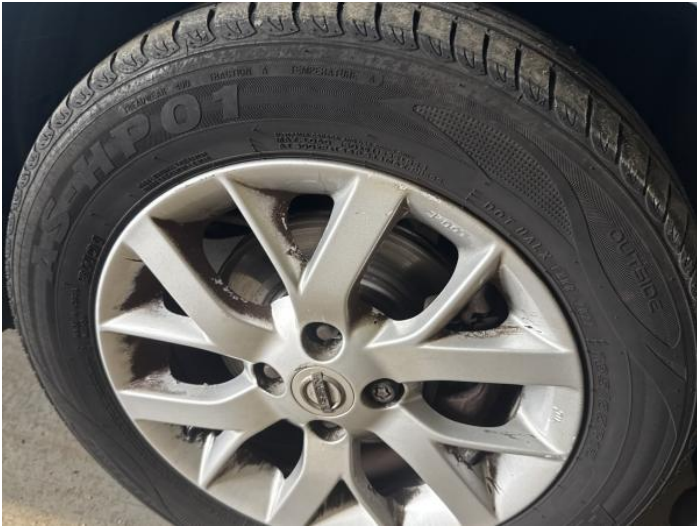
15: Wheel of
Scratched
Over 50mm

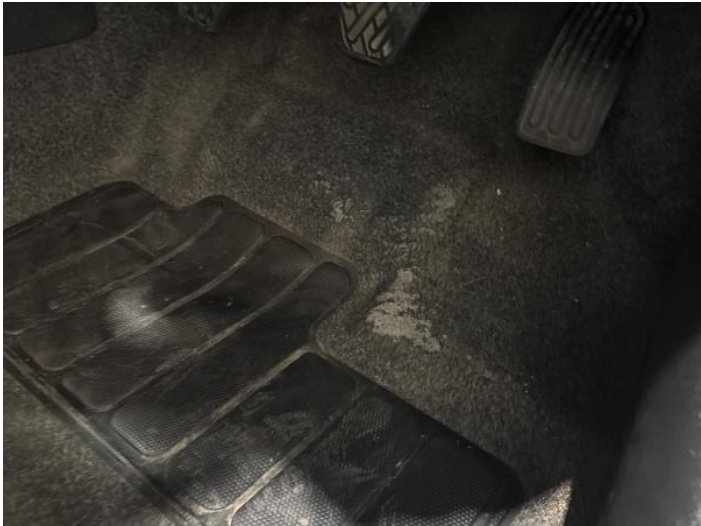
16: Carpets Front
Scuffed
Over 25mm

Carpet Condition	Poor	Upholstery Condition	Average
Seat Condition	Poor	Odour	No

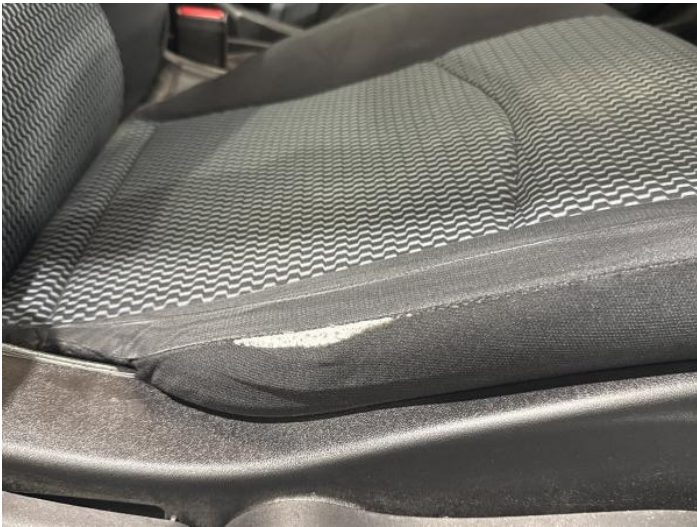
17: Seat Base Cover of
Scuffed
Over 25mm
