VEHICLE INSPECTION REPORT

GY66NXA

Mazda CX-3 2.0 Sport Nav 5dr

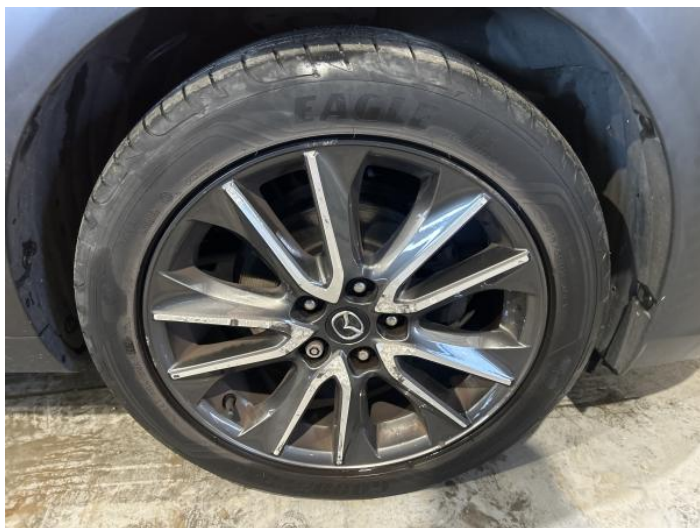
1: Wheel osf
Scratched
Over 50mm

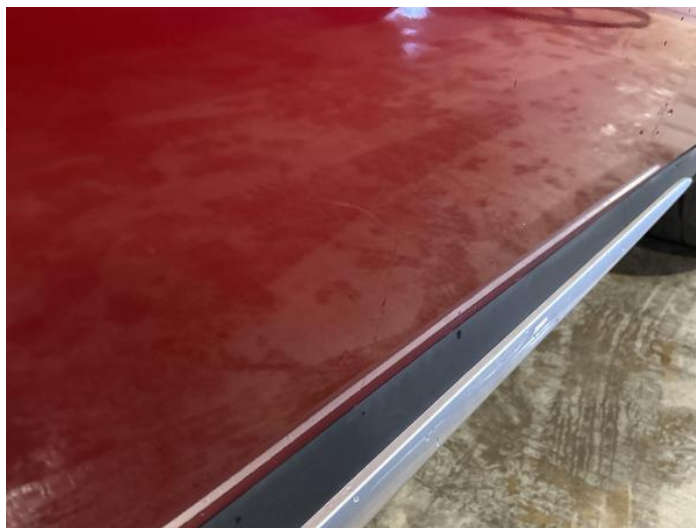
2: Door osf
Scratched
Over 25mm Not Thru Paint

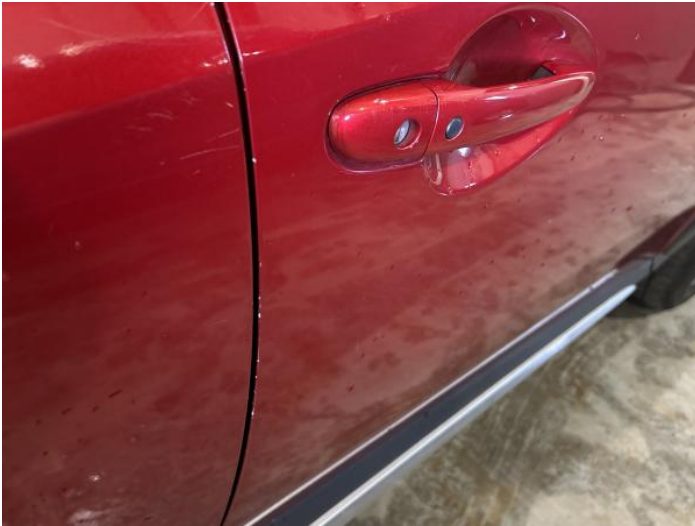
3: Door osf
Chipped
Edge Chip

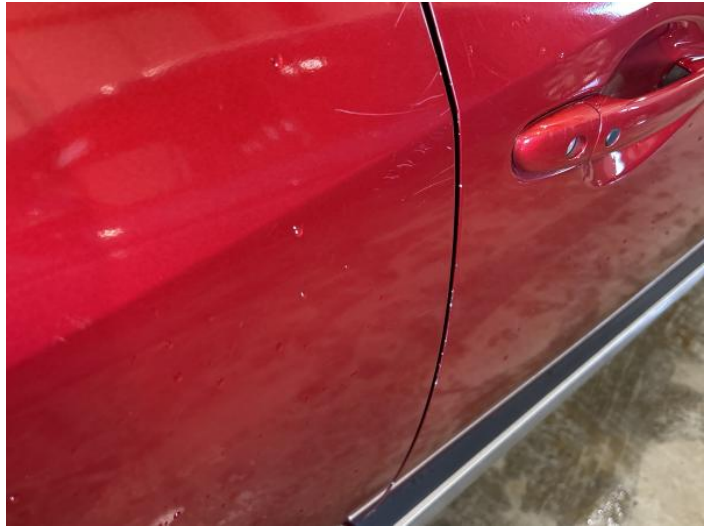
4: Door osr
Scratched
Over 25mm Not Thru Paint

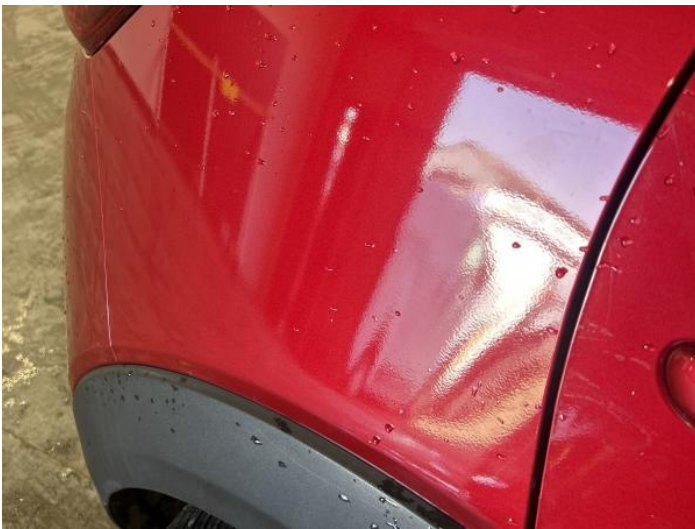
5: Qtr Panel osr
Poor Previous Repair
Poor Paint

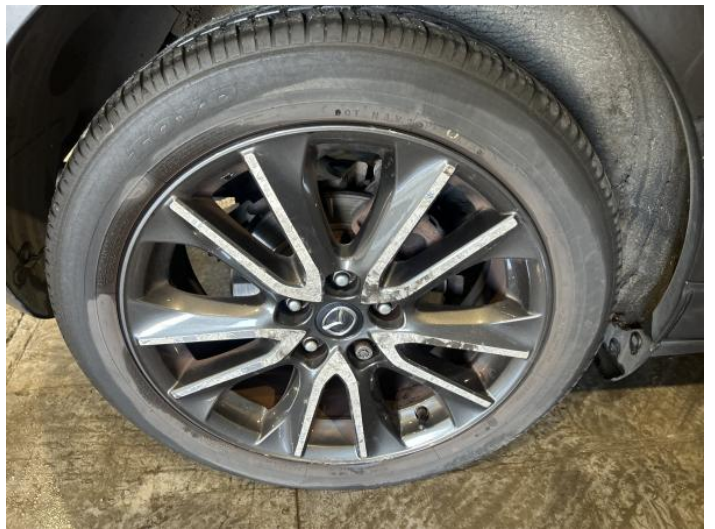
6: Wheel osr
Scratched
Over 50mm

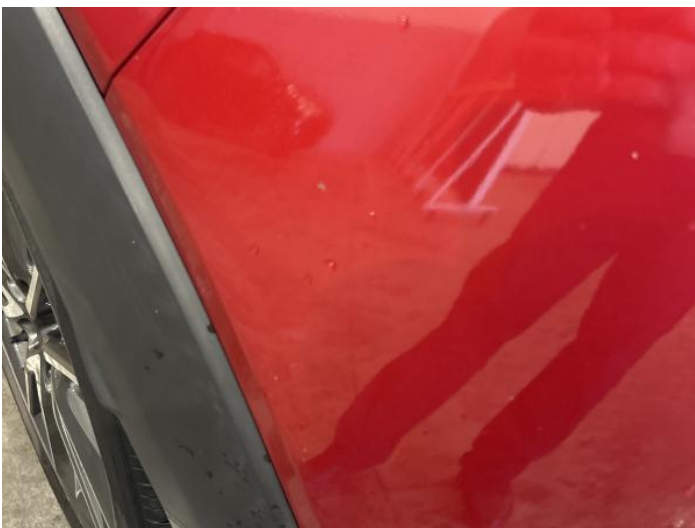
7: Bumper Rear
Chipped
1 To 5

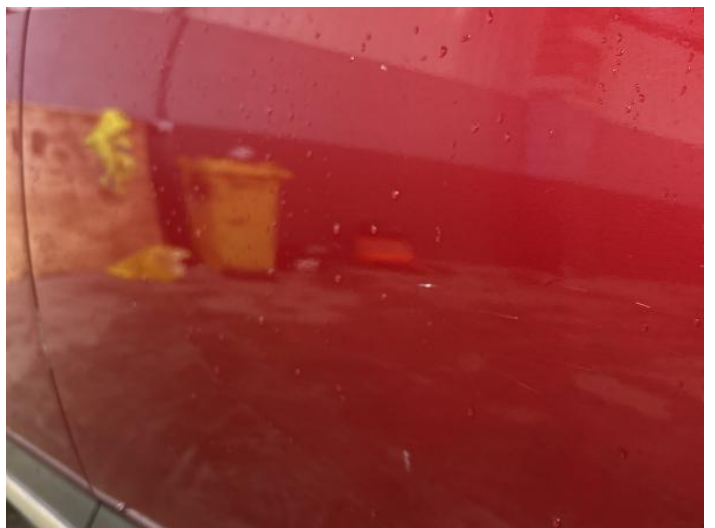
8: Door nsr
Scratched
Over 25mm Not Thru Paint

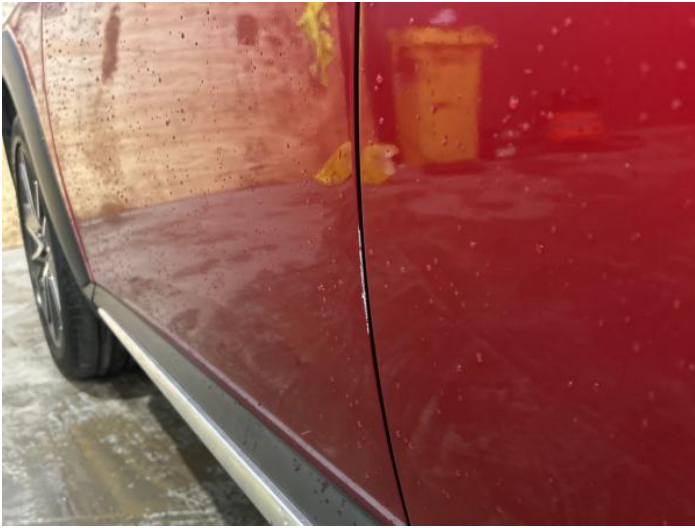
9: Door nsf
Chipped
Edge Chip

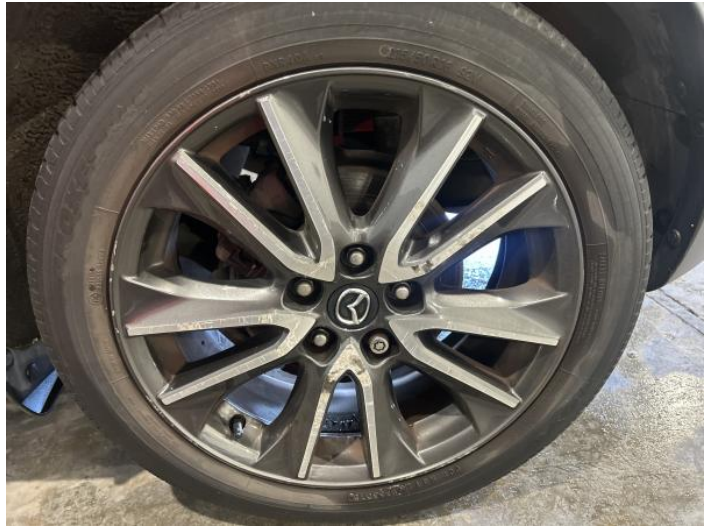
10: Wheel nsr
Scratched
Over 50mm

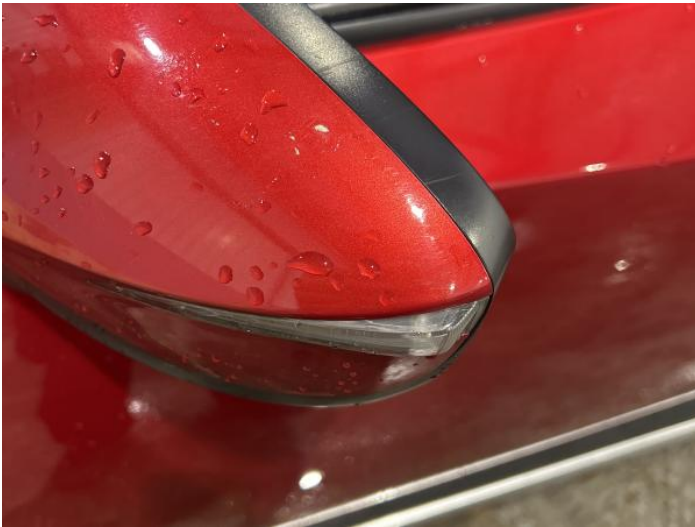
11: Door Mirror Assy nsf
Scratched (Painted)
UpTo 25mm Thru Paint

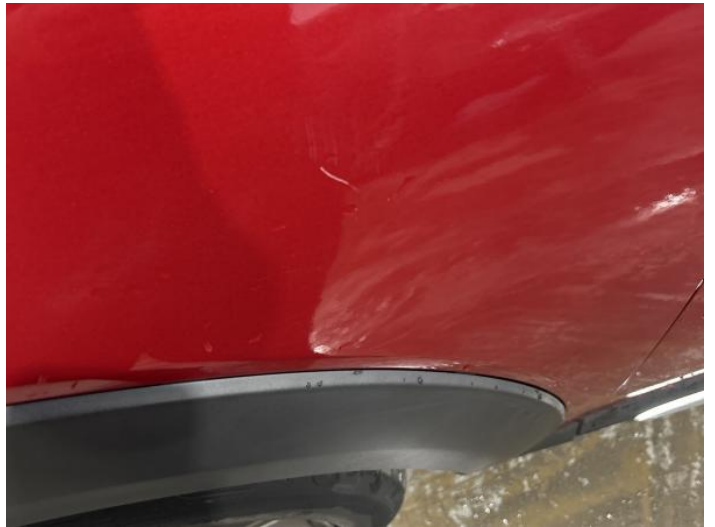
12: Wing nsf
Scratched
UpTo 25mm Thru Paint

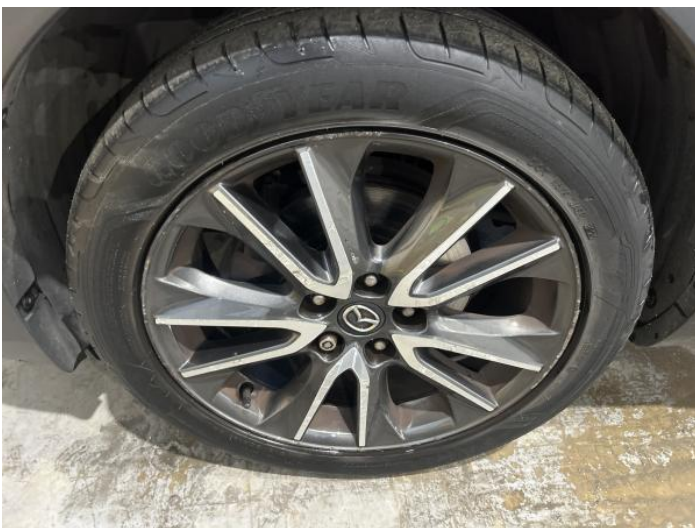
13: Wheel nsf
Scratched
Over 50mm

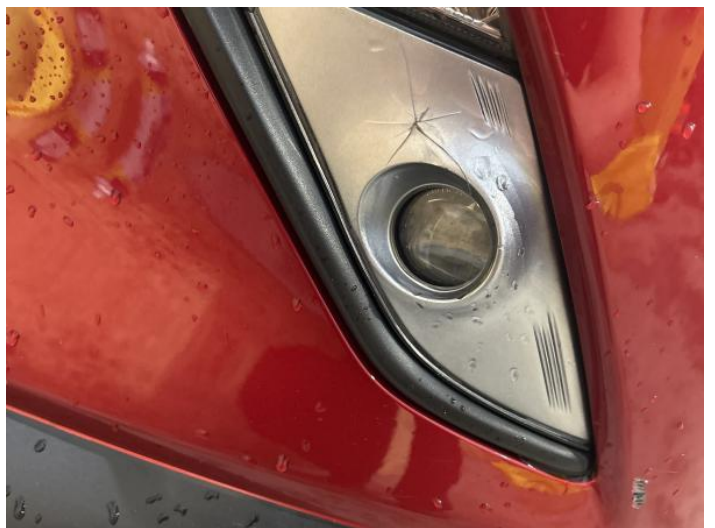
14: Flasher Side Repeater ns
Broken
Replace

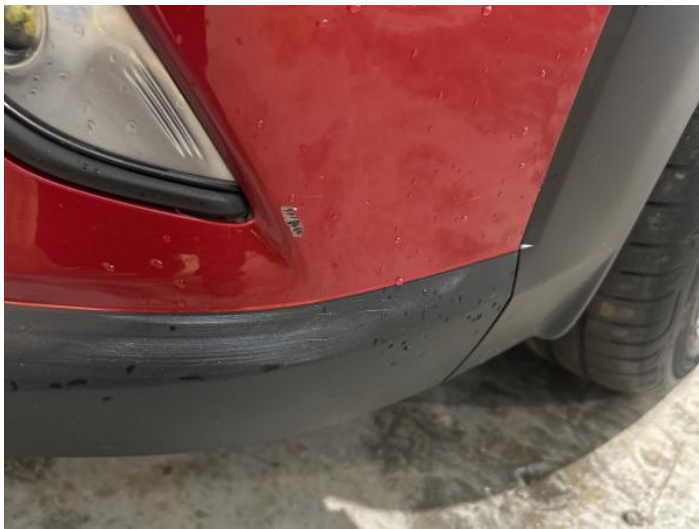
15: Bumper Front
Chipped
1 To 5
