VEHICLE INSPECTION REPORT

HT19UER

Honda Jazz 1.3 i-VTEC SE Navi 5dr

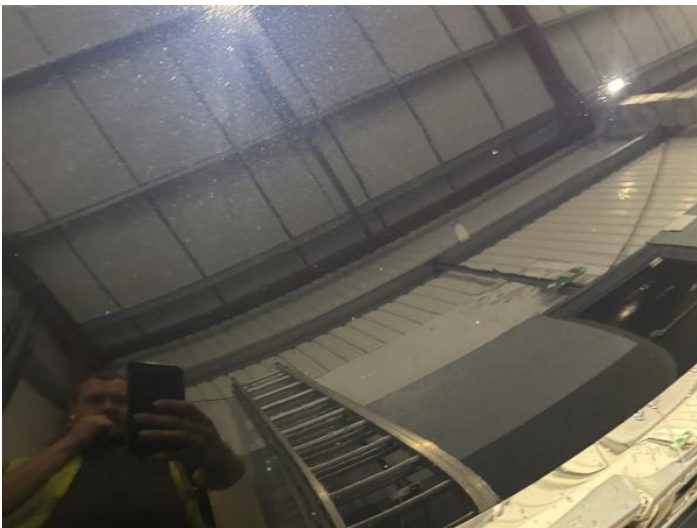
1: Bonnet
Chipped
1 To 5

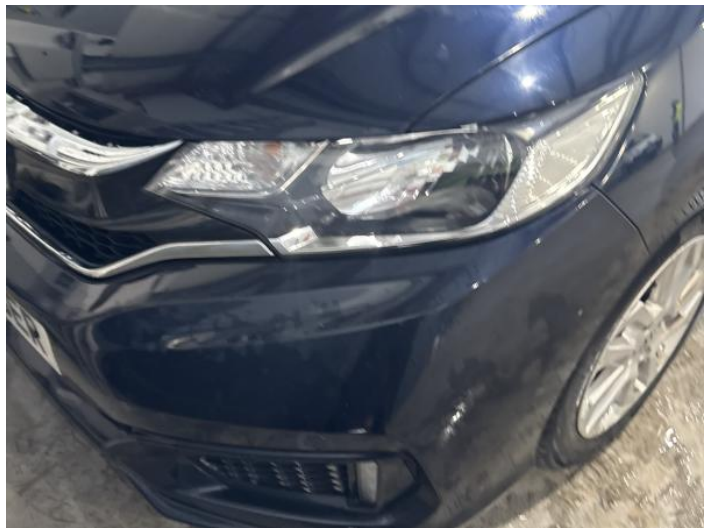
2: Bumper Front
Chipped
Multiple Chips

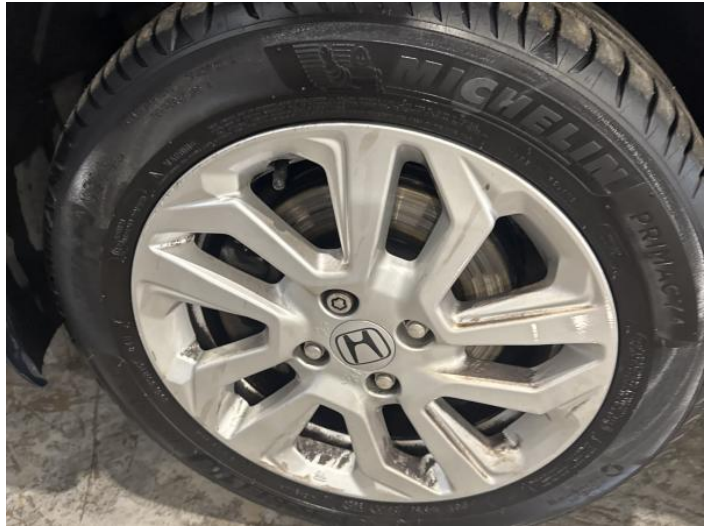
4: Wheel nsf
Scratched
Over 50mm

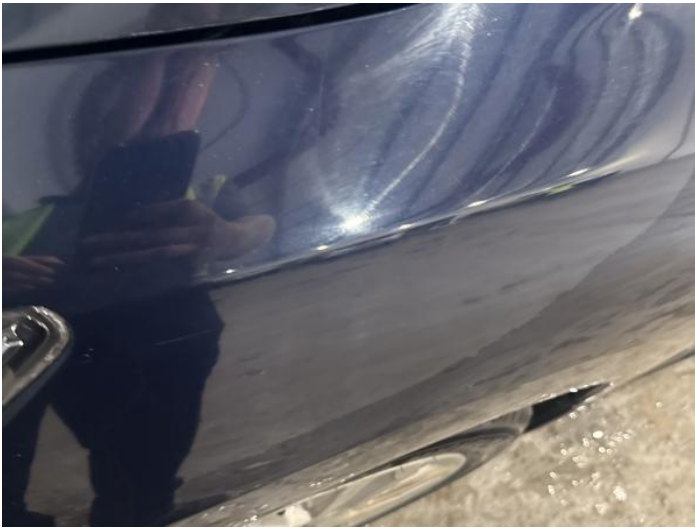
5: Wing nsf
Chipped
1 To 5

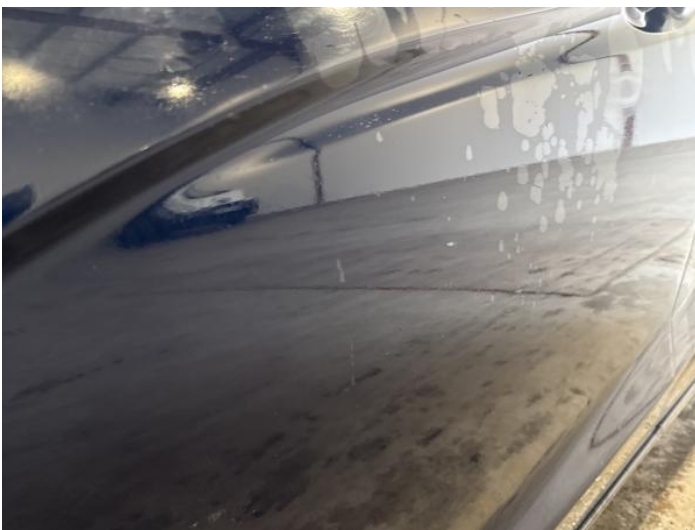
7: Door nsf
Dented
Over 2 UpTo 10mm

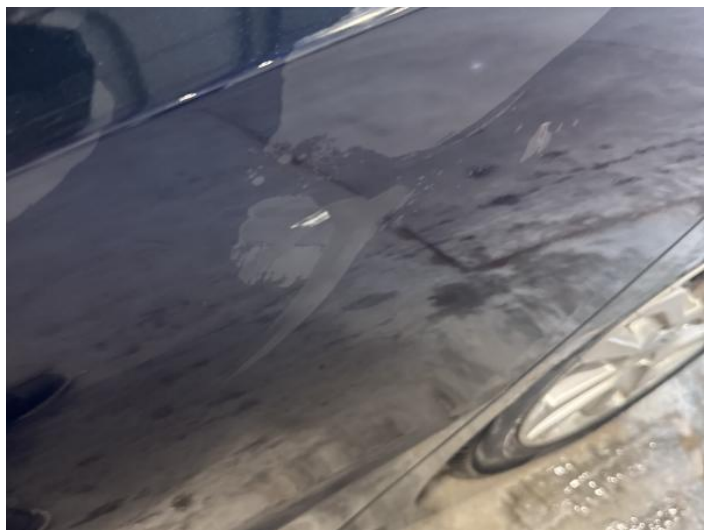
8: Door nsr
Scratched
Over 25mm Thru Paint

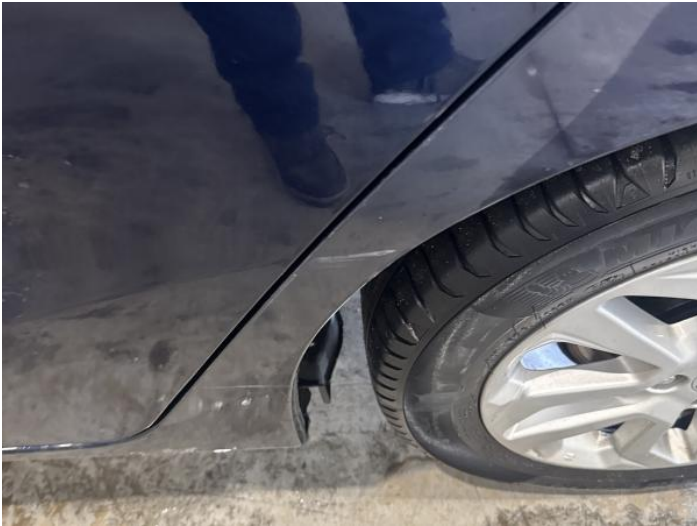
9: Qtr Panel nsr
Scratched
Over 25mm Thru Paint

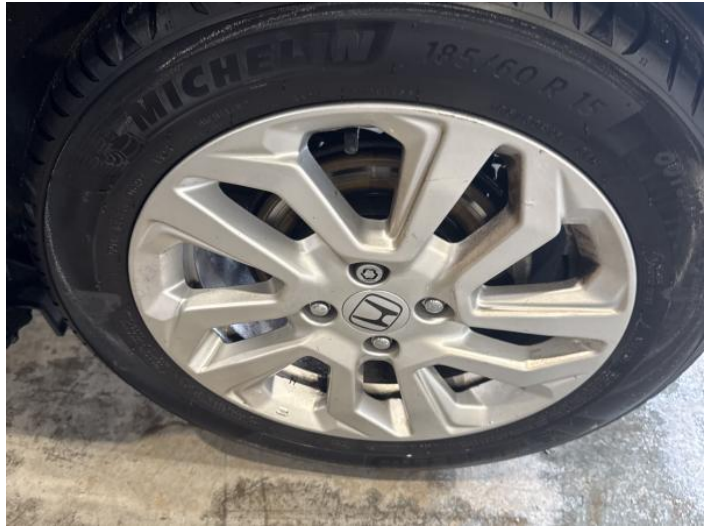
10: Wheel nsr
Scratched
Over 50mm

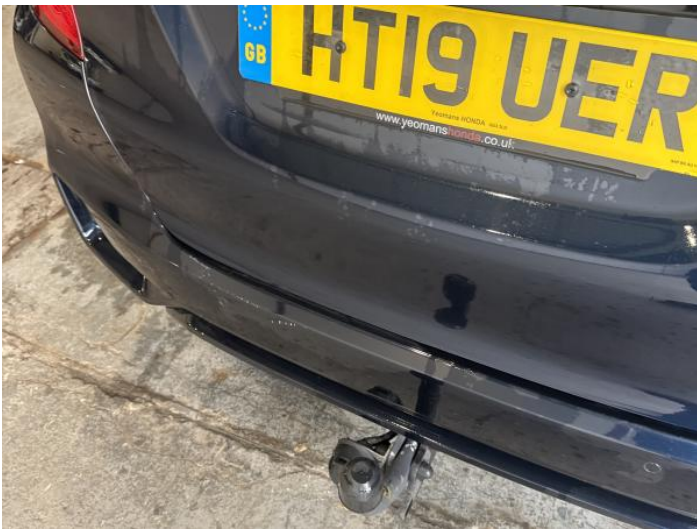
11: Bumper Rear
Scratched
Over 100mm Thru Paint

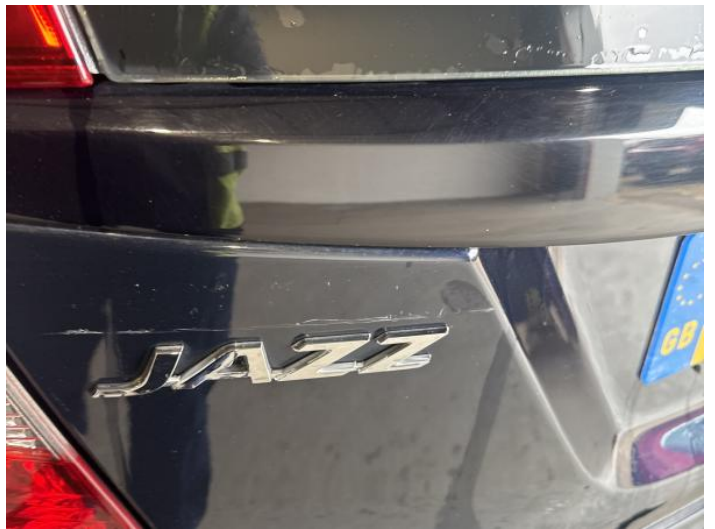
12: Boot Lid
Scratched
Over 25mm Thru Paint

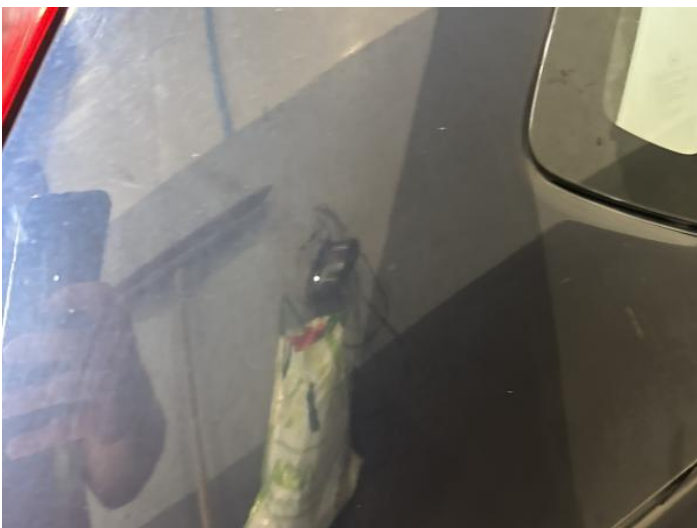
13: Qtr Panel osr
Chipped
1 To 5

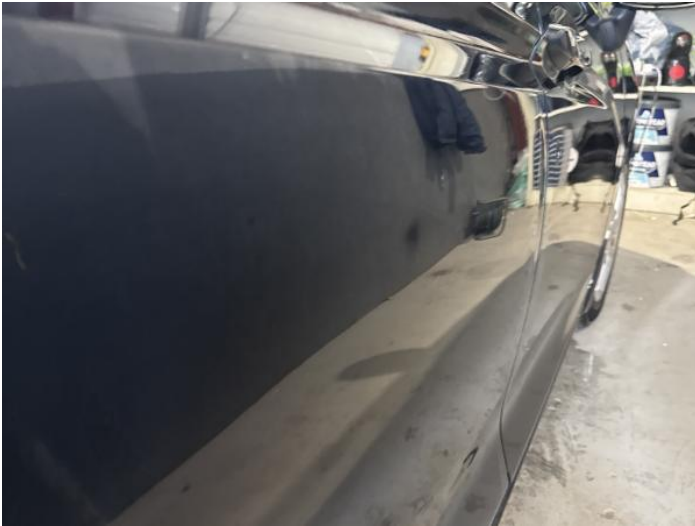
15: Door osr
Dented
Between 10mm + 30mm

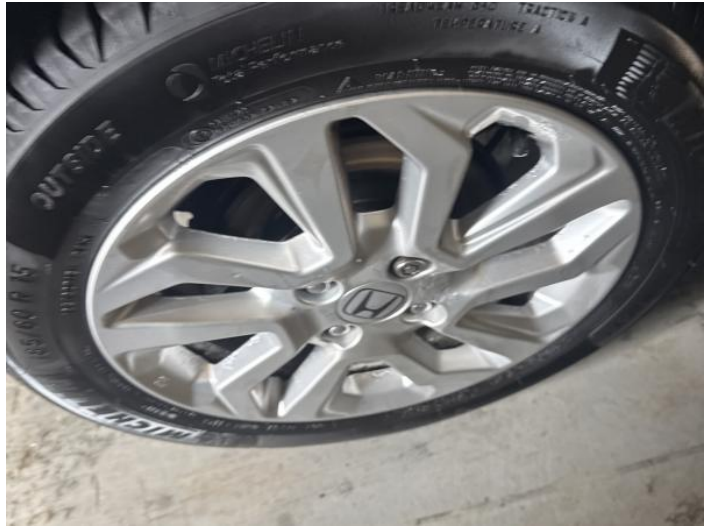
16: Wheel osr
Scratched
Over 50mm

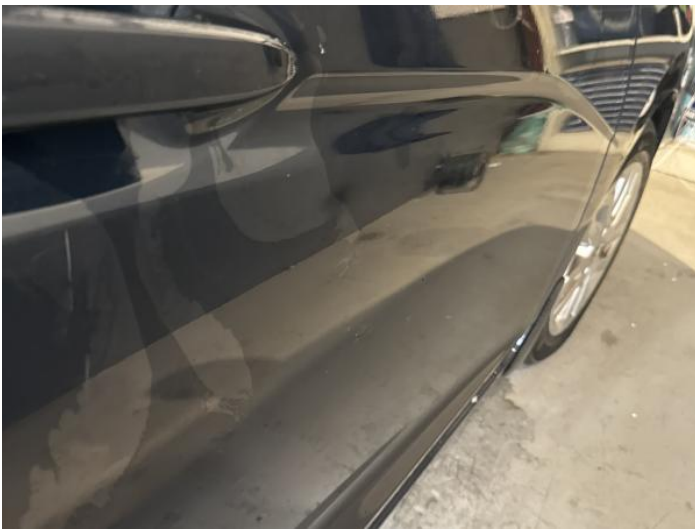
17: Door osf
Dented
Over 2 UpTo 10mm

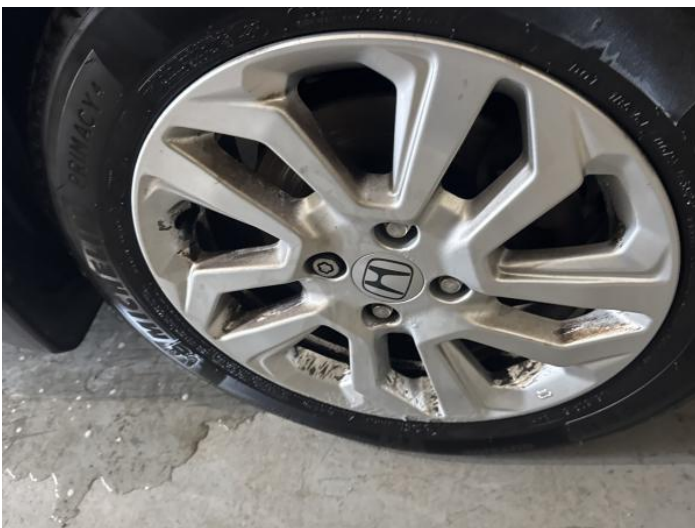
19: Wheel osf
Scratched
Over 50mm

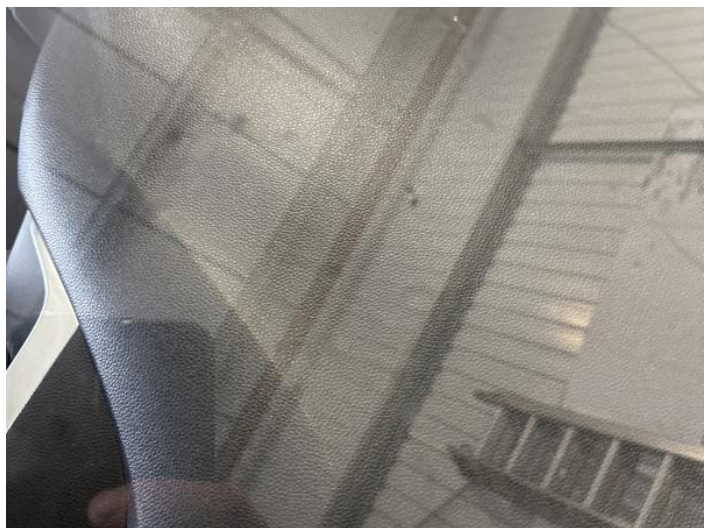
20: Screen Front
Chipped
UpTo 10mm
