# VEHICLE INSPECTION REPORT

**PO63VFW**

## Nissan Qashqai 1.5 dCi [110] 360 5dr

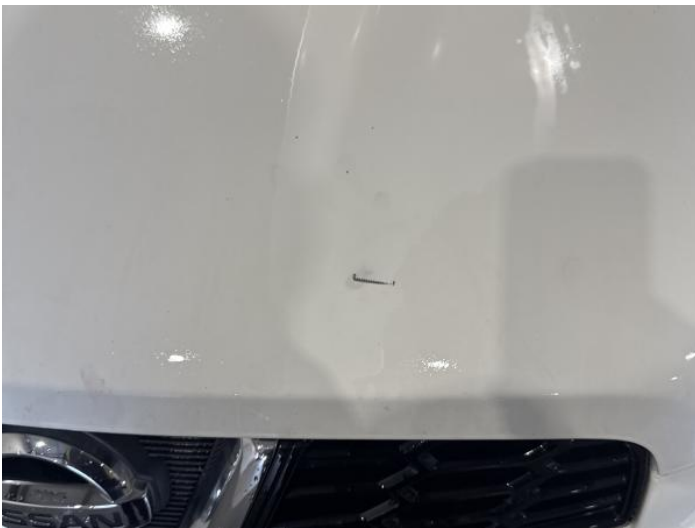
1: Bonnet  
Dented  
With Paint Damage

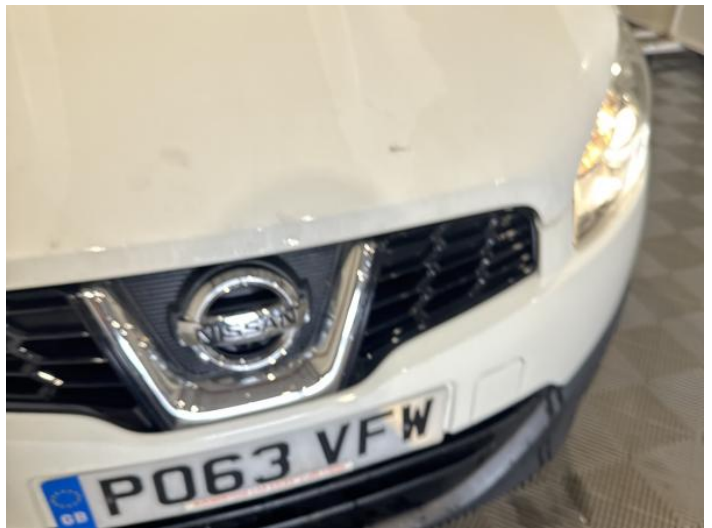
2: Bumper Front  
Poor Previous Repair  
Poor Colour

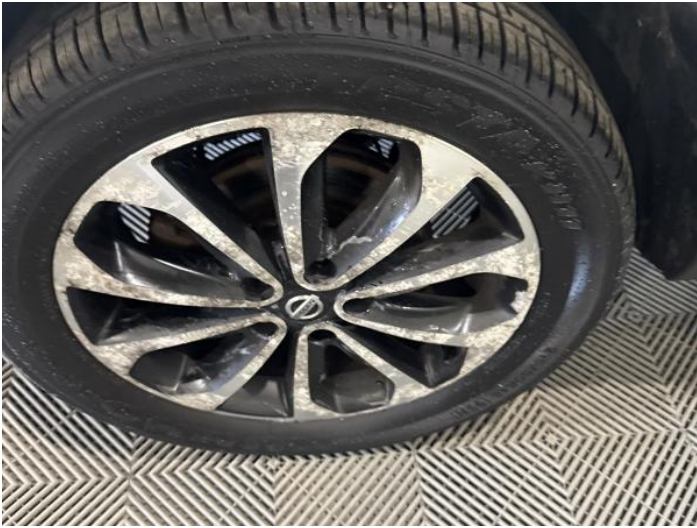
3: Wheel nsf  
Scratched  
Over 50mm

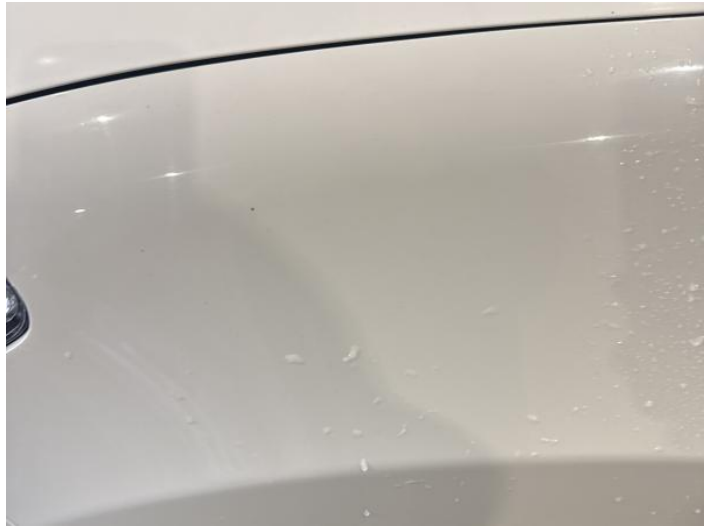
4: Wing nsf  
Chipped  
1 To 5

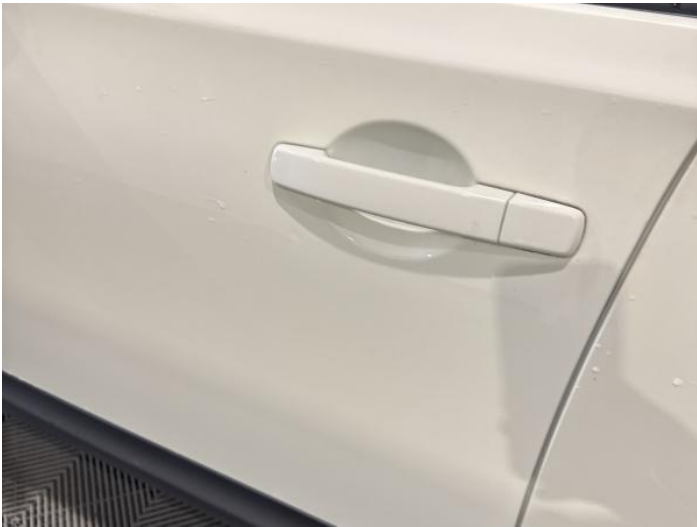
5: Door nsf  
Poor Previous Repair  
Poor Paint

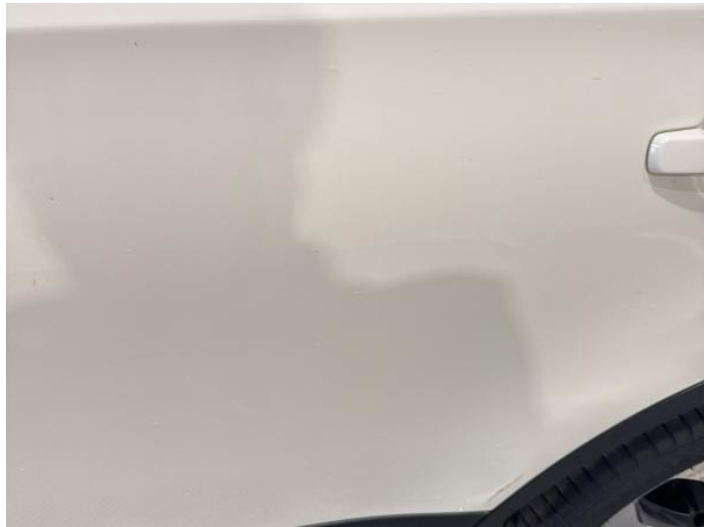
6: Door nsr  
Dented  
With Paint Damage

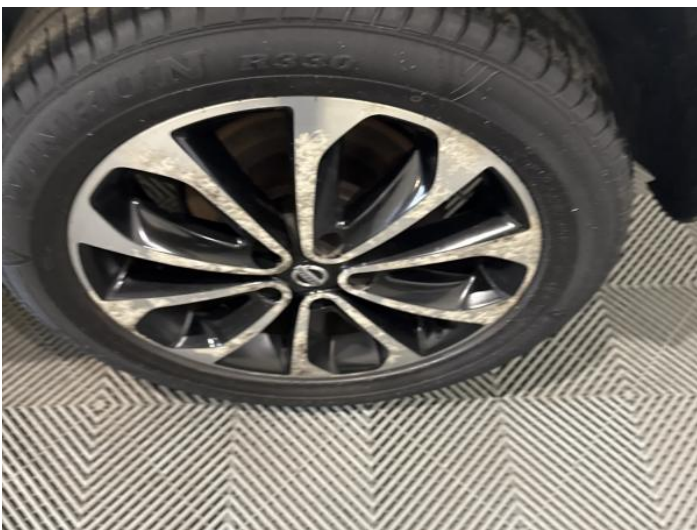
7: Wheel nsr  
Scratched  
Over 50mm

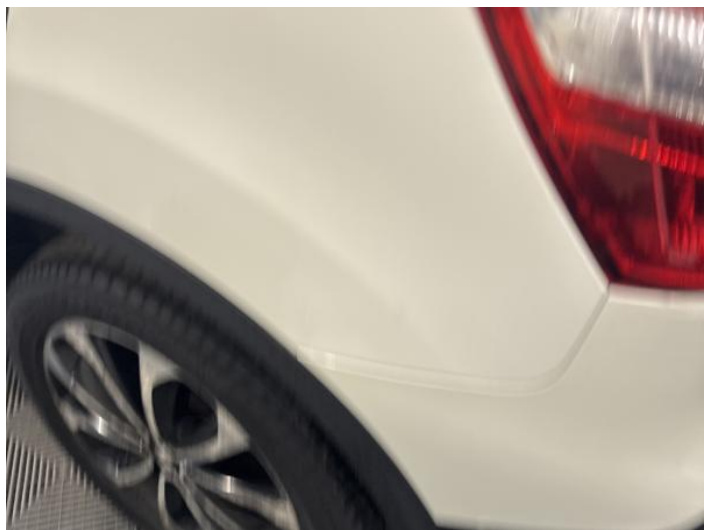
8: Qtr Panel nsr  
Poor Previous Repair  
Poor Paint

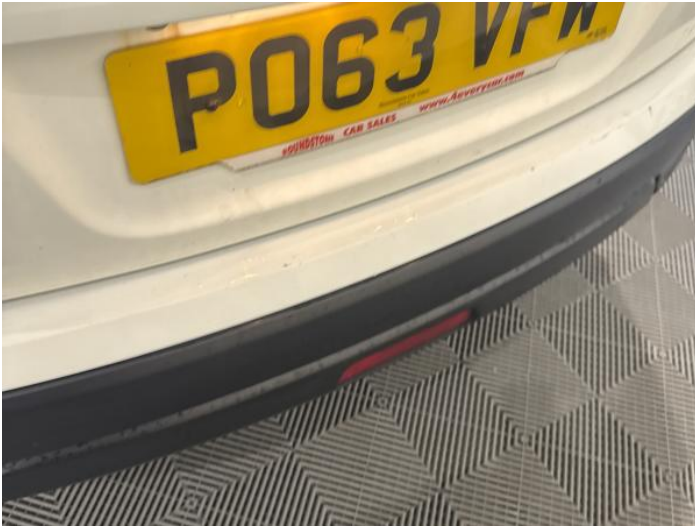
9: Bumper Rear  
Poor Previous Repair  
Poor Paint

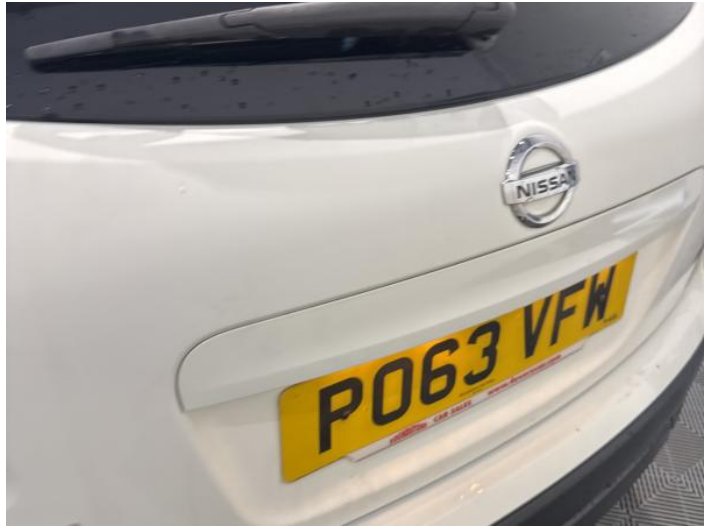
10: Boot Lid  
Poor Previous Repair  
Poor Paint

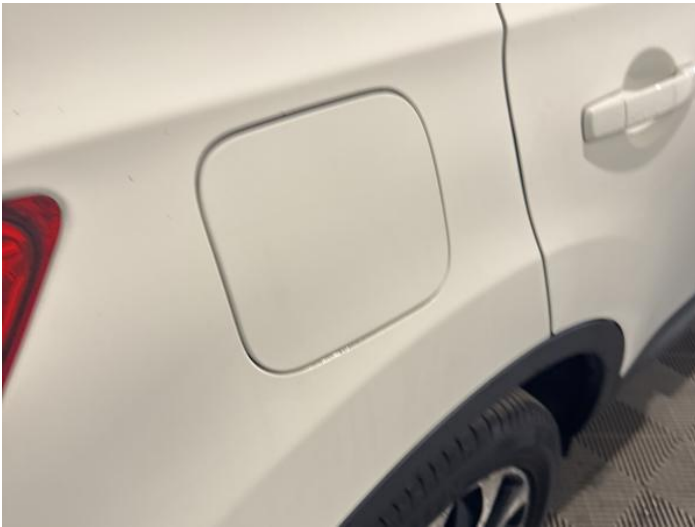
11: Qtr Panel osr  
Poor Previous Repair  
Poor Paint

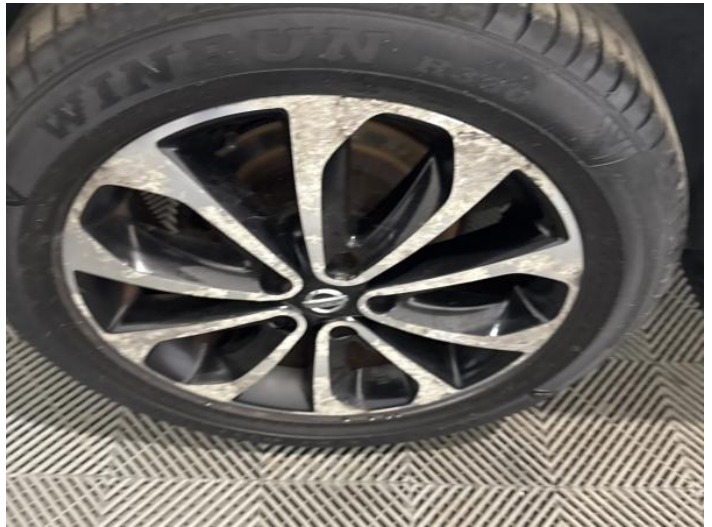
12: Wheel osr  
Scratched  
Over 50mm

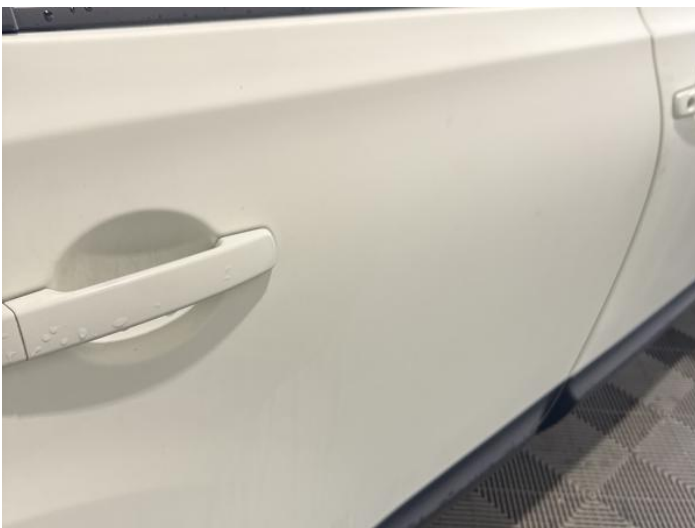
13: Door osr  
Poor Previous Repair  
Poor Paint

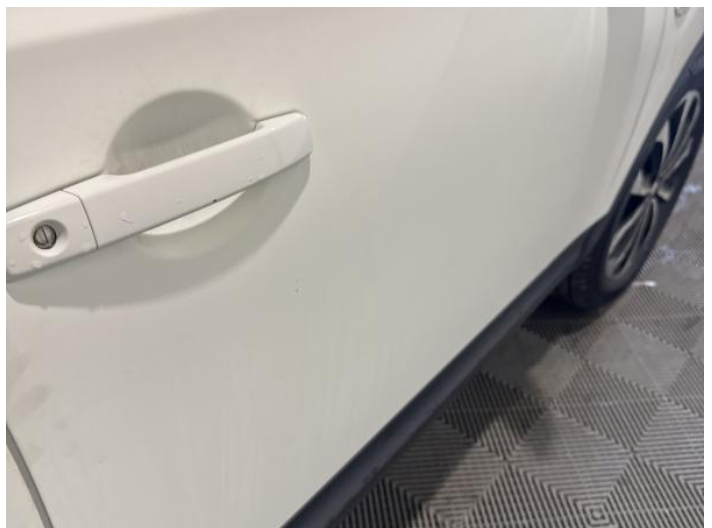
14: Door osf  
Poor Previous Repair  
Poor Paint

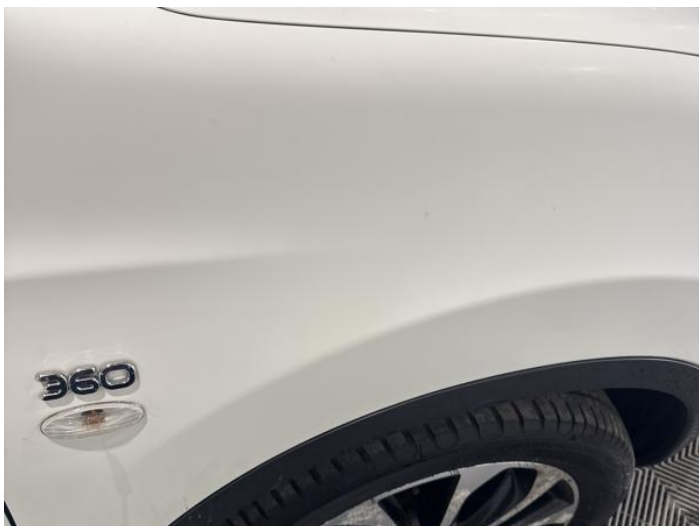
15: Wing of  
Poor Previous Repair  
Poor Paint

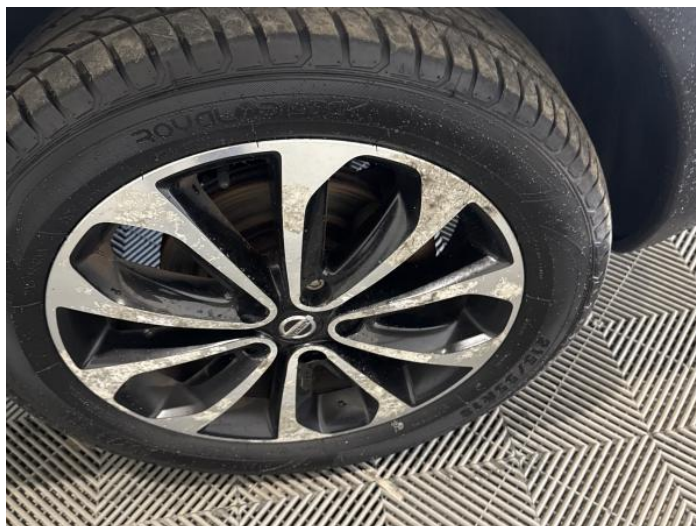
16: Wheel of  
Scratched  
Over 50mm

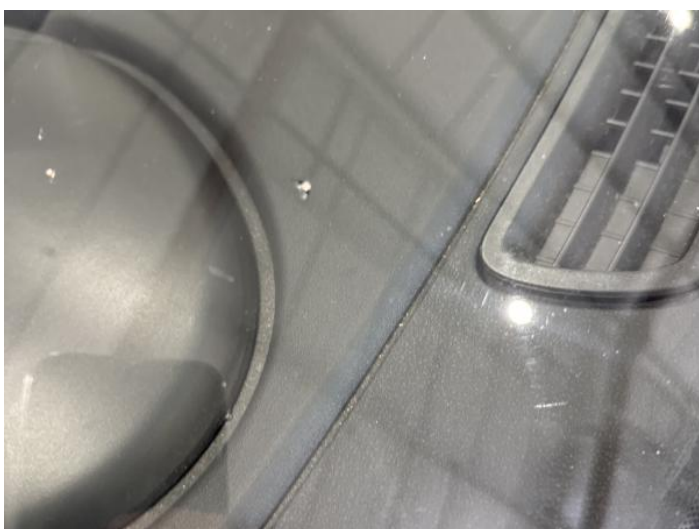
17: Screen Front  
Chipped  
Up To 10mm
