VEHICLE INSPECTION REPORT

RV66LOF

Nissan Juke 1.2 DiG-T Acenta 5dr

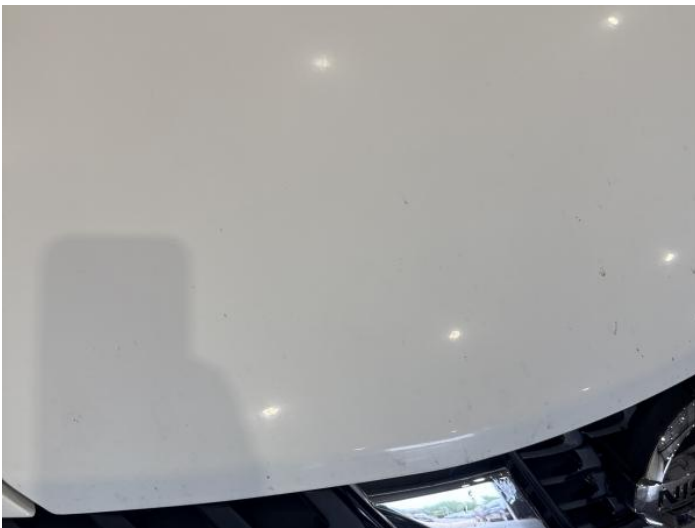
1: Bonnet
Chipped
Multiple Chips

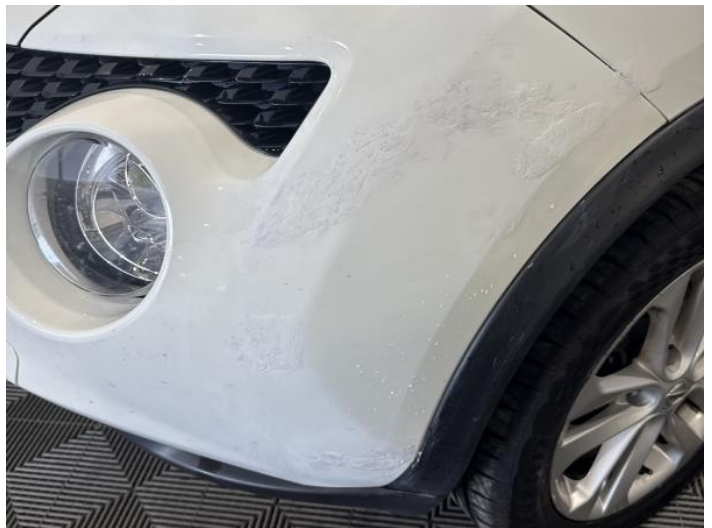
2: Bumper Front
Scratched
Over 100mm Thru Paint

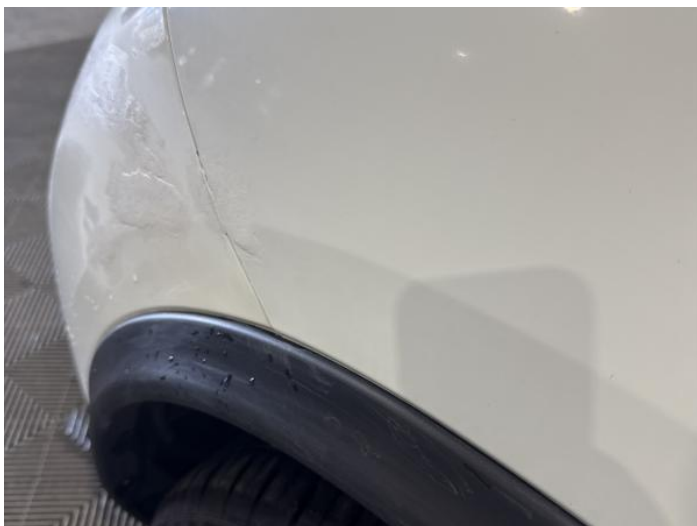
3: Wing nsf
Scratched
Over 25mm Thru Paint

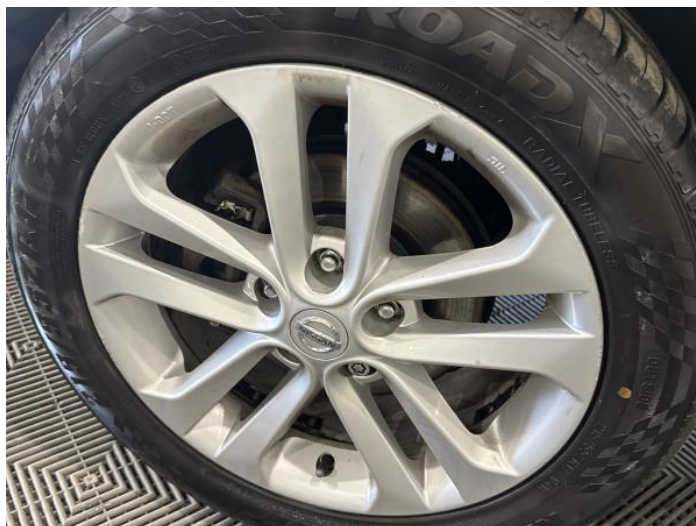
4: Wheel nsf
Scratched
Over 50mm

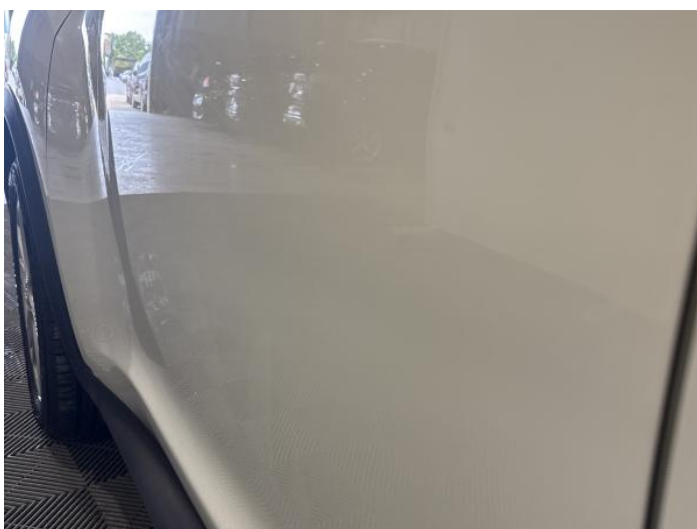
5: Door nsf
Dented
Between 10mm + 30mm

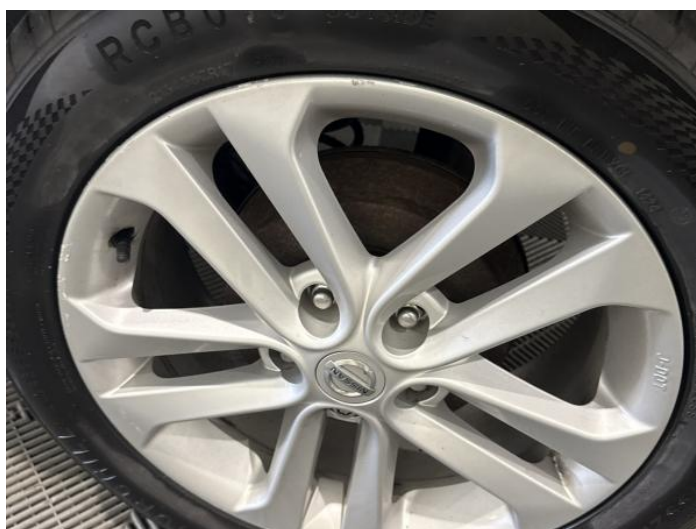
6: Wheel nsr
Scratched
Over 50mm

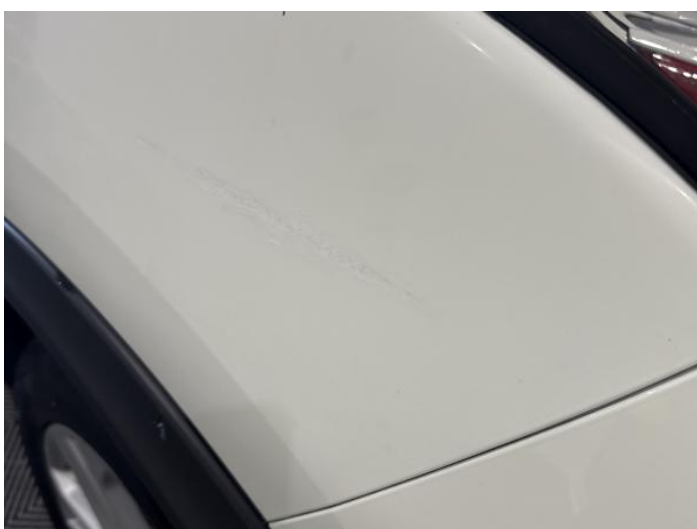
7: Qtr Panel nsr
Dented
With Paint Damage

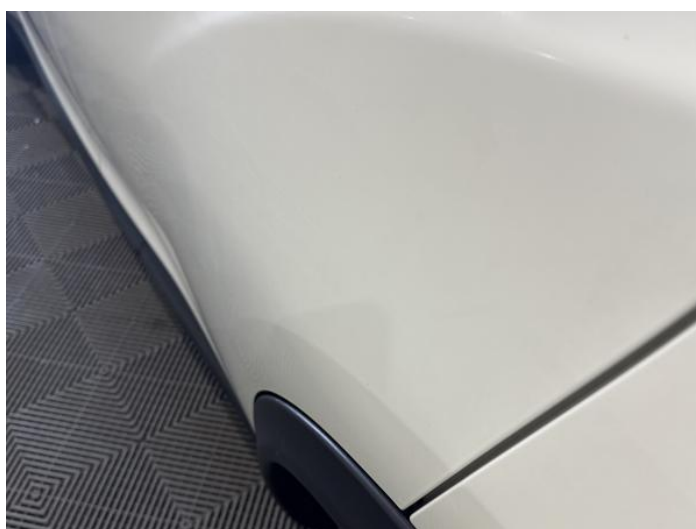
8: Door nsr
Scratched
Over 25mm Thru Paint

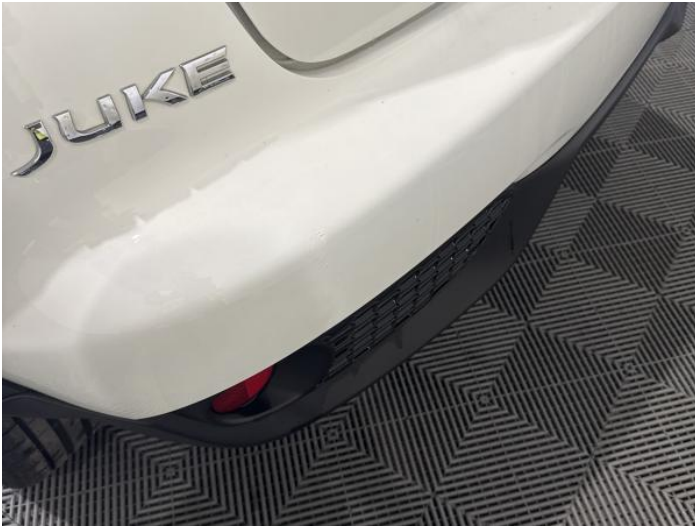
9: Bumper Rear
Dented
With Paint Damage

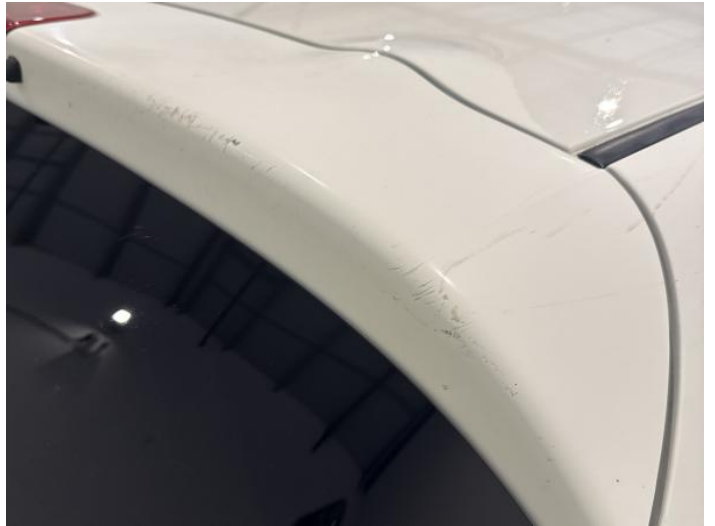
10: Tailgate
Scratched
Over 25mm Not Thru Paint

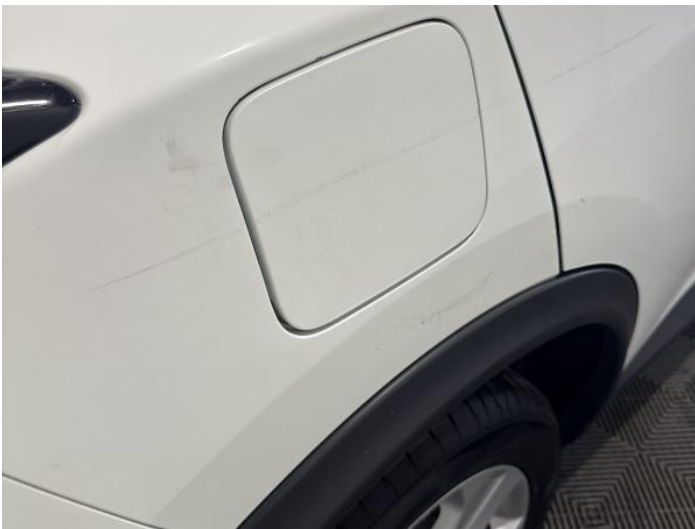
11: Qtr Panel osr
Scratched
Over 25mm Thru Paint

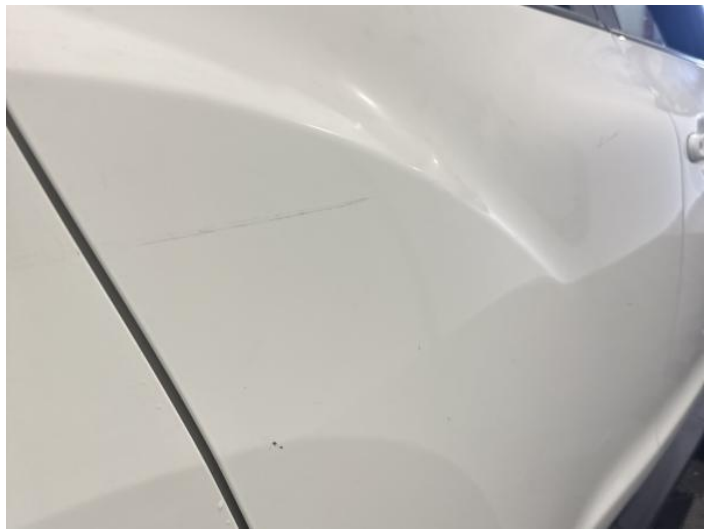
12: Door osr
Scratched
Over 25mm Thru Paint

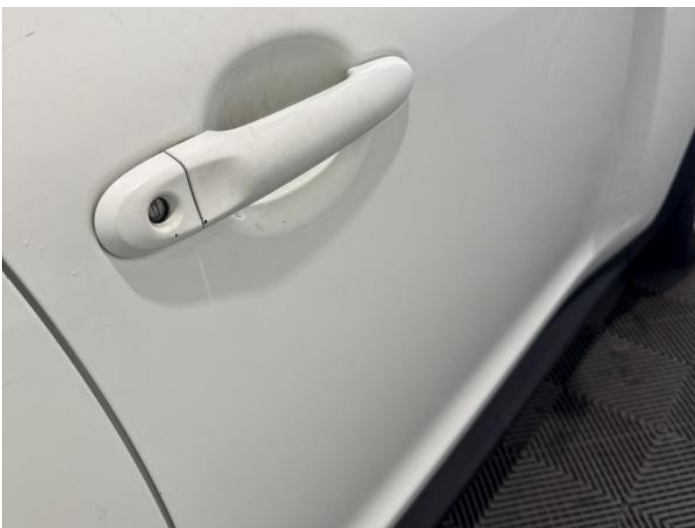
13: Door osf
Dented
Between 10mm + 30mm

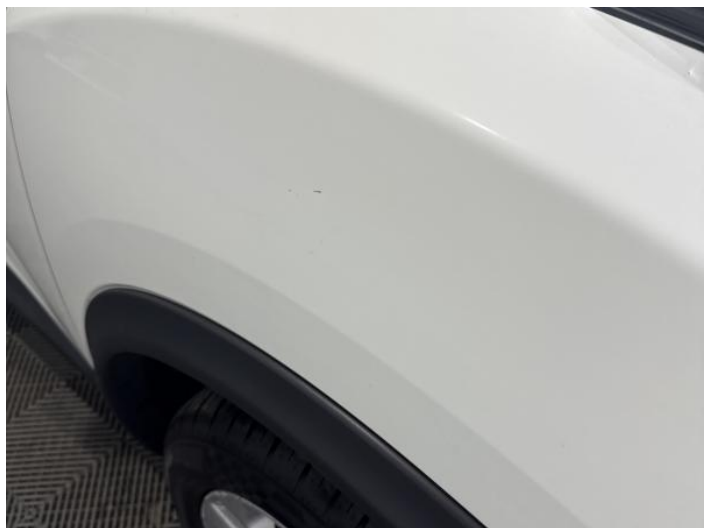
14: Wing osf
Scratched
Over 25mm Thru Paint

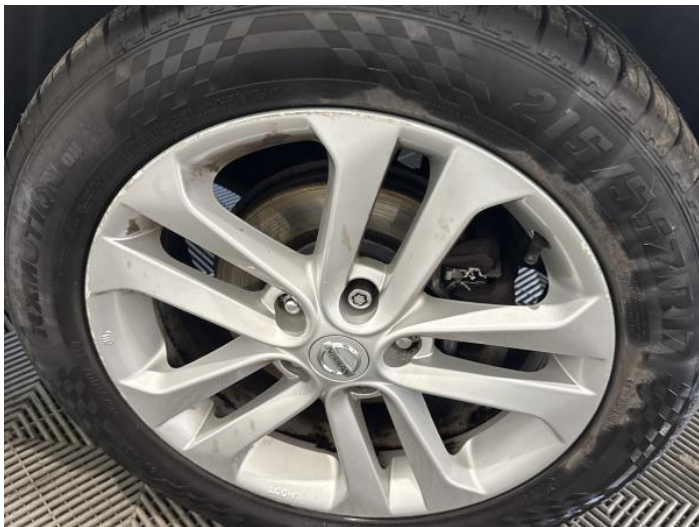
15: Wheel osf
Scratched
Over 50mm

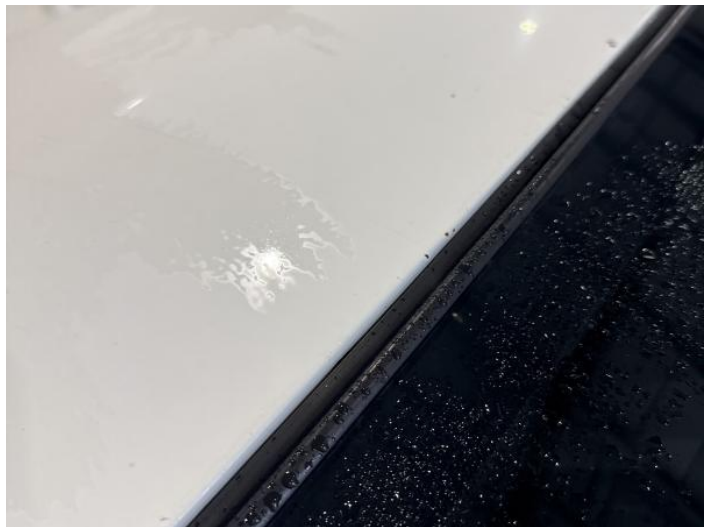
16: Roof
Chipped
Multiple Chips
