VEHICLE INSPECTION REPORT

HN62UYO

Toyota Verso 2.0 D-4D Icon 5dr

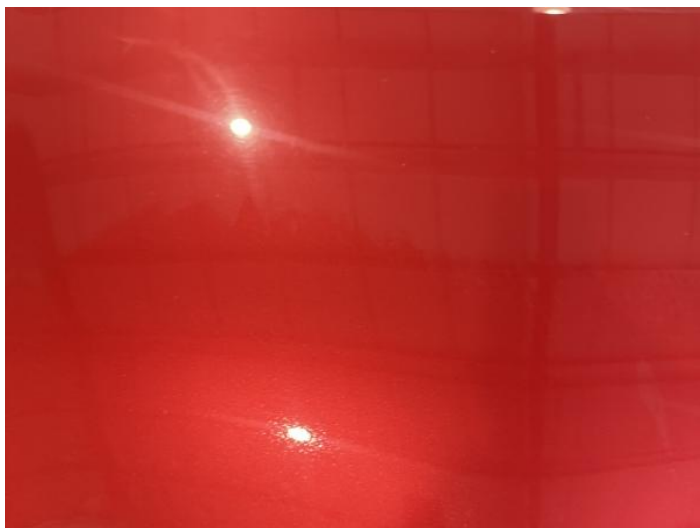
1: Bonnet
Chipped
1 To 5

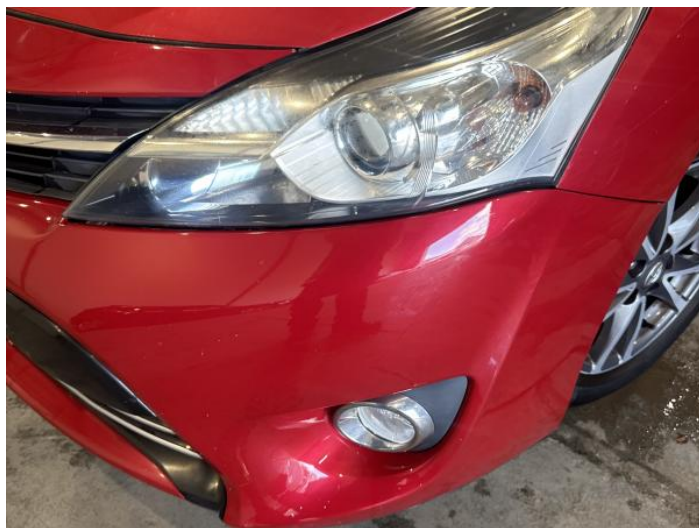
2: Bumper Front
Chipped
Multiple Chips

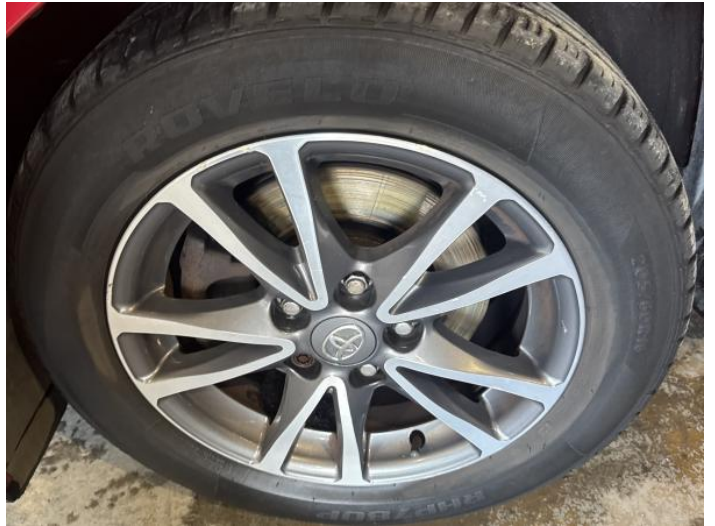
4: Wheel nsf
Scratched
Up To 50mm

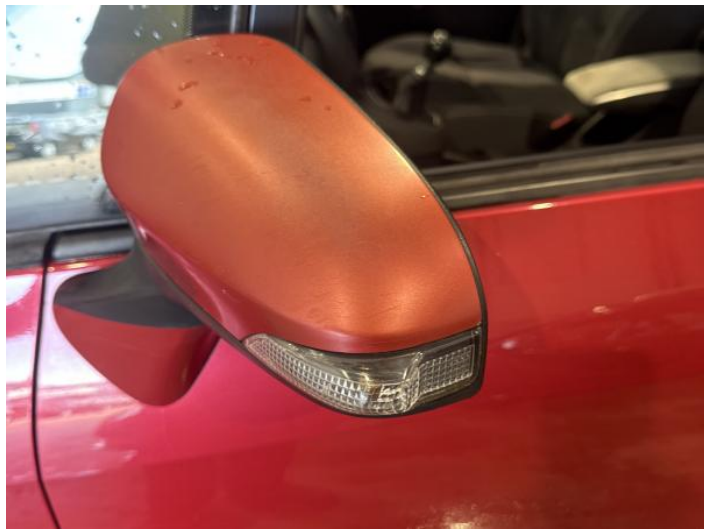
6: Door Mirror Assy nsf
Scratched (Painted)
Over 25mm Thru Paint

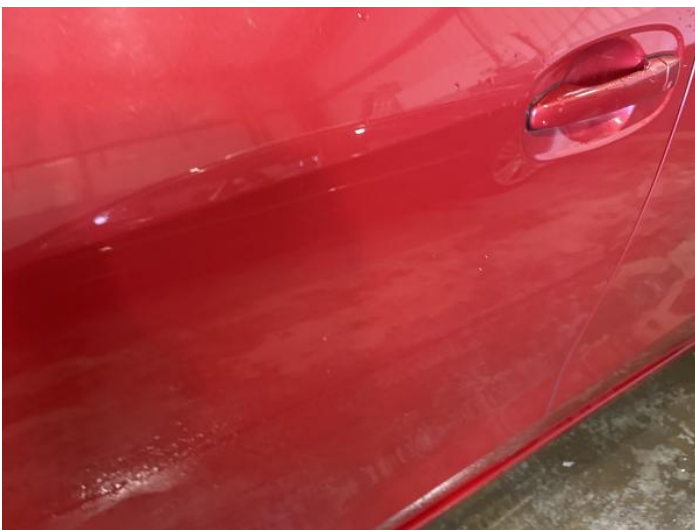
7: Door nsf
Chipped
1 To 5

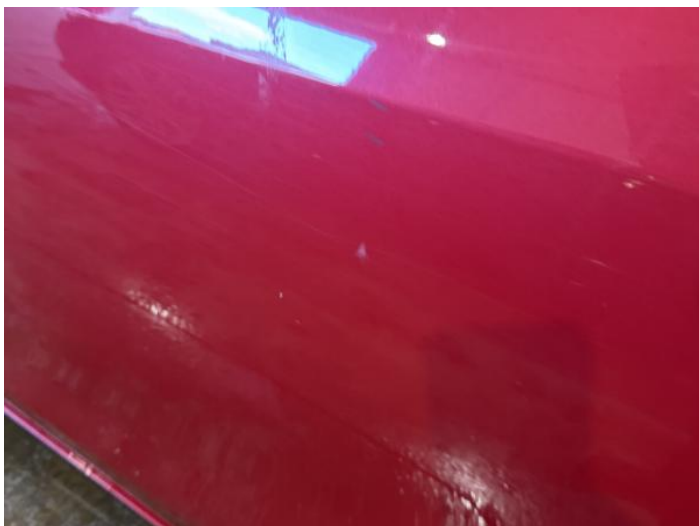
9: Door nsr
Scratched
Over 25mm Thru Paint

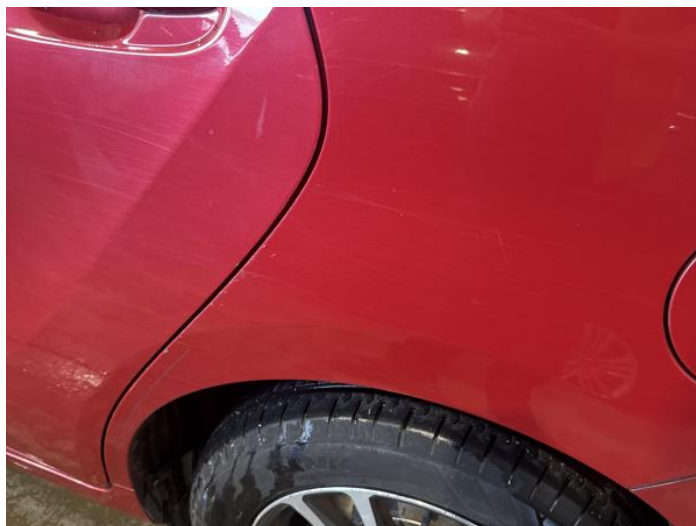
10: Qtr Panel nsr
Chipped
1 To 5

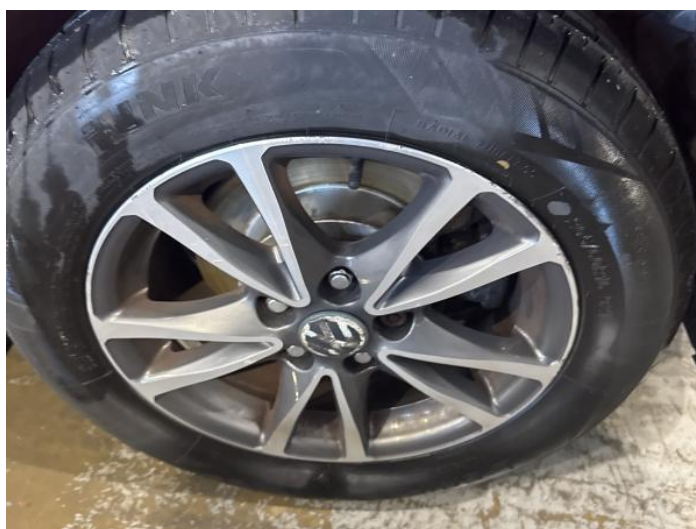
12: Wheel nsr
Scratched
Over 50mm

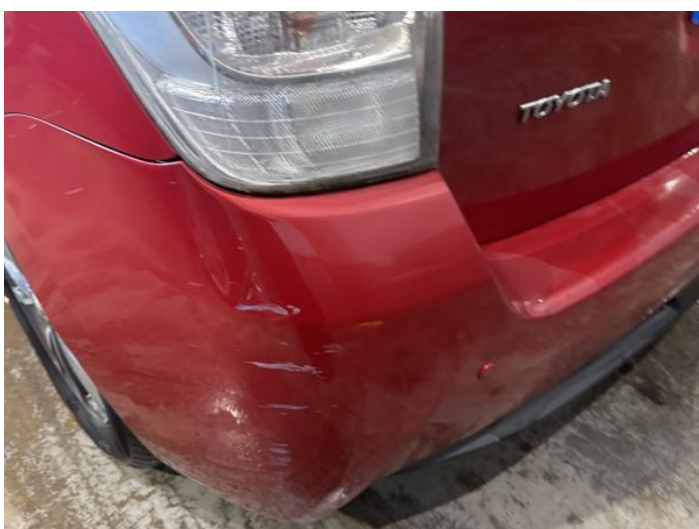
13: Bumper Rear
Scratched
Over 100mm Thru Paint

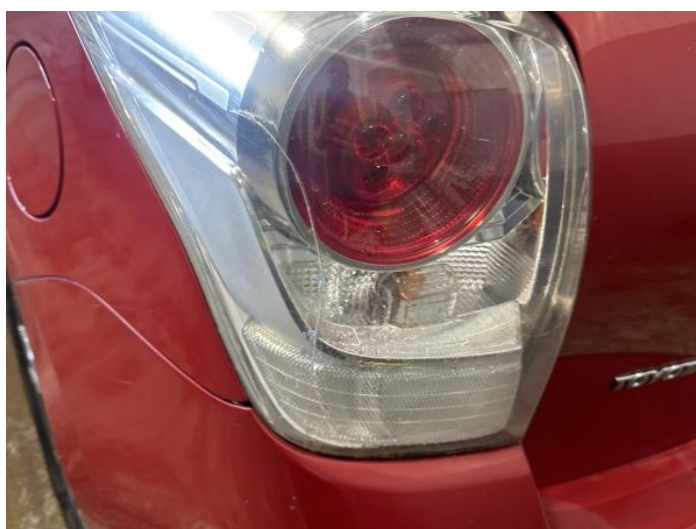
14: Lamp nsr
Broken
Replace

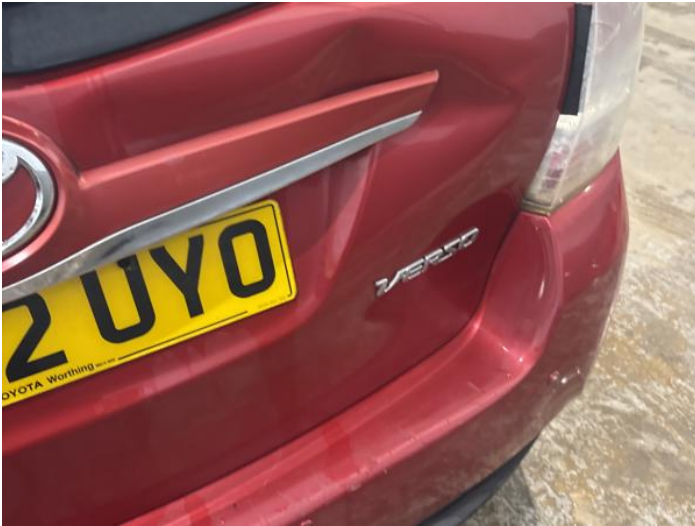
15: Boot Lid
Dented
Over 30mm

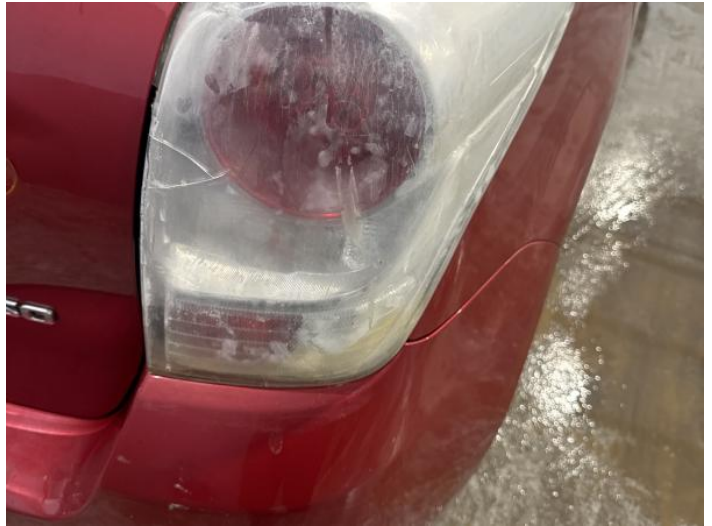
16: Lamp osr
Broken
Replace

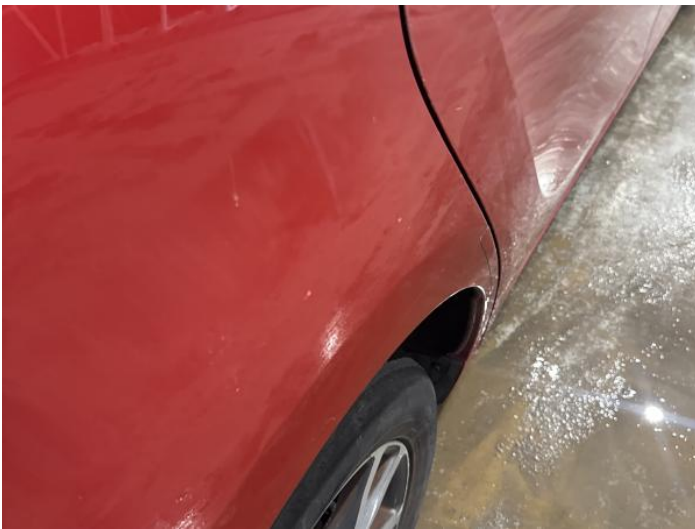
17: Qtr Panel osr
Chipped
1 To 5

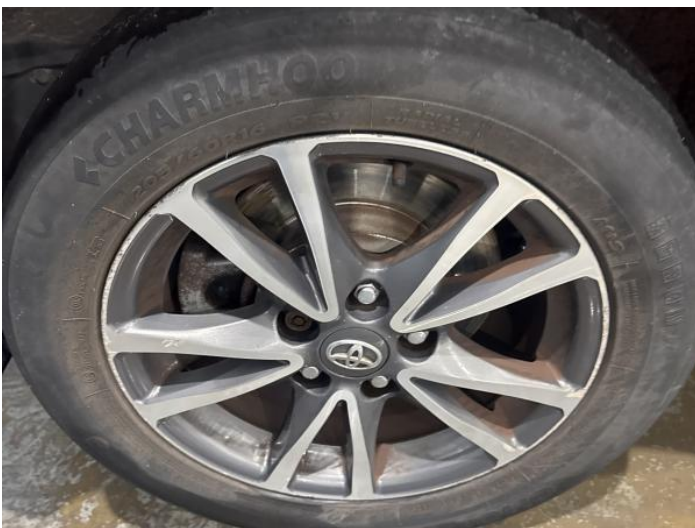
19: Wheel osr
Scratched
Over 50mm

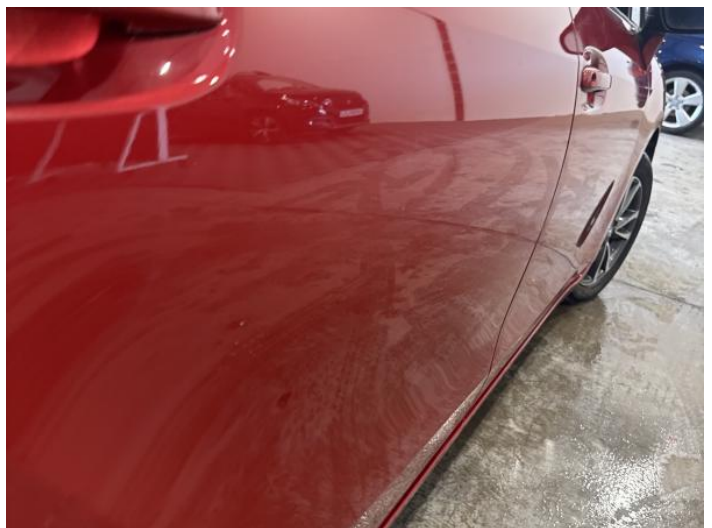
20: Door osr
Chipped
1 To 5

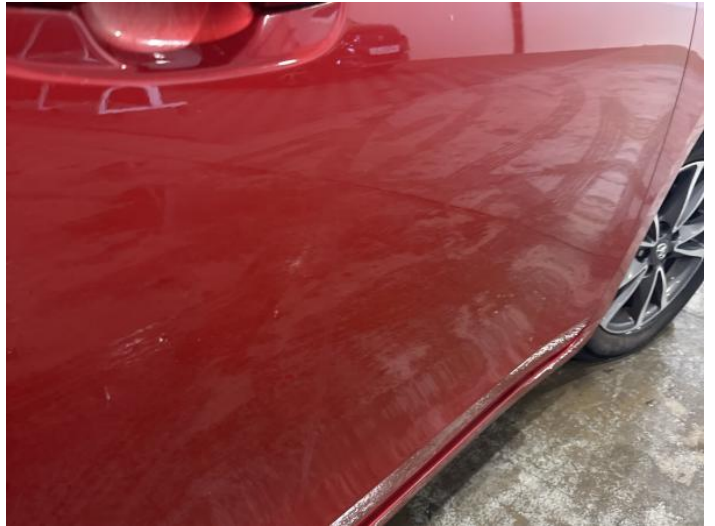
21: Door osr
Scratched
Over 25mm Not Thru Paint

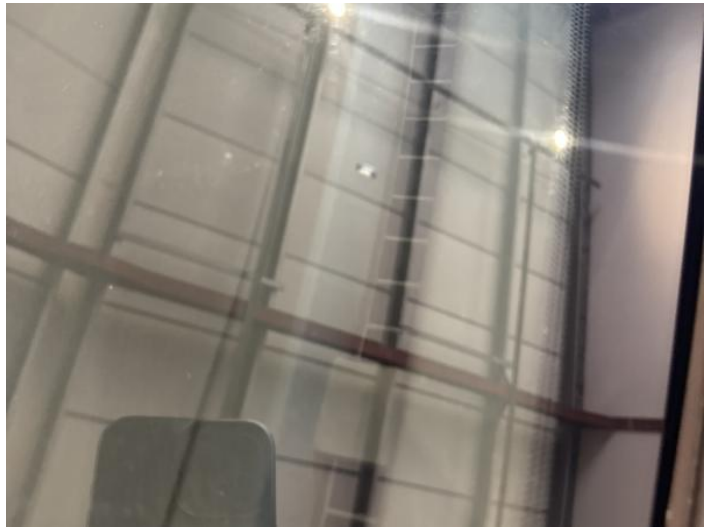
23: Door osf
Scratched
Over 25mm Not Thru Paint
