VEHICLE INSPECTION REPORT

MC07ZGE

Volvo XC70 2.4 D5 SE 5dr Geartronic [185]

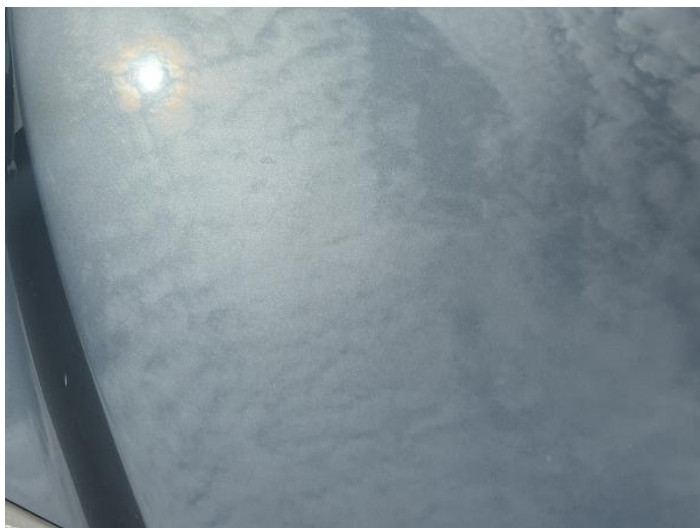
1: Bonnet
Chipped
1 To 5

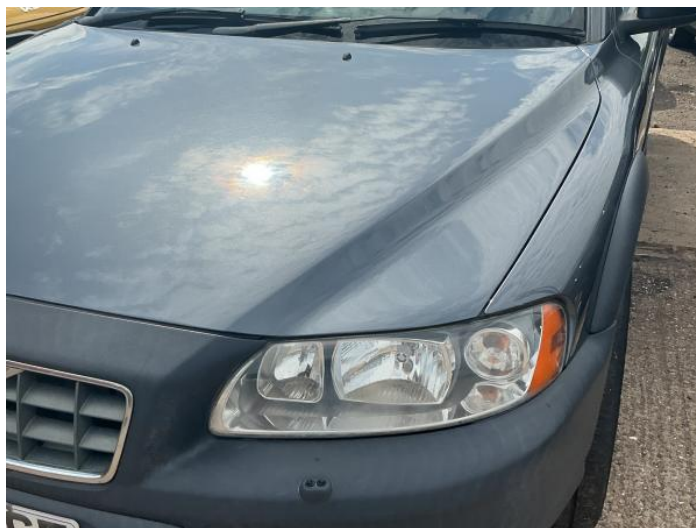
2: Bumper Front Moulding
Scuffed (Unpainted)
Over 100mm

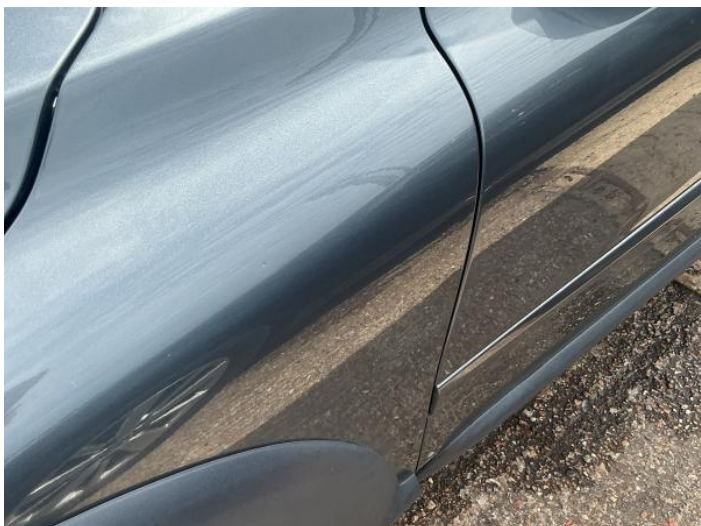
3: Wing nsf
Chipped
1 To 5

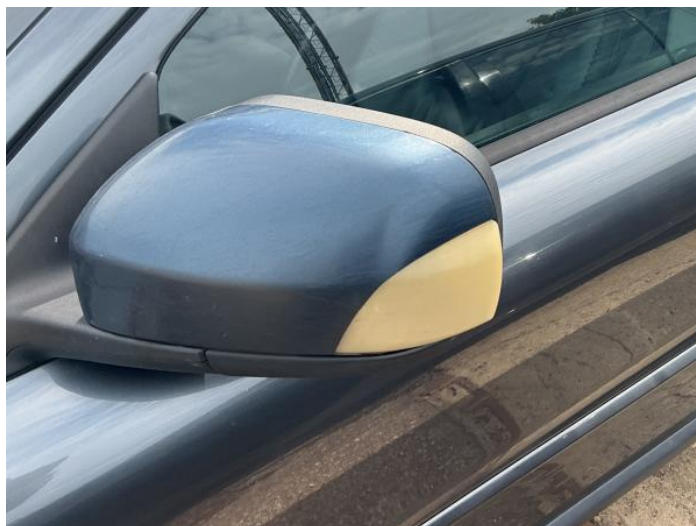
4: Door Mirror Assy nsf
Broken
Replace

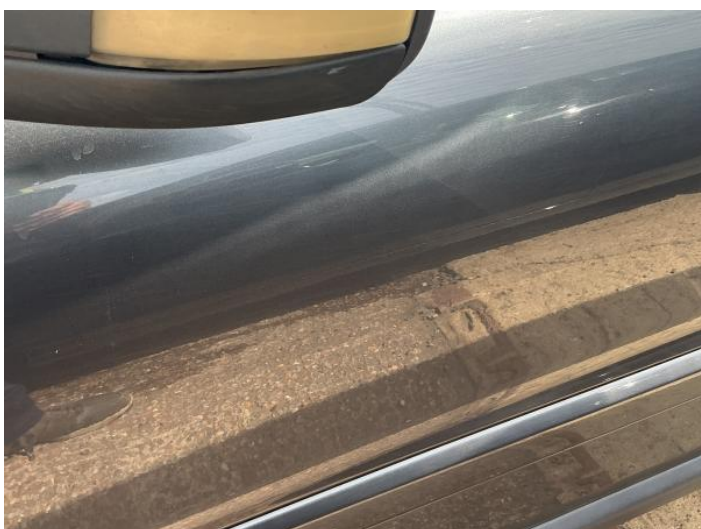
5: Door nsf
Dented
Over 2 UpTo 10mm

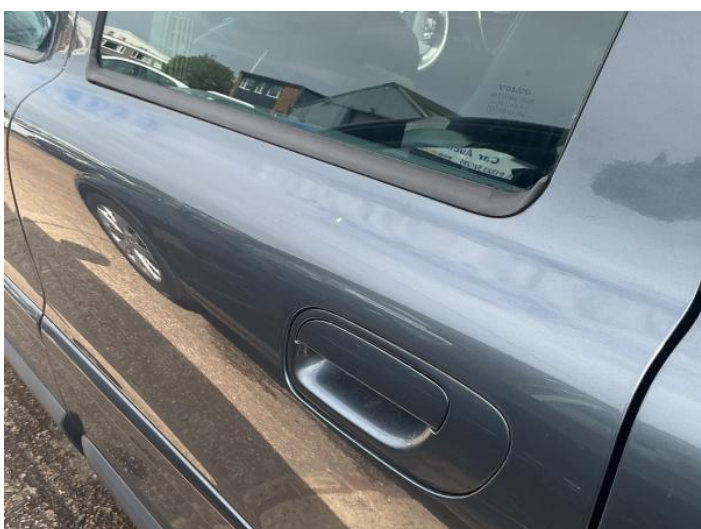
7: Door nsr
Poor Previous Repair
Poor Paint

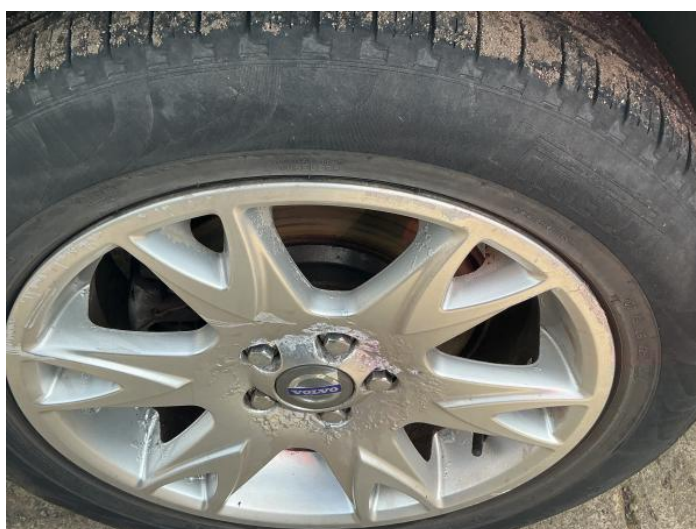
8: Wheel nsr
Scratched
Over 50mm

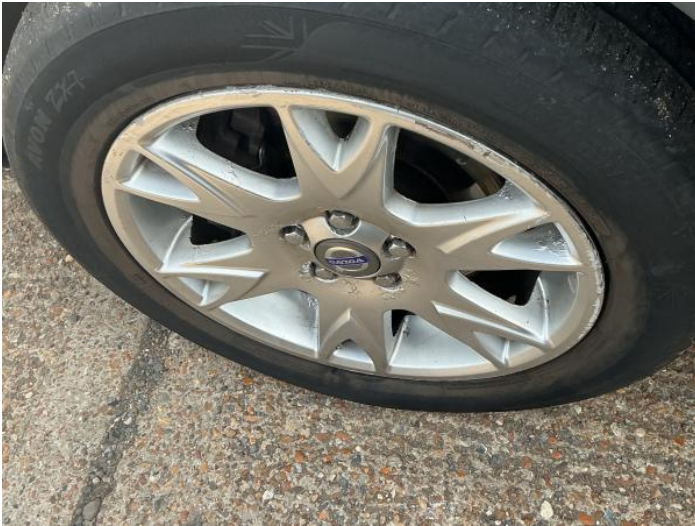
9: Wheel nsf
Scratched
Over 50mm

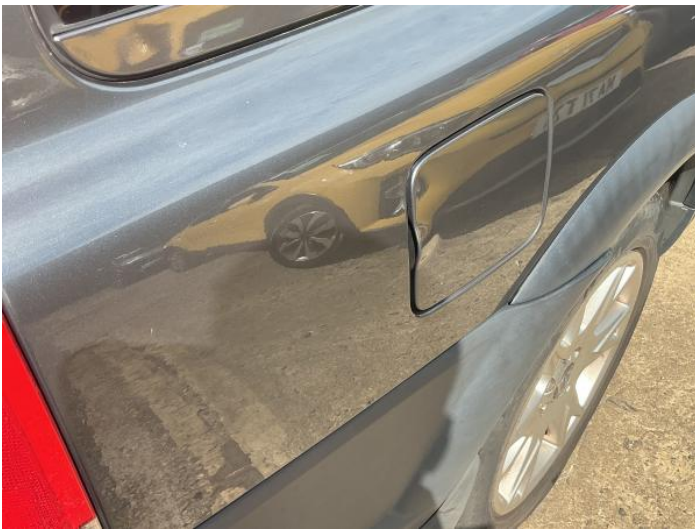
11: Qtr Panel osr
Dented
2 Or Less UpTo 10mm

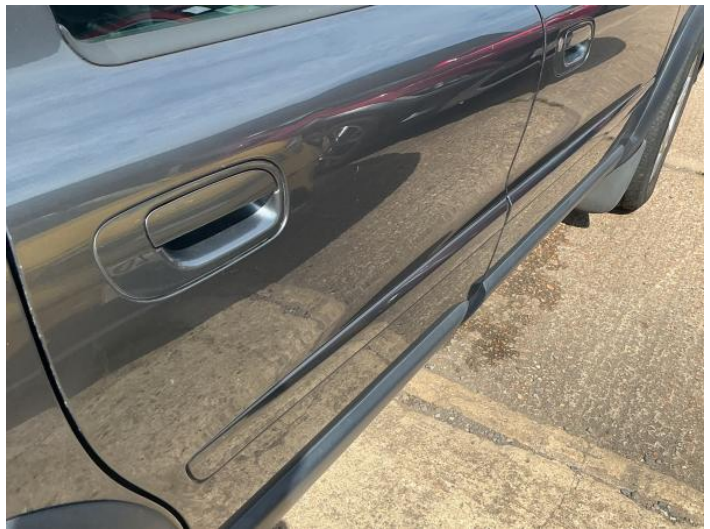
12: Door osr
Dented
Over 30mm

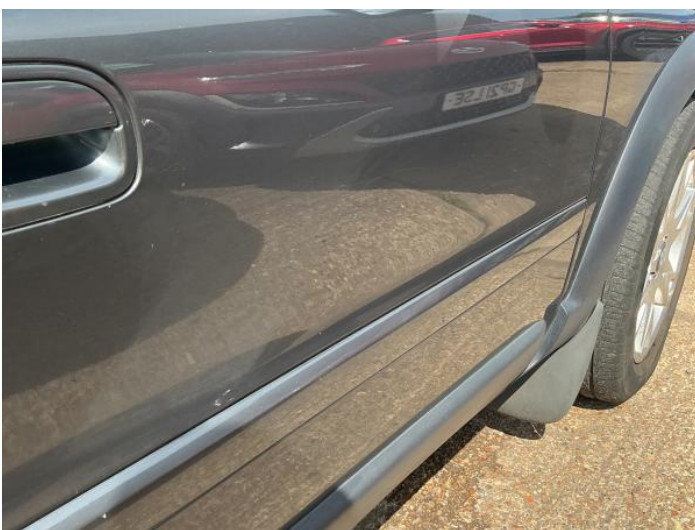
13: Door osf
Poor Previous Repair
Poor Paint

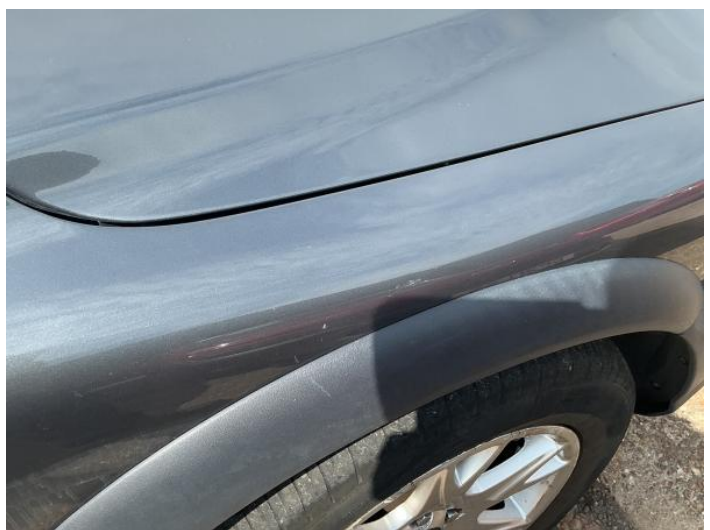
14: Wing osf
Chipped
1 To 5

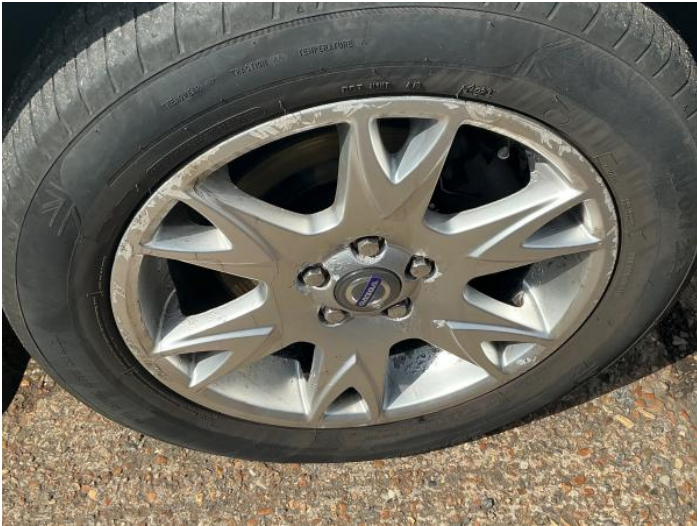
15: Wheel osf
Scratched
Over 50mm

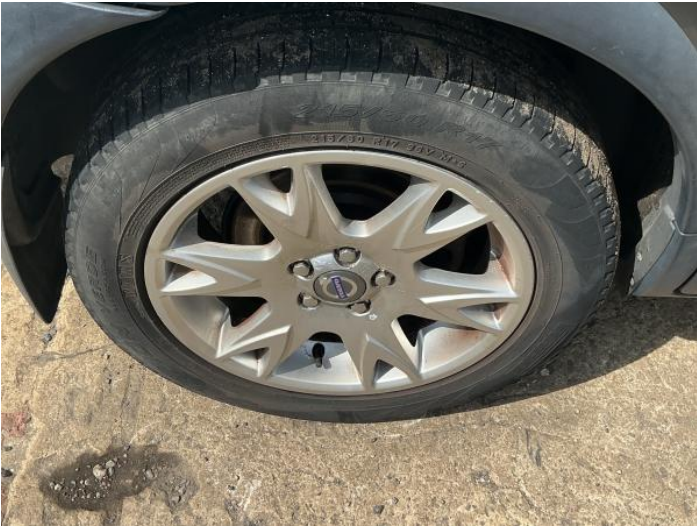
16: Wheel osr
Scratched
Over 50mm
