VEHICLE INSPECTION REPORT

GN66WVS

Ford Fiesta 1.0 EcoBoost Titanium 5dr

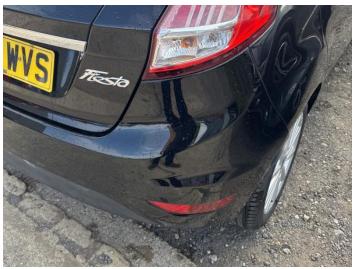
2: Bumper Rear Scratched Over 25mm Not Thru Paint

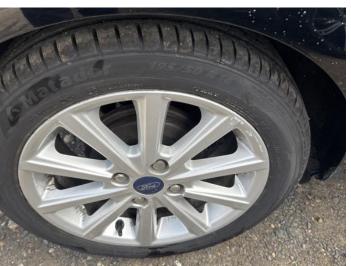
5: Wheel osr Scratched Over 50mm

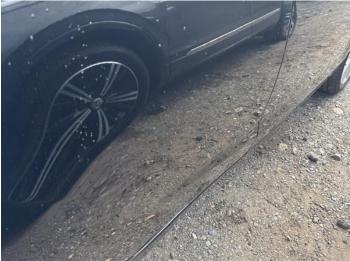
6: Door osr Chipped 1 To 5

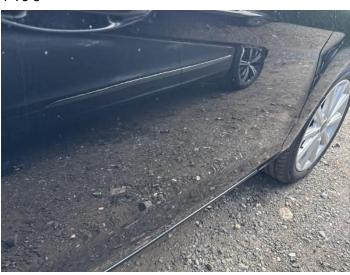
8: Door osf Chipped 1 To 5

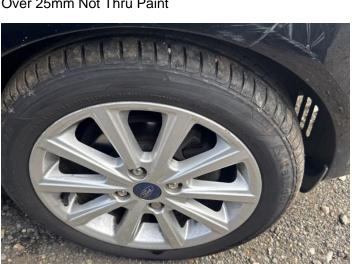
11: Wheel osf Scratched Over 50mm

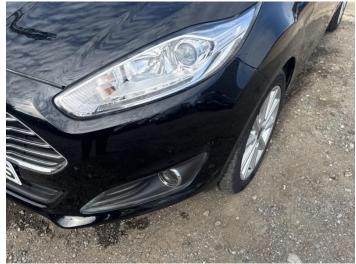
13: Bumper Front Scratched Over 100mm Thru Paint

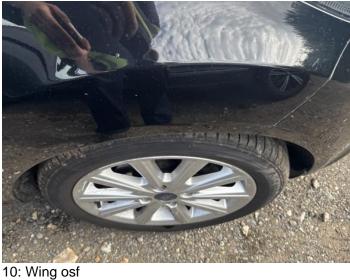
Scratched
Over 25mm Thru Paint

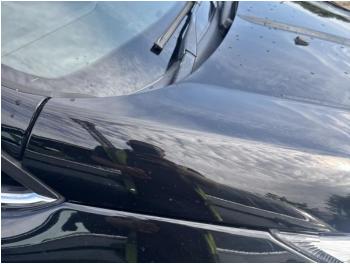
12: Bonnet Chipped Multiple Chips

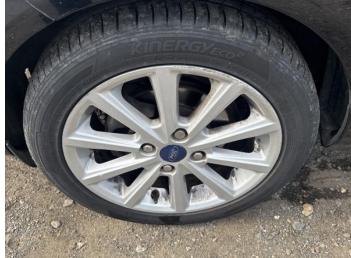
14: Wheel nsf Scratched Over 50mm

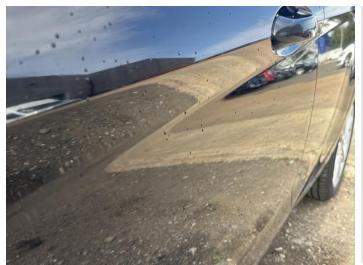
17: Door nsf Chipped 1 To 5

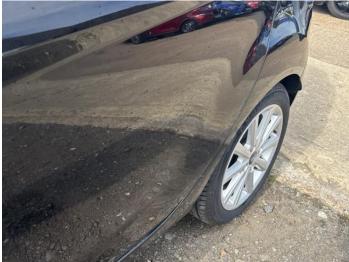
19: Door nsr Chipped 1 To 5

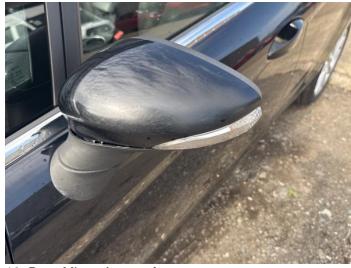
16: Door Mirror Assy nsf Broken Replace

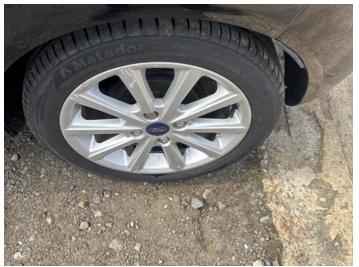
21: Wheel nsr Scratched Over 50mm
