# VEHICLE INSPECTION REPORT

**GY55UCO**

## Hyundai Accent 1.6 CDX 5dr Auto

**Cat: N**  
**Inspection**

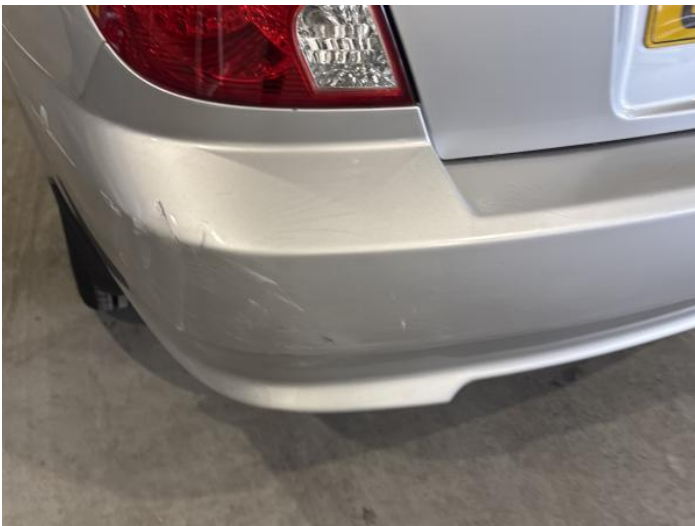
1: Bumper Rear  
Poor Previous Repair  
Rippled Up To 30%

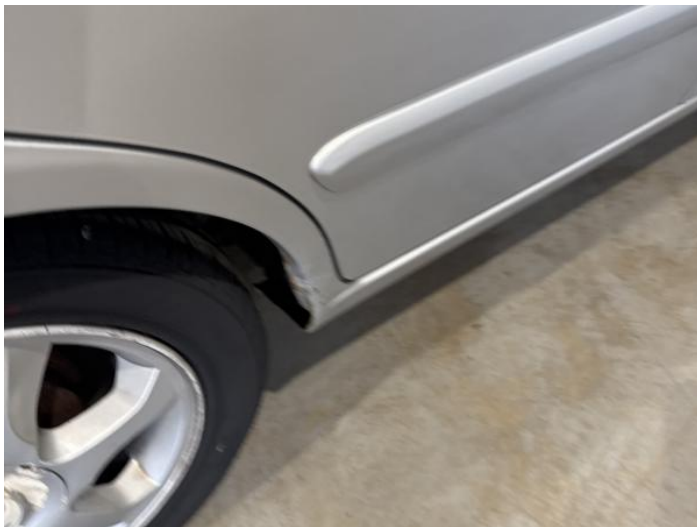
3: Qtr Panel osr  
Rusted  
Over 5mm

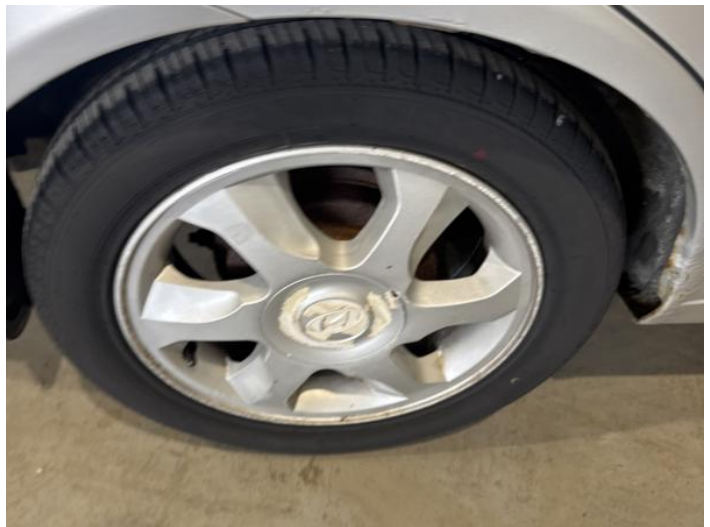
4: Wheel osr  
Scratched  
Over 50mm

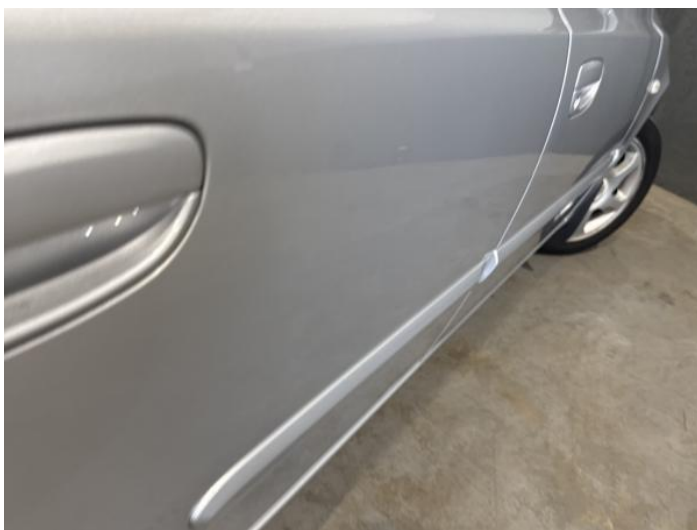
5: Door osr  
Chipped  
1 To 5

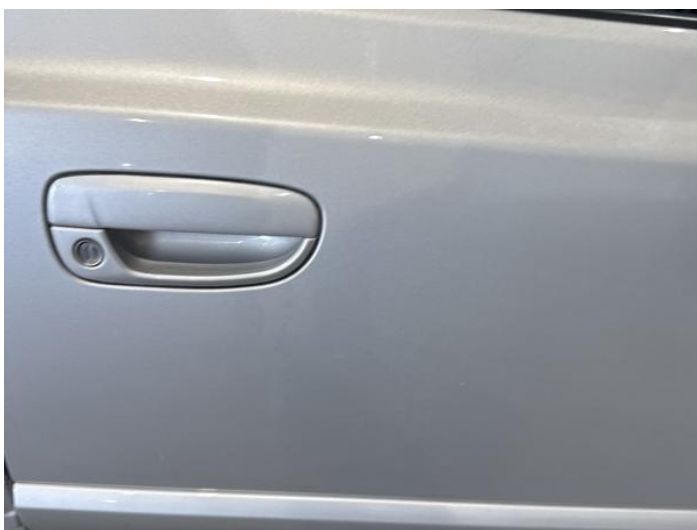
7: Door osf  
Chipped  
1 To 5

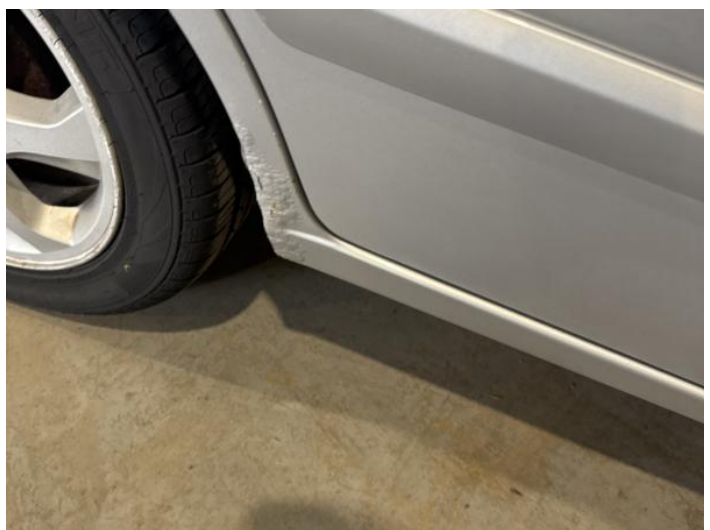
8: Sill os  
Rusted  
Over 5mm

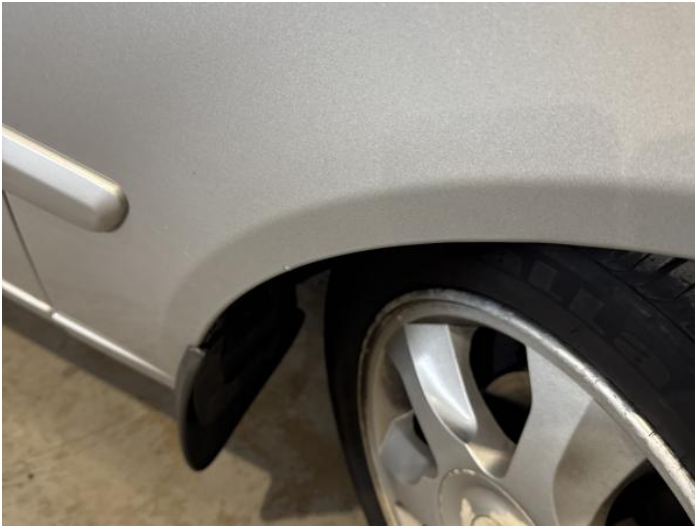
9: Wing osf  
Chipped  
1 To 5

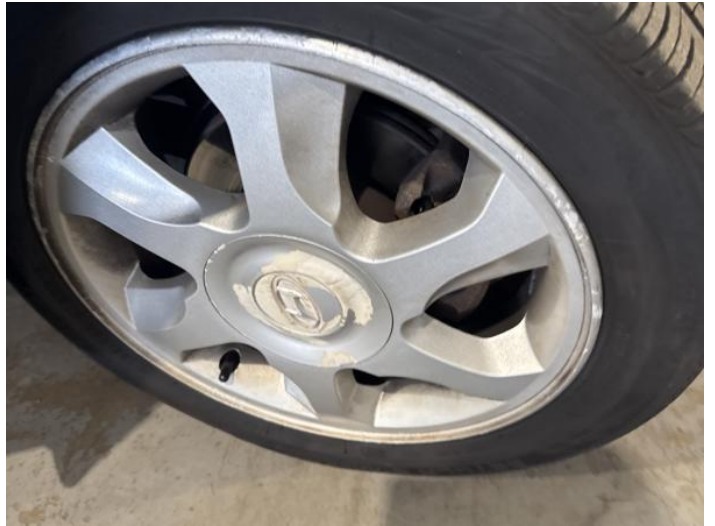
10: Wheel osf  
Scratched  
Over 50mm

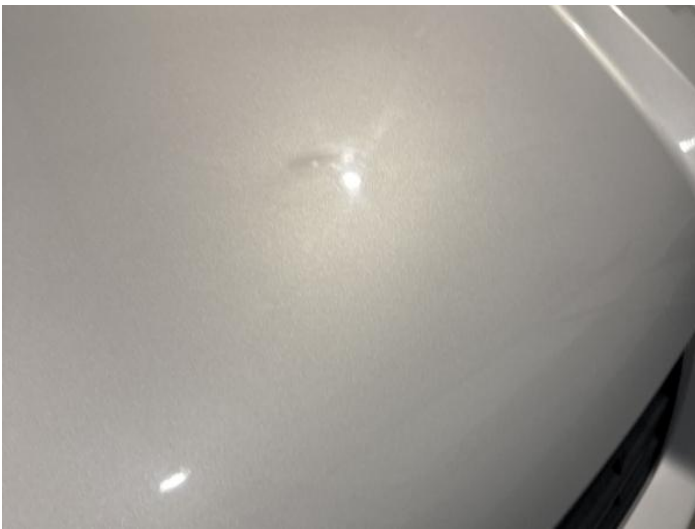
11: Bonnet  
Poor Previous Repair  
Poor Paint

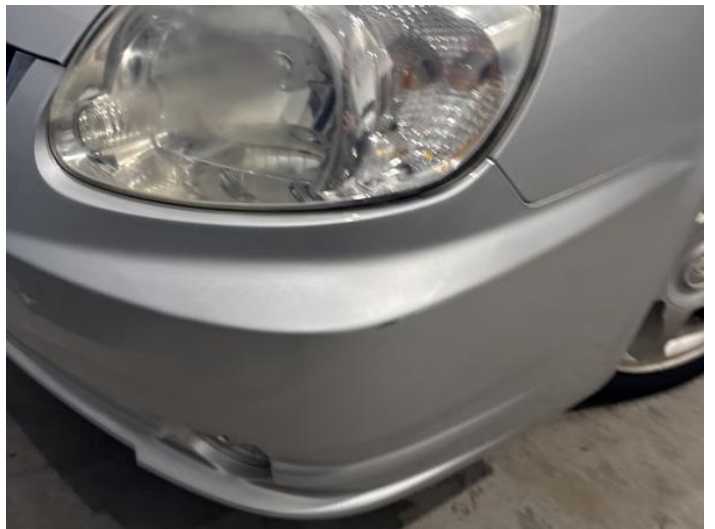
12: Bumper Front  
Scratched  
25 to 100mm Thru Paint

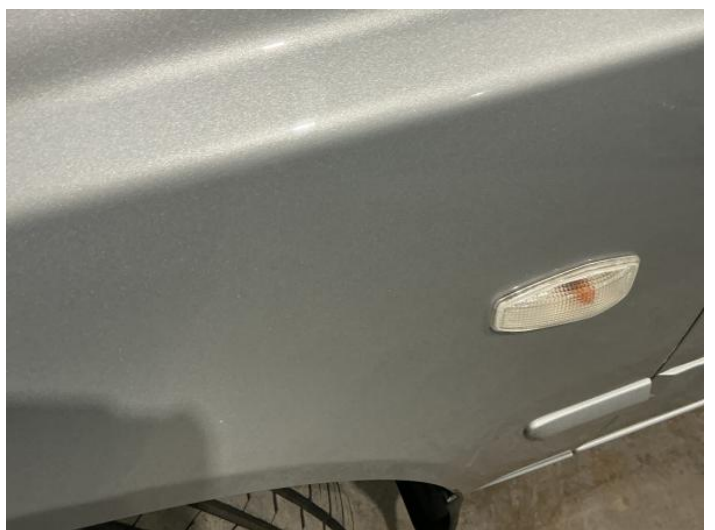
14: Wing nsf  
Chipped  
1 To 5

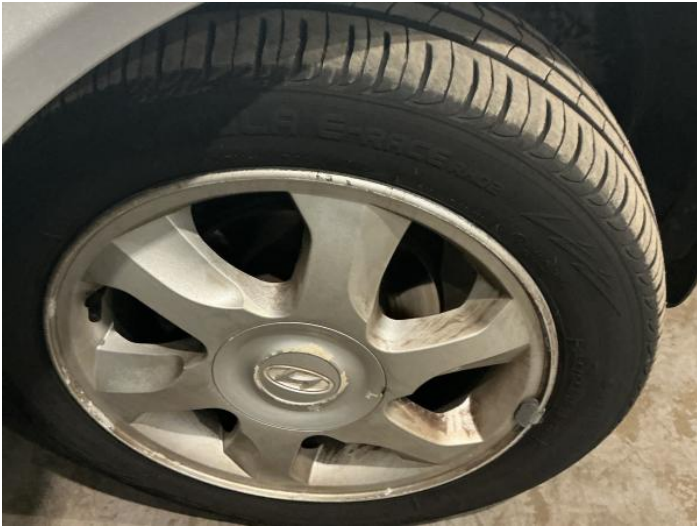
15: Wheel nsf  
Scratched  
Over 50mm

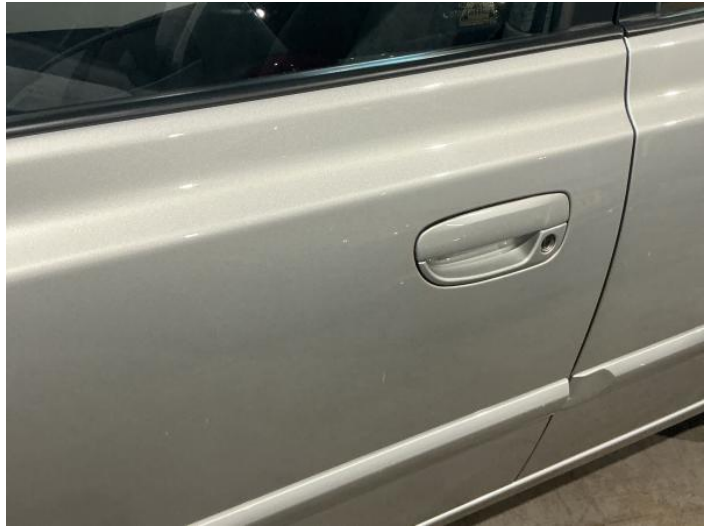
16: Door nsf  
Dented  
Between 10mm + 30mm

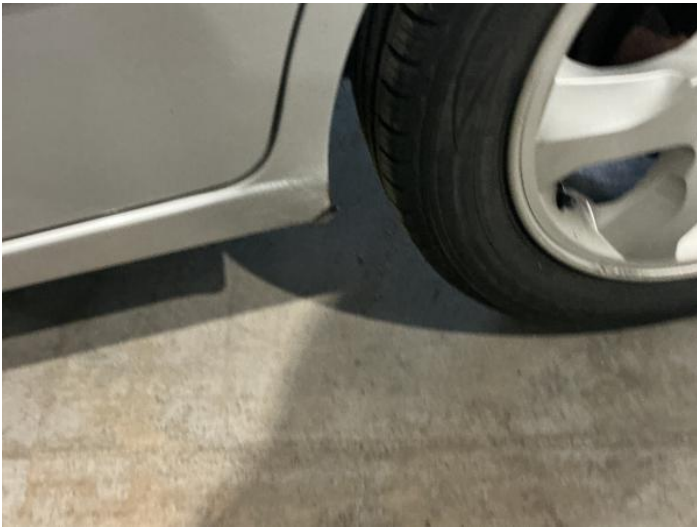
17: Sill ns  
Rusted  
Over 5mm

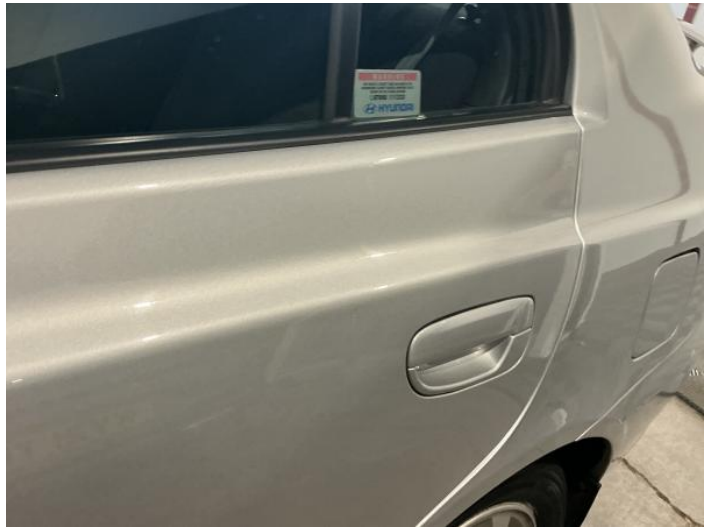
18: Door nsr  
Dented  
Between 10mm + 30mm
