VEHICLE INSPECTION REPORT

RJ64FFG

Volkswagen Tiguan 2.0 TDi BlueMotion Tech Match 5dr

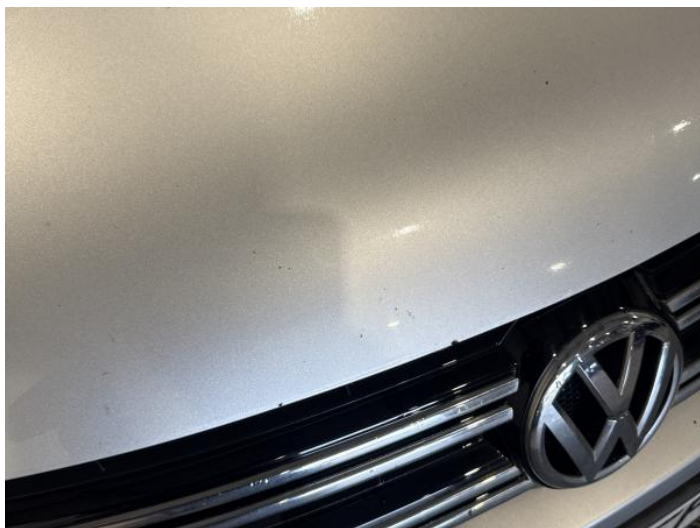
1: Bonnet
Chipped
Multiple Chips

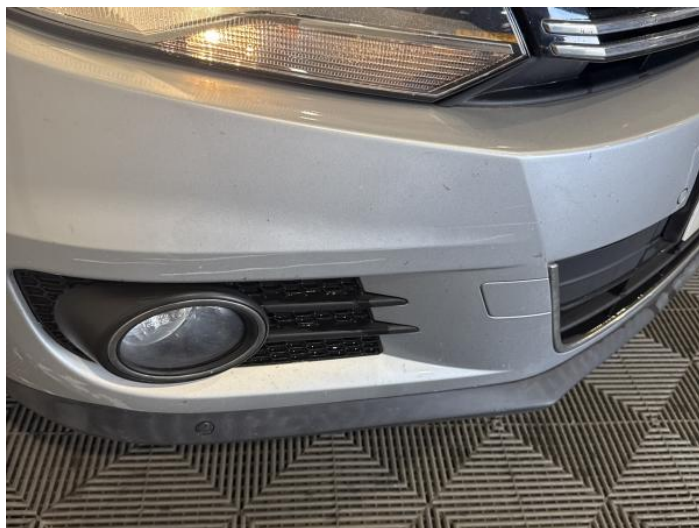
2: Bumper Front
Scratched
Over 100mm Thru Paint

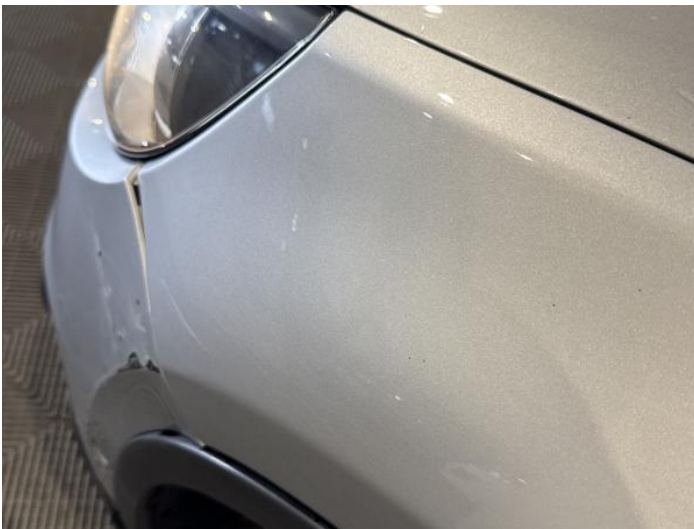
5: Wing nsf
Scratched
Over 25mm Thru Paint

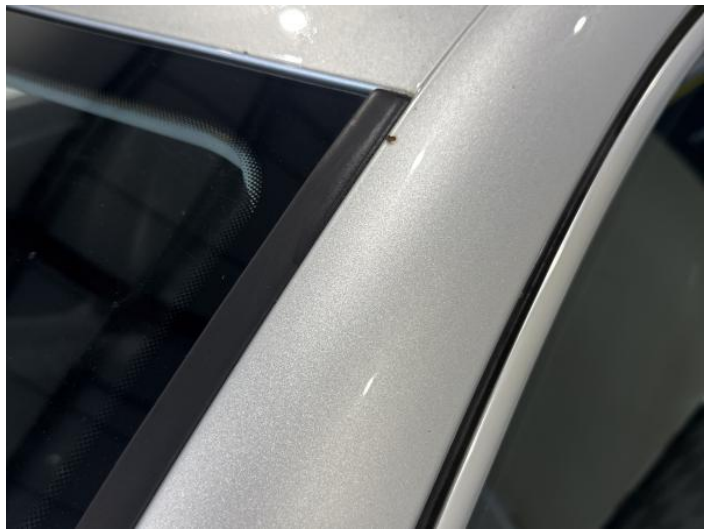
6: A Post ns
Chipped
Over 5mm

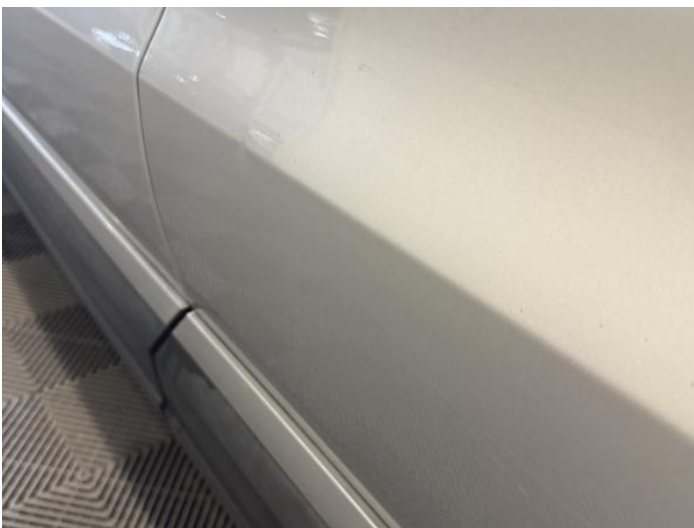
7: Door nsr
Dented
Between 10mm + 30mm

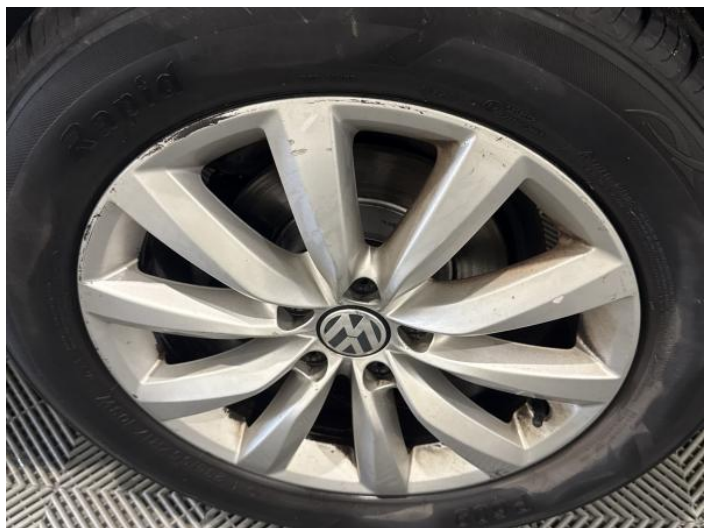
8: Wheel nsr
Scratched
Over 50mm

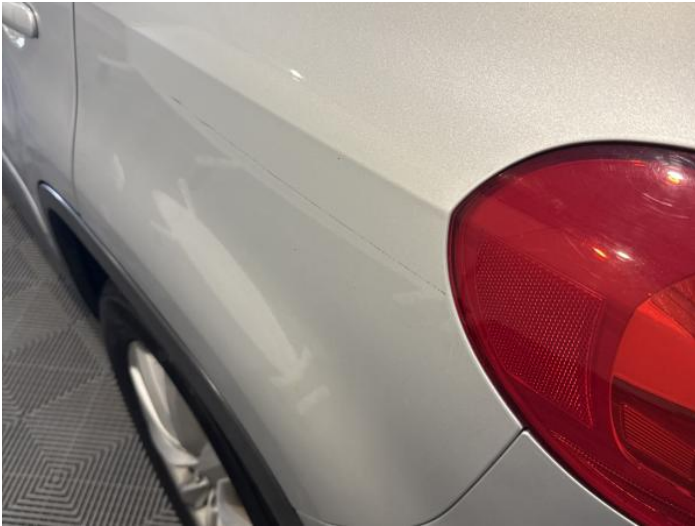
9: Qtr Panel nsr
Scratched
Over 25mm Thru Paint

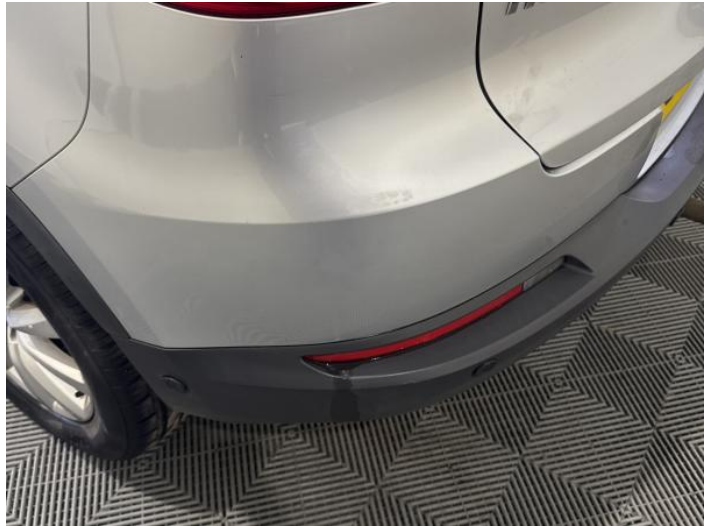
10: Bumper Rear
Scratched
25 to 100mm Thru Paint

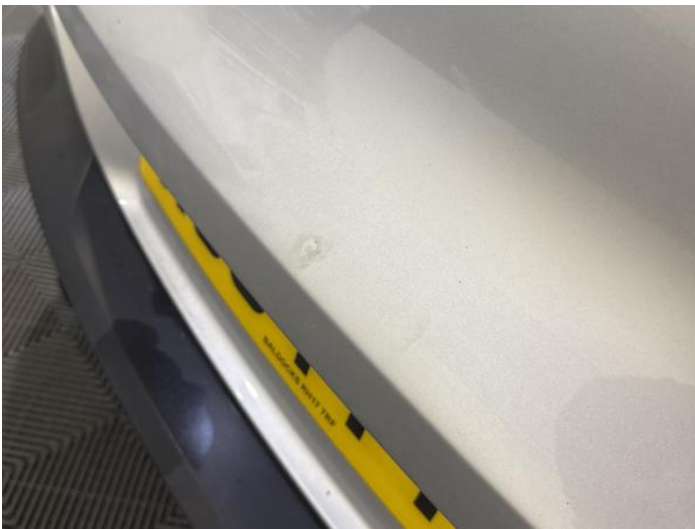
11: Tailgate
Scratched
Over 25mm Thru Paint

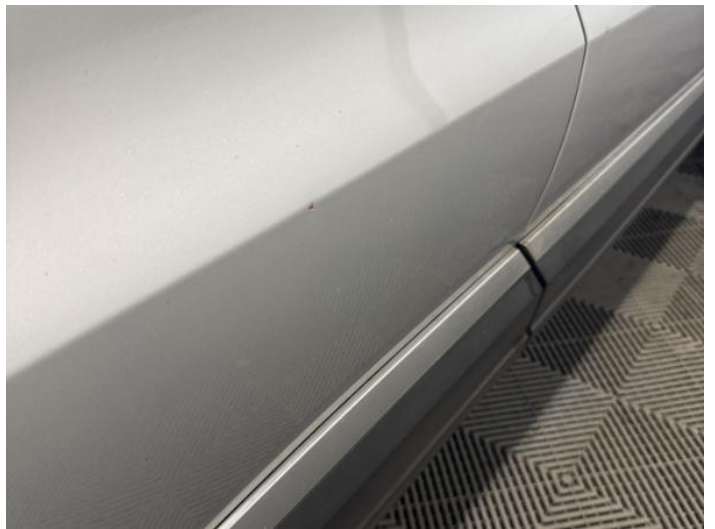
12: Door osr
Dented
Between 10mm + 30mm

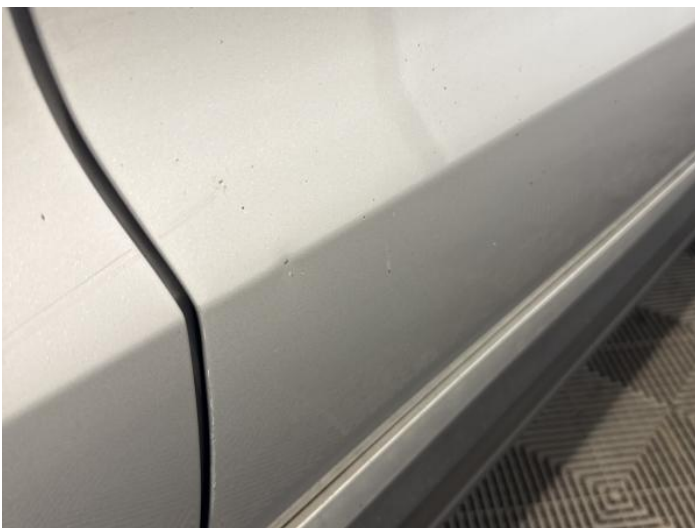
13: Door osf
Dented
Over 30mm

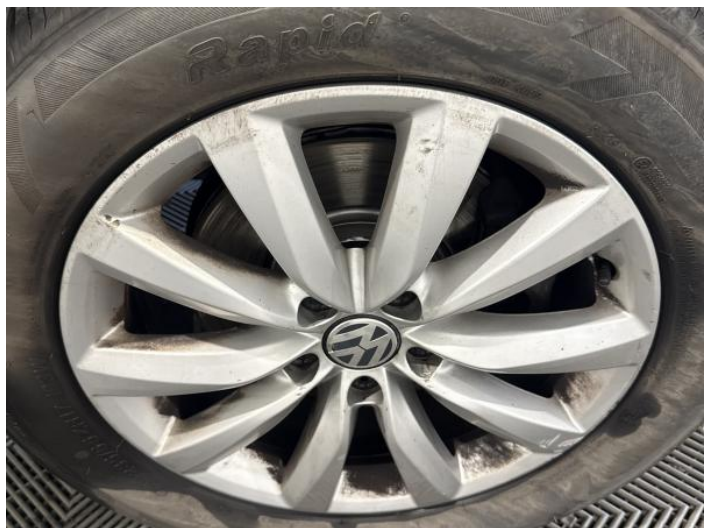
14: Wheel osf
Scratched
Over 50mm
