# VEHICLE INSPECTION REPORT

**GF16ZRX**

## Kia Sportage 1.7 CRDi ISG 3 5dr [Sat Nav]

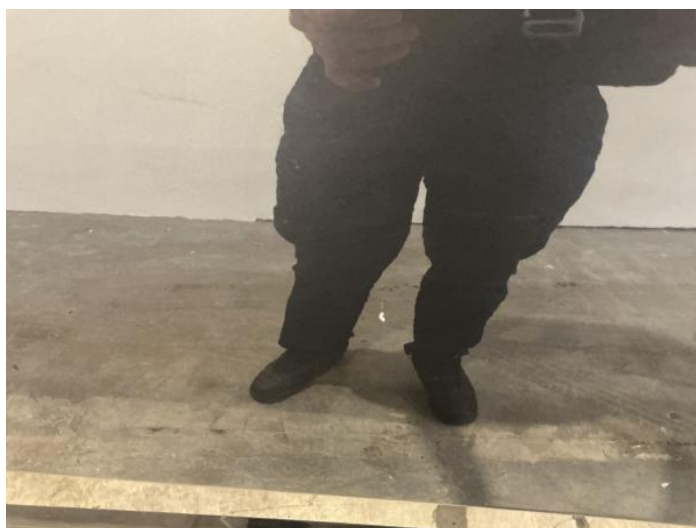
2: Door osf  
Chipped  
1 To 5

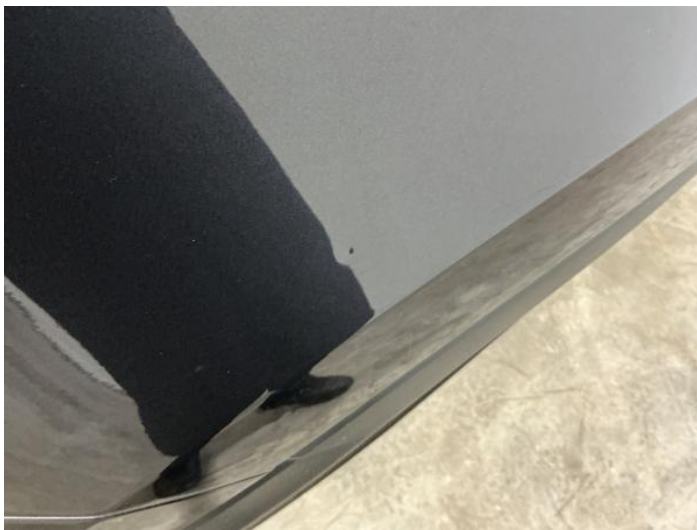
5: Qtr Panel osr  
Dented  
2 Or Less UpTo 10mm

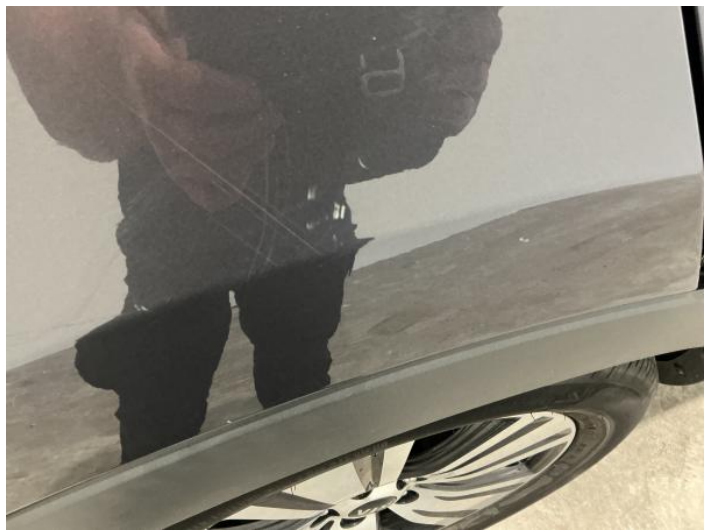
6: Qtr Panel osr  
Chipped  
1 To 5

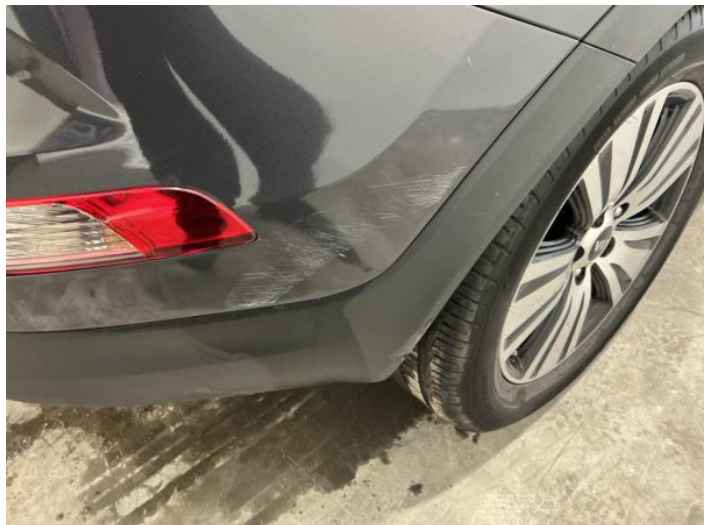
8: Bumper Rear  
Scratched  
25 to 100mm Thru Paint

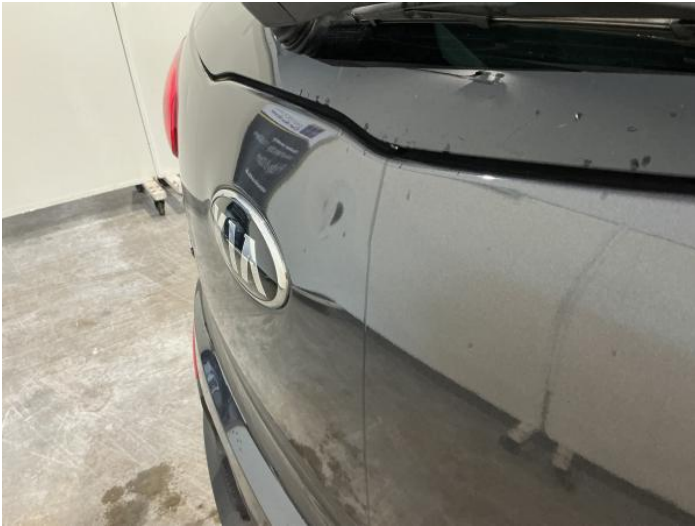
9: Tailgate  
Dented  
Between 10mm + 30mm

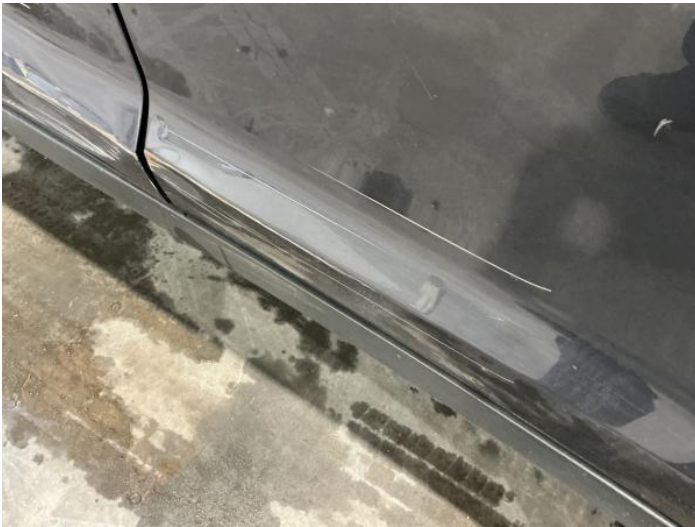
11: Door nsr  
Dented  
With Paint Damage

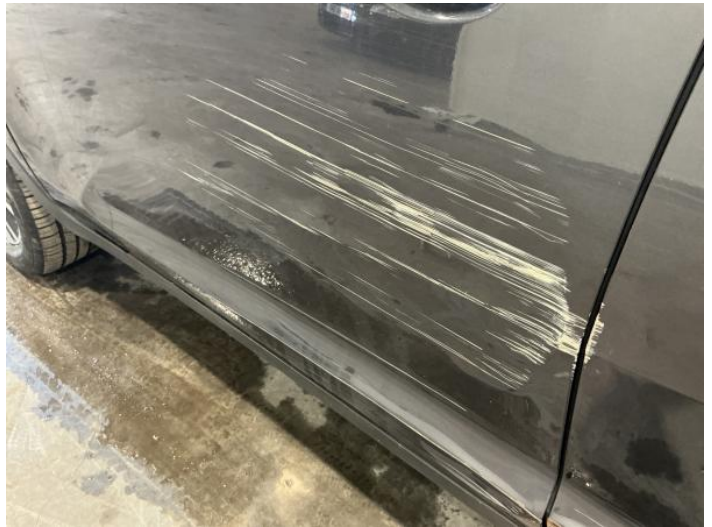
12: Door nsf  
Dented  
With Paint Damage

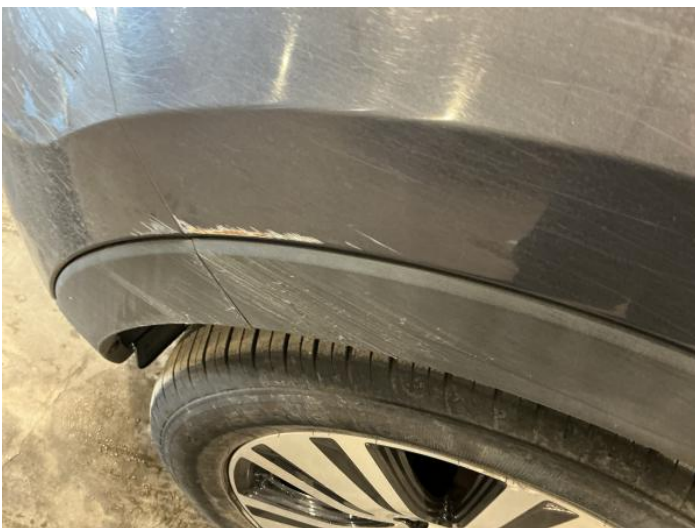
13: Wing nsf  
Scratched  
Over 25mm Thru Paint

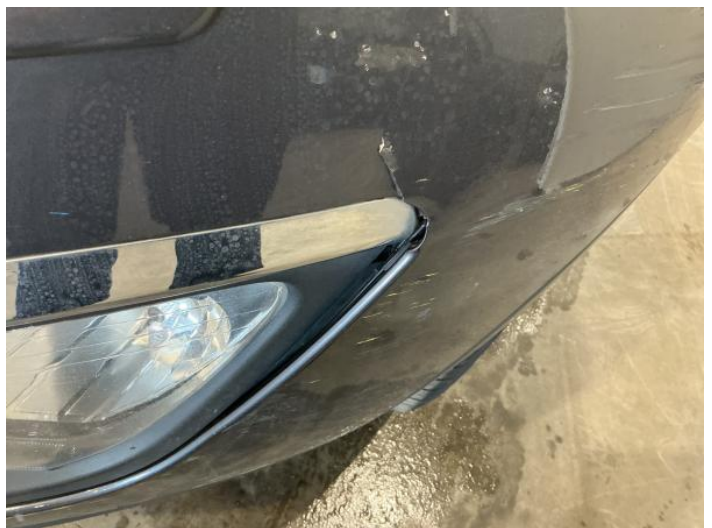
14: Bumper Front  
Cracked  
Over 25mm

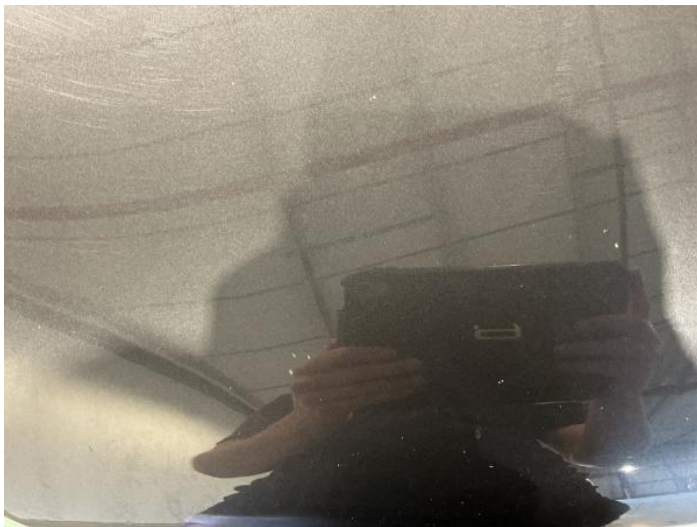
15: Bonnet  
Chipped  
1 To 5

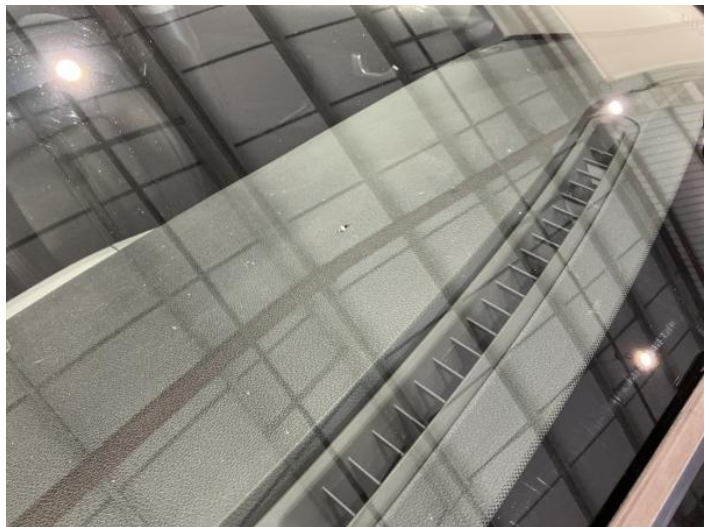
16: Screen Front  
Chipped  
UpTo 10mm
