VEHICLE INSPECTION REPORT

GU63GKJ

Volkswagen Tiguan 2.0 TDi BlueMotion Tech Match 5dr DSG

nama
GRADE
4

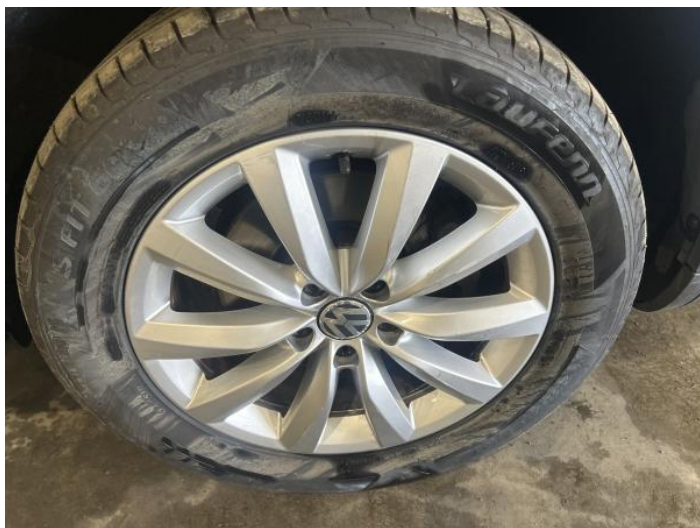
1: Wheel osf
Scratched
Up To 50mm

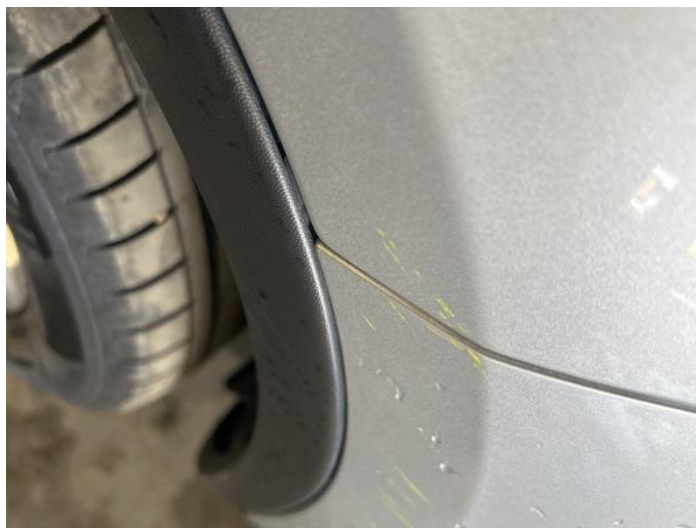
2: Wing osf
Scratched
UpTo 25mm Not Thru Paint

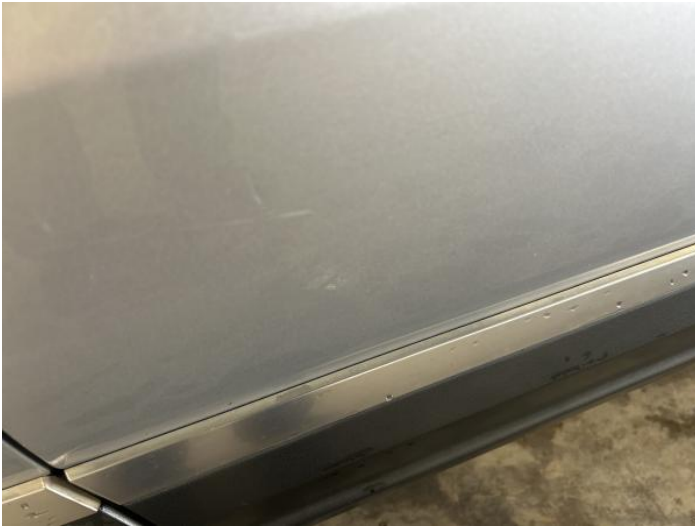
3: Door osf
Scratched
UpTo 25mm Thru Paint

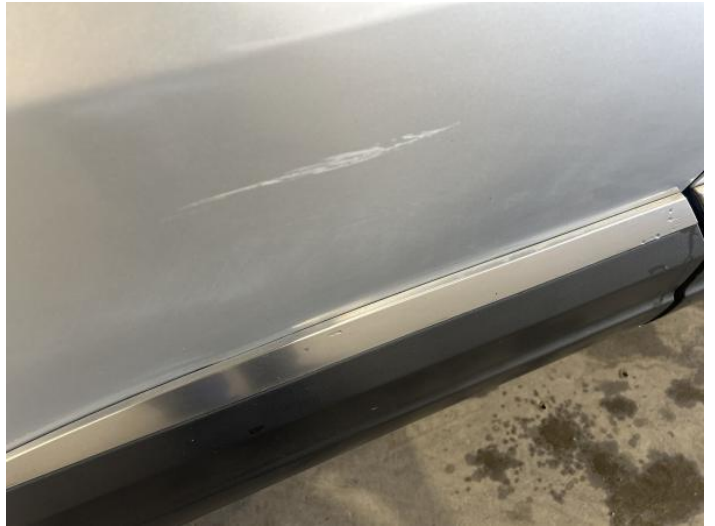
4: Door osr
Scratched
Over 25mm Thru Paint

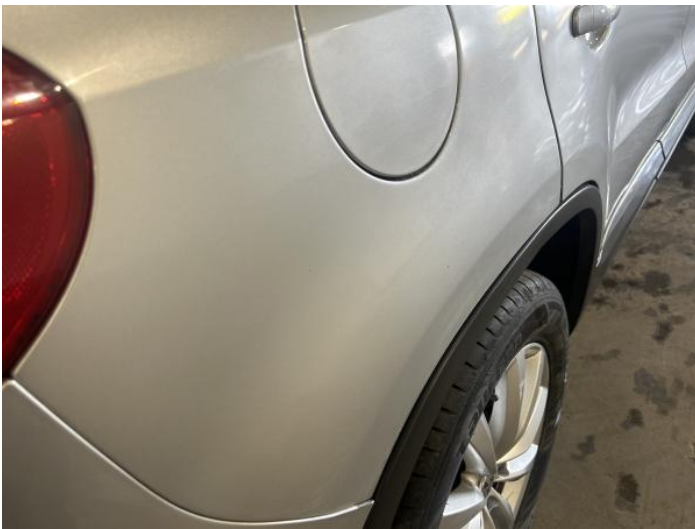
5: Qtr Panel osr
Poor Previous Repair
Poor Paint

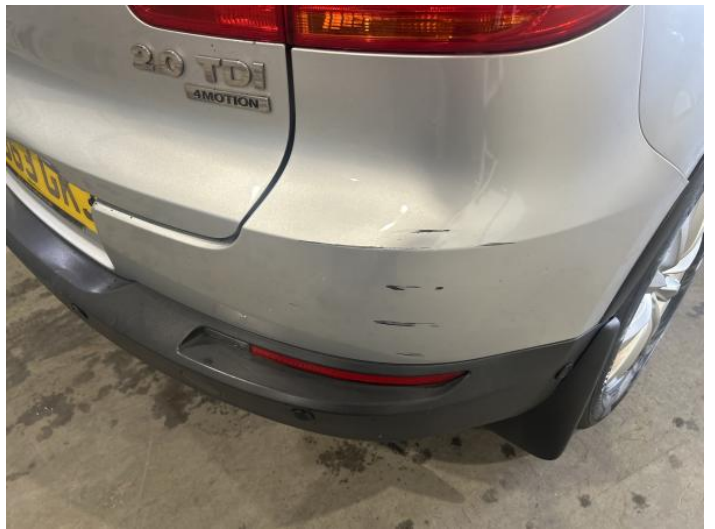
6: Bumper Rear
Scratched
Over 100mm Thru Paint

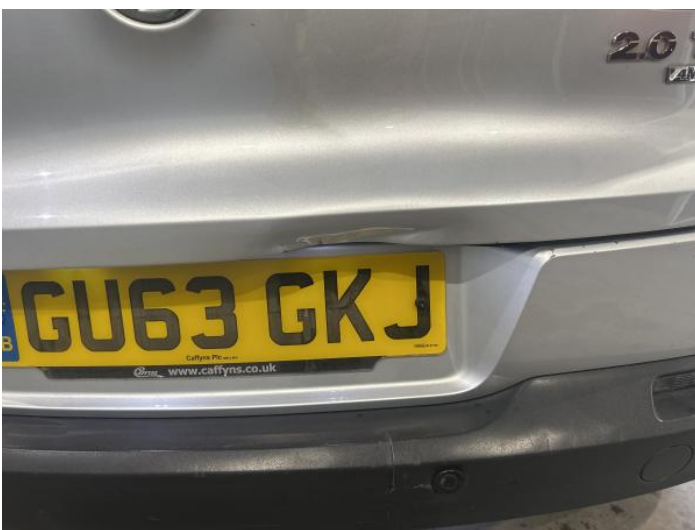
7: Tailgate
Dented
With Paint Damage

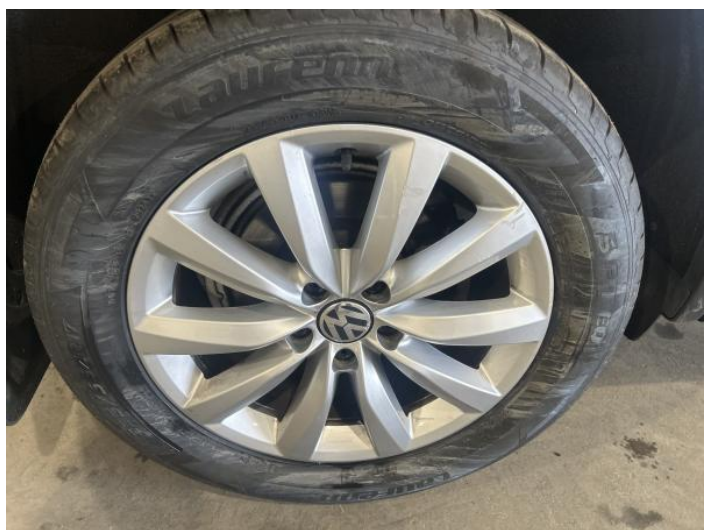
8: Wheel osr
Scratched
Over 50mm

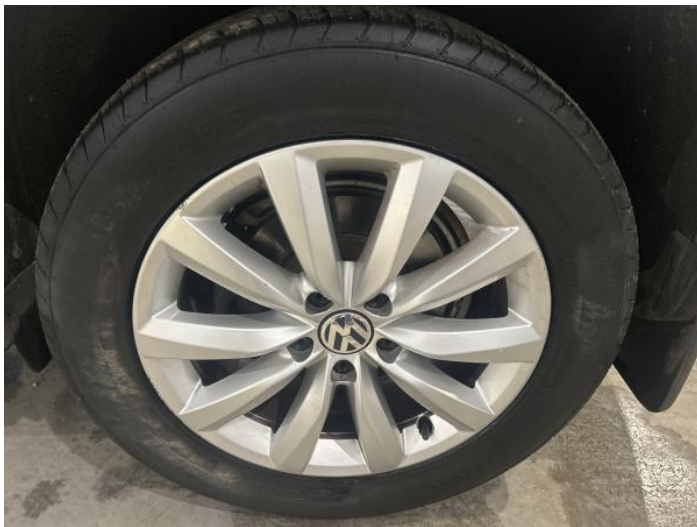
9: Wheel nsr
Scratched
Up To 50mm

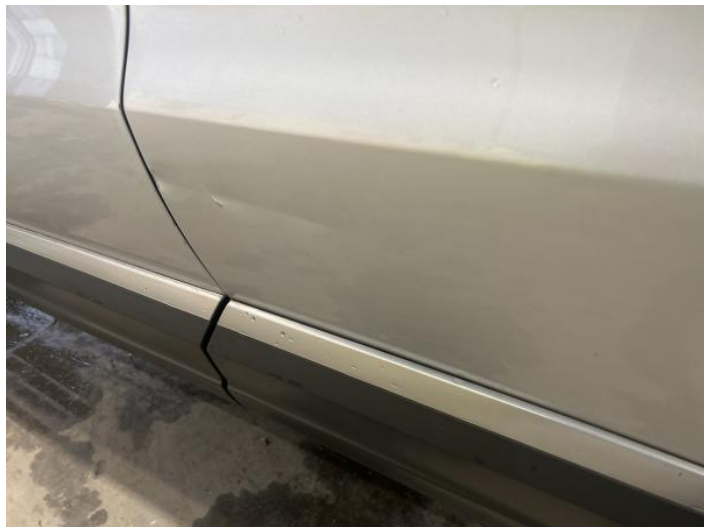
10: Door nsr
Dented
With Paint Damage

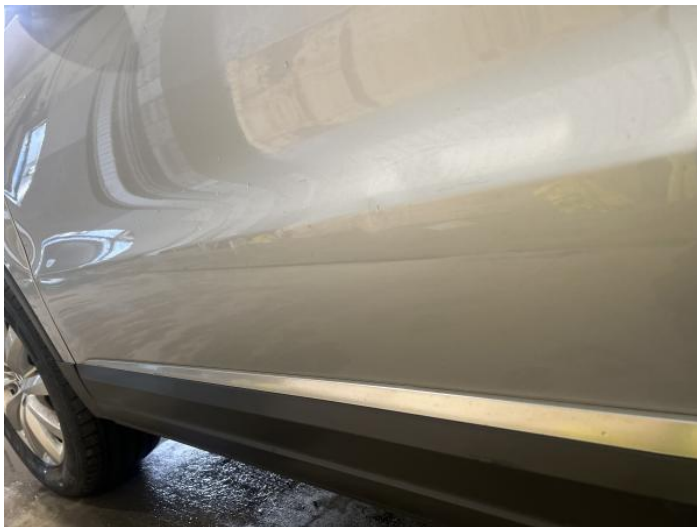
11: Door nsf
Dented
Over 30mm

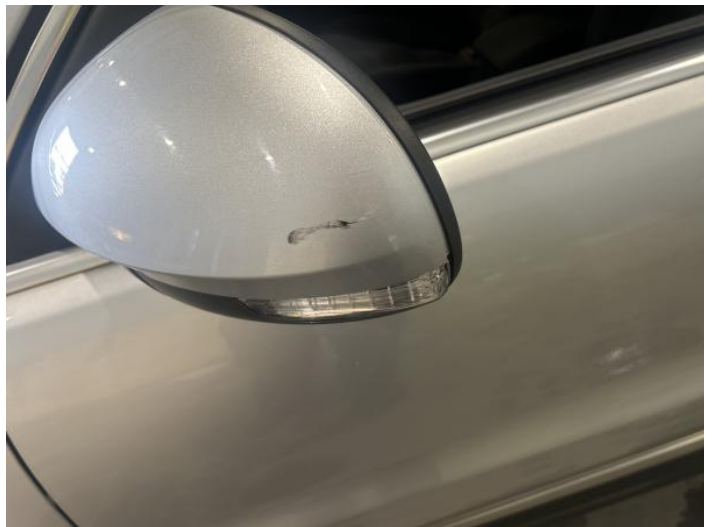
12: Door Mirror Assy nsf
Scratched (Painted)
Over 25mm Not Thru Paint

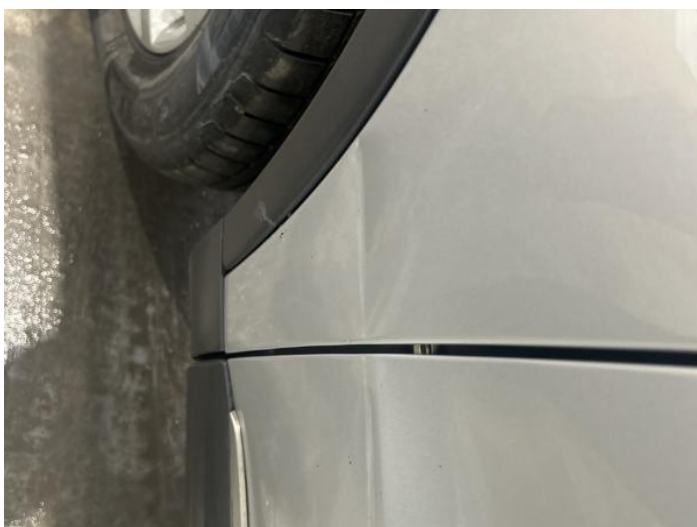
13: Wing nsf
Dented
Over 30mm

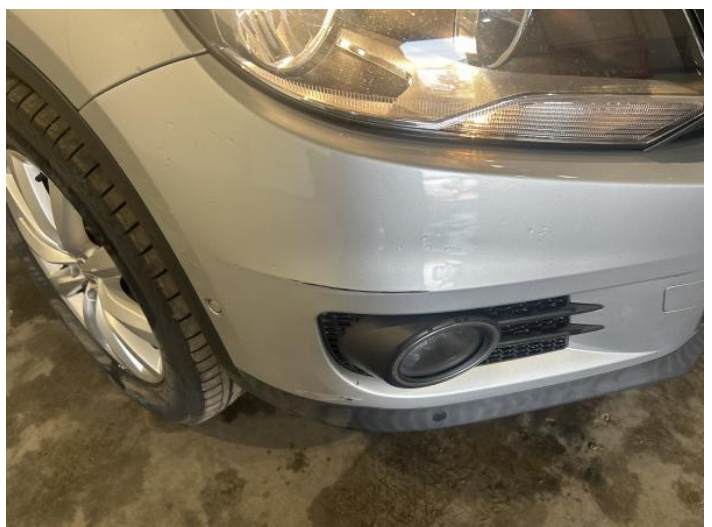
14: Bumper Front
Scratched
Over 100mm Thru Paint

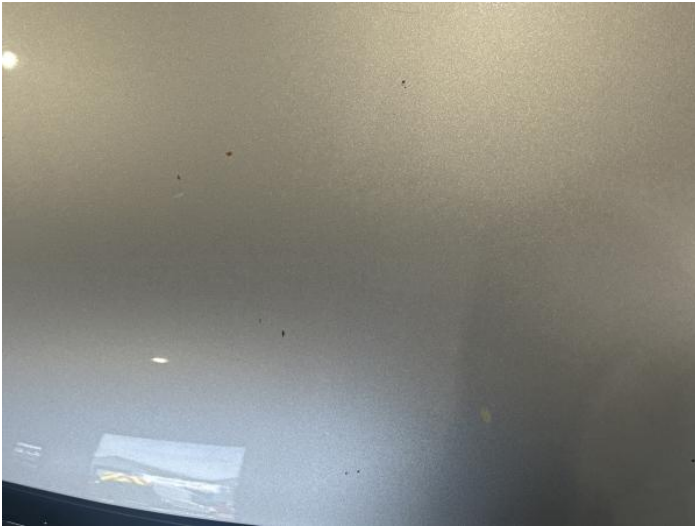
15: Bonnet
Chipped
1 To 5

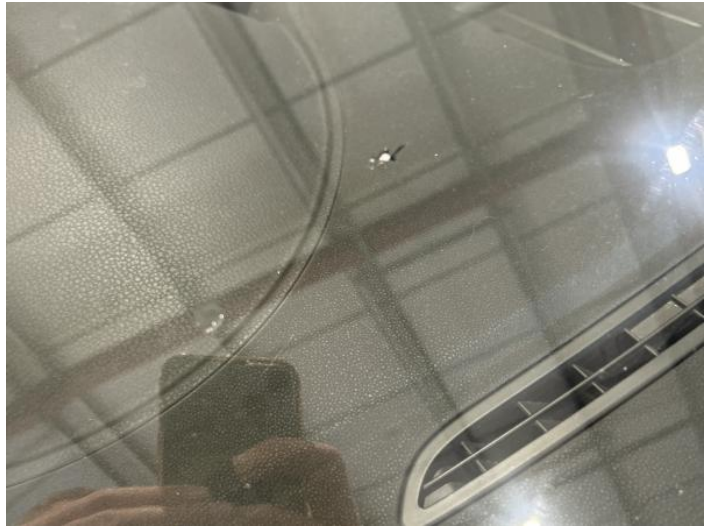
16: Screen Front
Chipped
UpTo 10mm

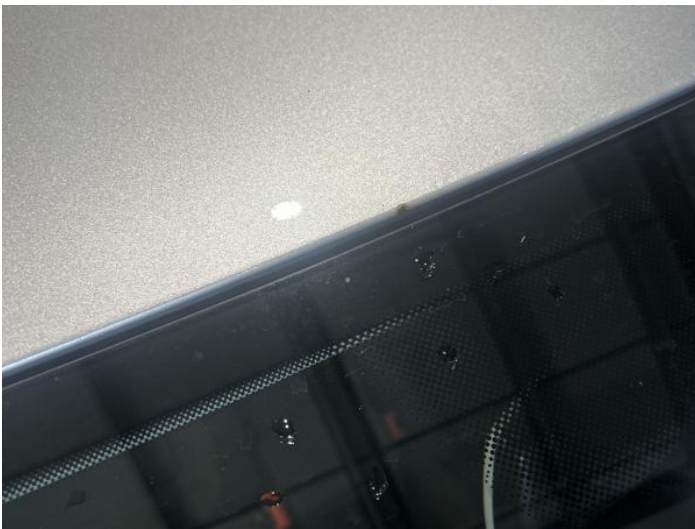
17: Roof
Chipped
1 To 5

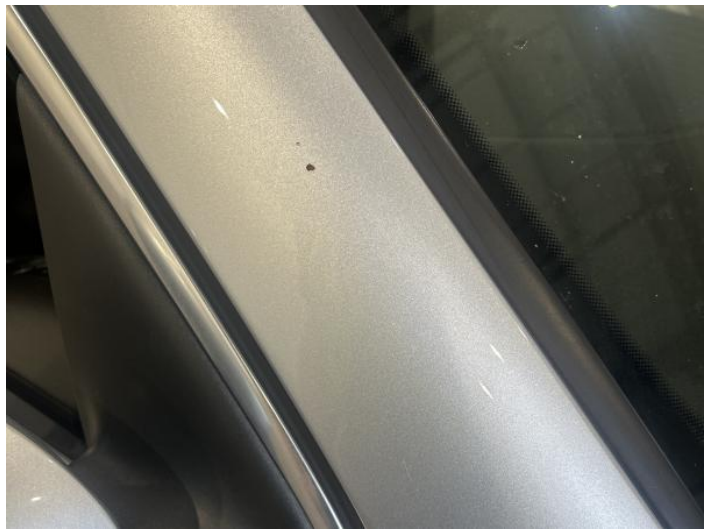
18: A Post os
Chipped
1 To 5

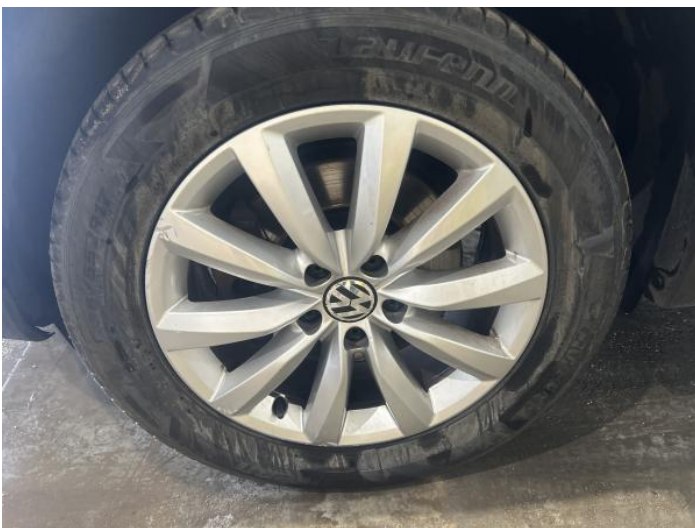
19: Wheel nsf
Scratched
Over 50mm

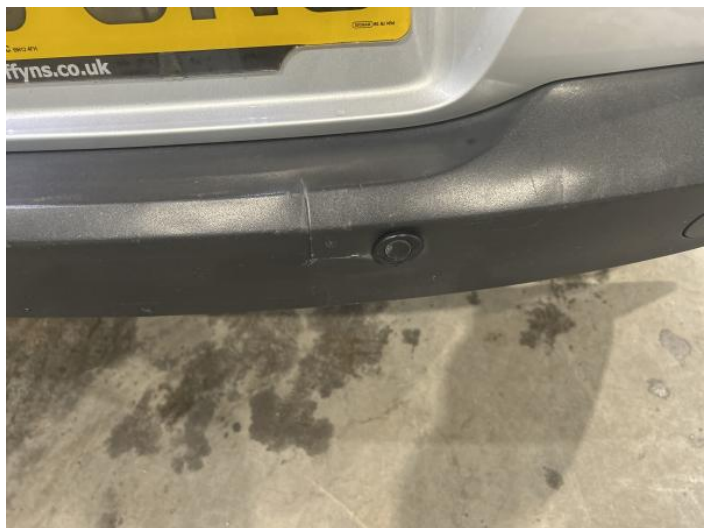
20: Bumper Rear Moulding
Scuffed (Unpainted)
UpTo 100mm
