# VEHICLE INSPECTION REPORT

**GV55MWD**

## Volkswagen Polo 1.4 S 75 5dr

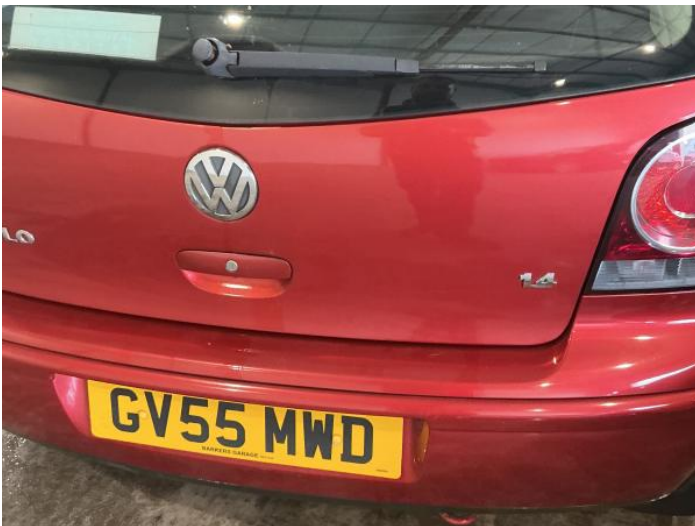
1: Bumper Rear  
Scratched  
Over 100mm Thru Paint

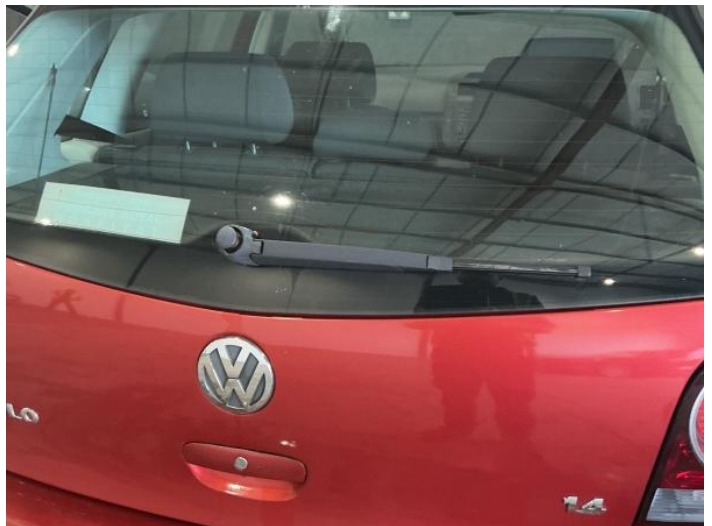
2: Boot Lid  
Chipped  
1 To 5

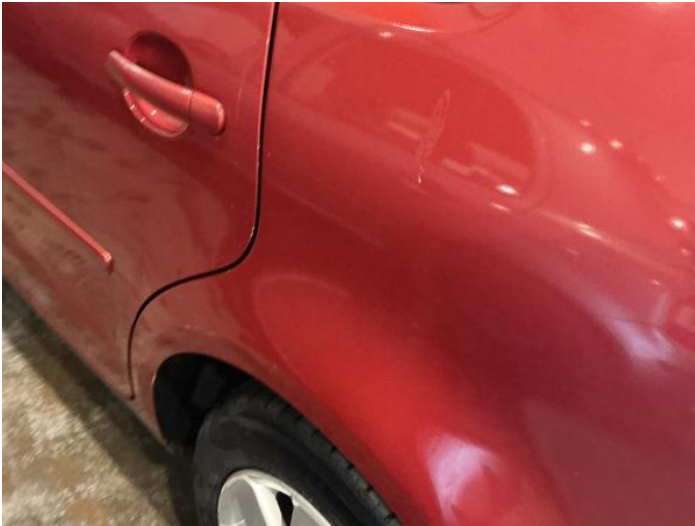
3: Qtr Panel nsr  
Dented  
With Paint Damage

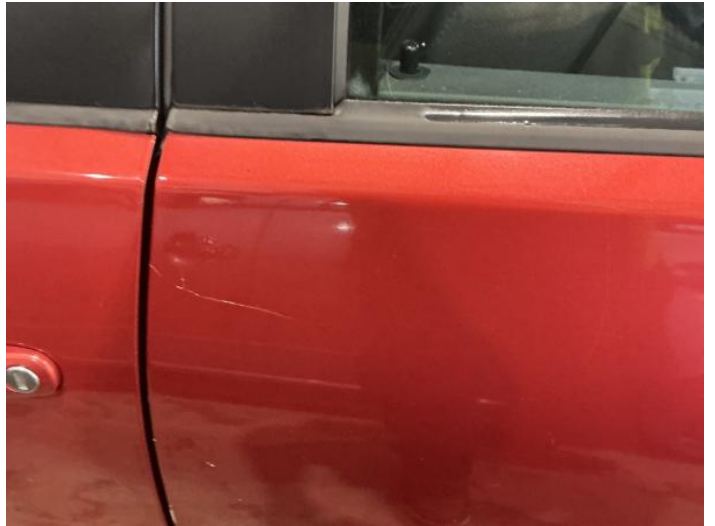
4: Door nsr  
Scratched  
Over 25mm Thru Paint

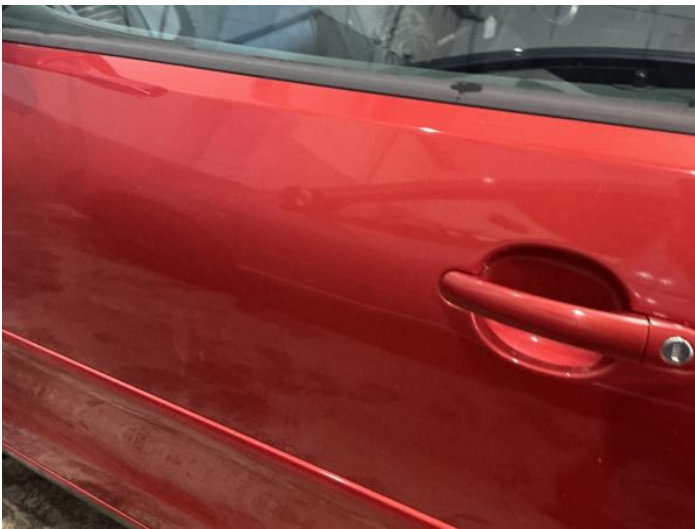
5: Door nsf  
Chipped  
1 To 5

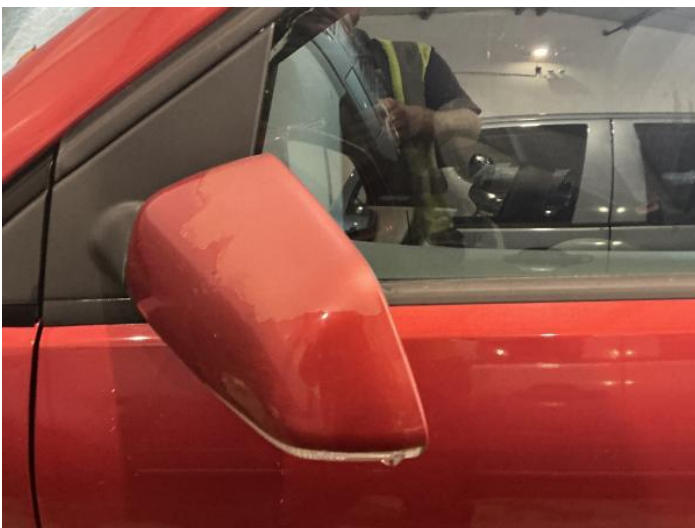
7: Door Mirror Assy nsf  
Scratched (Painted)  
Over 25mm Thru Paint

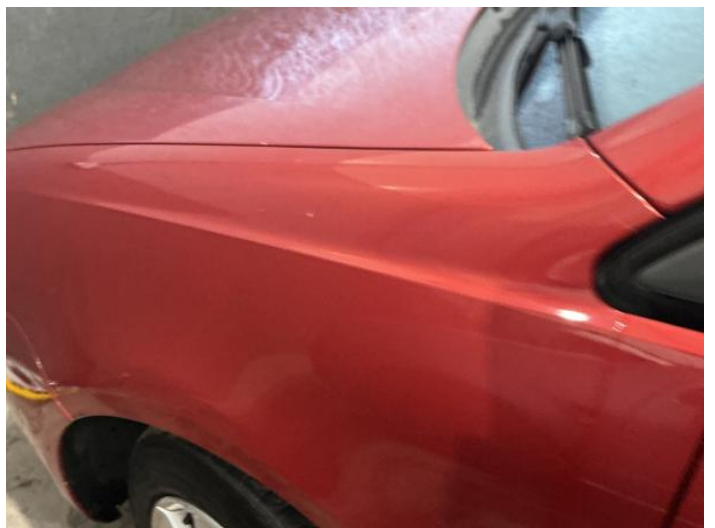
8: Wing nsf  
Dented  
With Paint Damage

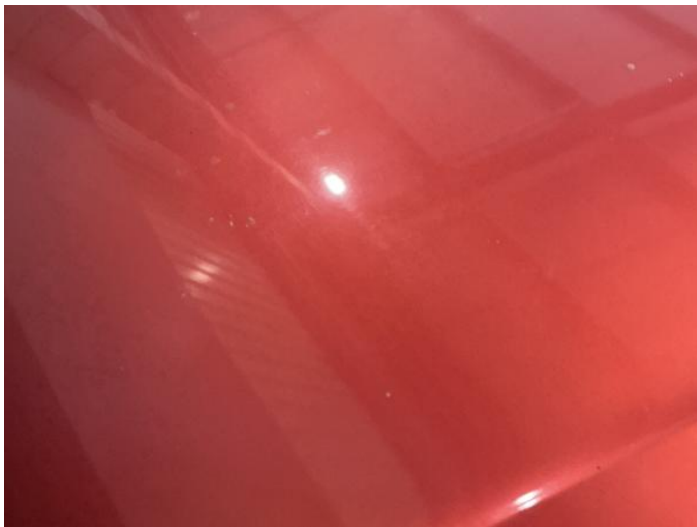
9: Bonnet  
Chipped  
Multiple Chips

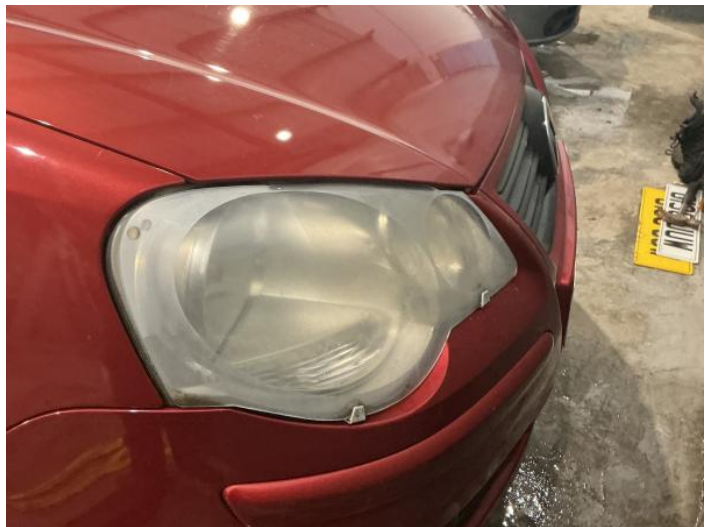
10: Bumper Front  
Scratched  
25 to 100mm Thru Paint

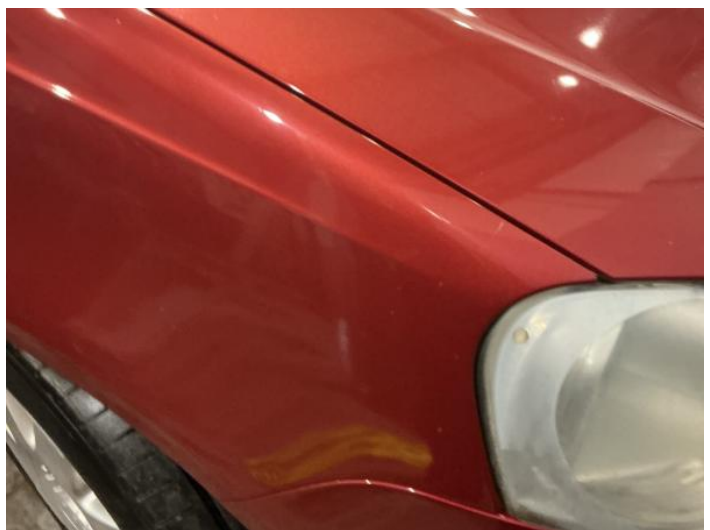
12: Wing osf  
Dented  
Over 2 UpTo 10mm

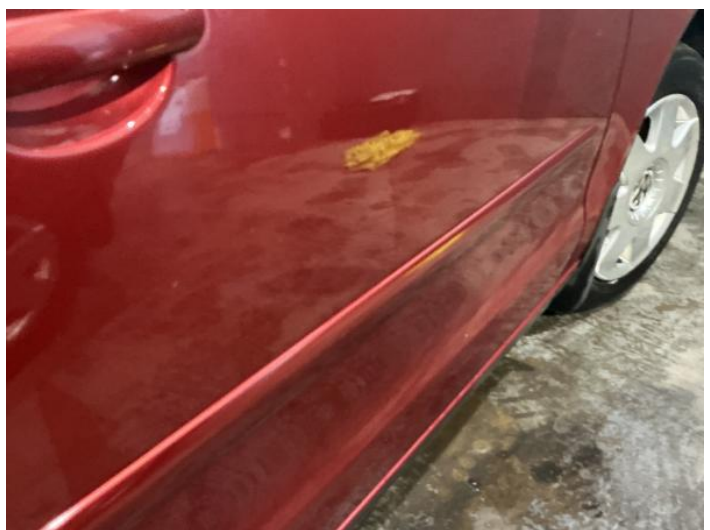
14: Door osf  
Chipped  
1 To 5

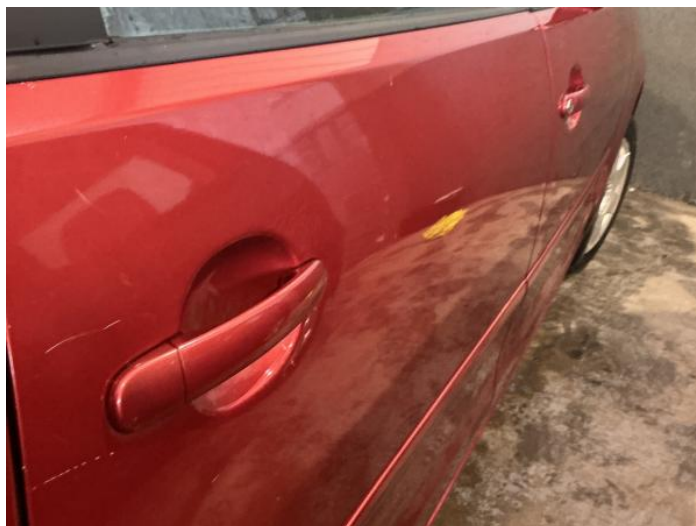
16: Door osr  
Scratched  
Over 25mm Thru Paint

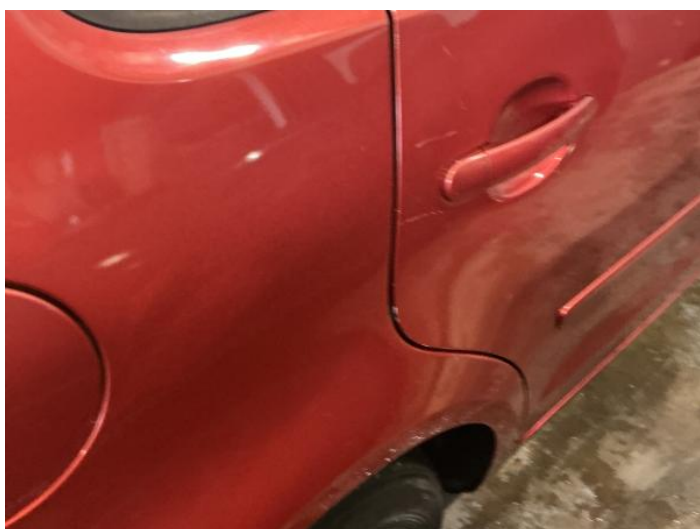
17: Qtr Panel osr  
Dented  
With Paint Damage
