# VEHICLE INSPECTION REPORT

**NU15ZVK**

## Volkswagen UP 1.0 Move Up 3dr

nama  
GRADE  
**3**

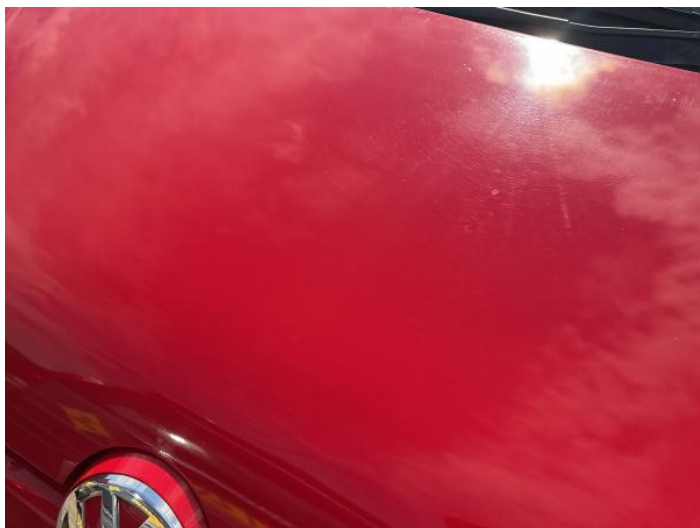
1: Bonnet  
Chipped  
1 To 5

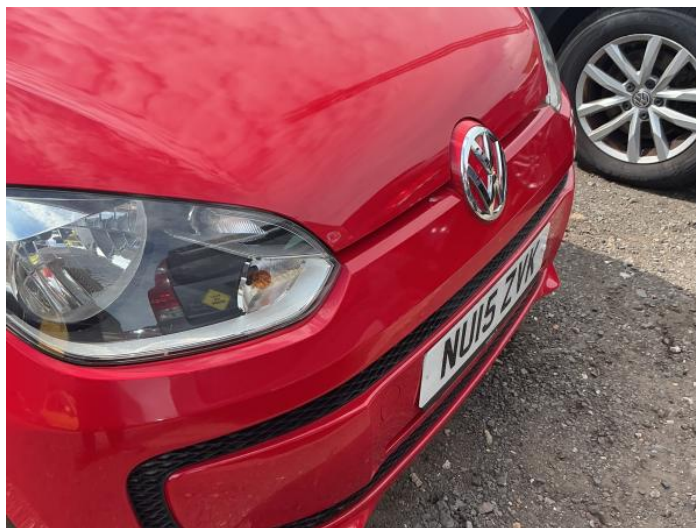
2: Bumper Front  
Chipped  
Multiple Chips

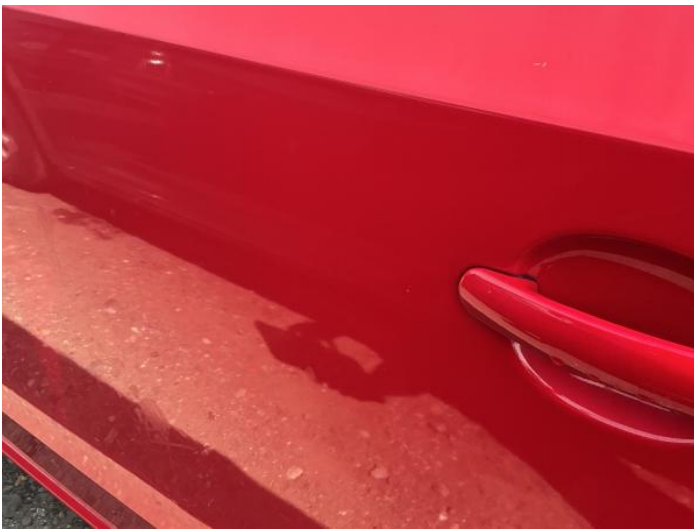
5: Door nsf  
Poor Previous Repair  
Poor Paint

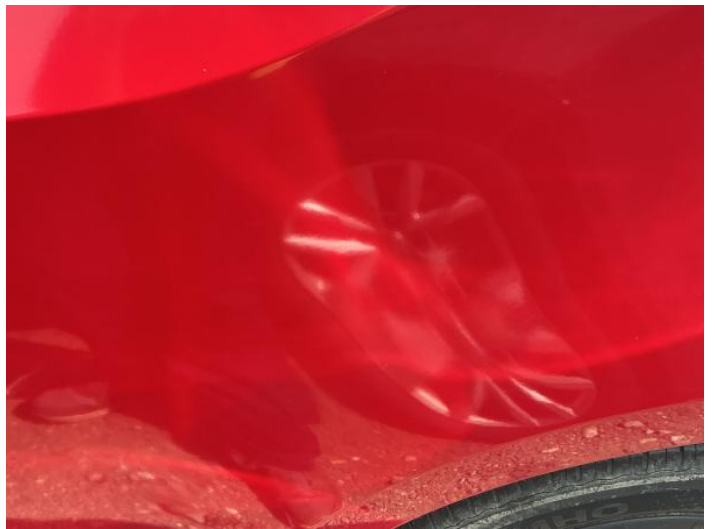
6: Qtr Panel nsr  
Poor Previous Repair  
Poor Paint

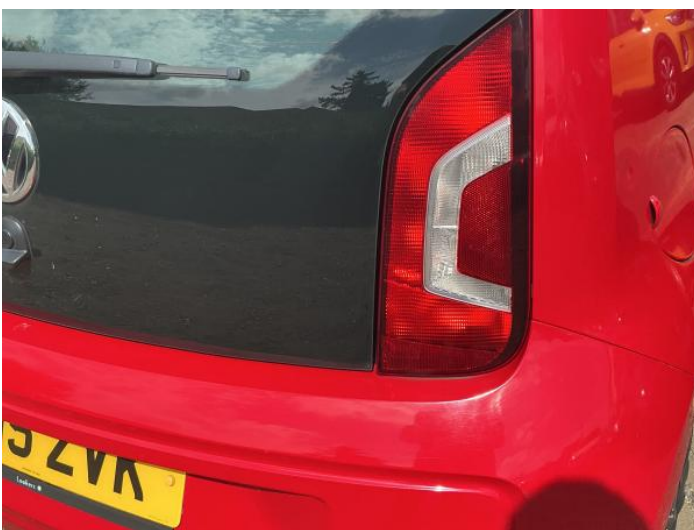
7: Bumper Rear  
Chipped  
Multiple Chips

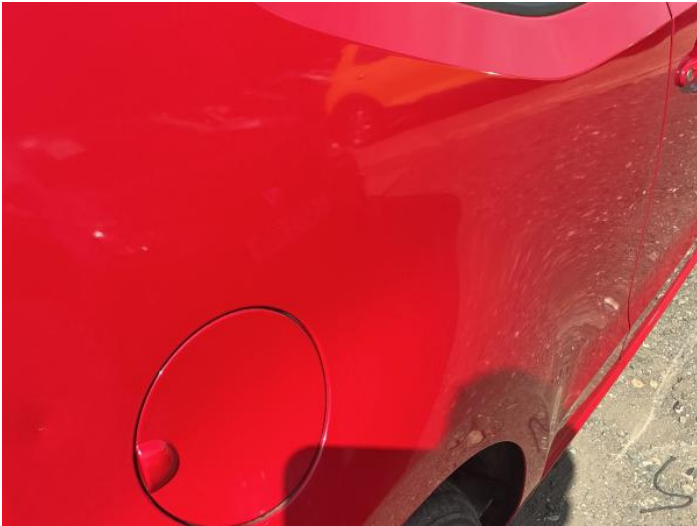
9: Qtr Panel osr  
Dented  
2 Or Less UpTo 10mm

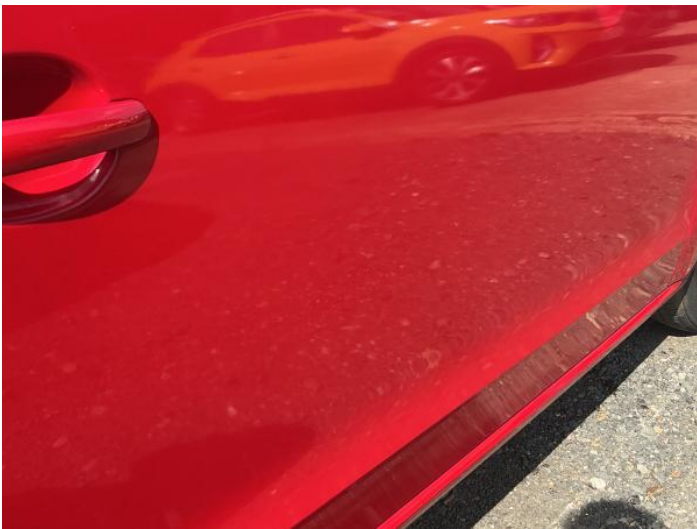
11: Door osf  
Chipped  
1 To 5
