# **VEHICLE INSPECTION REPORT**

**GU68CLN**

## Nissan Leaf 110kW N-Connecta 40kWh 5dr Auto

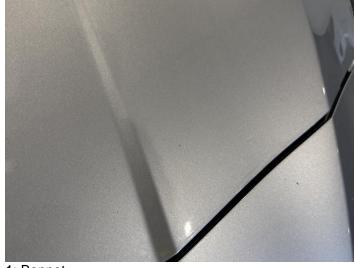
1: Bonnet Chipped 1 To 5

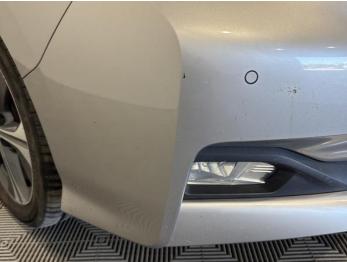
2: Bumper Front Scratched 25 to 100mm Thru Paint

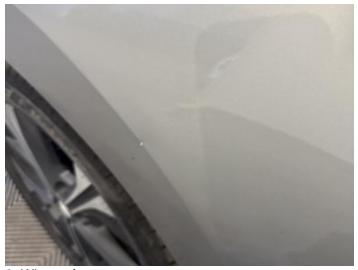
3: Wing nsf Dented Between 10mm + 30mm

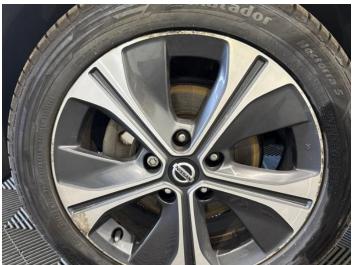
4: Wheel nsf Scratched Over 50mm

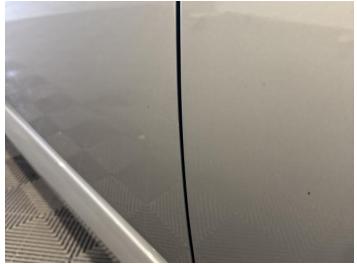
5: Door nsf Chipped Edge Chip

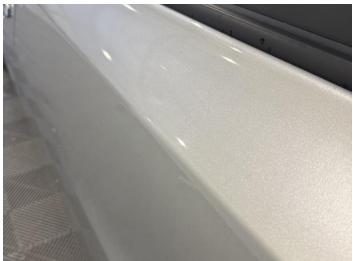
6: Door nsr Dented Over 30mm

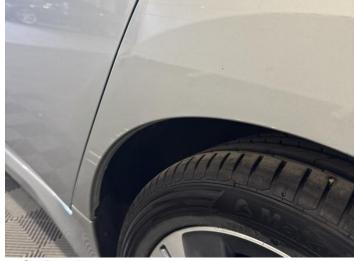
7: Qtr Panel nsr Scratched Over 25mm Thru Paint

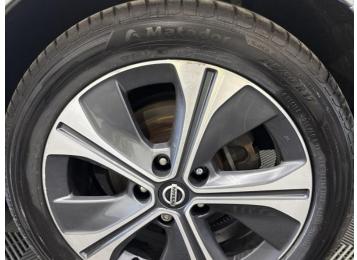
8: Wheel nsr Scratched Over 50mm

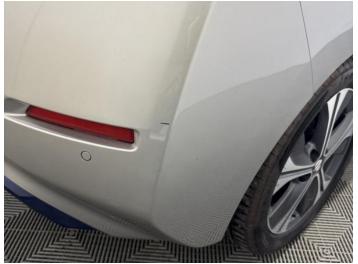
9: Bumper Rear Scratched Over 100mm Thru Paint

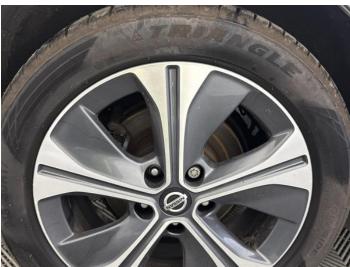
10: Wheel osr Scratched Over 50mm

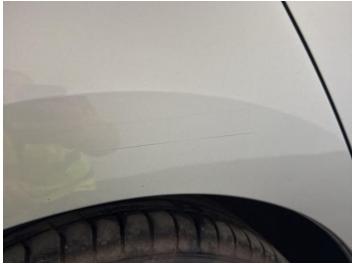
11: Qtr Panel osr Scratched Over 25mm Thru Paint

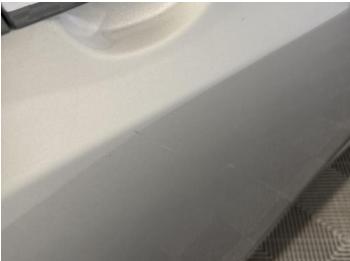
12: Door osr Scratched Over 25mm Thru Paint

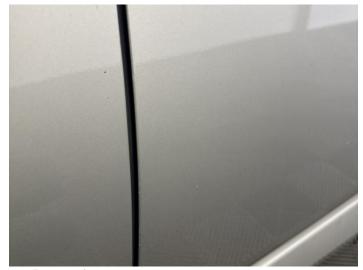
13: Door osf Chipped Edge Chip

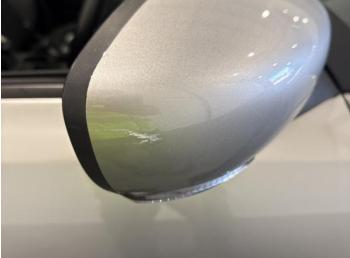
14: Door Mirror Assy osf Scratched (Painted) Over 25mm Thru Paint

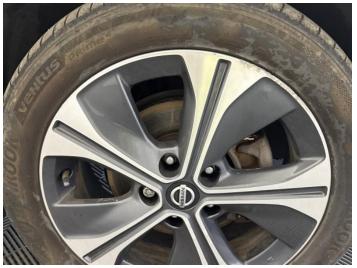
15: Wheel osf Scratched Over 50mm

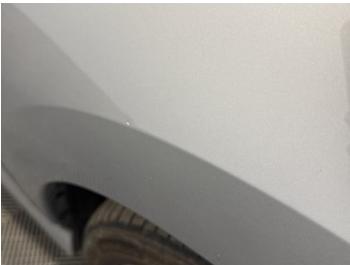
16: Wing osf Dented Between 10mm + 30mm

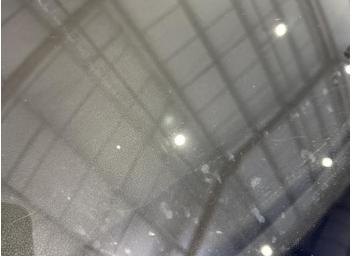
17: Screen Front Chipped UpTo 10mm

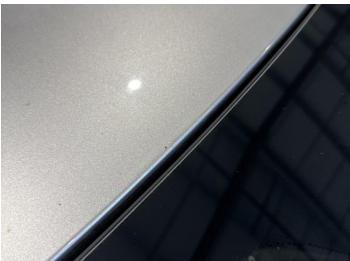
18: Roof Chipped Edge Chip
