# VEHICLE INSPECTION REPORT

**GU19BKD**

## Skoda Kodiaq 1.5 TSI SE 5dr DSG [7 Seat]

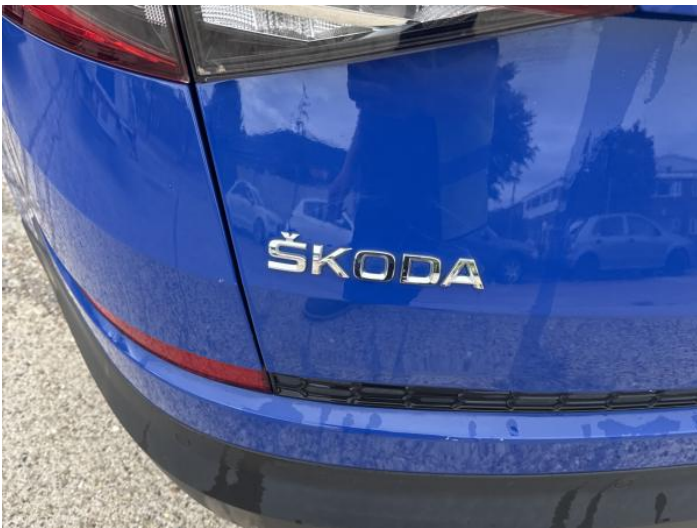
1: Bumper Rear  
Scratched  
25 to 100mm Thru Paint

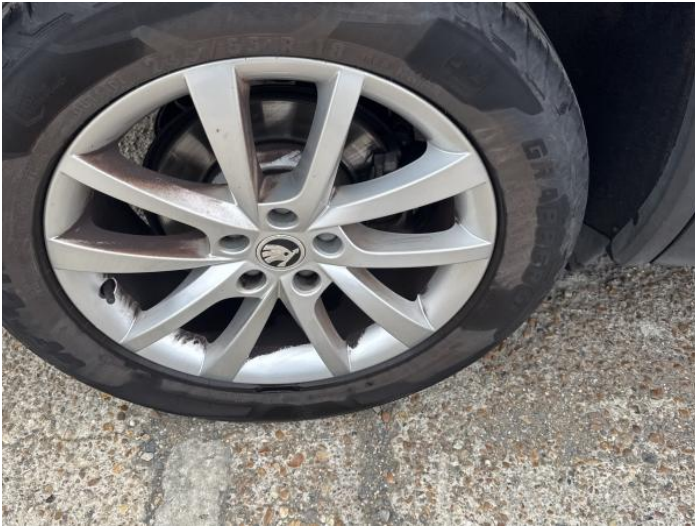
3: Wheel osr  
Scratched  
Up To 50mm

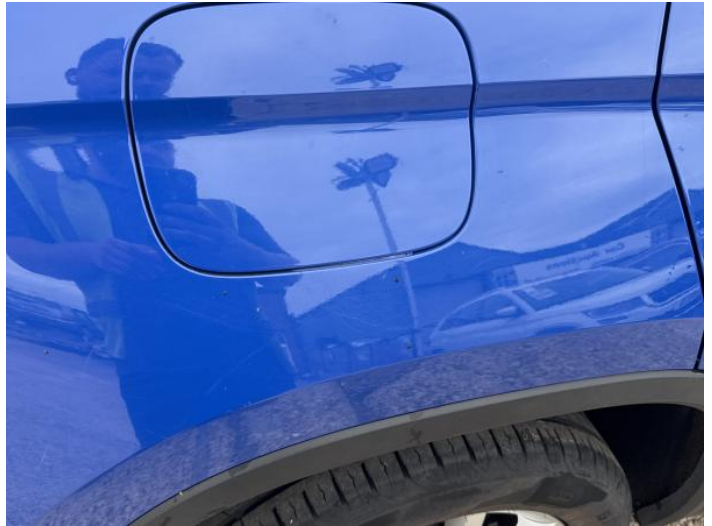
4: Qtr Panel osr  
Scratched  
Over 25mm Thru Paint

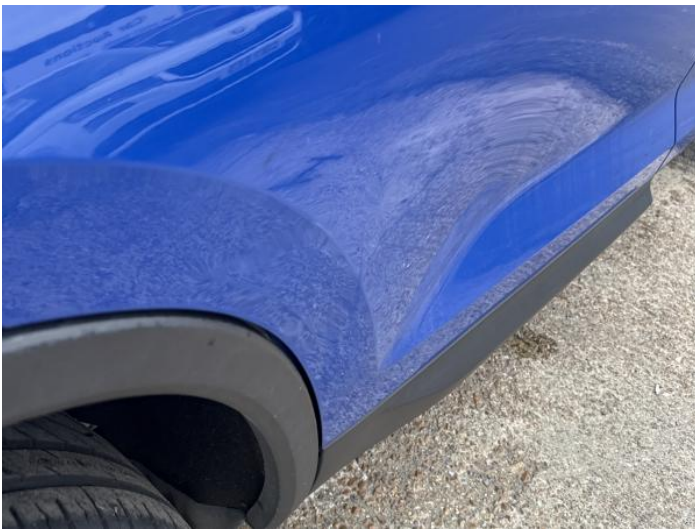
5: Door osr  
Dented  
With Paint Damage

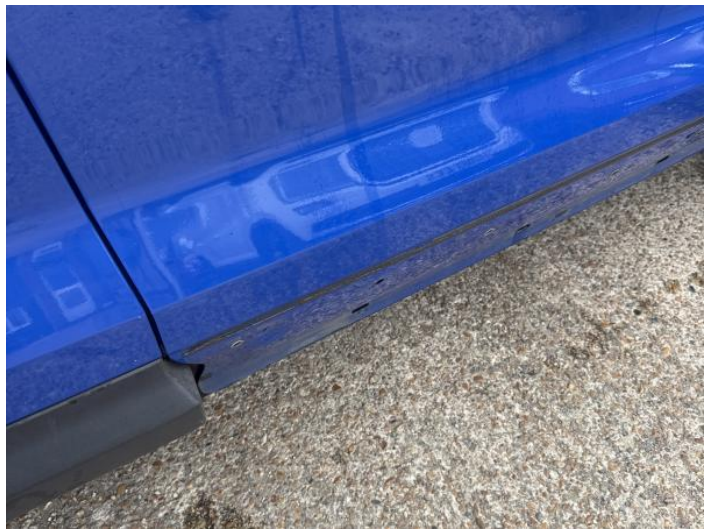
6: Door osf  
Dented  
Over 30mm

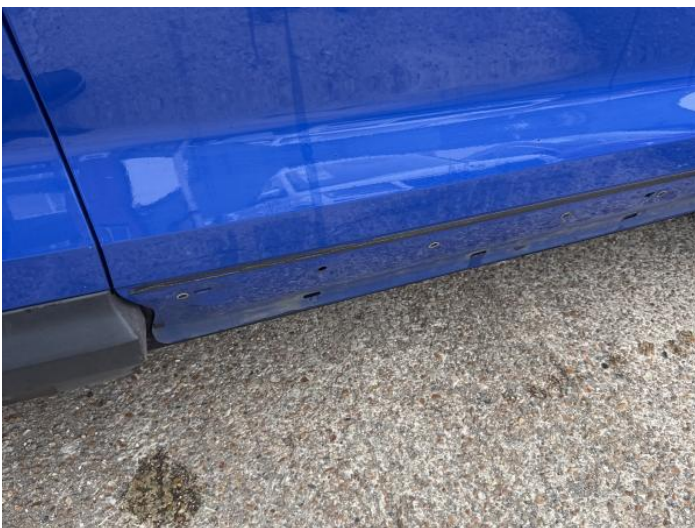
7: Door Moulding osf  
Missing  
Replace

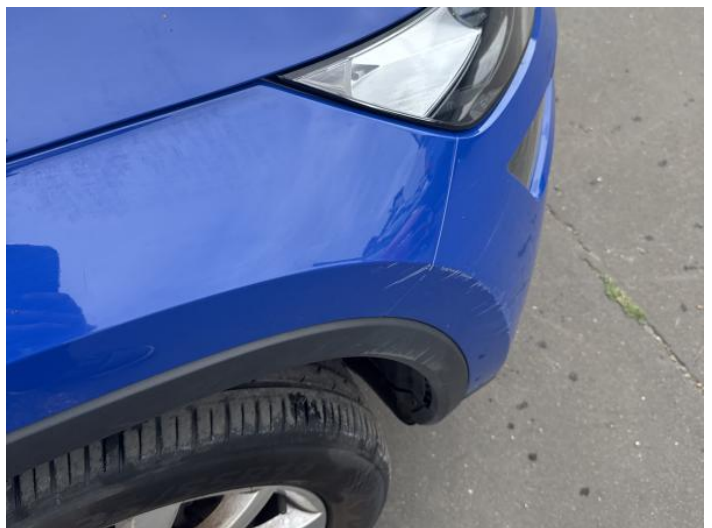
8: Wing osf  
Scratched  
Over 25mm Thru Paint

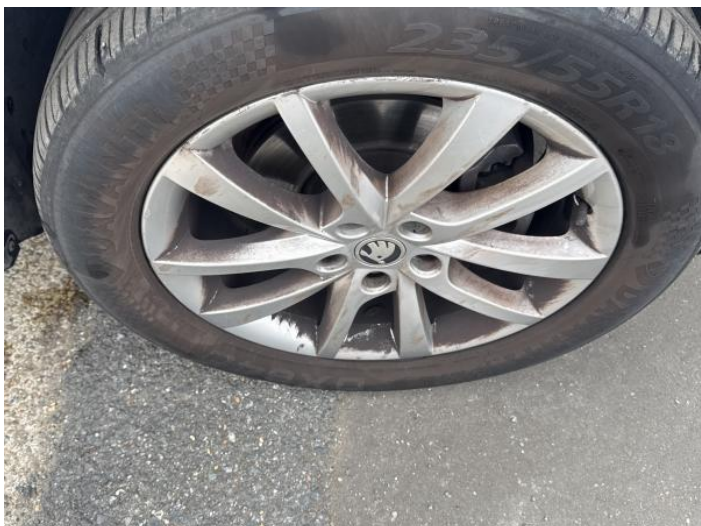
9: Wheel osf  
Scratched  
Over 50mm

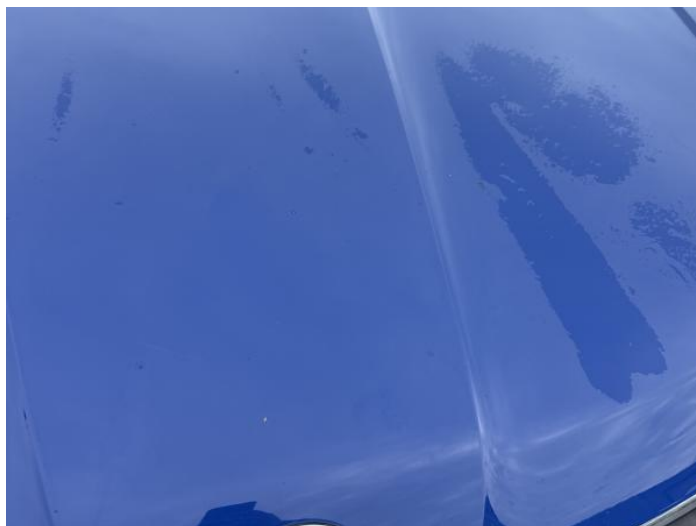
10: Bonnet  
Chipped  
1 To 5

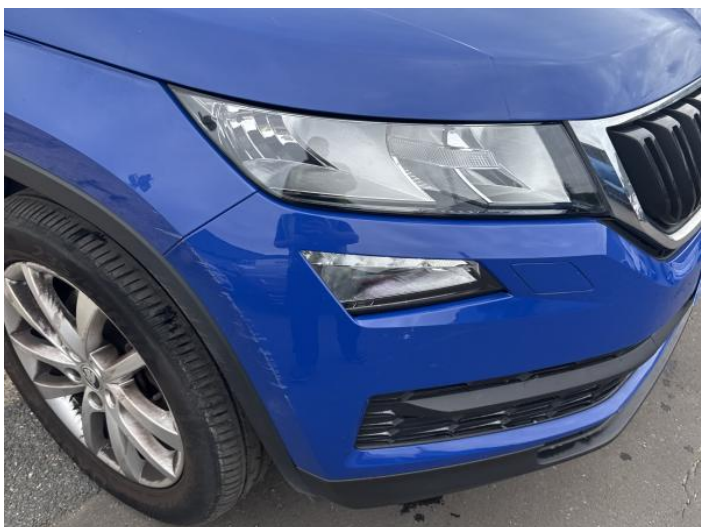
11: Bumper Front  
Scratched  
Over 100mm Thru Paint

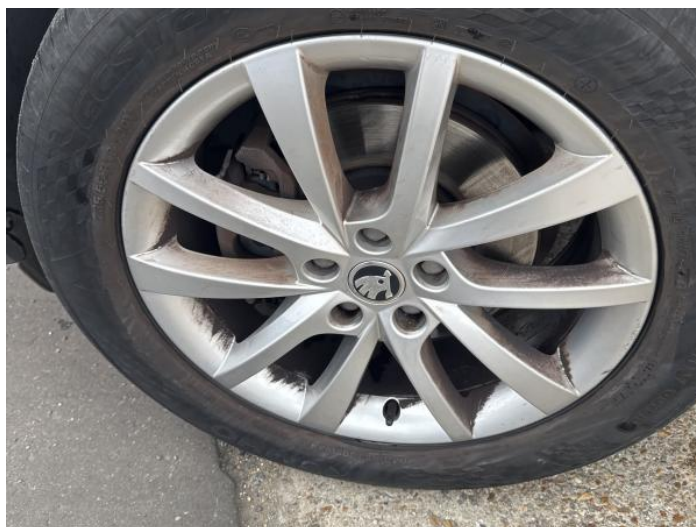
12: Wheel nsf  
Scratched  
Over 50mm

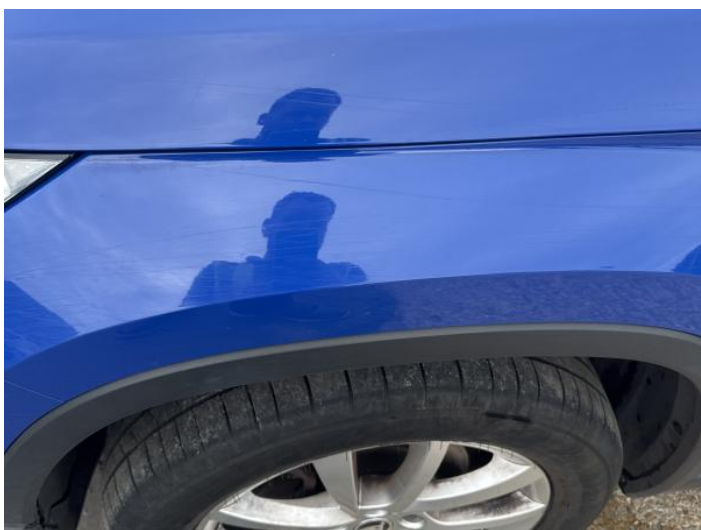
13: Wing nsf  
Chipped  
1 To 5

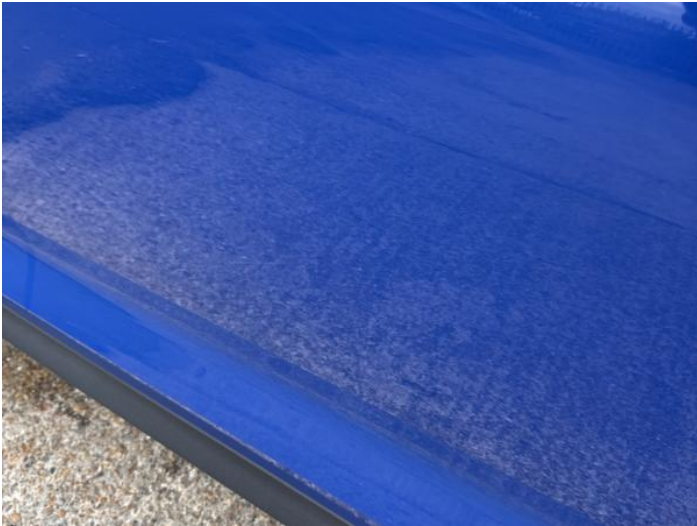
15: Door nsf  
Dented  
Over 2 UpTo 10mm

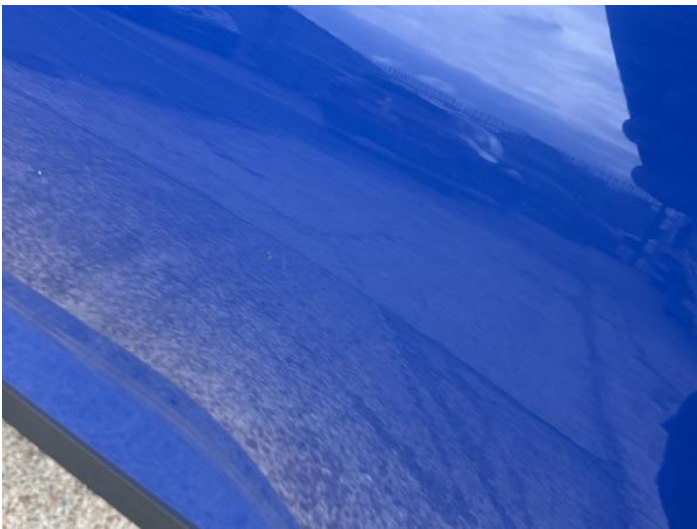
17: Door nsr  
Dented  
2 Or Less UpTo 10mm

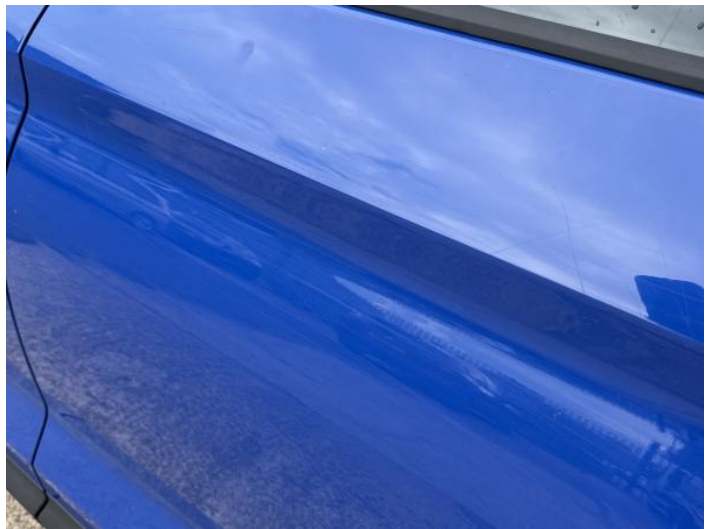
18: Door nsr  
Chipped  
1 To 5

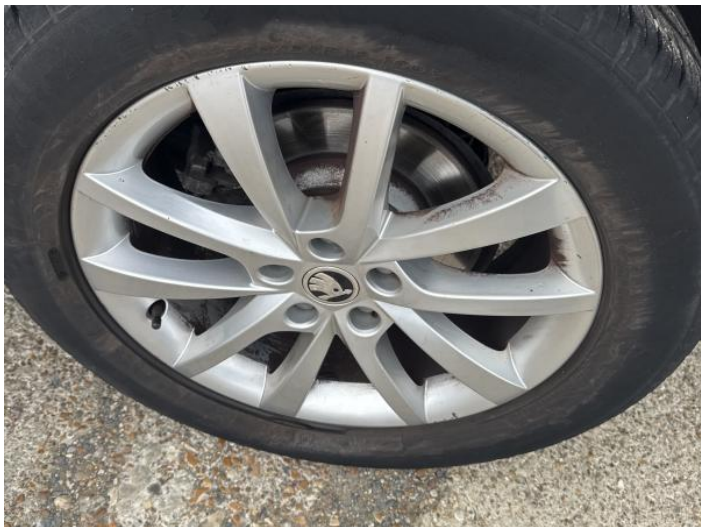
21: Wheel nsr  
Scratched  
Up To 50mm
