VEHICLE INSPECTION REPORT

LT61YCX

Mazda 6 2.0 TS2 5dr

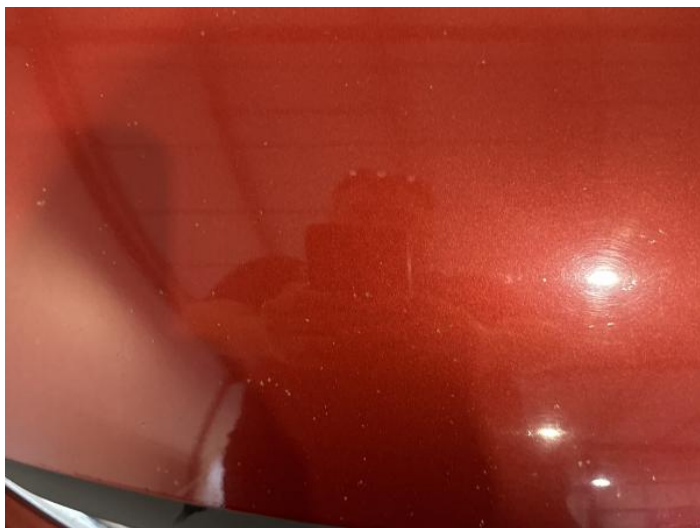
1: Bonnet
Chipped
Multiple Chips

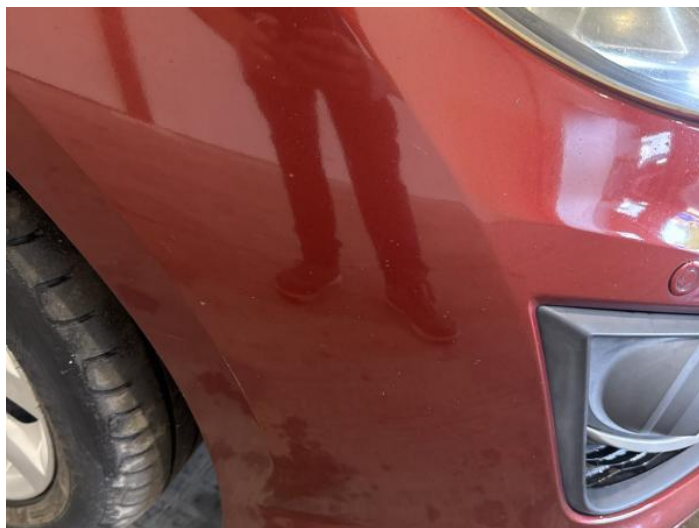
2: Bumper Front
Scratched
Over 100mm Thru Paint

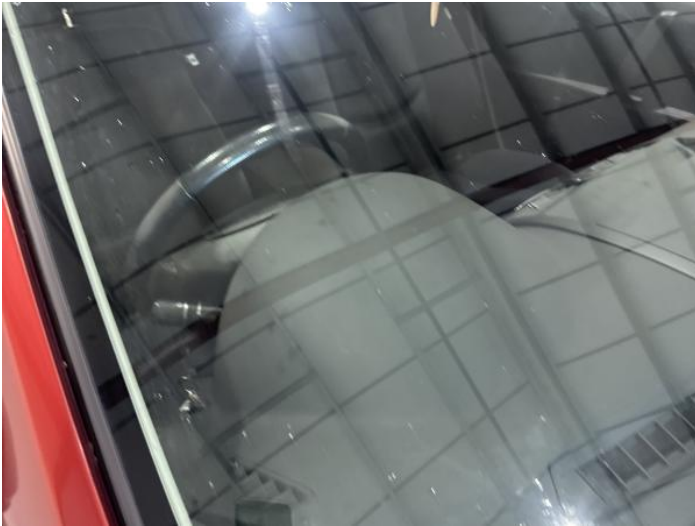
3: Screen Front
Chipped
UpTo 10mm

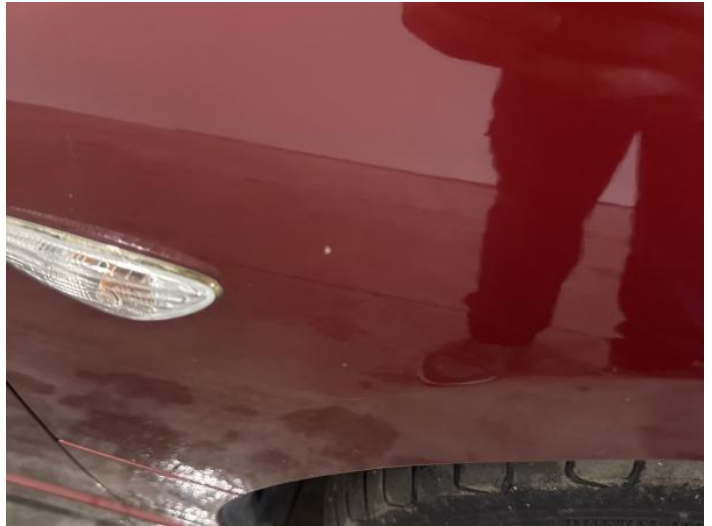
4: Wing osf
Chipped
1 To 5

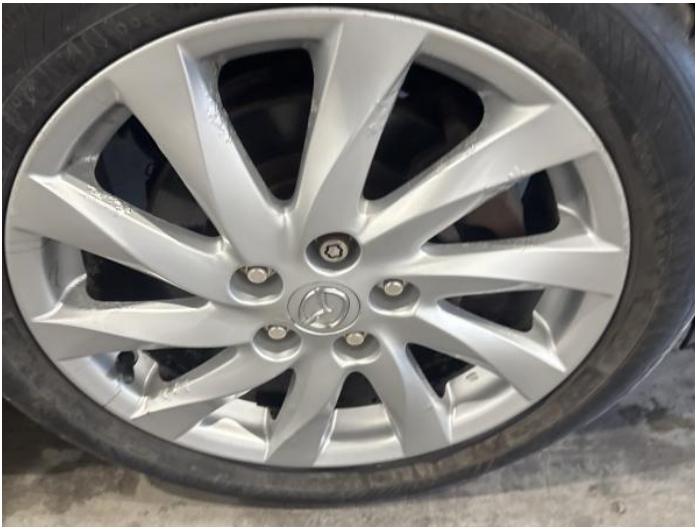
5: Wheel osf
Corroded
Light

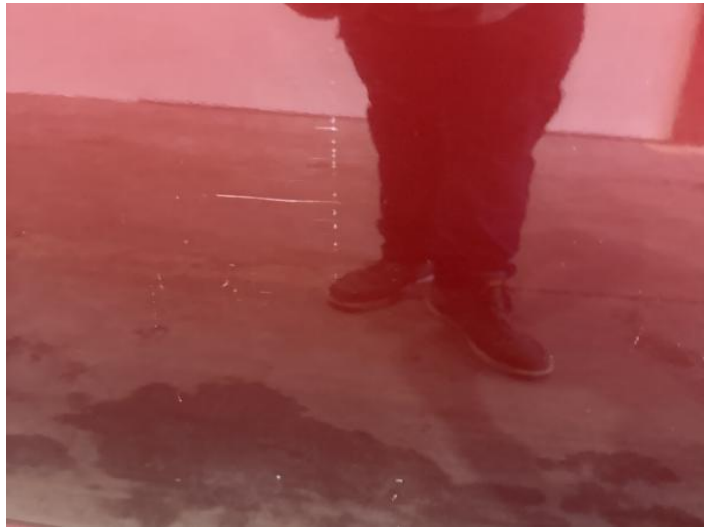
6: Door osf
Scratched
Over 25mm Thru Paint

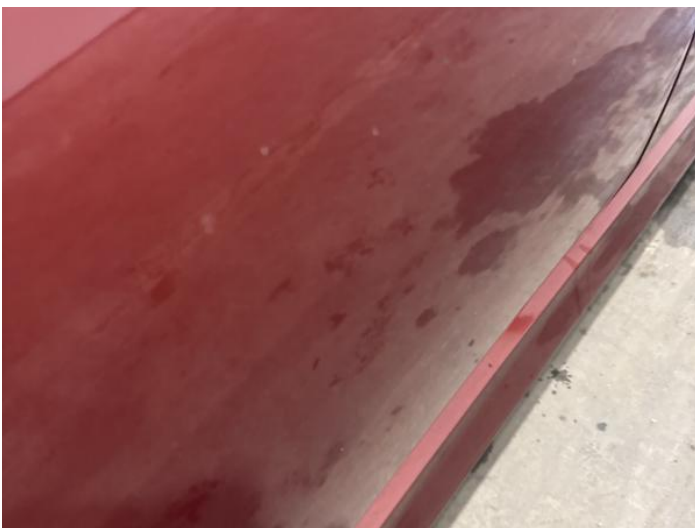
7: Door osr
Chipped
1 To 5

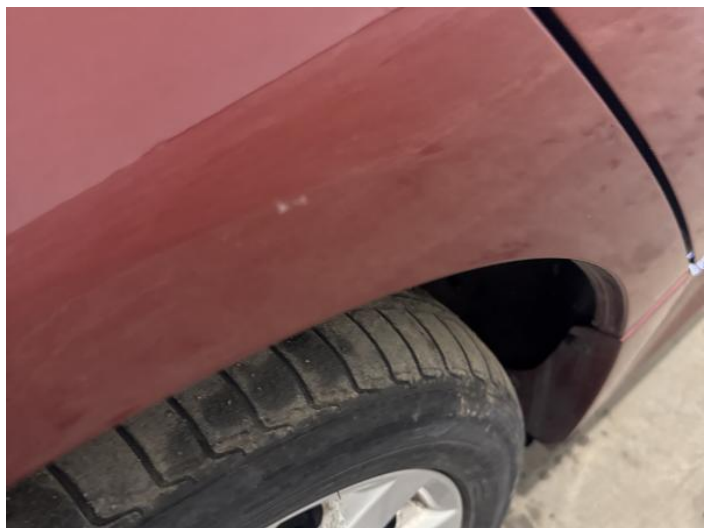
8: Qtr Panel osr
Chipped
1 To 5

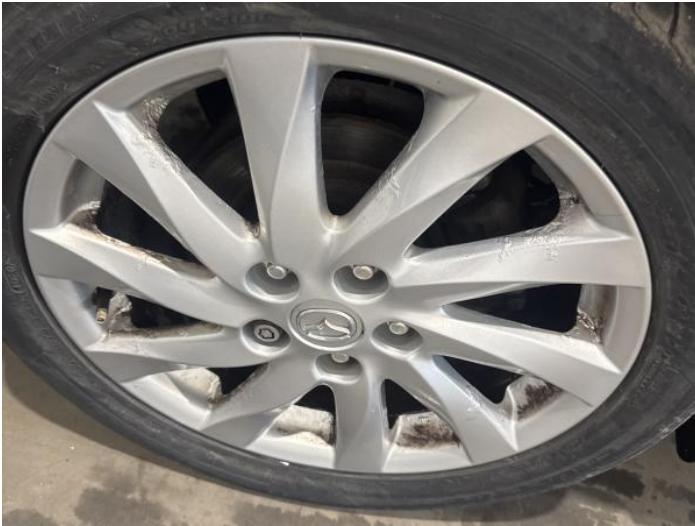
9: Wheel osr
Corroded
Light

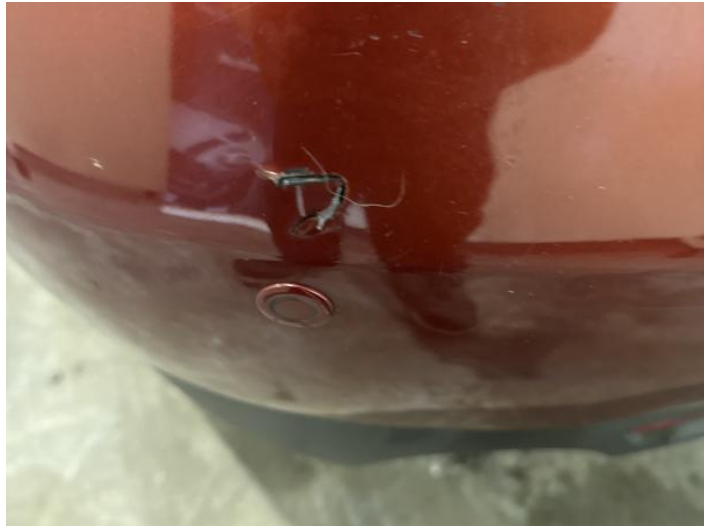
10: Bumper Rear
Cracked
UpTo 25mm

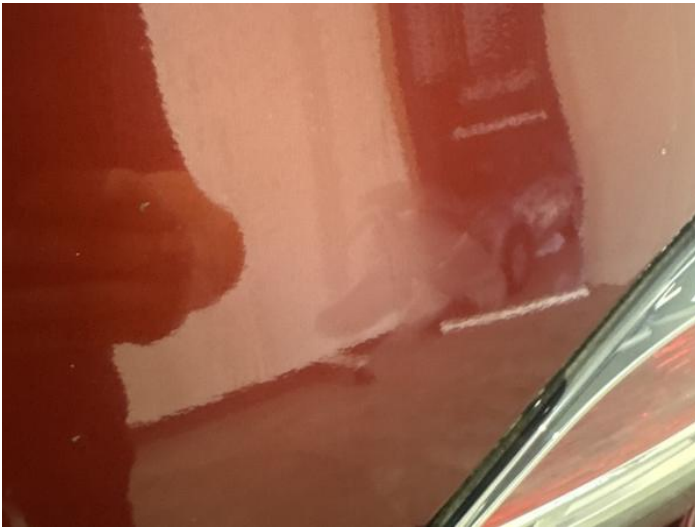
11: Boot Lid
Chipped
1 To 5

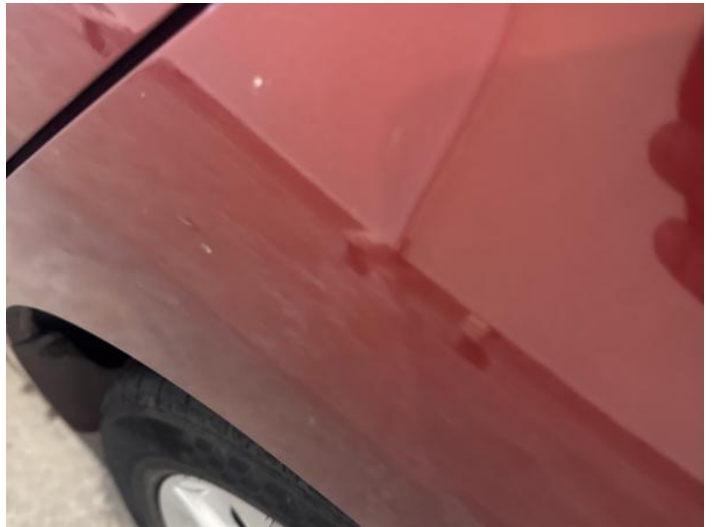
12: Qtr Panel nsr
Chipped
1 To 5

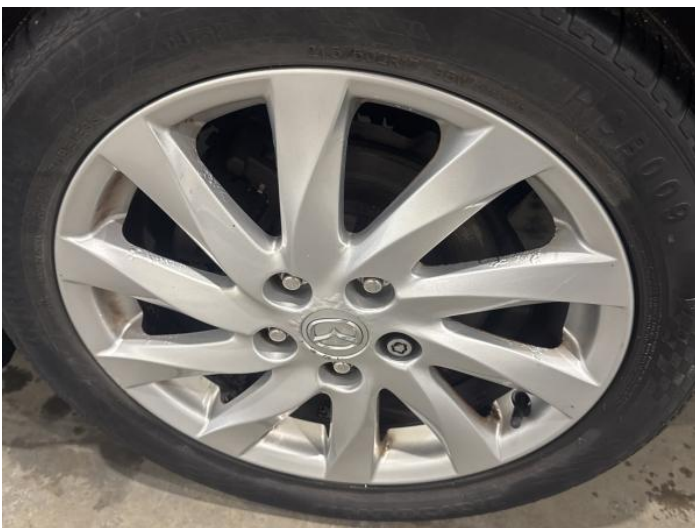
13: Wheel nsr
Corroded
Light

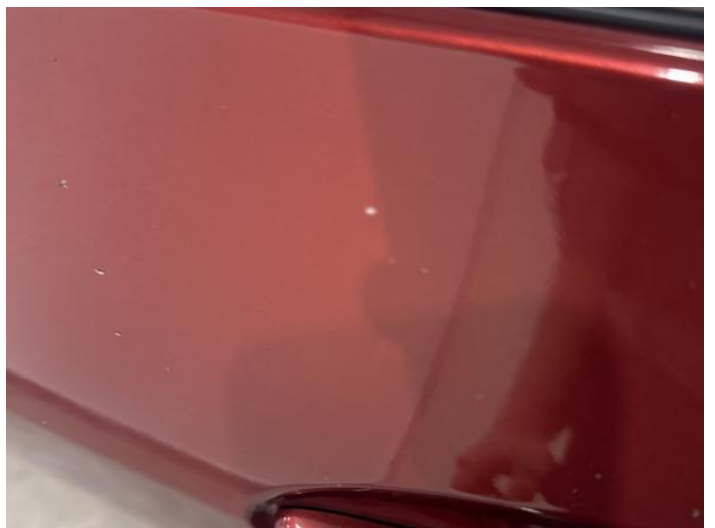
14: Door nsr
Chipped
1 To 5

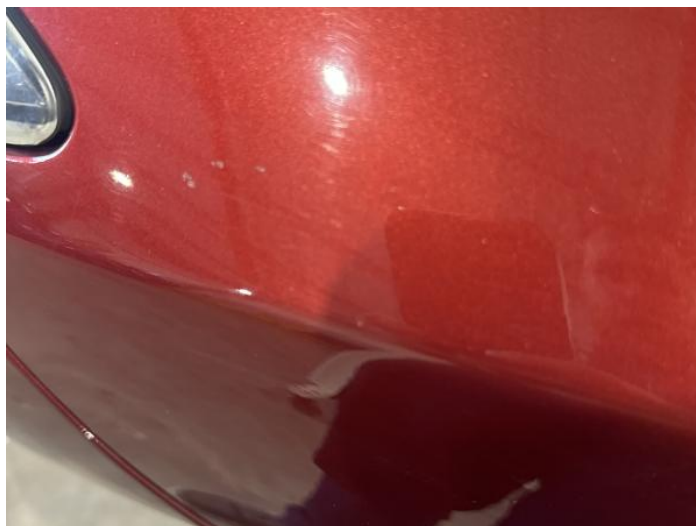
15: Door nsf
Scratched
UpTo 25mm Not Thru Paint

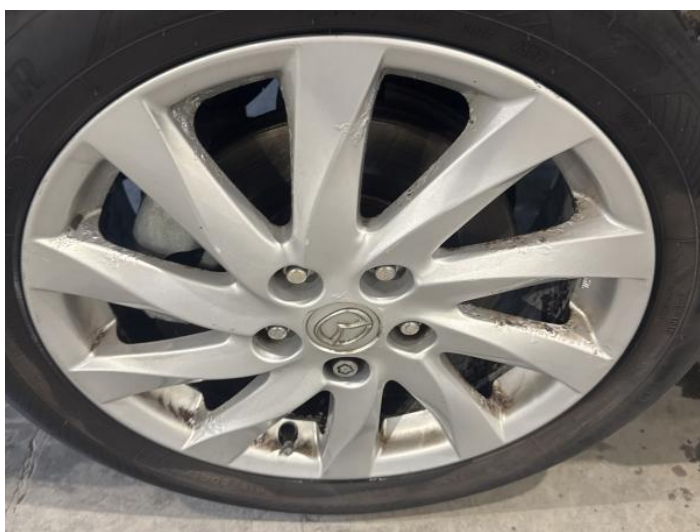
17: Wheel nsf
Corroded
Light
