# VEHICLE INSPECTION REPORT

AK12ZBX

## Ford Fiesta 1.25 Zetec 5dr [82]

nama  
GRADE  
4

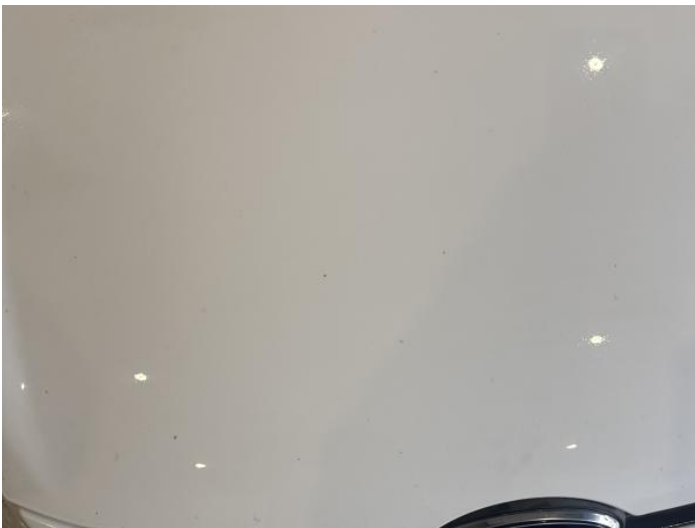
1: Bonnet  
Chipped  
1 To 5

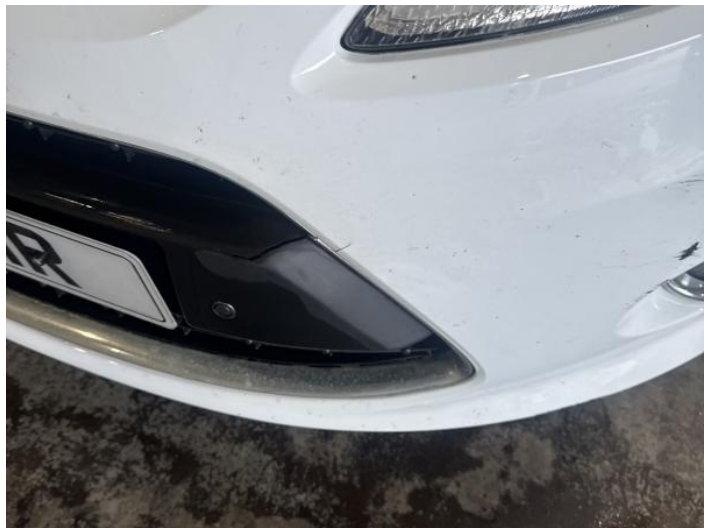
2: Bumper Front  
Cracked  
UpTo 25mm

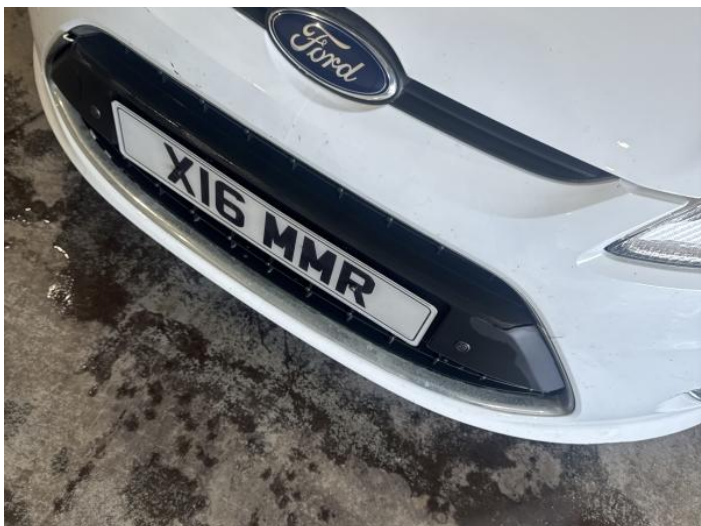
3: Bumper Front Moulding  
Broken  
Replace

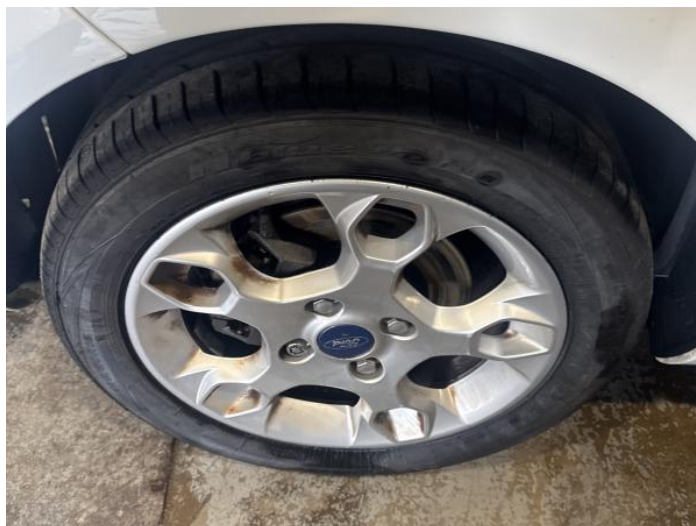
4: Wheel nsf  
Scratched  
Up To 50mm

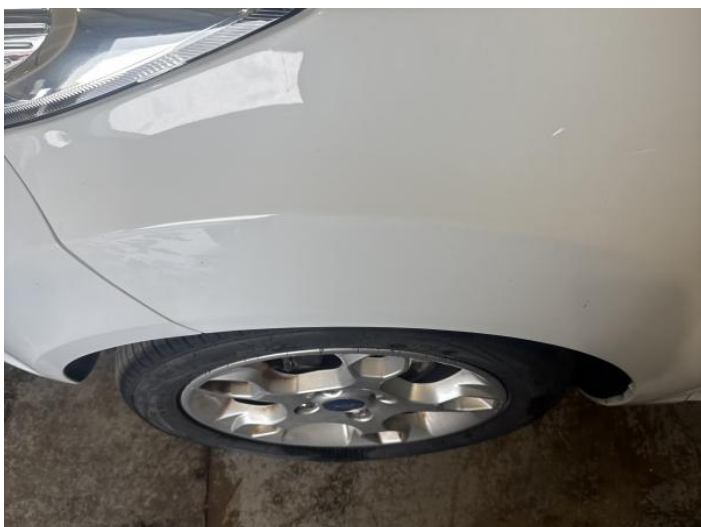
5: Wing nsf  
Chipped  
1 To 5

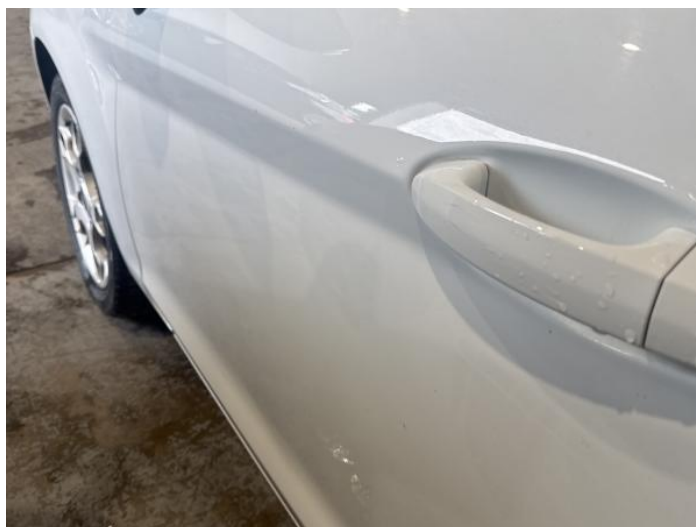
6: Door nsf  
Chipped  
1 To 5

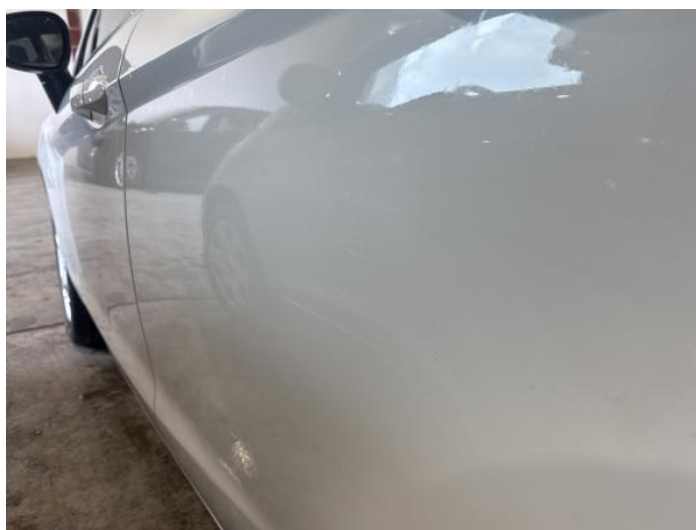
8: Door nsr  
Chipped  
1 To 5

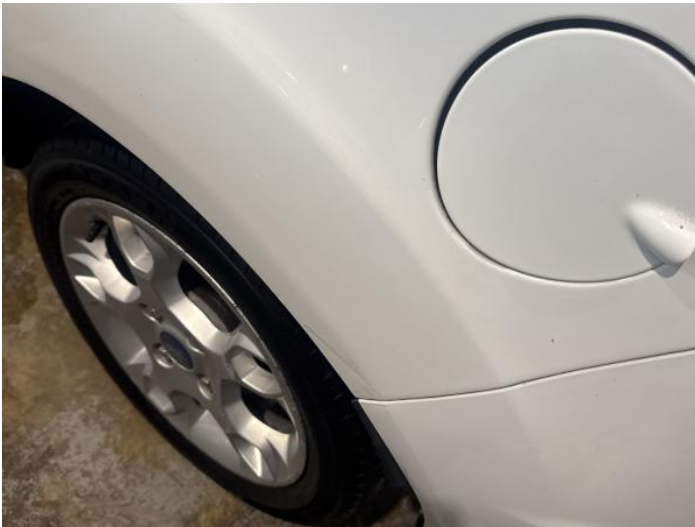
11: Qtr Panel nsr  
Dented  
With Paint Damage

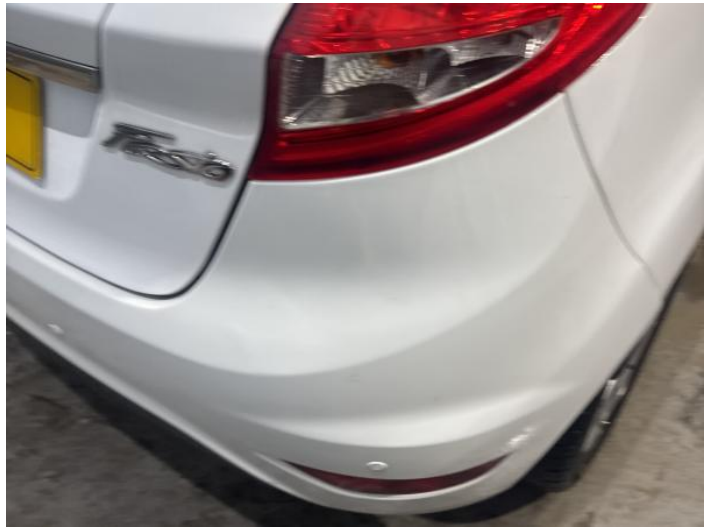
12: Bumper Rear  
Poor Previous Repair  
Poor Colour

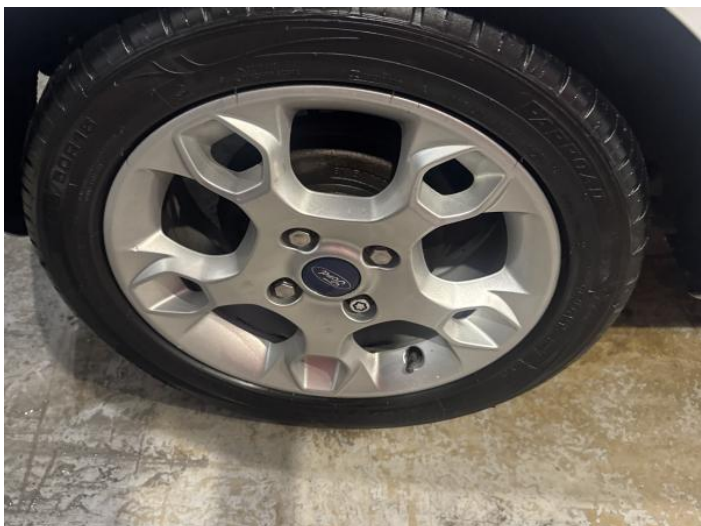
15: Wheel osr  
Scratched  
Over 50mm

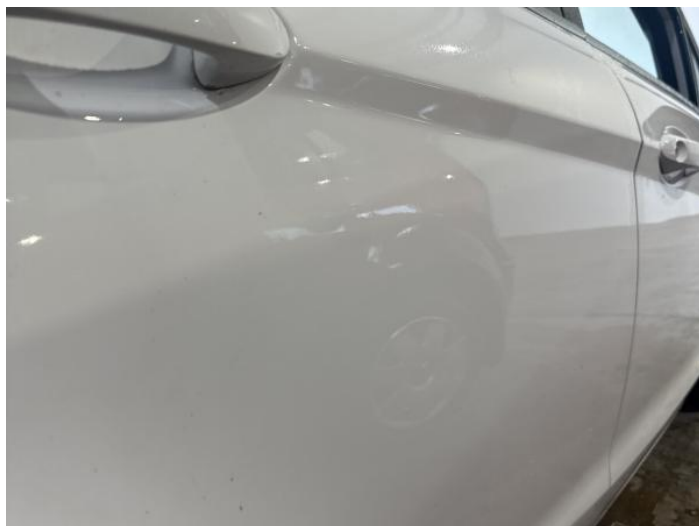
16: Door osr  
Chipped  
1 To 5

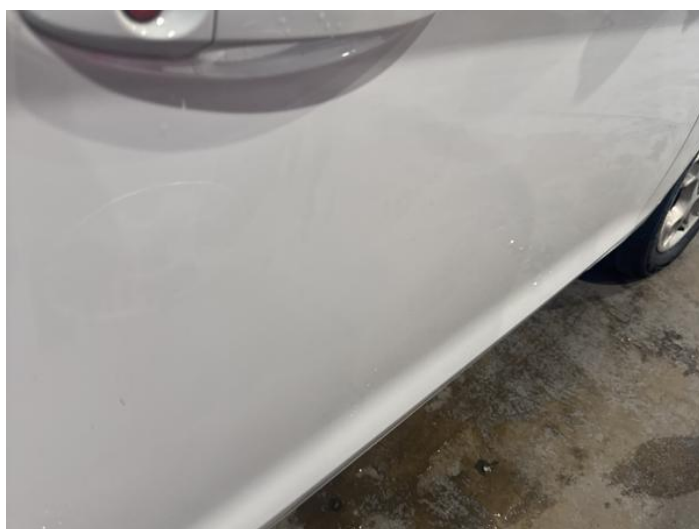
18: Door osf  
Chipped  
1 To 5

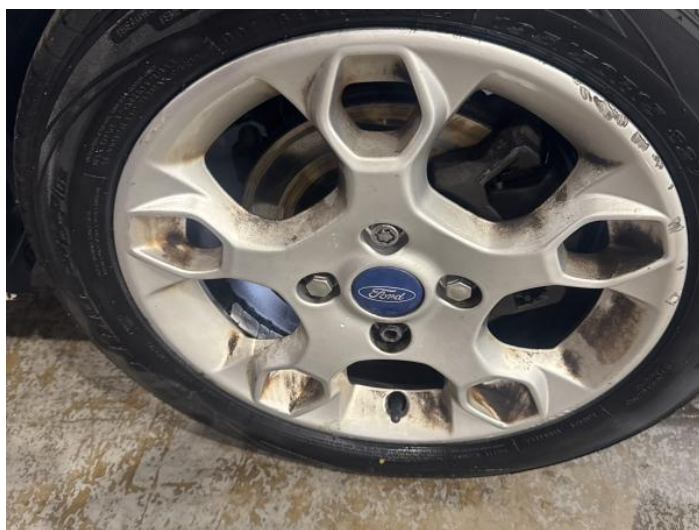
20: Wheel osf  
Scratched  
Over 50mm
