VEHICLE INSPECTION REPORT

LP65KWB

Smart Forfour 1.0 Proxy Premium Plus 5dr

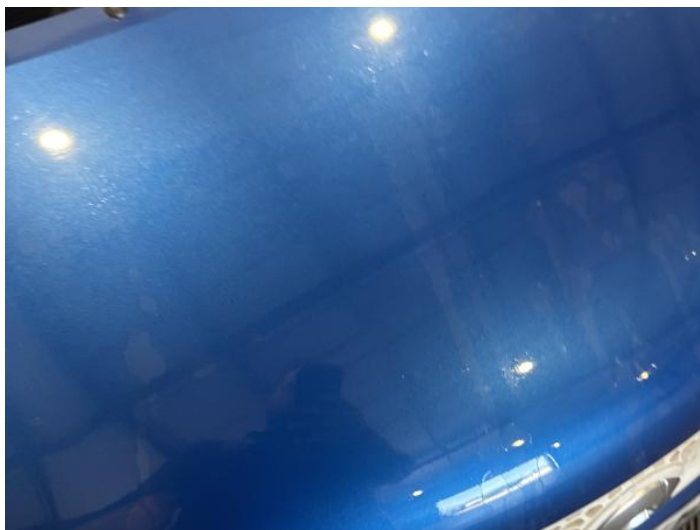
1: Bonnet
Chipped
1 To 5

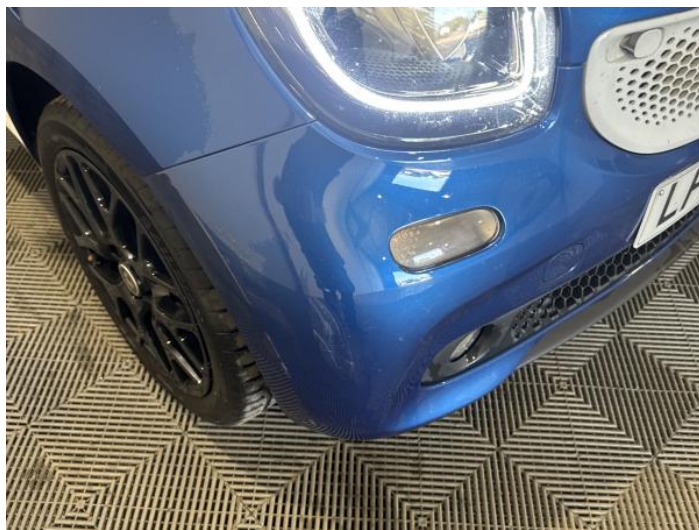
2: Bumper Front
Scratched
25 to 100mm Thru Paint

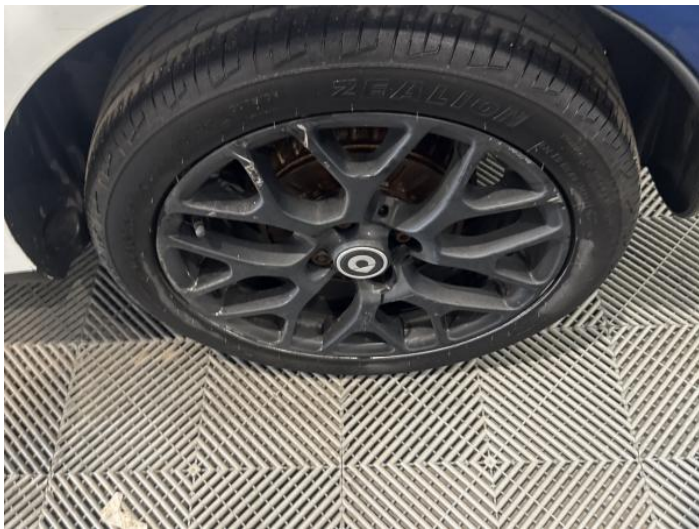
9: Wheel nsr
Scratched
Over 50mm

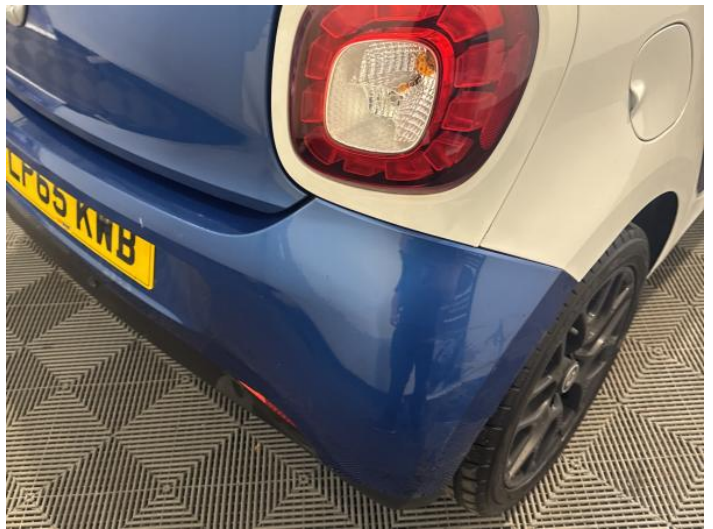
10: Bumper Rear
Scratched
25 to 100mm Thru Paint

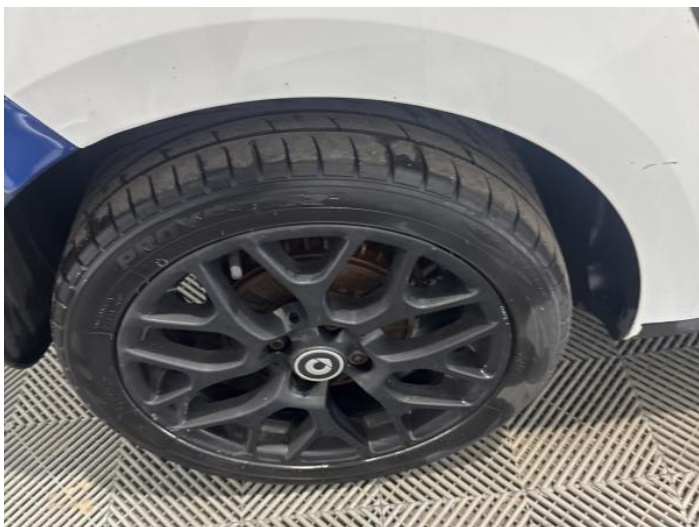
13: Wheel osr
Scratched
Over 50mm

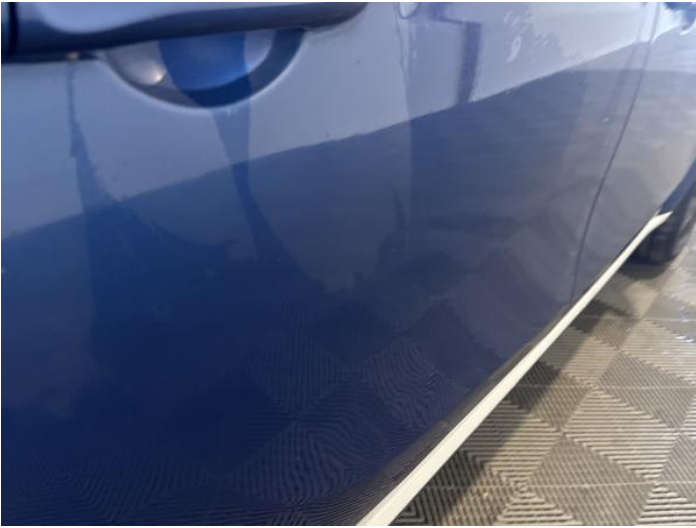
15: Door osr
Chipped
1 To 5

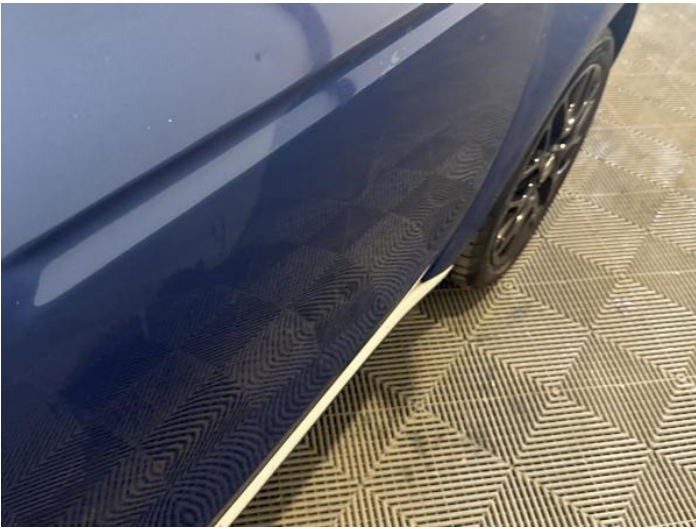
17: Door osf
Dented
Between 10mm + 30mm

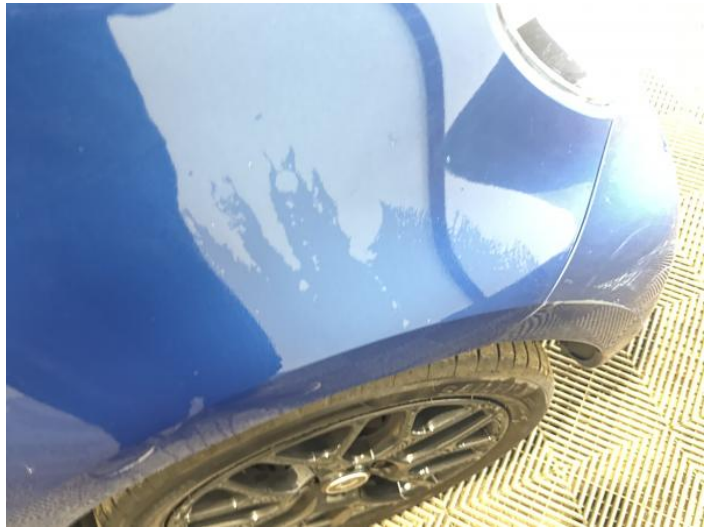
18: Wing nsf
Chipped
1 To 5

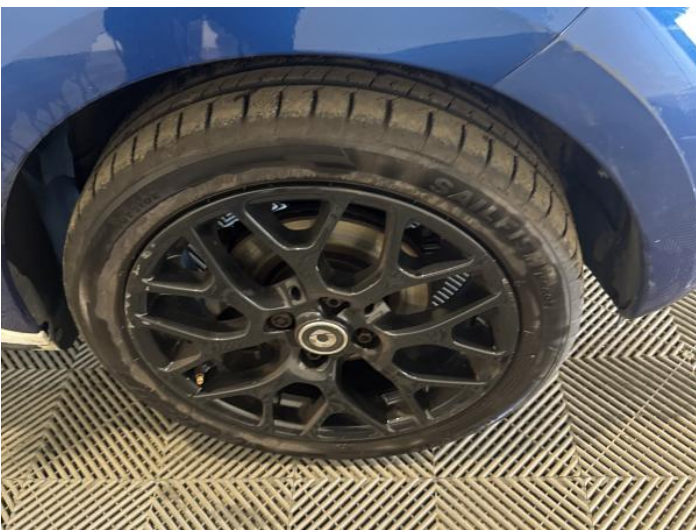
19: Wheel osf
Scratched
Over 50mm
