# VEHICLE INSPECTION REPORT

**EK11NZM**

## Ford Kuga 2.0 TDCi 163 Titanium 5dr Powershift

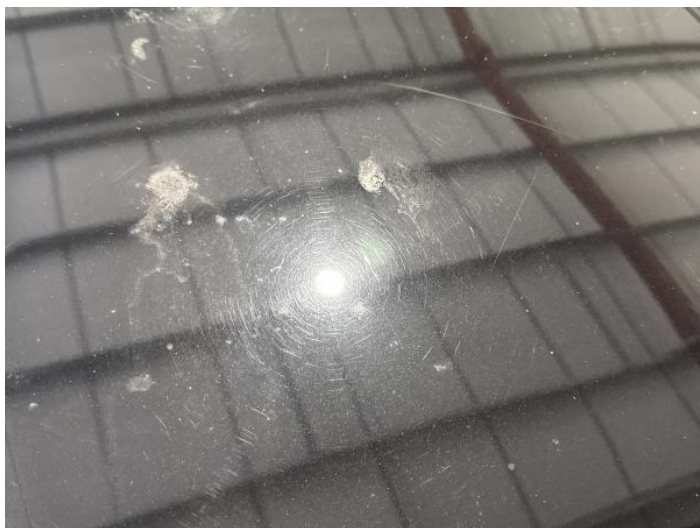
1: Bonnet  
Scratched  
Over 25mm Thru Paint

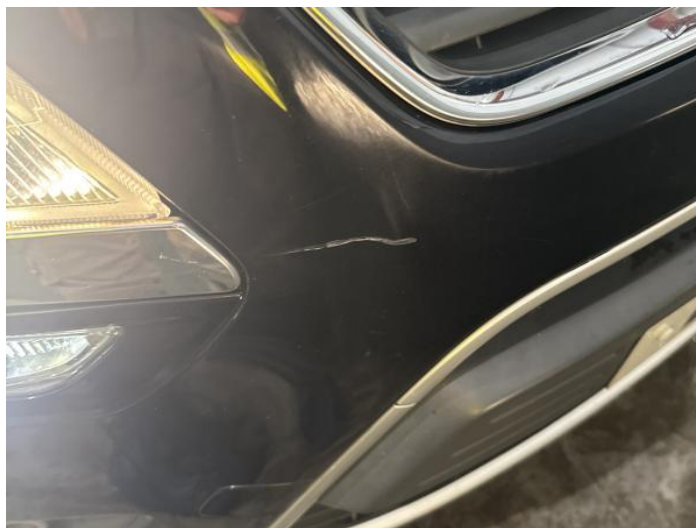
2: Bumper Front  
Scratched  
Over 100mm Thru Paint

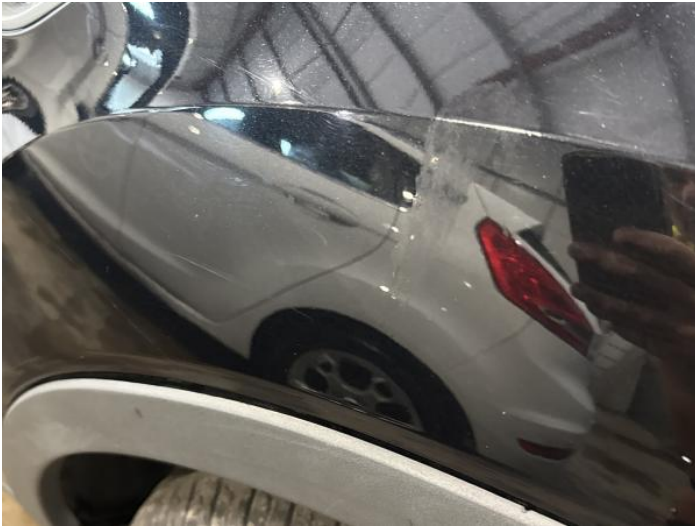
3: Wing osf  
Scratched  
Over 25mm Thru Paint

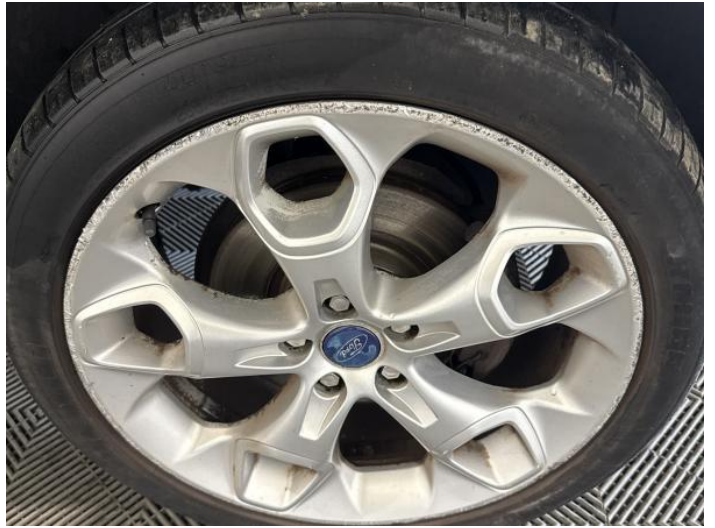
4: Wheel osf  
Scratched  
Over 50mm

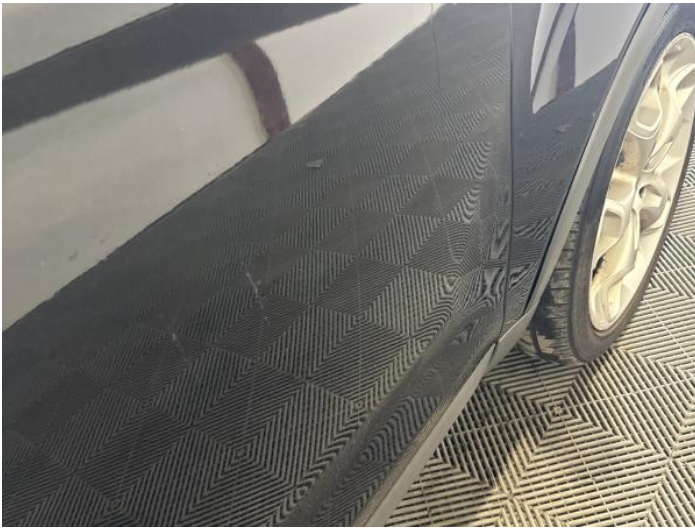
5: Door osf  
Scratched  
Over 25mm Thru Paint

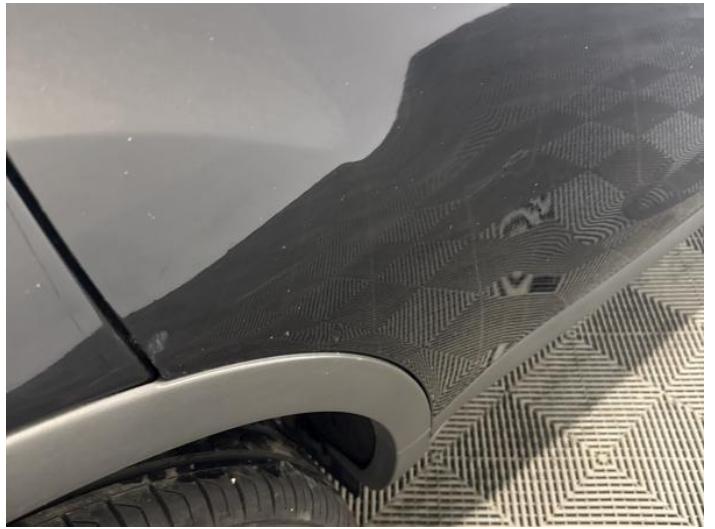
6: Door osr  
Scratched  
Over 25mm Thru Paint

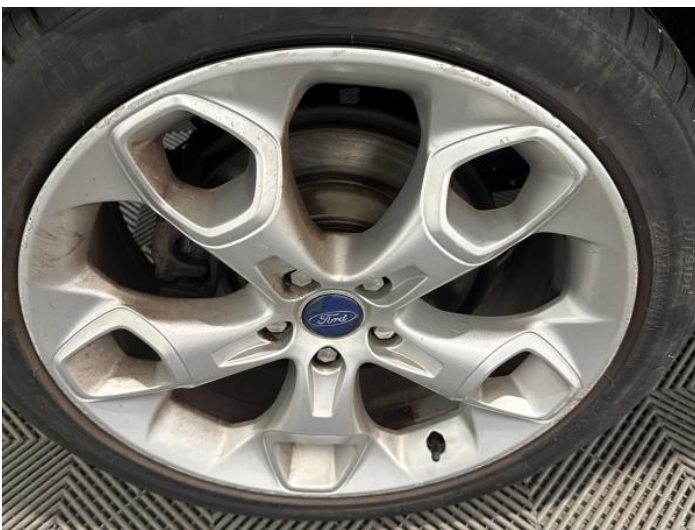
7: Wheel osr  
Scratched  
Over 50mm

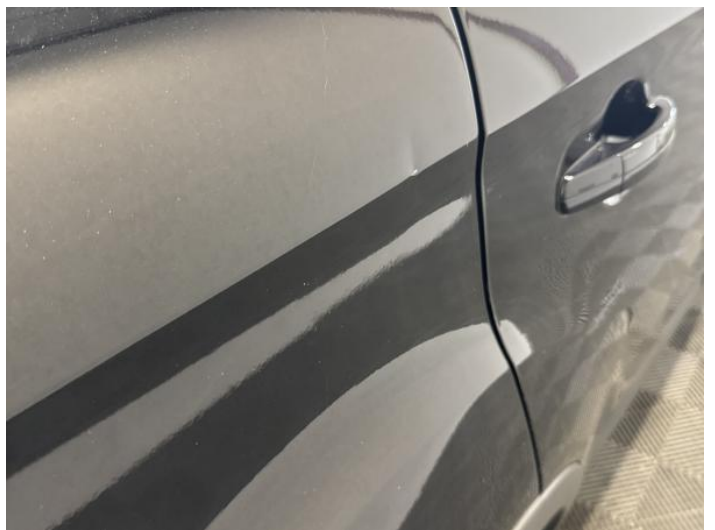
8: Qtr Panel osr  
Dented  
Over 30mm

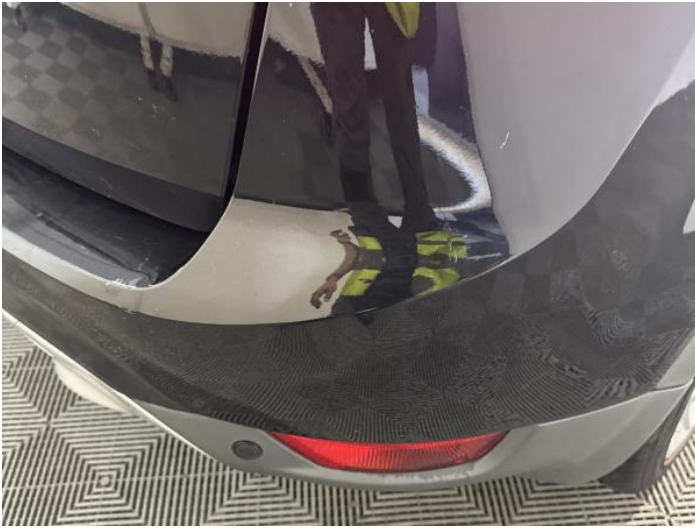
9: Bumper Rear  
Scratched  
Over 100mm Thru Paint

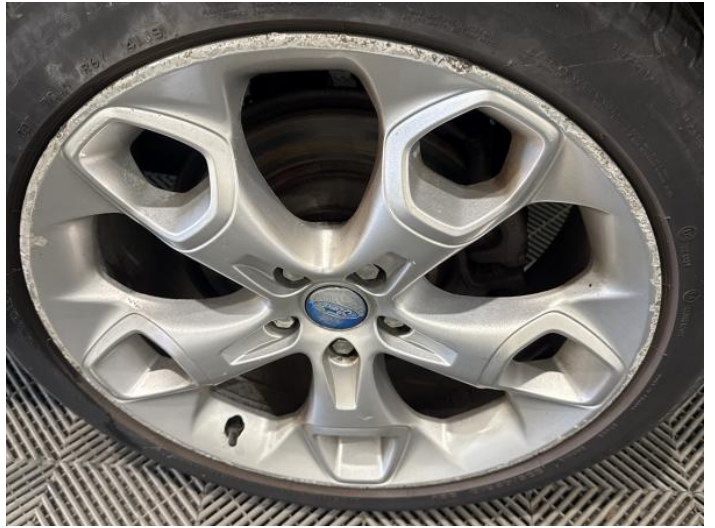
10: Wheel nsr  
Scratched  
Over 50mm

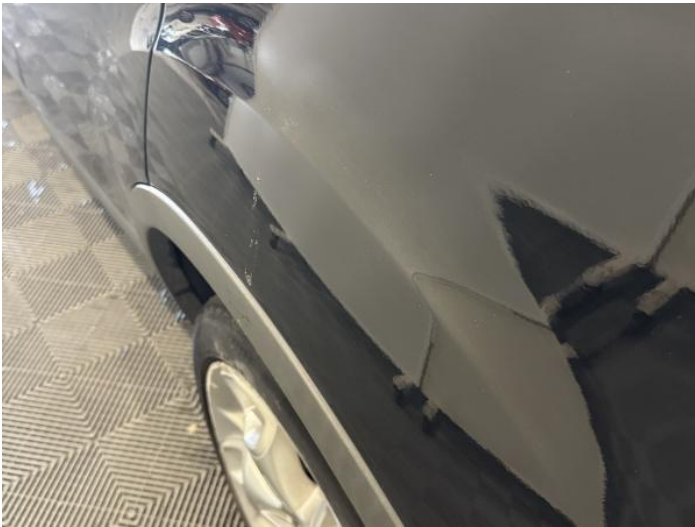
11: Qtr Panel nsr  
Scratched  
Over 25mm Thru Paint

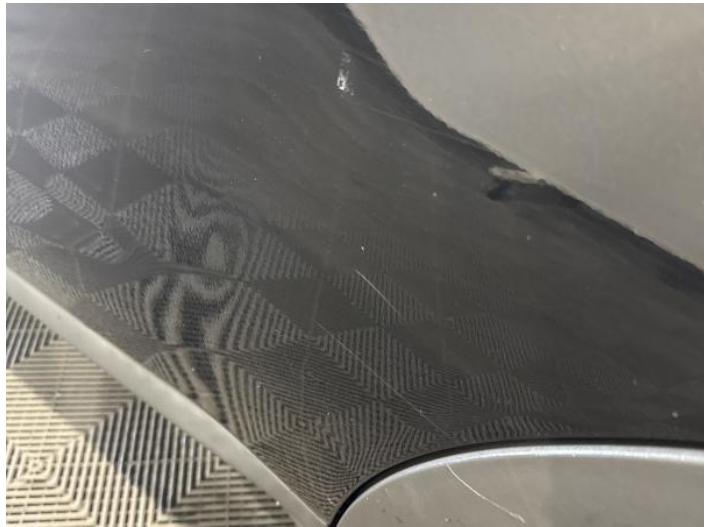
12: Door nsr  
Scratched  
Over 25mm Thru Paint

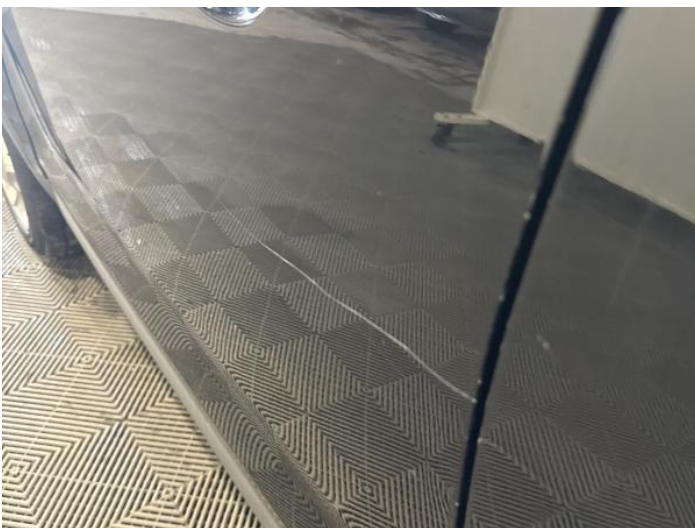
13: Door nsf  
Scratched  
Over 25mm Thru Paint

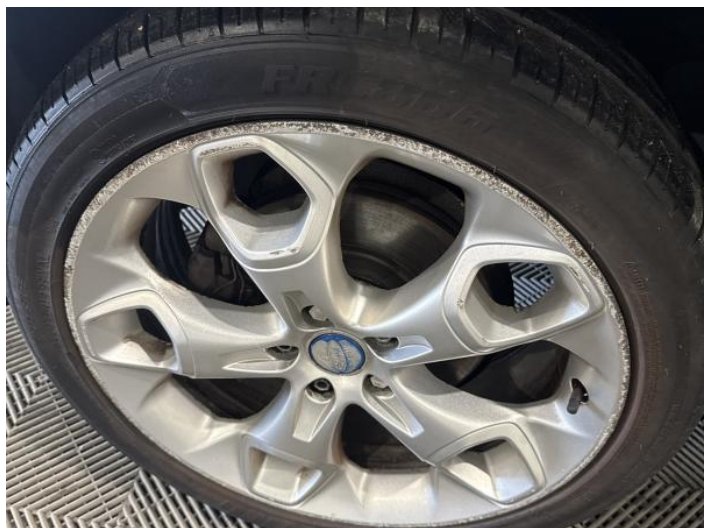
14: Wheel nsf  
Scratched  
Over 50mm

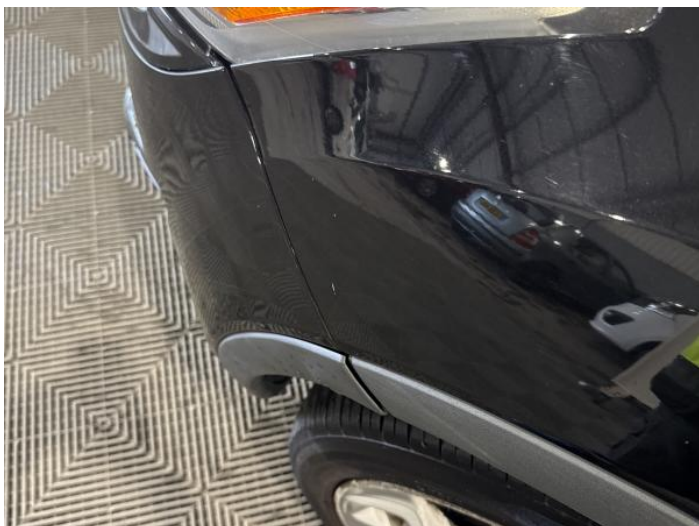
15: Wing nsf  
Scratched  
UpTo 25mm Thru Paint

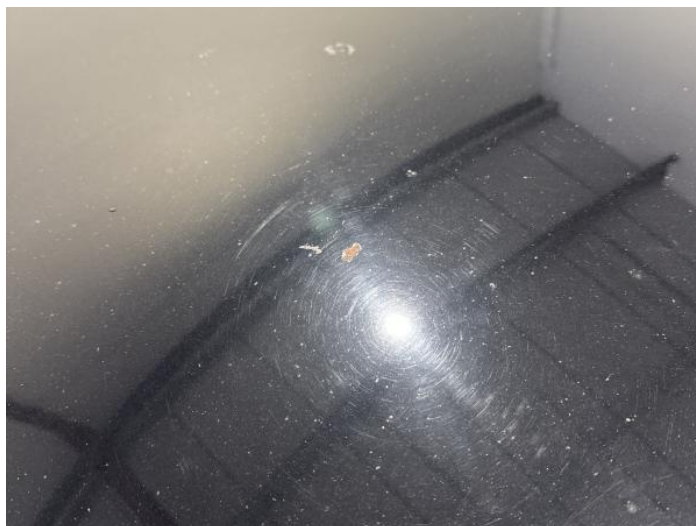
16: Roof  
Scratched  
Over 25mm Thru Paint

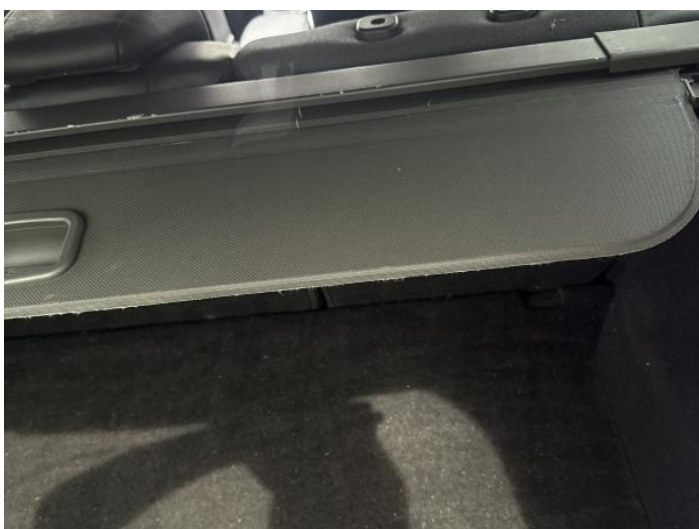
17: Headrest Assy Rear Seat os  
Missing  
Replace
