VEHICLE INSPECTION REPORT

AP65GYR

Land Rover Discovery Sport 2.0 TD4 180 HSE Luxury 5dr Auto

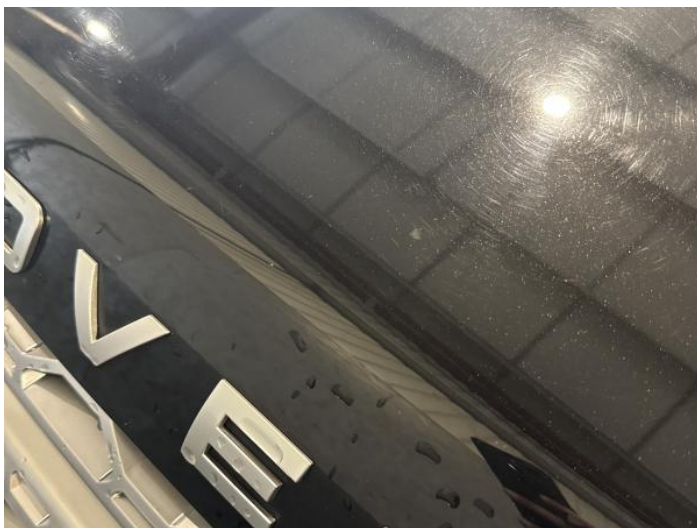
1: Bonnet
Chipped
1 To 5

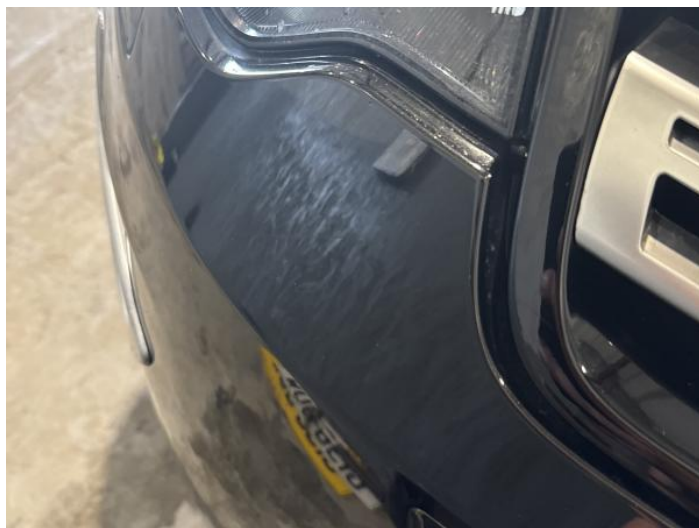
2: Bumper Front
Scratched
25 to 100mm Thru Paint

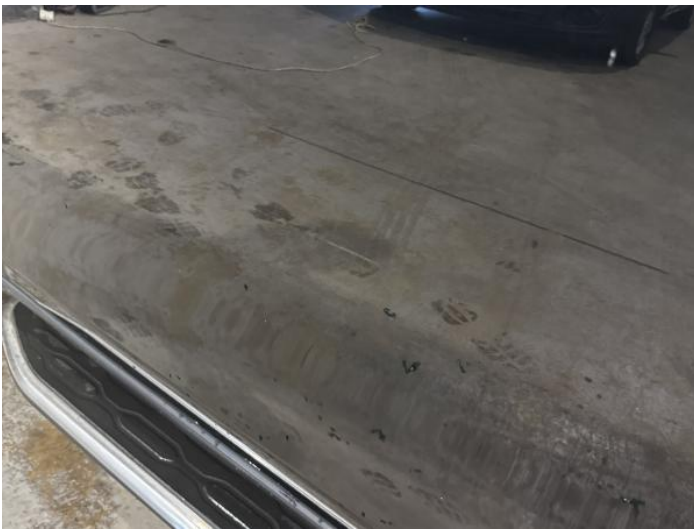
5: Door nsf
Scratched
Over 25mm Thru Paint

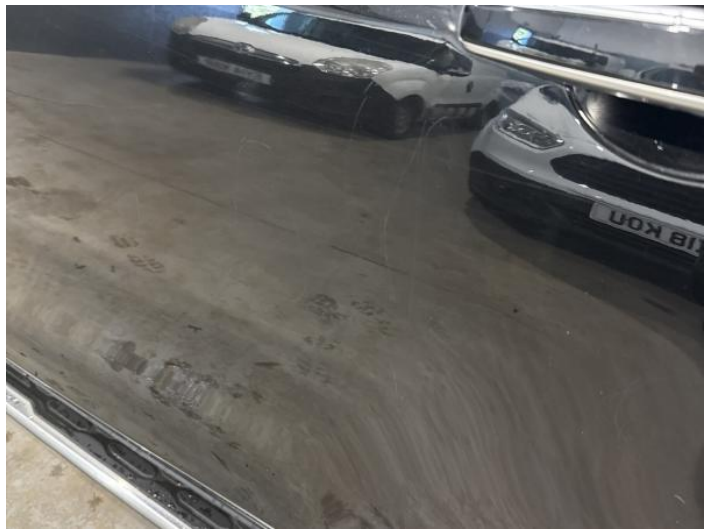
6: Door nsr
Scratched
Over 25mm Thru Paint

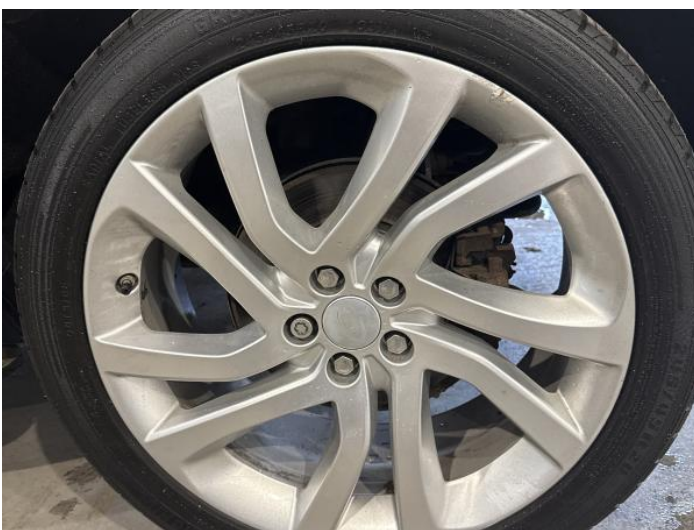
7: Wheel nsr
Scratched
Over 50mm

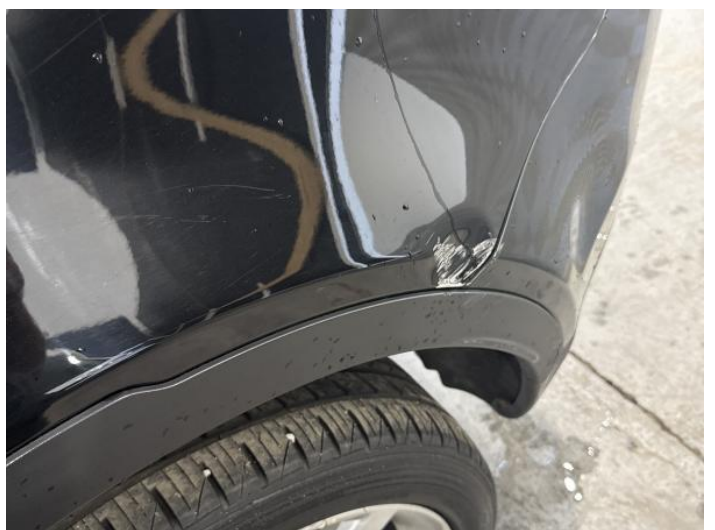
8: Qtr Panel nsr
Dented
Over 30mm

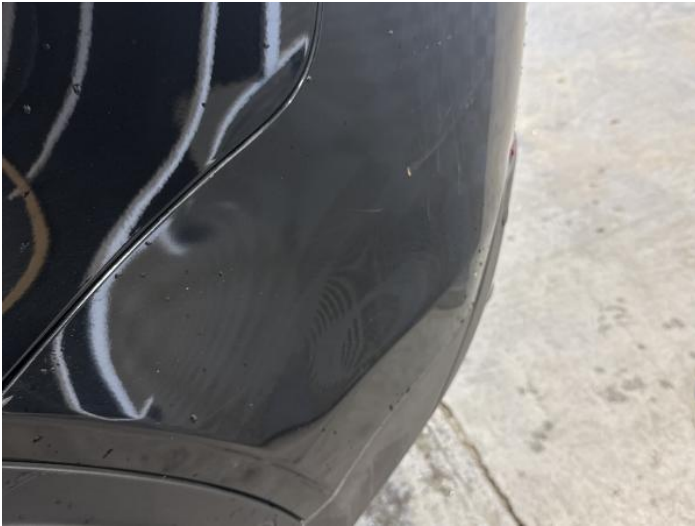
9: Bumper Rear
Scratched
Over 100mm Thru Paint

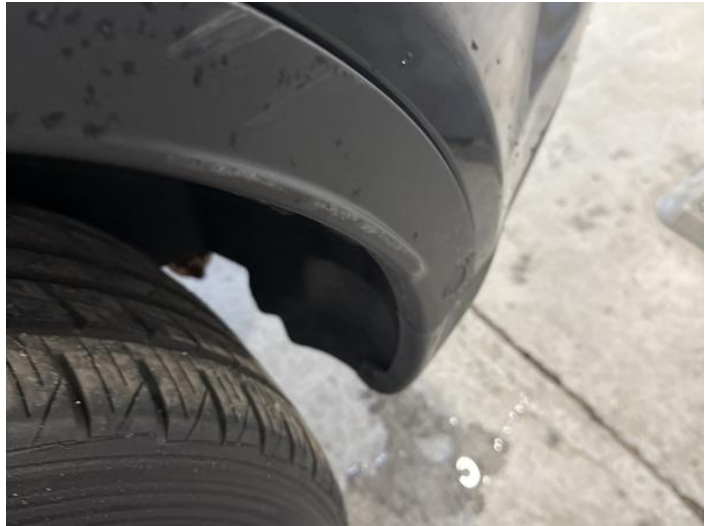
10: Qtr Panel Arch Extension ns
Scuffed (Unpainted)
Over 100mm

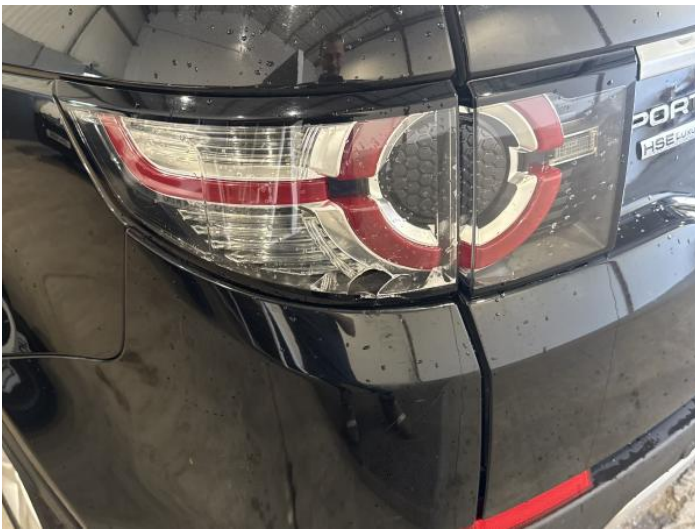
11: Lamp nsr
Broken
Replace

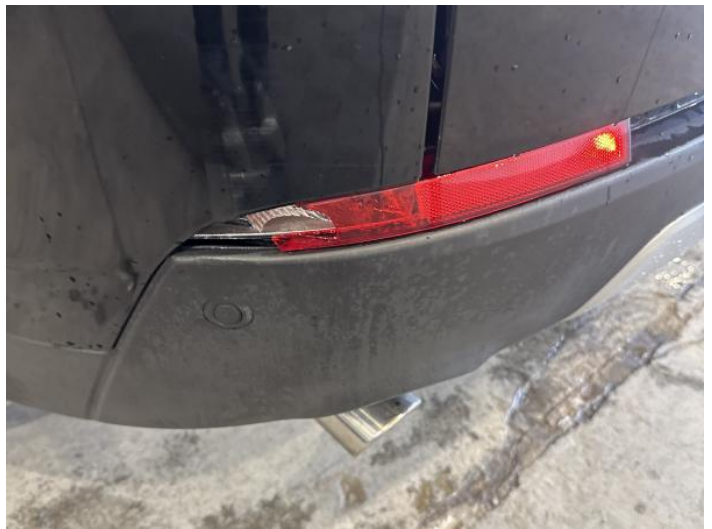
12: Bumper Reflector nsr
Broken
Replace

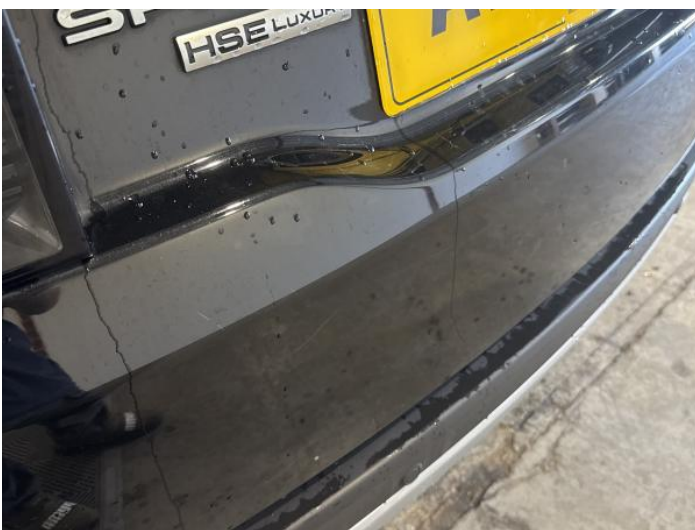
13: Tailgate
Scratched
Over 25mm Thru Paint

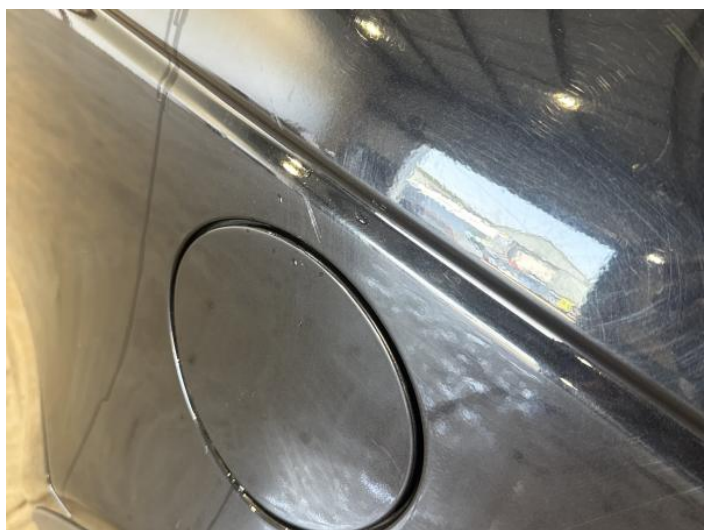
14: Qtr Panel osr
Scratched
Over 25mm Thru Paint

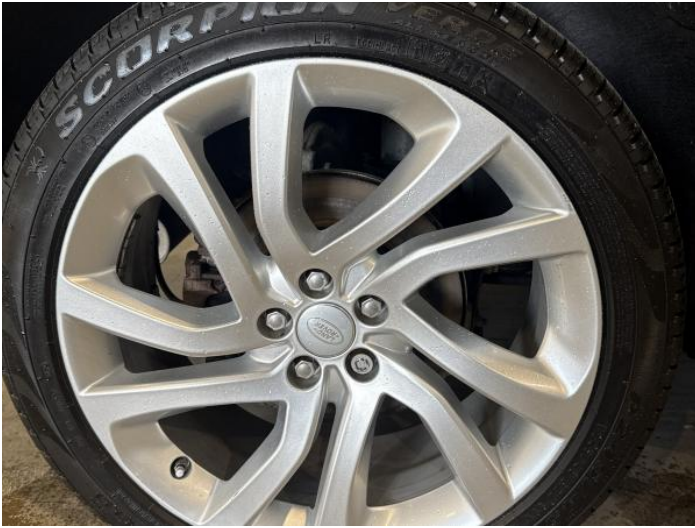
15: Wheel osr
Scratched
Up To 50mm

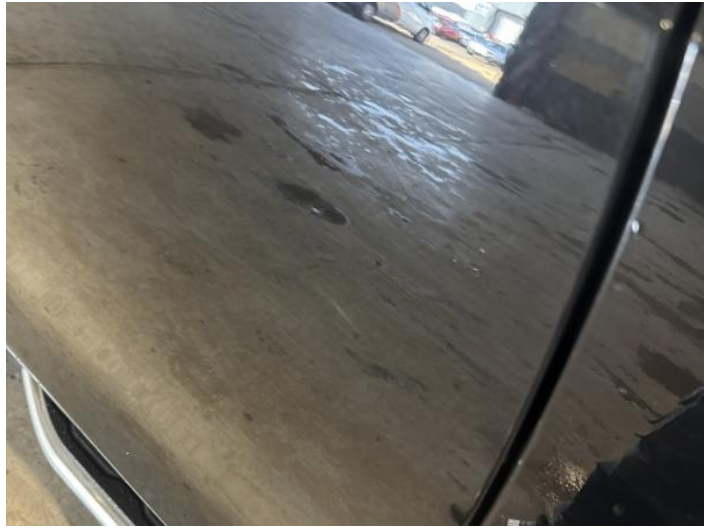
16: Door osr
Scratched
UpTo 25mm Thru Paint

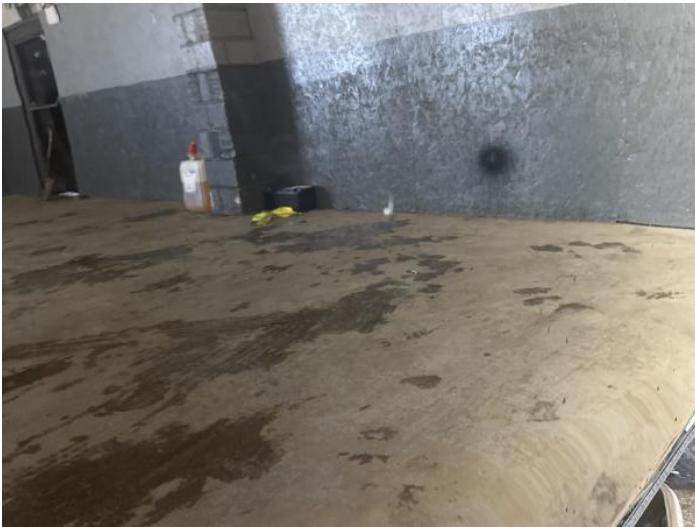
17: Door osf
Scratched
UpTo 25mm Thru Paint

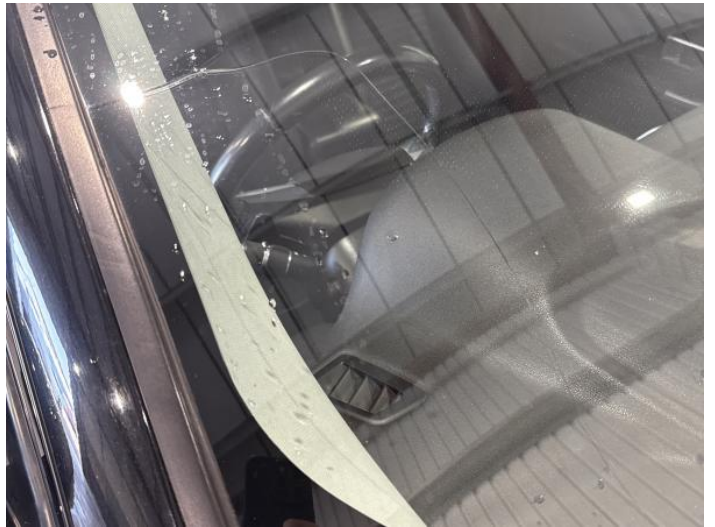
18: Screen Front
Cracked
Replace

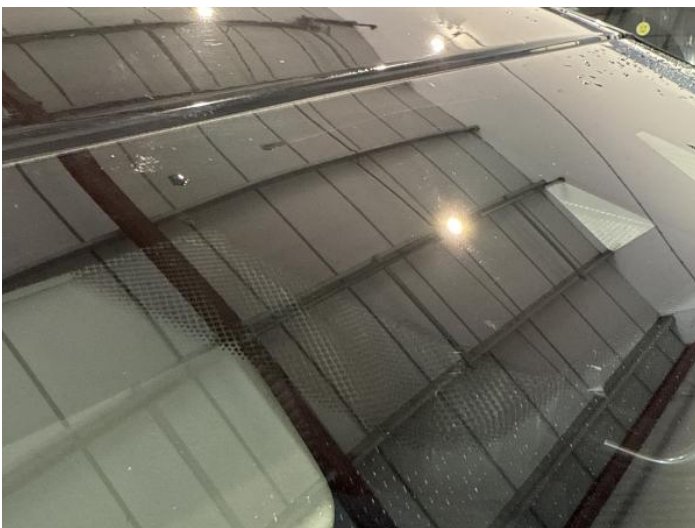
19: Roof
Dented
Over 30mm

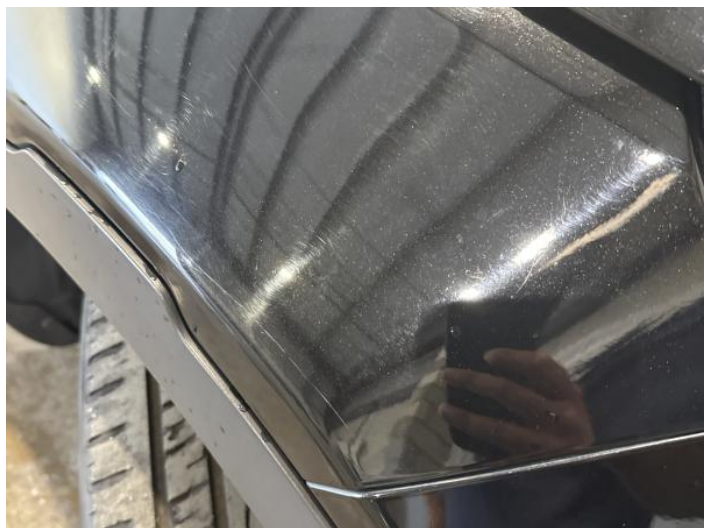
20: Wing osf
Scratched
Over 25mm Thru Paint

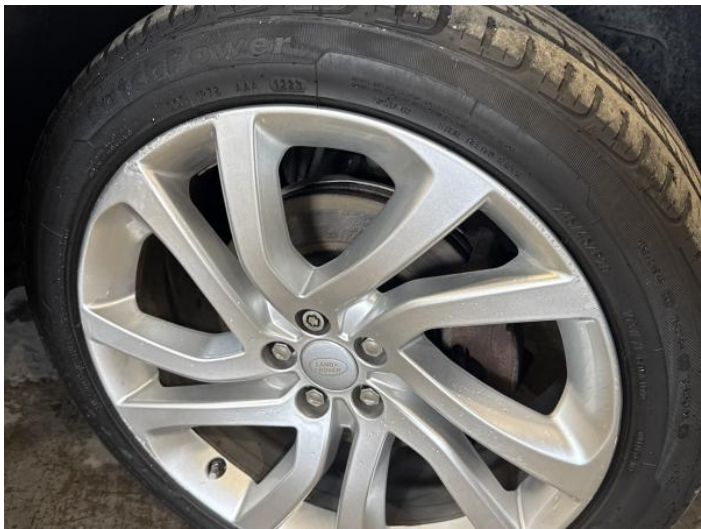
21: Wheel of
Scratched
Over 50mm
