VEHICLE INSPECTION REPORT

RK56XHW

Nissan X-Trail 2.5 16v Aventura 5dr Auto

Cat: C
Inspection

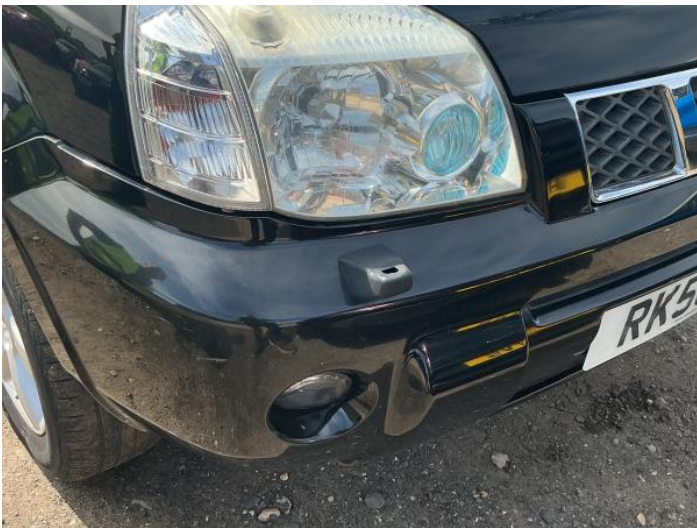
1: Bumper Front
Scratched
Over 100mm Thru Paint

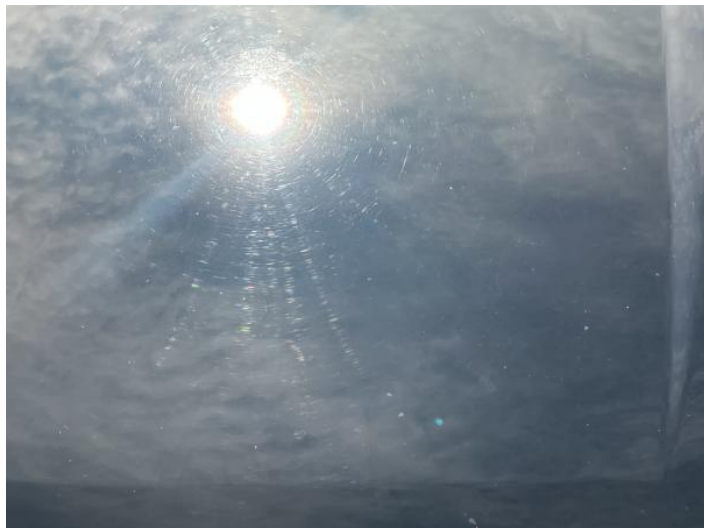
2: Bonnet
Chipped
Multiple Chips

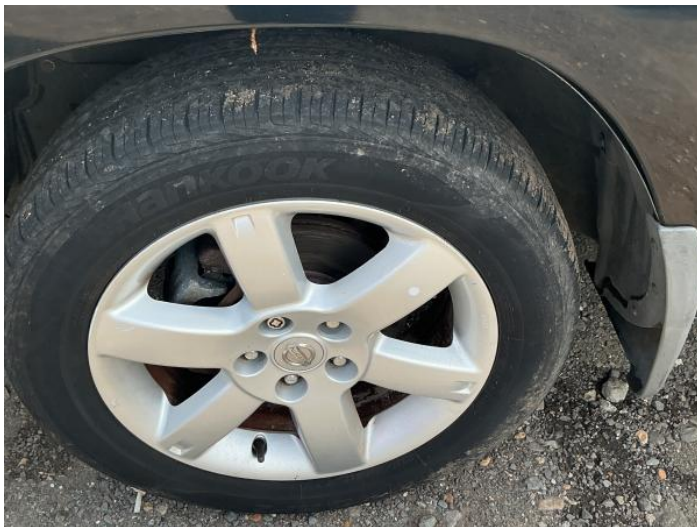
3: Wheel nsf
Scratched
Over 50mm

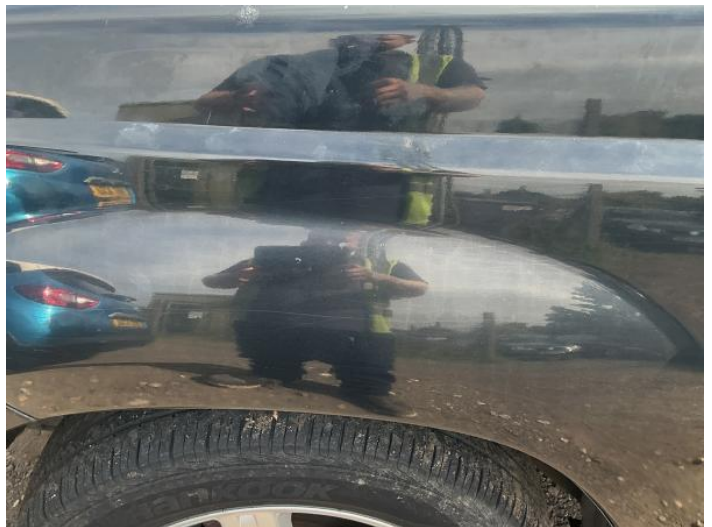
4: Wing nsf
Poor Previous Repair
Poor Paint

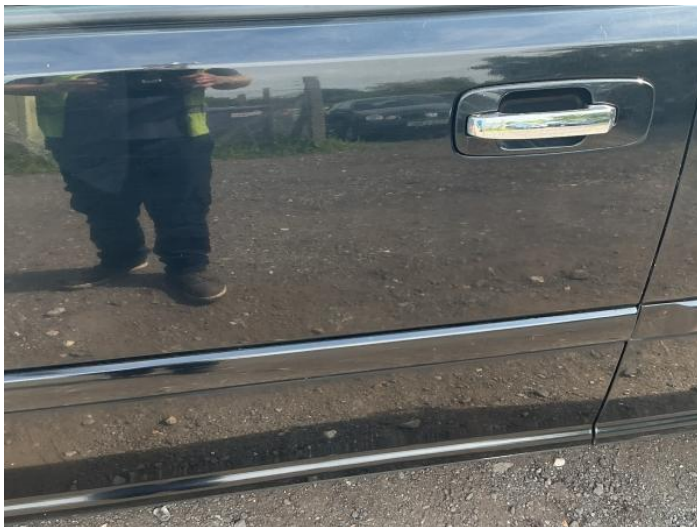
5: Door nsf
Chipped
1 To 5

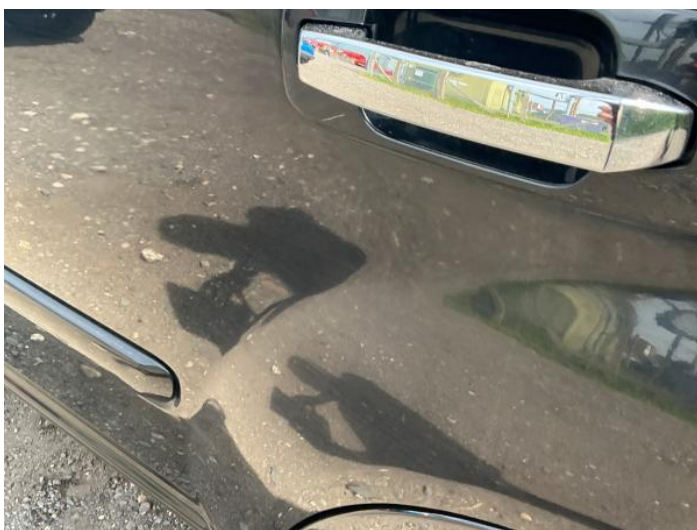
7: Door nsr
Dented
With Paint Damage

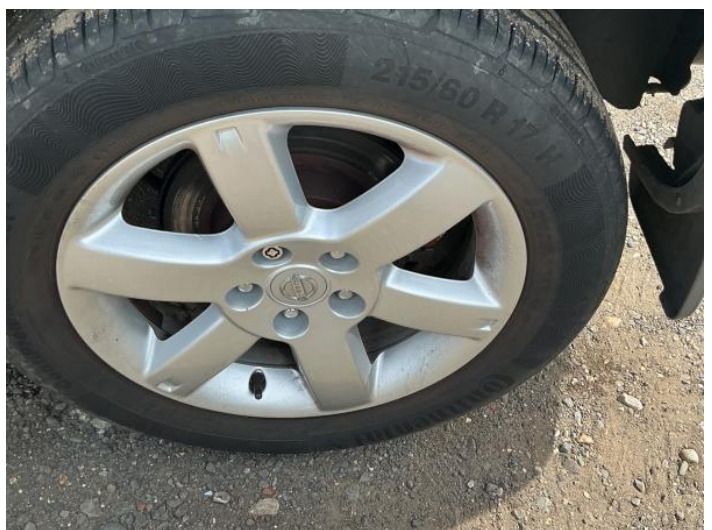
8: Wheel nsr
Scratched
Over 50mm

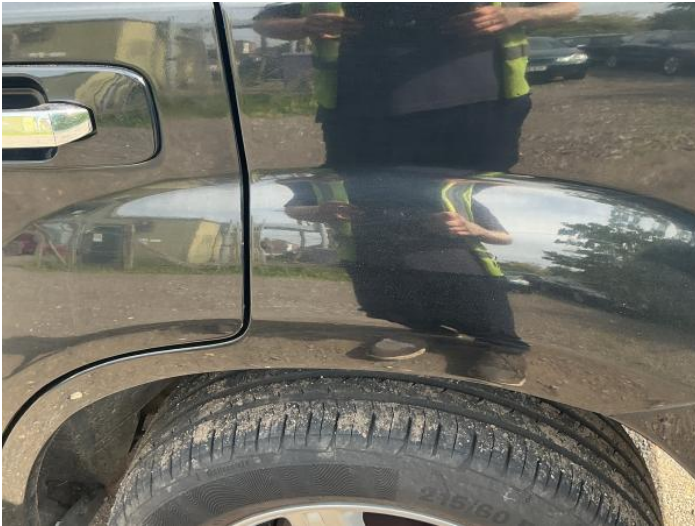
9: Qtr Panel nsr
Dented
With Paint Damage

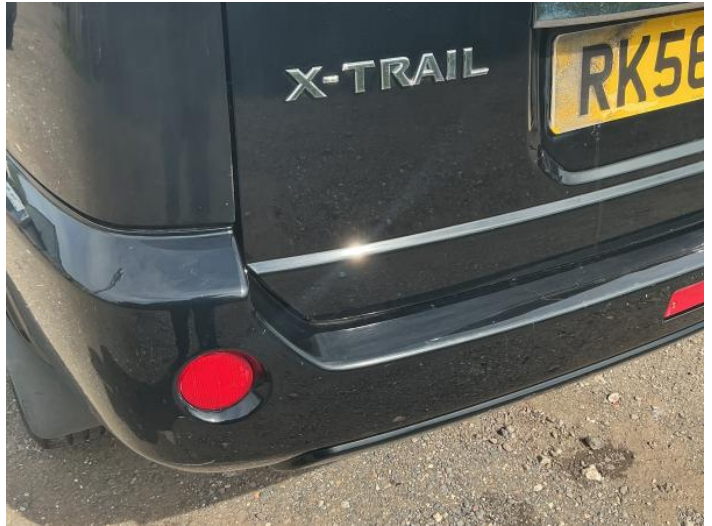
10: Bumper Rear
Scratched
Over 100mm Thru Paint

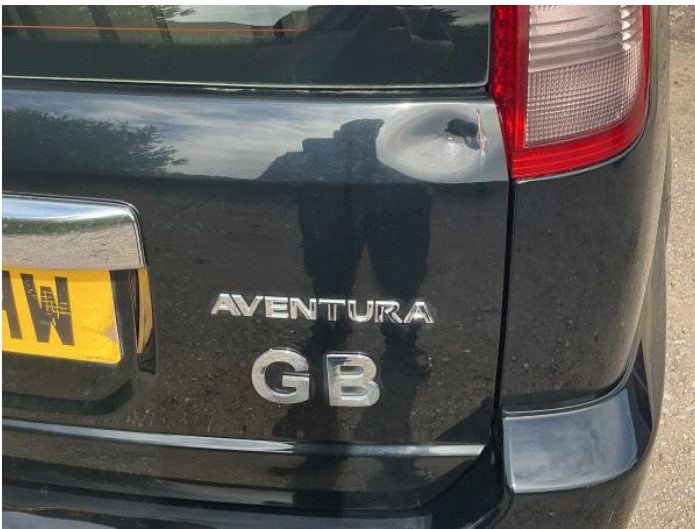
11: Boot Lid
Dented
With Paint Damage

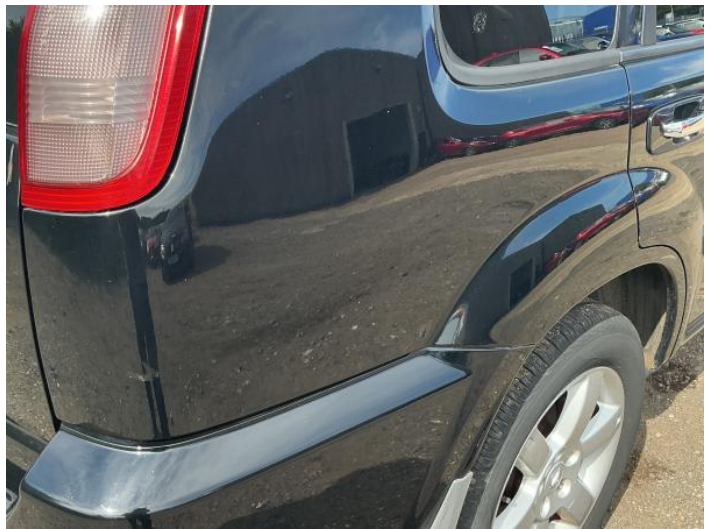
12: Qtr Panel osr
Poor Previous Repair
Poor Paint

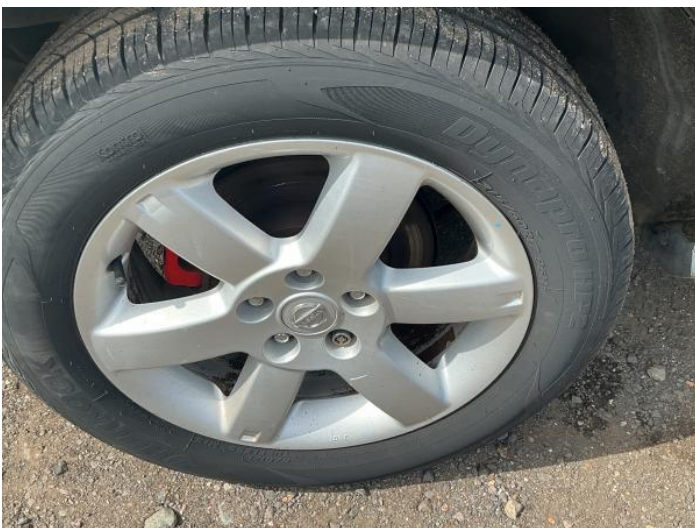
13: Wheel osr
Scratched
Over 50mm

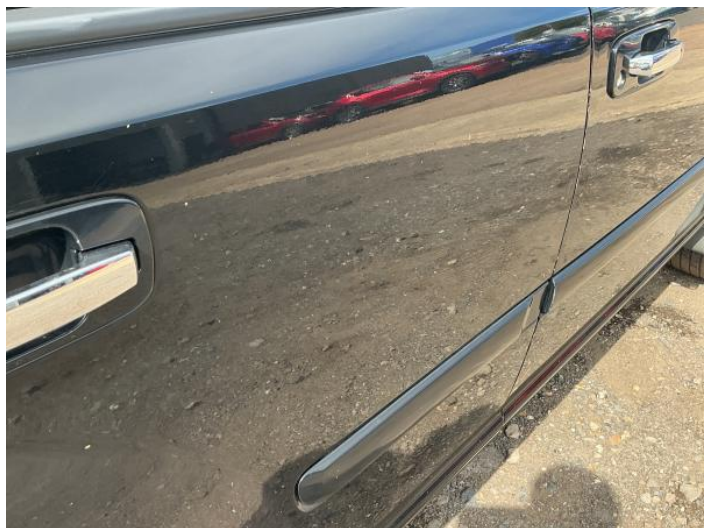
14: Door osr
Chipped
Multiple Chips

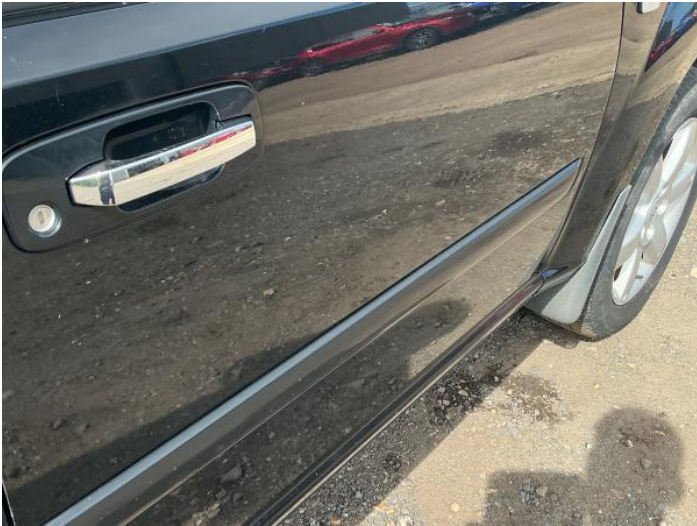
15: Door osf
Dented
With Paint Damage

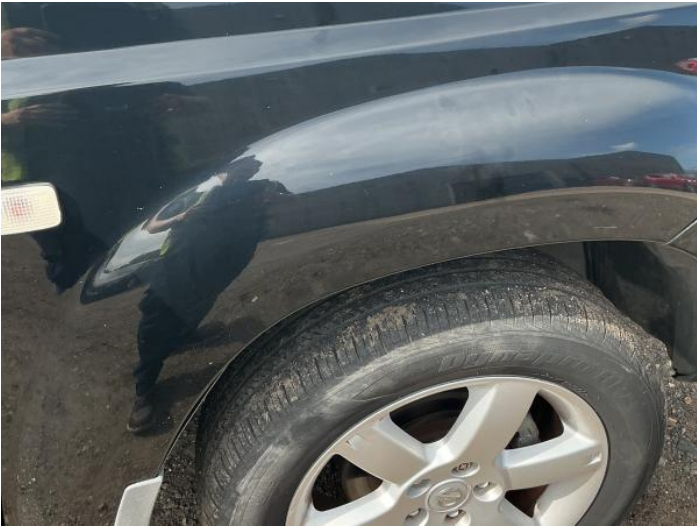
16: Wing osf
Chipped
1 To 5

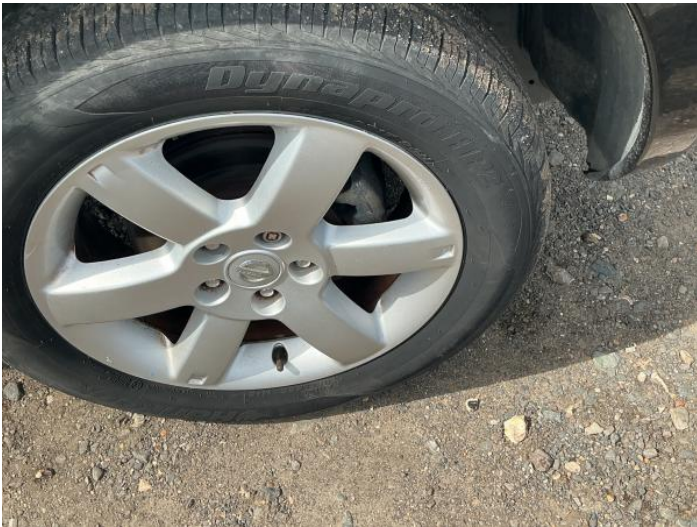
17: Wheel osf
Scratched
Over 50mm

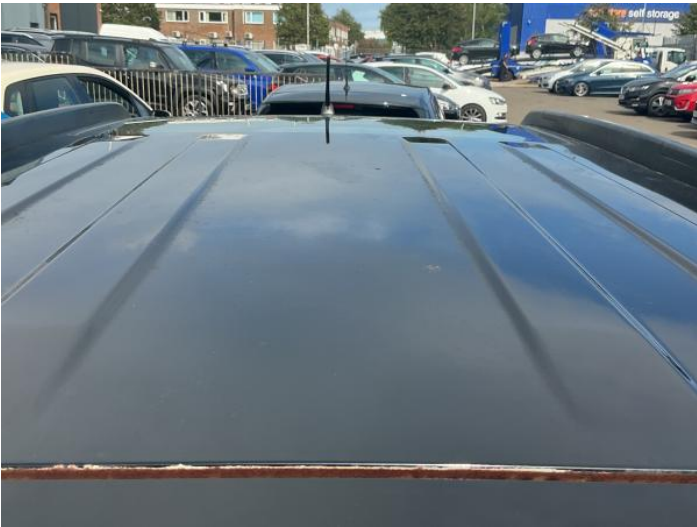
18: Roof
Chipped
Edge Chip
