## **VEHICLE INSPECTION REPORT**

PG10HZV

## Fiat 500 1.2 Pop 2dr

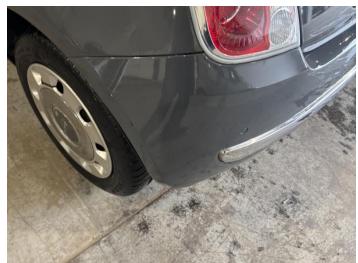
1: Bumper Rear Scratched Up To 25mm Thru Paint

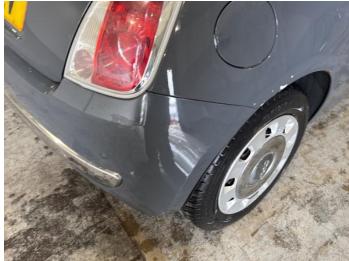
2: Bumper Rear Scratched 25 to 100mm Thru Paint

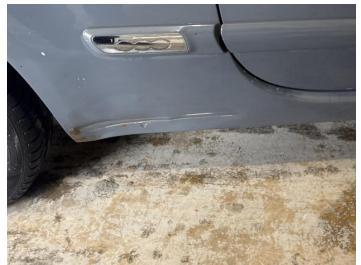
5: Sill os Dented With Paint Damage

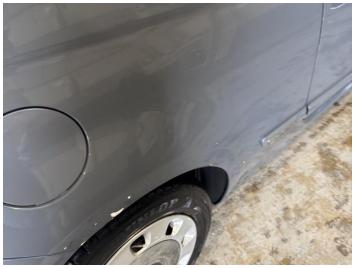
4: Qtr Panel osr Dented With Paint Damage

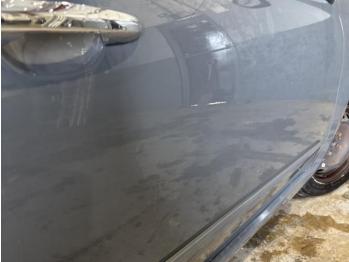
6: Door osf Dented Over 2 UpTo 10mm

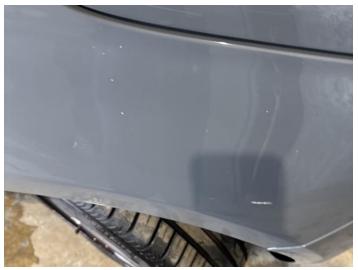
9: Wing osf Dented With Paint Damage

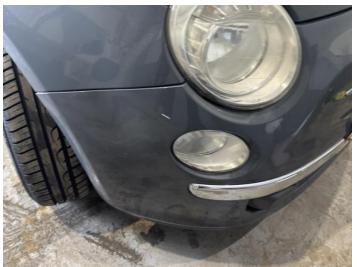
11: Bumper Front Scratched 25 to 100mm Thru Paint

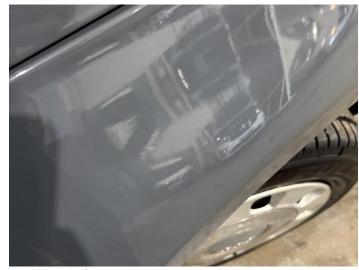
13: Wing nsf Chipped 1 To 5

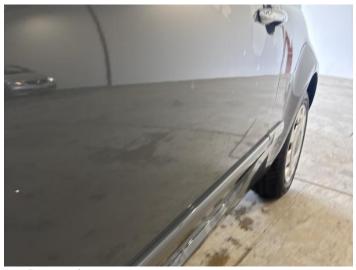
14: Door nsf Dented Over 2 UpTo 10mm

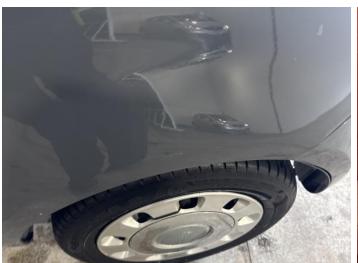
17: Qtr Panel nsr Dented With Paint Damage

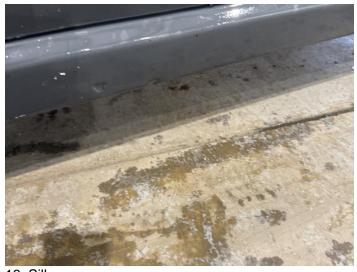
16: Sill ns Dented 2 Or Less UpTo 10mm

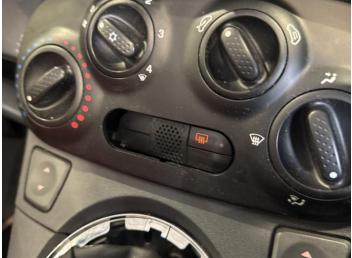
Radios doesn't work

20: Switches And Controls Broken Replace
