VEHICLE INSPECTION REPORT

HV68SVX

Ford Mondeo 2.0 TDCi Titanium Edition 5dr

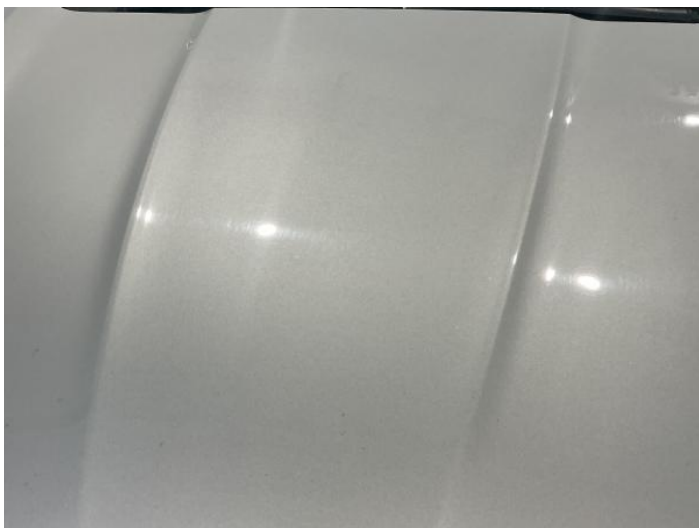
1: Bonnet
Chipped
Multiple Chips

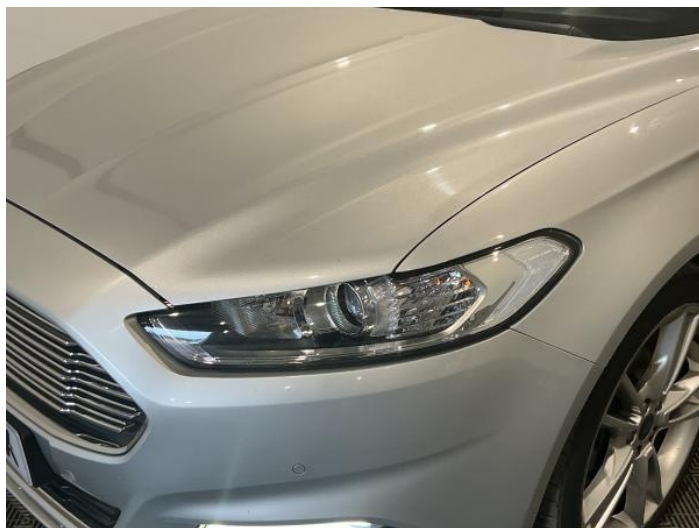
2: Bumper Front
Chipped
Multiple Chips

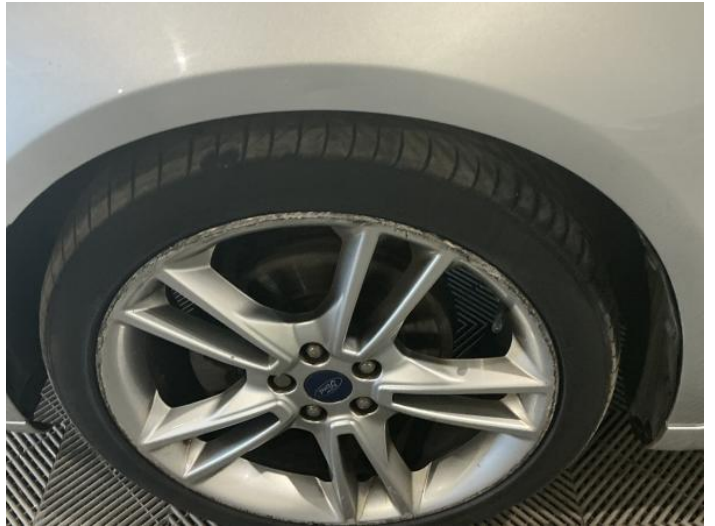
4: Wheel nsf
Scratched
Over 50mm

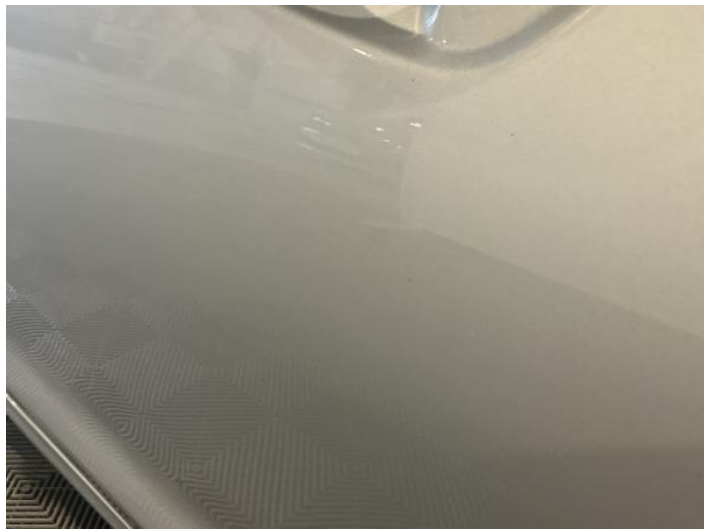
6: Door nsf
Dented
2 Or Less UpTo 10mm

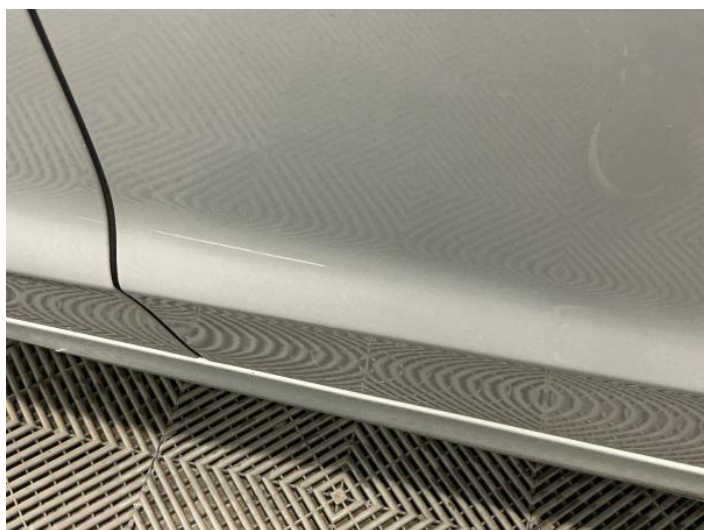
8: Door nsr
Scratched
Over 25mm Thru Paint

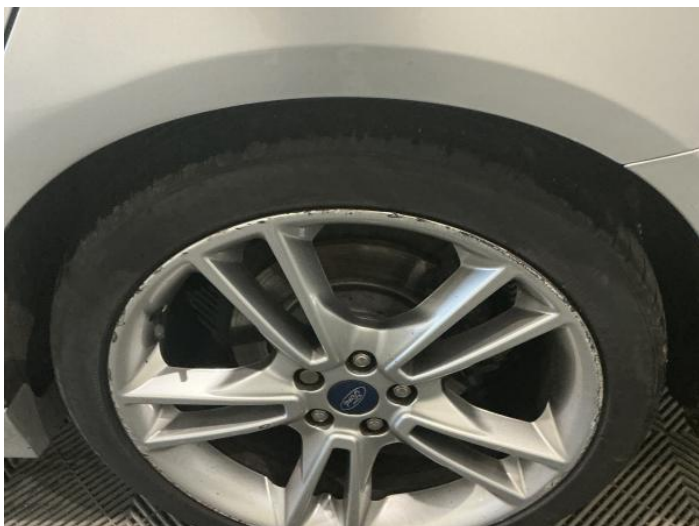
9: Wheel nsr
Scratched
Over 50mm

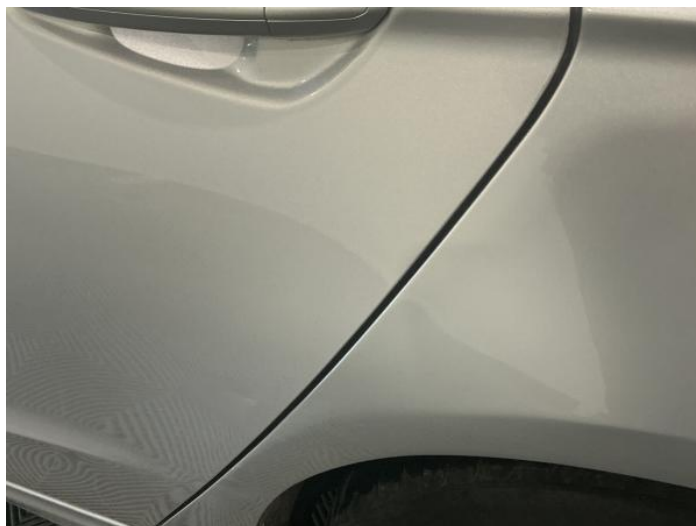
10: Qtr Panel nsr
Dented
With Paint Damage

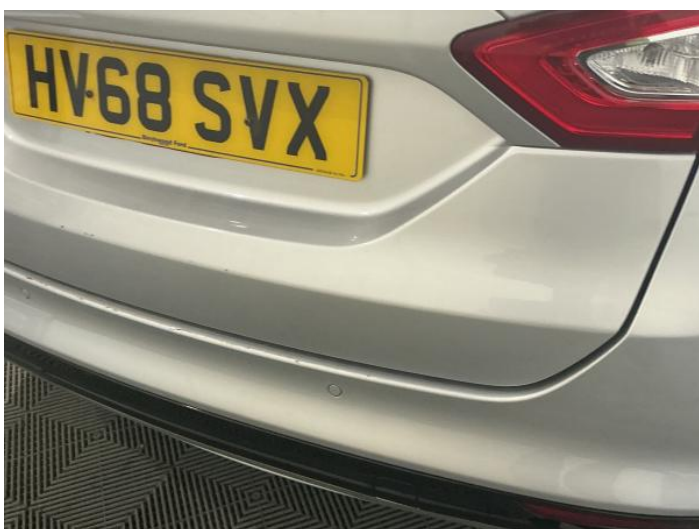
11: Bumper Rear
Scratched
25 to 100mm Thru Paint

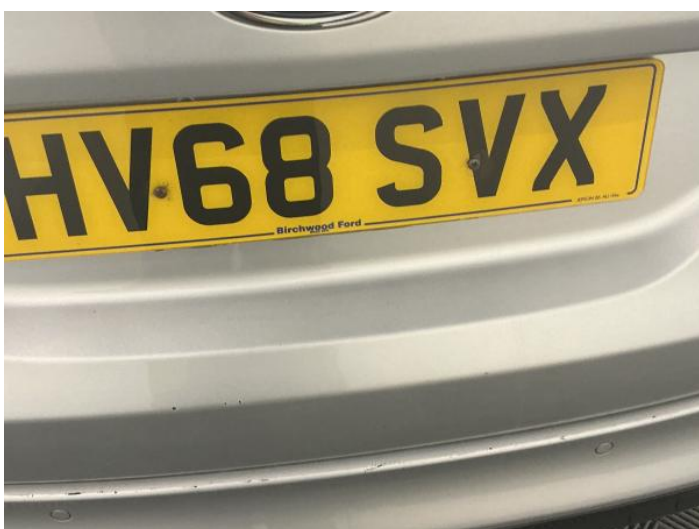
13: Boot Lid
Chipped
1 To 5

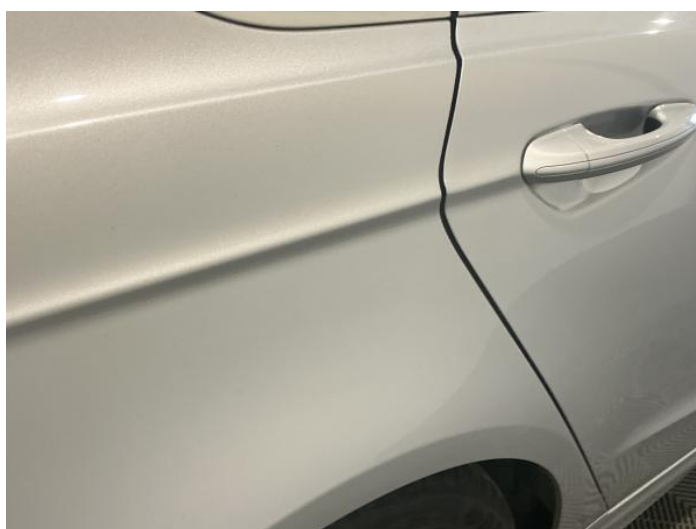
14: Qtr Panel osr
Dented
2 Or Less UpTo 10mm

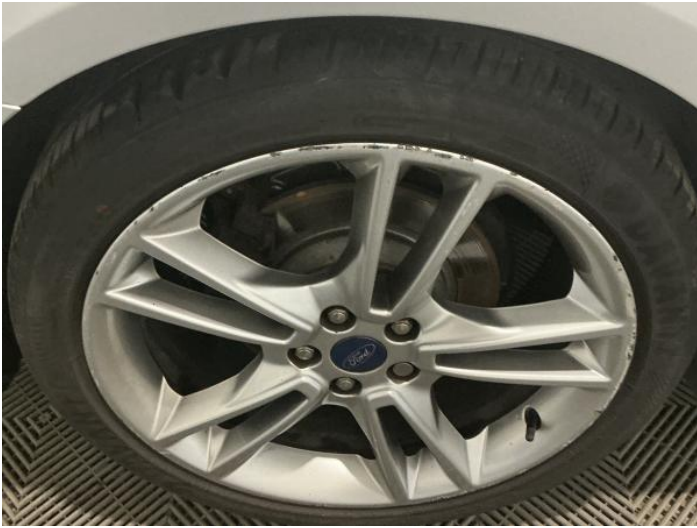
15: Wheel osr
Scratched
Over 50mm

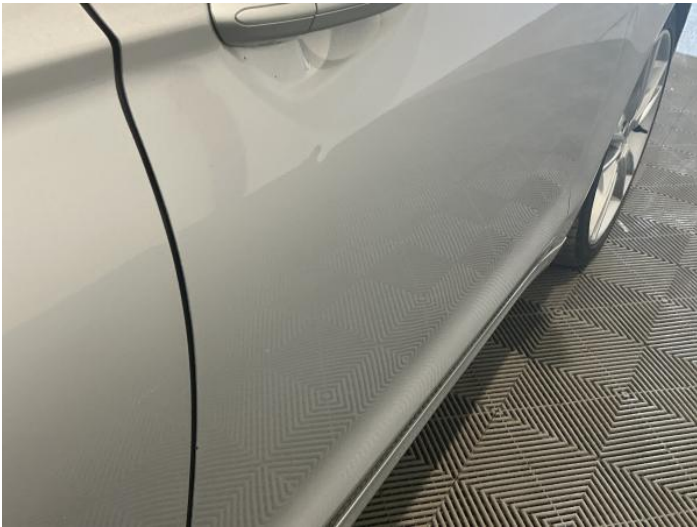
17: Door osf
Dented
Over 2 UpTo 10mm

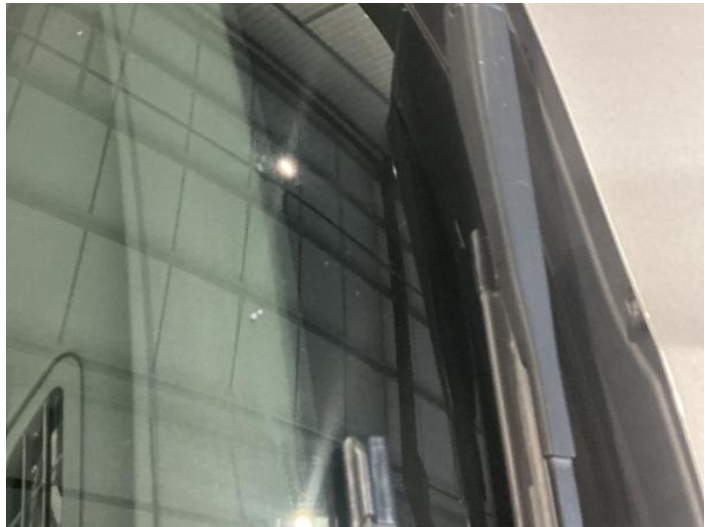
18: Screen Front
Chipped
UpTo 10mm

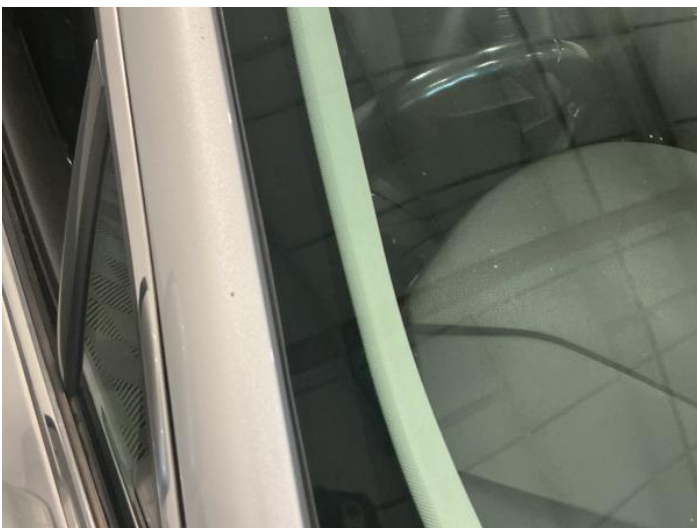
19: A Post os
Chipped
1 To 5

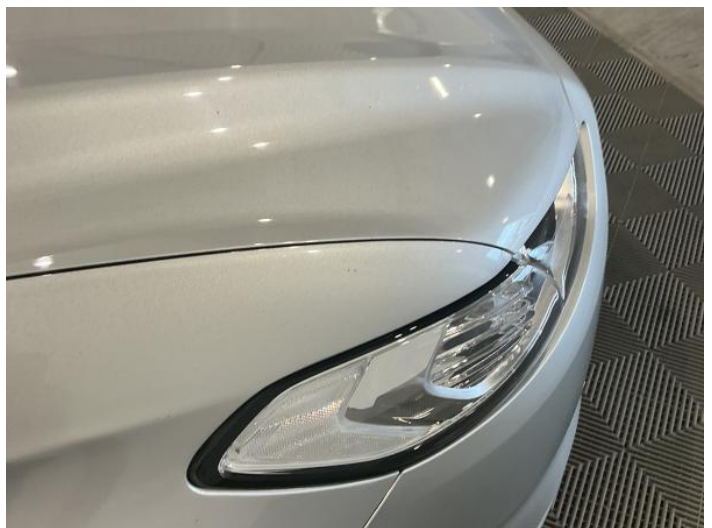
20: Wing osf
Chipped
1 To 5

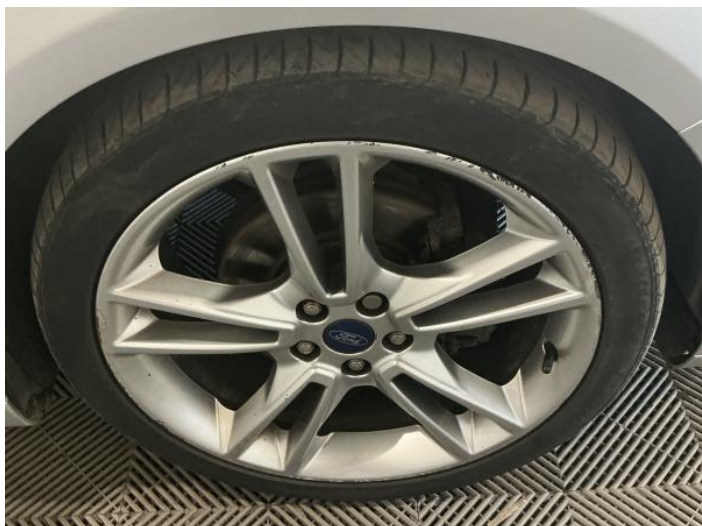
21: Wheel of
Scratched
Over 50mm
