VEHICLE INSPECTION REPORT

LF21CLP

Kia Niro 1.6 GDi Hybrid 4 5dr DCT

nama
GRADE
3

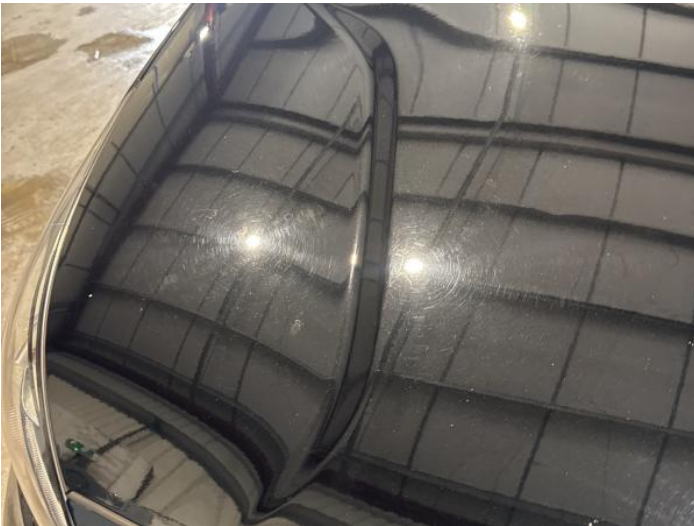
1: Bonnet
Chipped
1 To 5

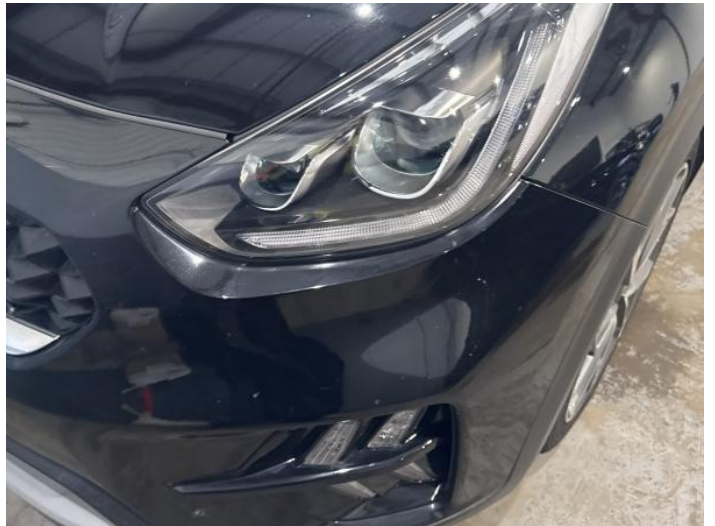
2: Bumper Front
Chipped
Multiple Chips

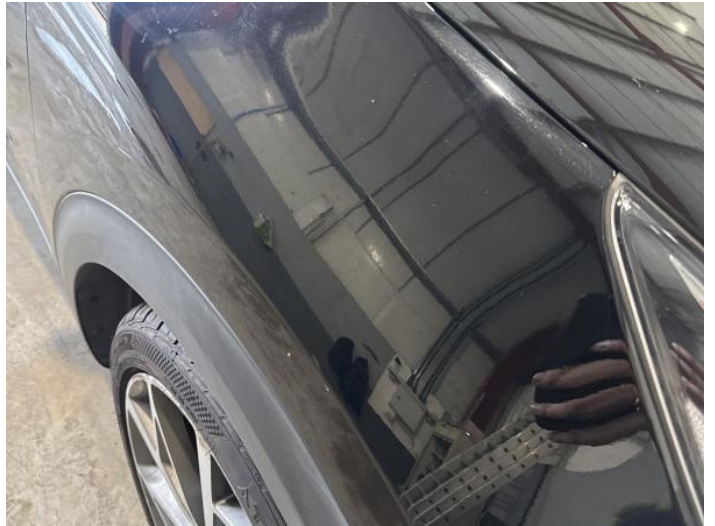
4: Wing osf
Chipped
1 To 5

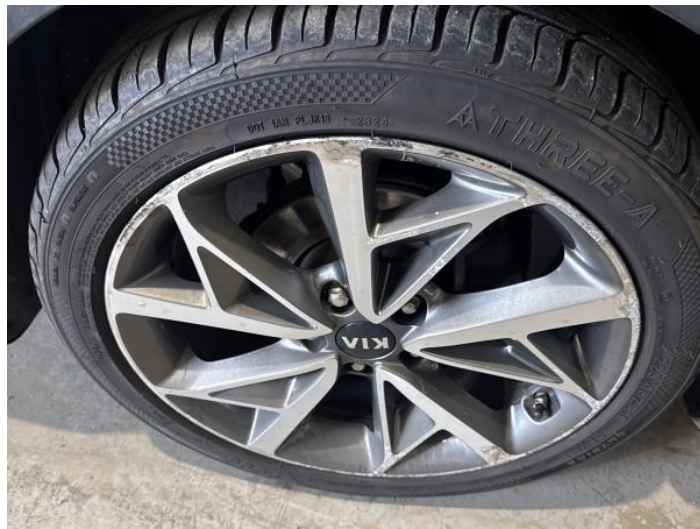
5: Wheel osf
Scratched
Over 50mm

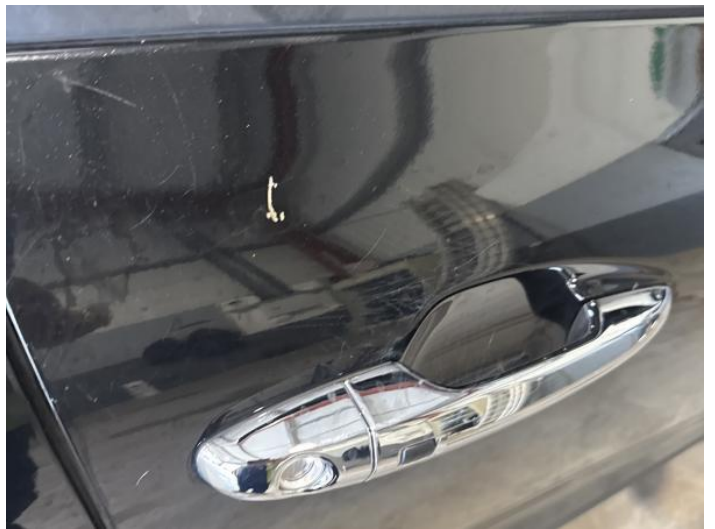
6: Door osf
Scratched
Over 25mm Thru Paint

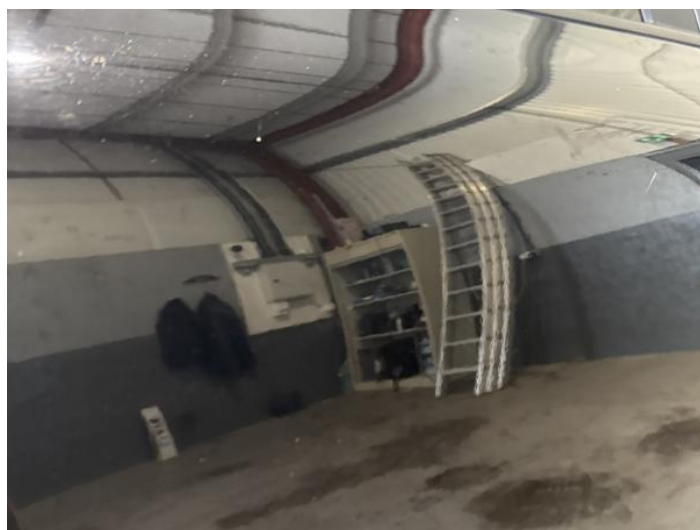
7: Door osr
Chipped
1 To 5

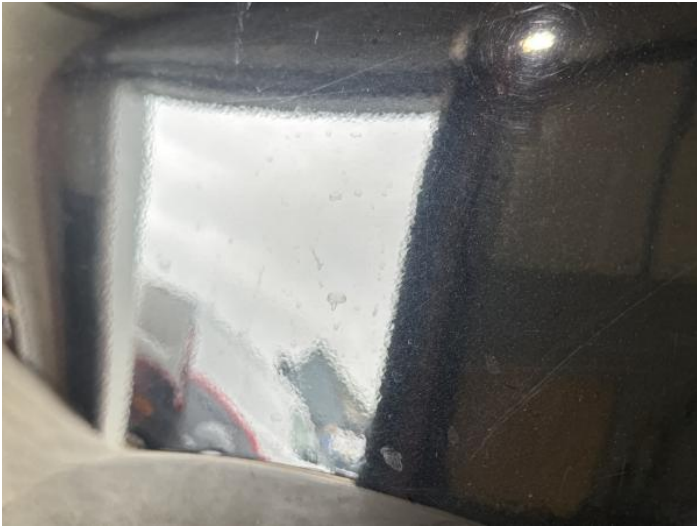
9: Qtr Panel osr
Chipped
1 To 5

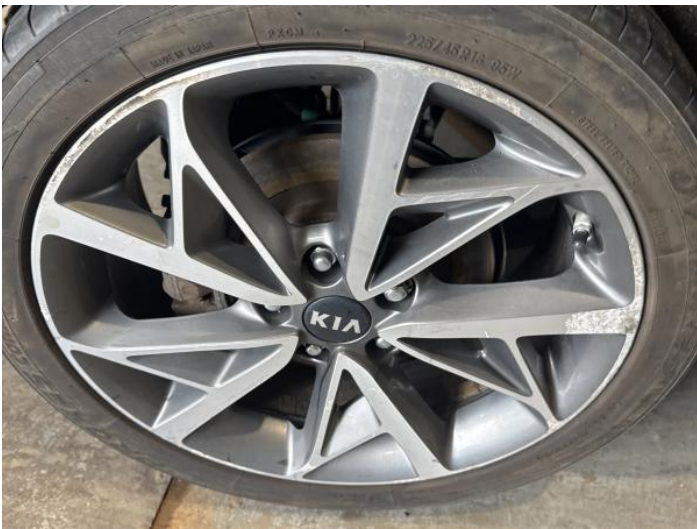
11: Wheel osr
Scratched
Over 50mm

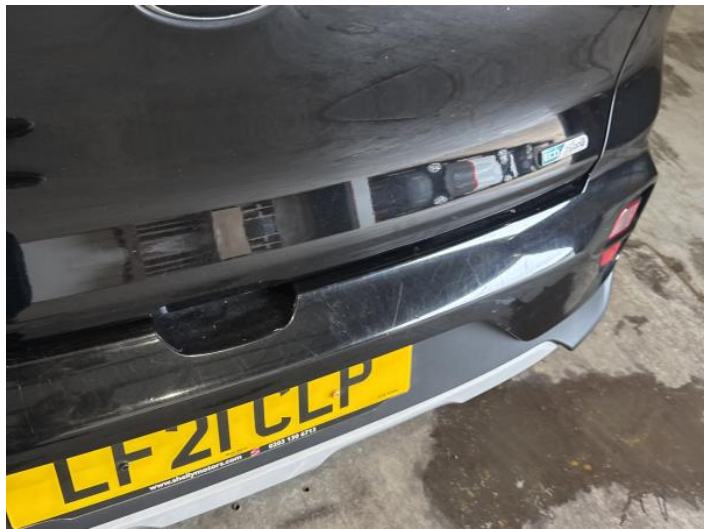
12: Bumper Rear
Scratched
25 to 100mm Thru Paint

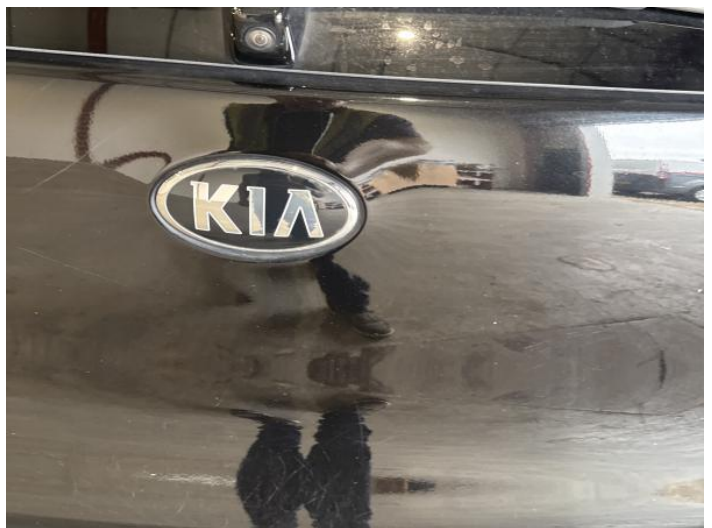
14: Boot Lid
Chipped
1 To 5

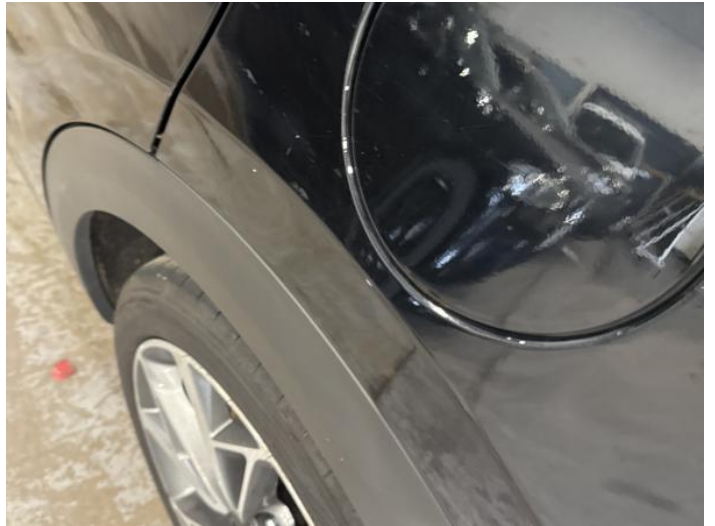
16: Qtr Panel nsr
Dented
With Paint Damage

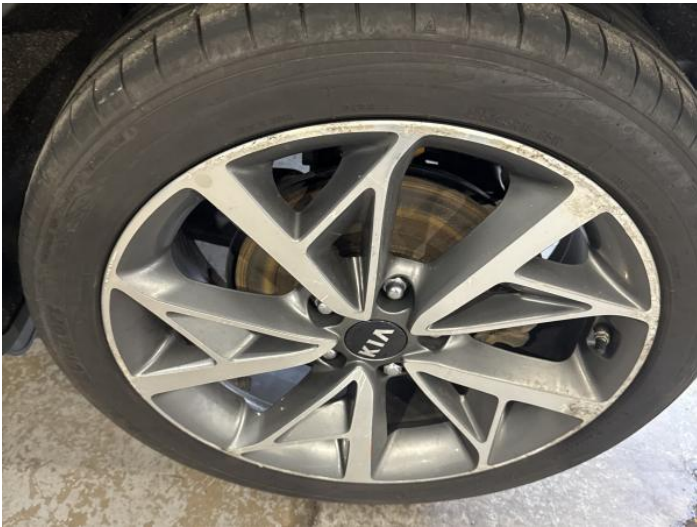
17: Wheel nsr
Scratched
Over 50mm

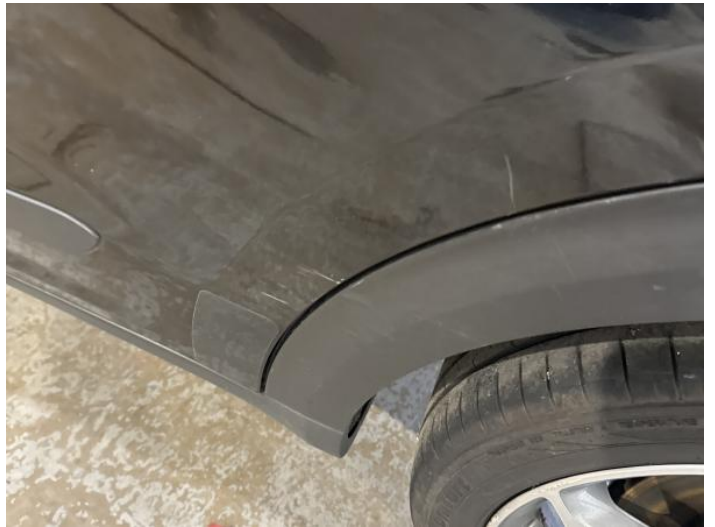
18: Door nsr
Scratched
Over 25mm Thru Paint

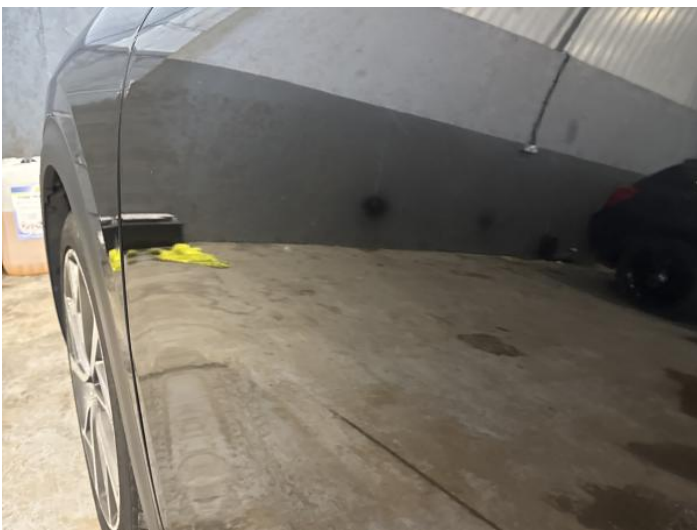
19: Door nsf
Chipped
1 To 5

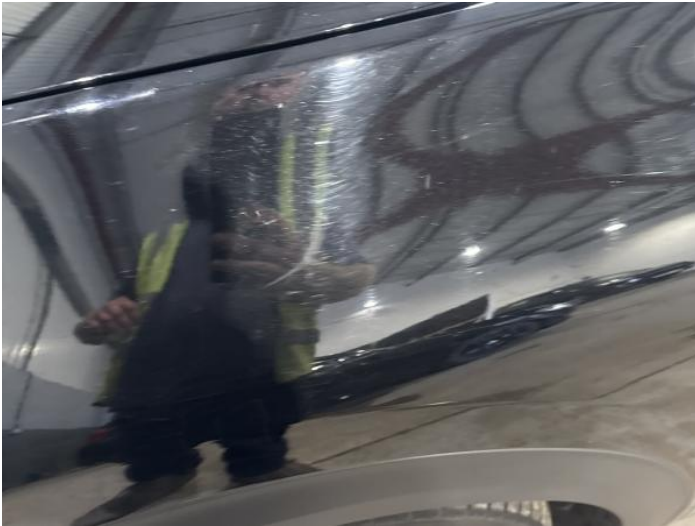
21: Wing nsf
Chipped
1 To 5

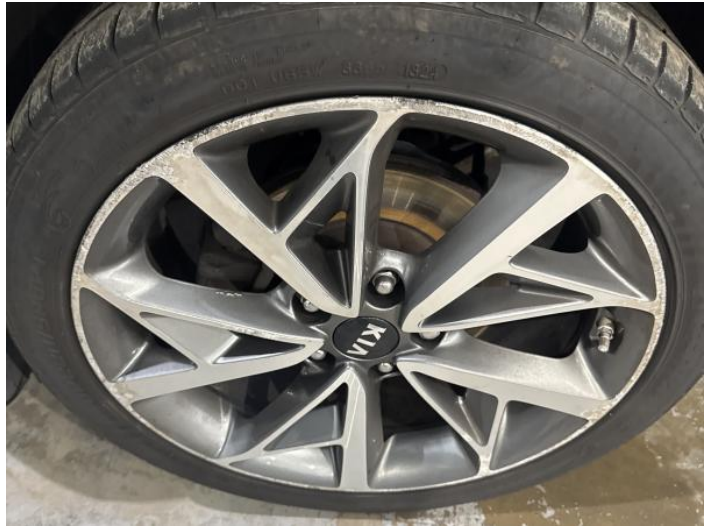
22: Wheel nsf
Scratched
Over 50mm

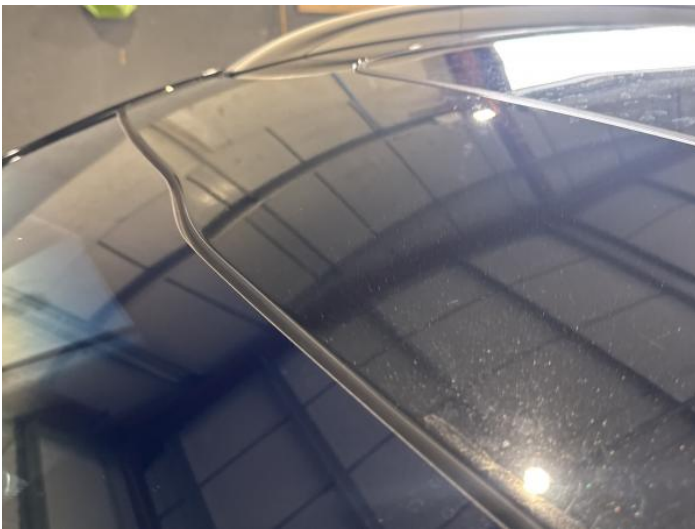
23: Roof
Dented
Between 10mm + 30mm
