VEHICLE INSPECTION REPORT

FM17XBJ

Ford B-Max 1.0 EcoBoost Titanium Navigator 5dr

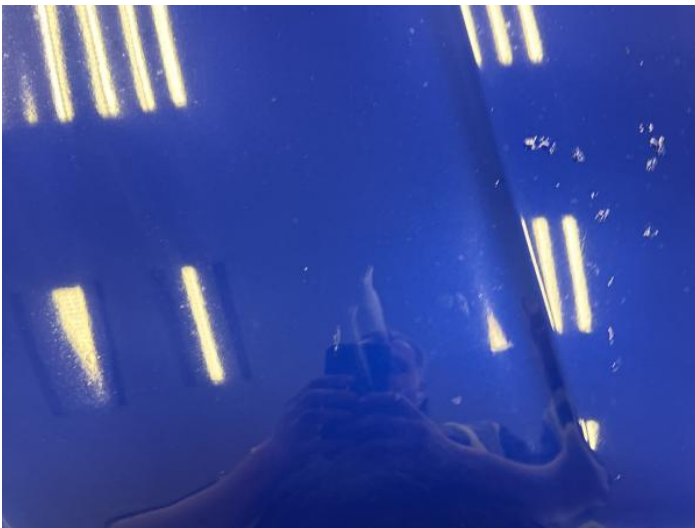
1: Bonnet
Poor Previous Repair
Poor Paint

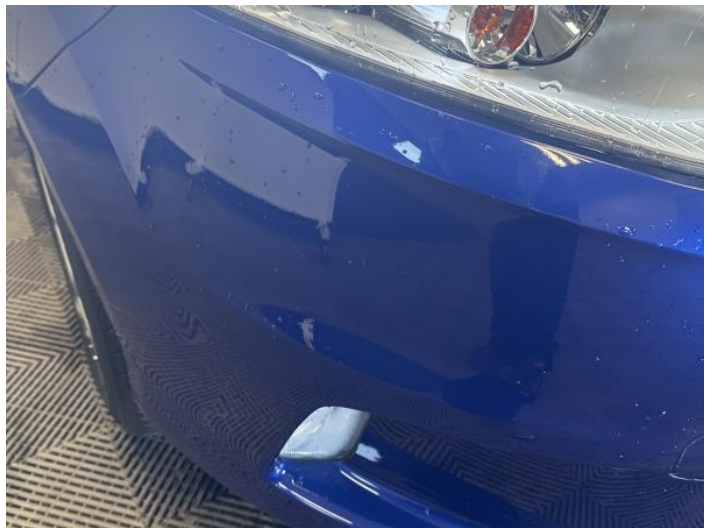
2: Bumper Front
Scratched
25 to 100mm Thru Paint

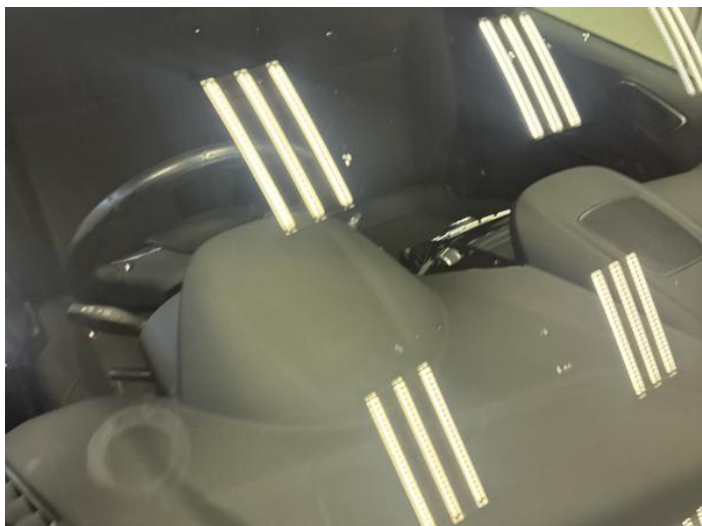
3: Screen Front
Chipped
UpTo 10mm

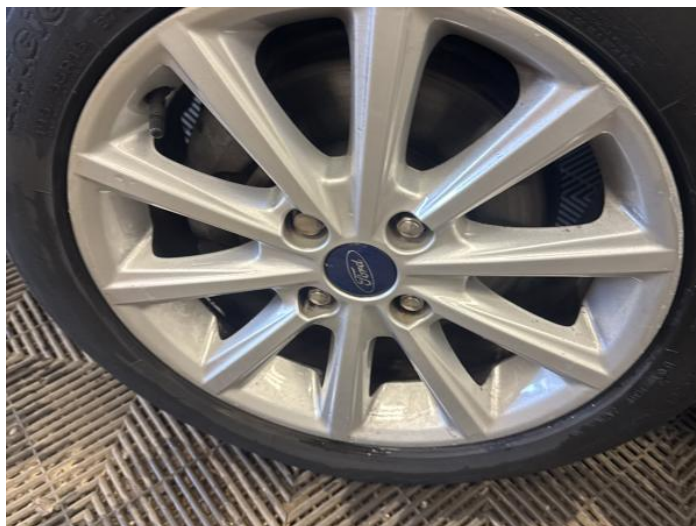
4: Wheel nsf
Scratched
Over 50mm

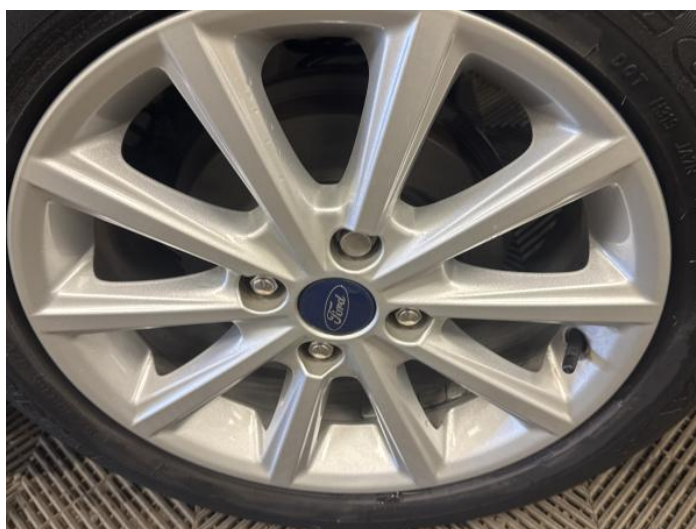
6: Wheel nsr
Scratched
Up To 50mm

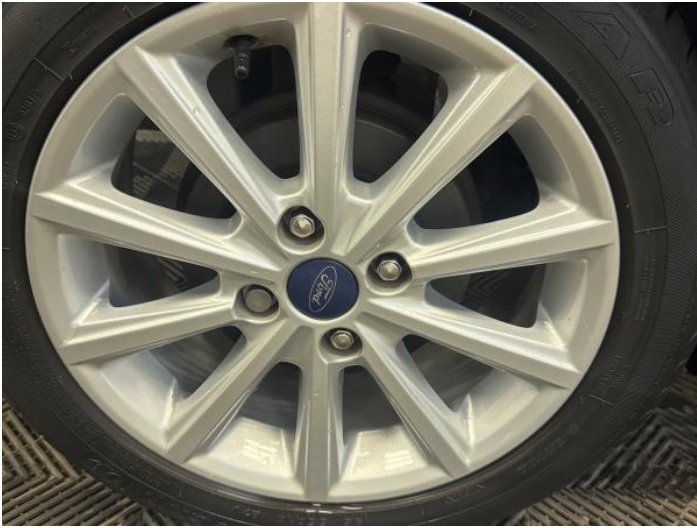
9: Wheel osr
Scratched
Up To 50mm

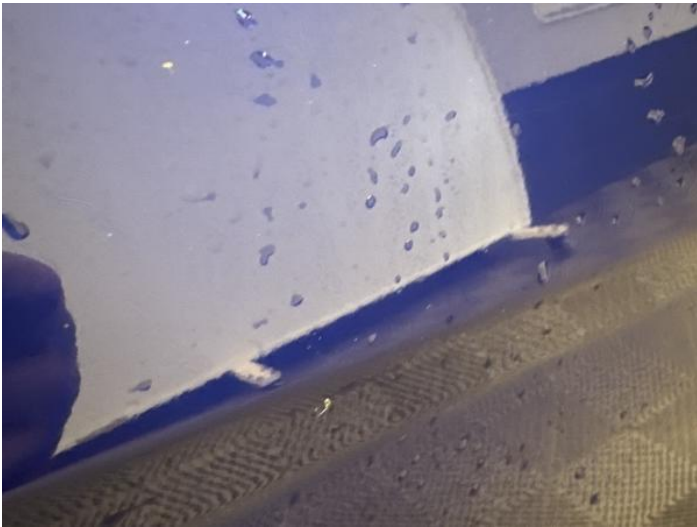
11: Door osf
Chipped
1 To 5

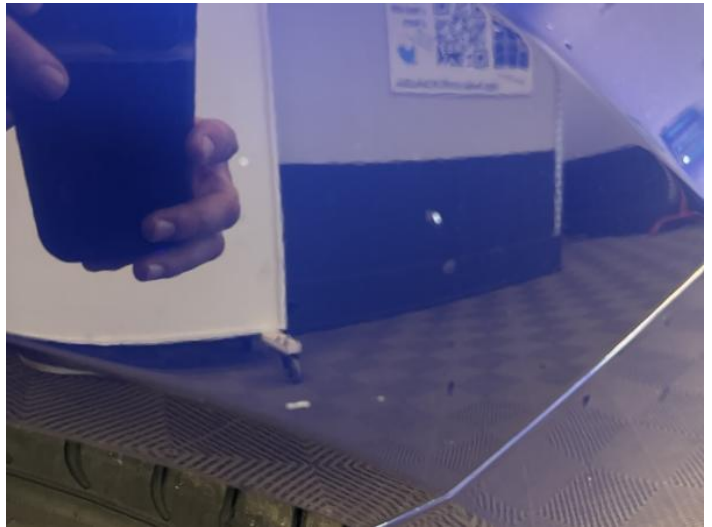
12: Wing osf
Chipped
1 To 5

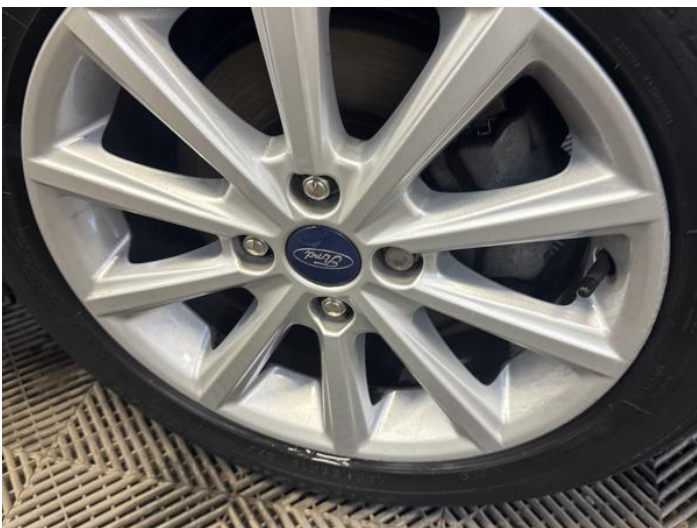
13: Wheel osr
Scratched
Over 50mm
