VEHICLE INSPECTION REPORT

GY14VXW

BMW 5 Series 520d SE 4dr Step Auto

nama
GRADE
4

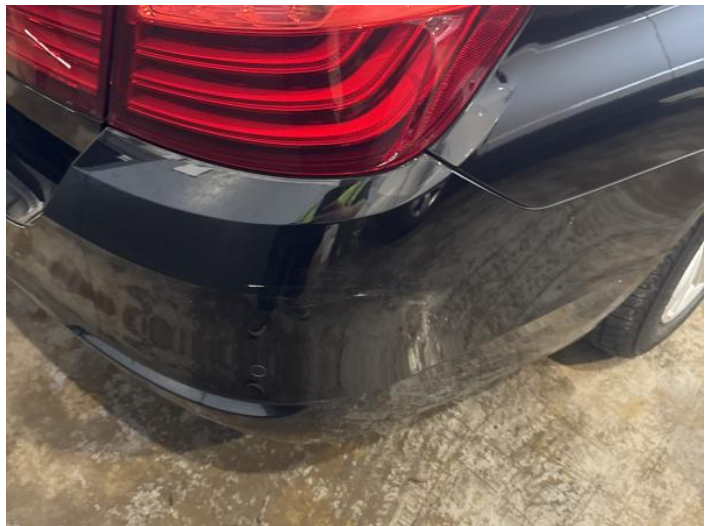
2: Bumper Rear
Scratched
Over 100mm Thru Paint

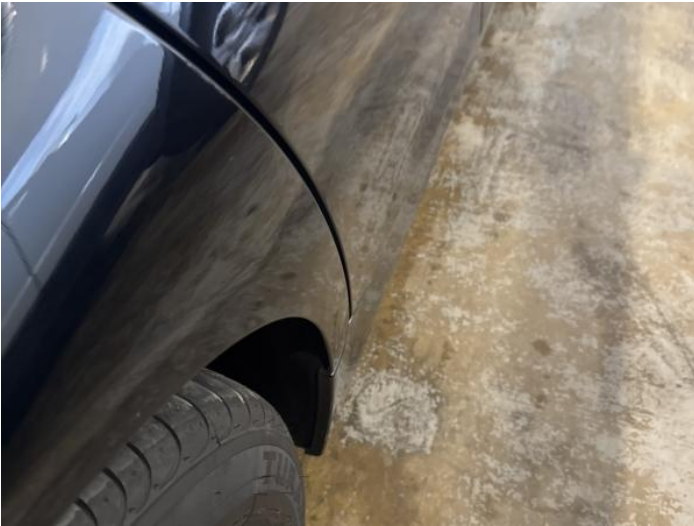
3: Qtr Panel osr
Dented
2 Or Less UpTo 10mm

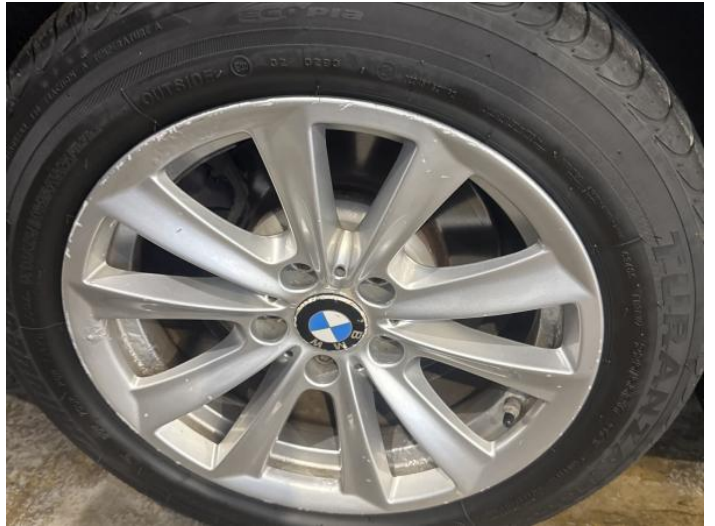
4: Wheel osr
Scratched
Over 50mm

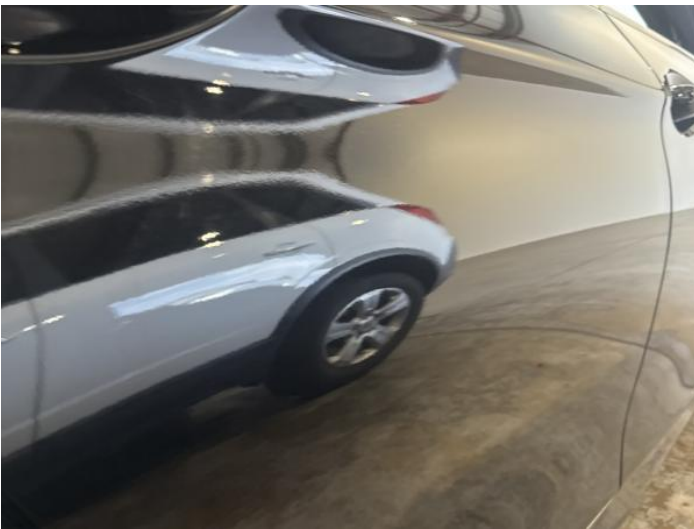
5: Door osr
Poor Previous Repair
Poor Paint

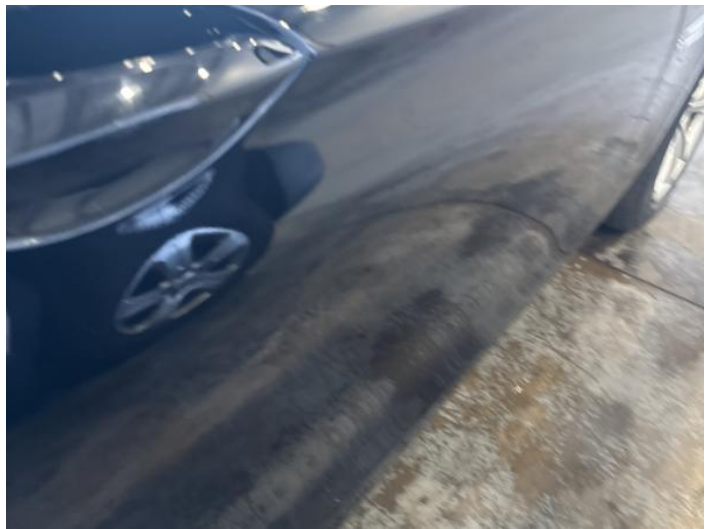
6: Door osf
Poor Previous Repair
Poor Paint

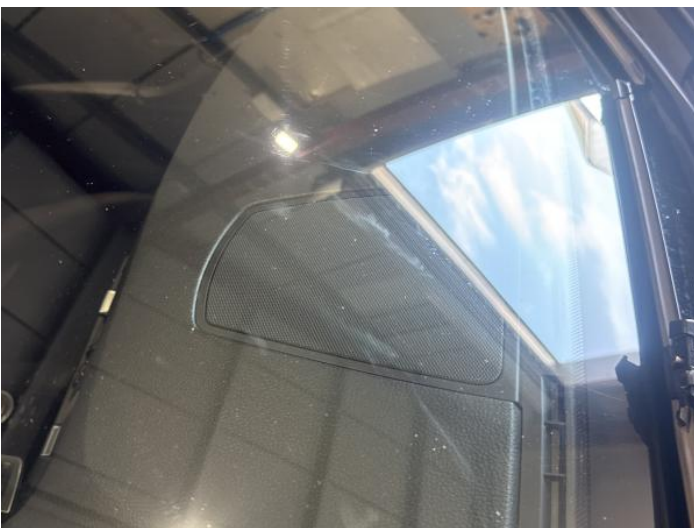
7: Screen Front
Chipped
UpTo 10mm

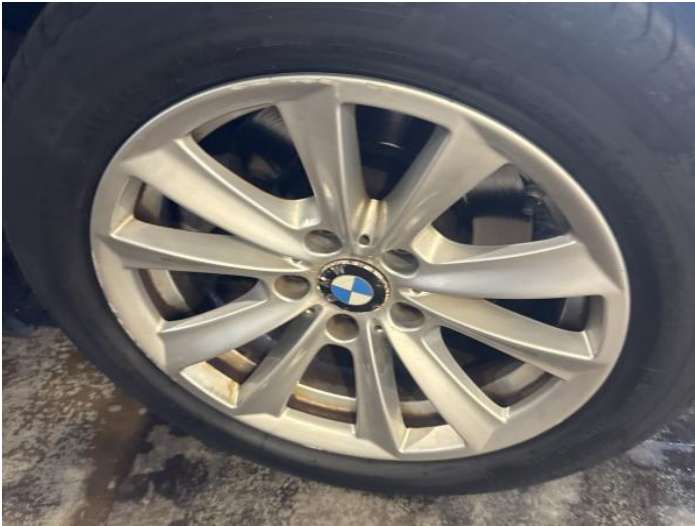
9: Wheel osf
Scratched
Over 50mm

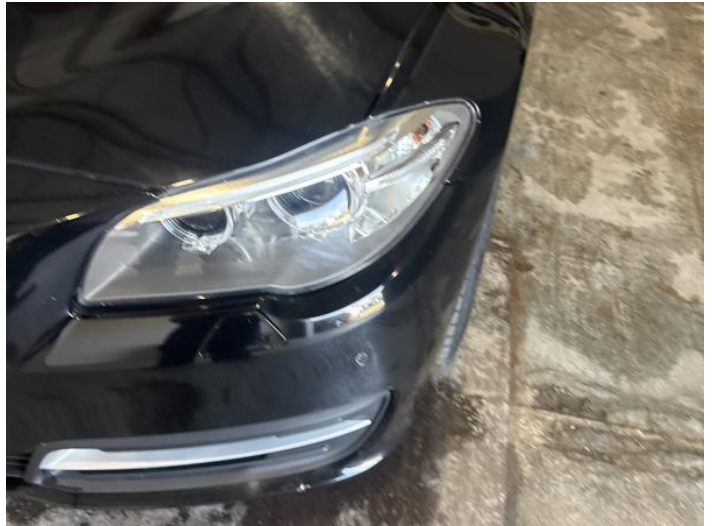
10: Bumper Front
Poor Previous Repair
Poor Paint

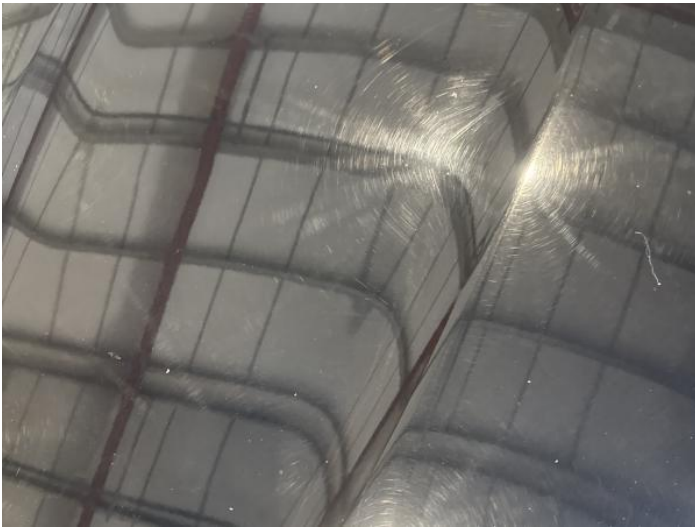
11: Bonnet
Chipped
1 To 5

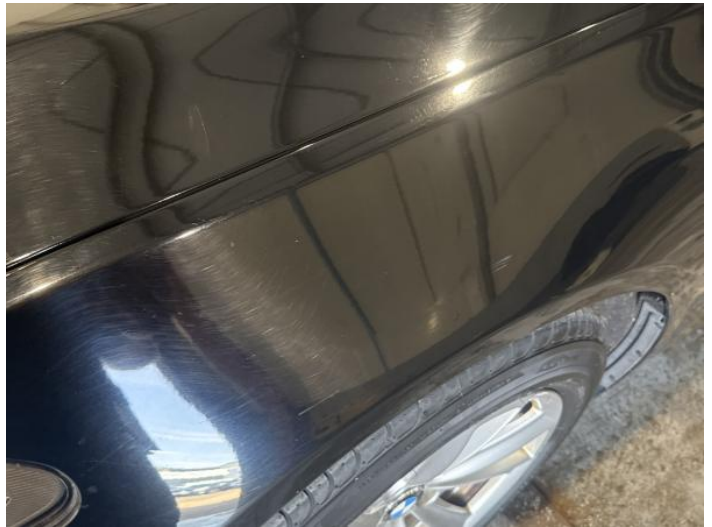
12: Wing nsf
Chipped
1 To 5

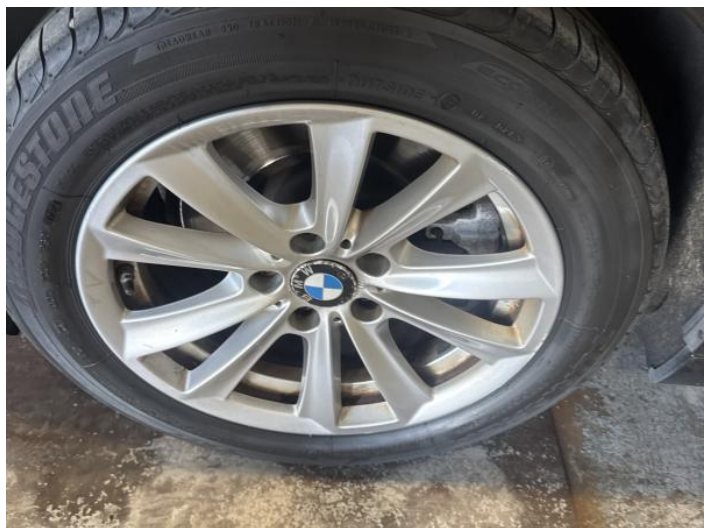
14: Wheel nsf
Scratched
Up To 50mm

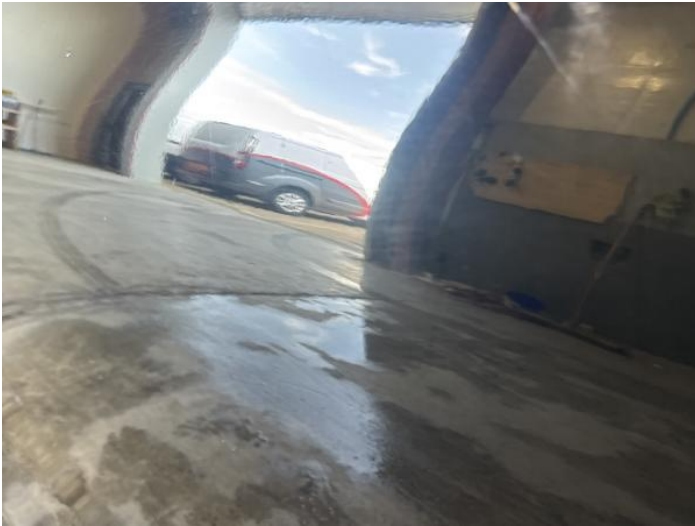
15: Door nsf
Chipped
1 To 5

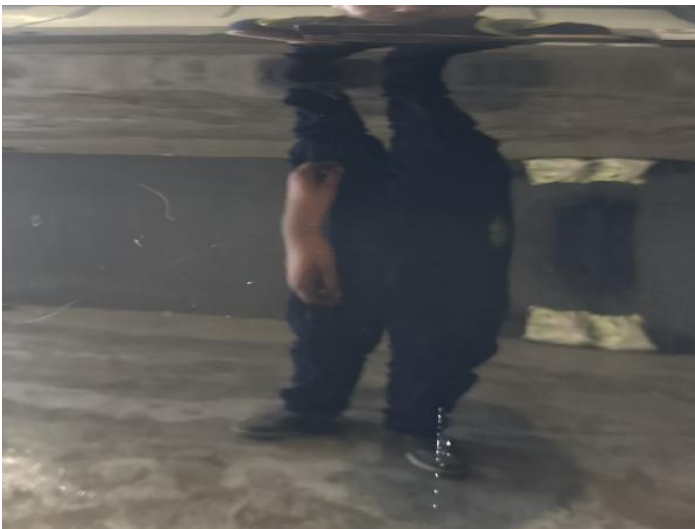
17: Door nsr
Chipped
Multiple Chips

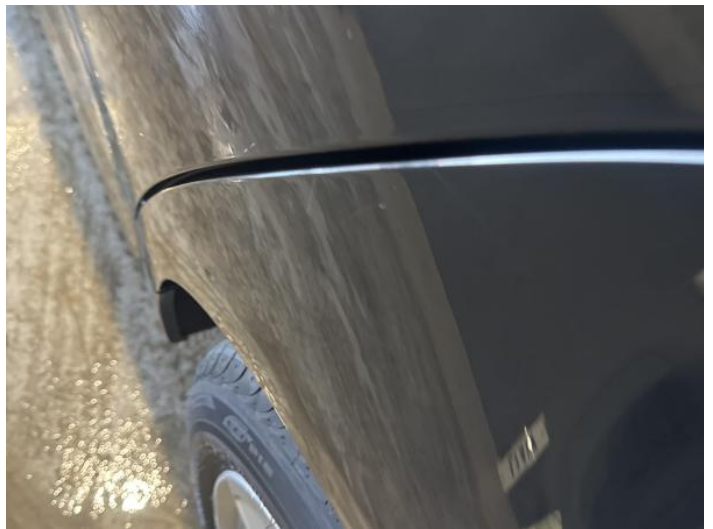
18: Qtr Panel nsr
Dented
2 Or Less UpTo 10mm

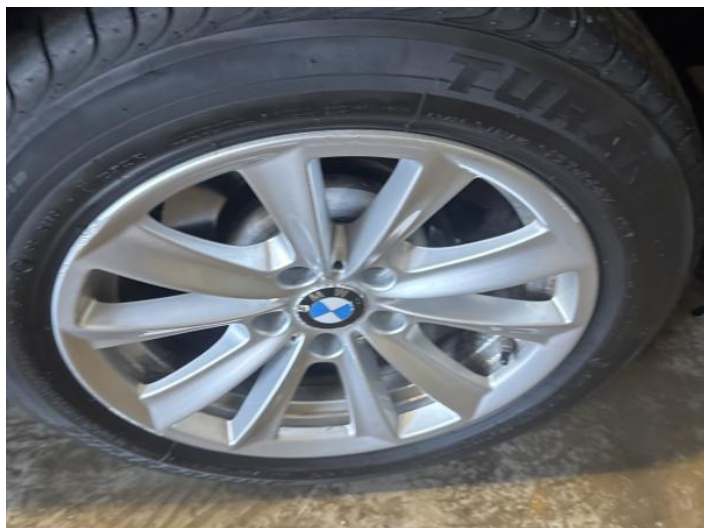
20: Wheel nsr
Scratched
Over 50mm

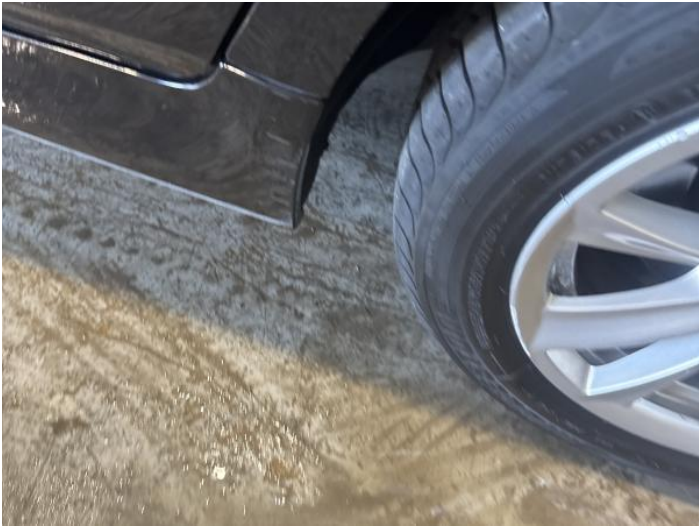
21: Sill Panel Trim ns
Scratched (Painted)
Over 25mm Thru Paint

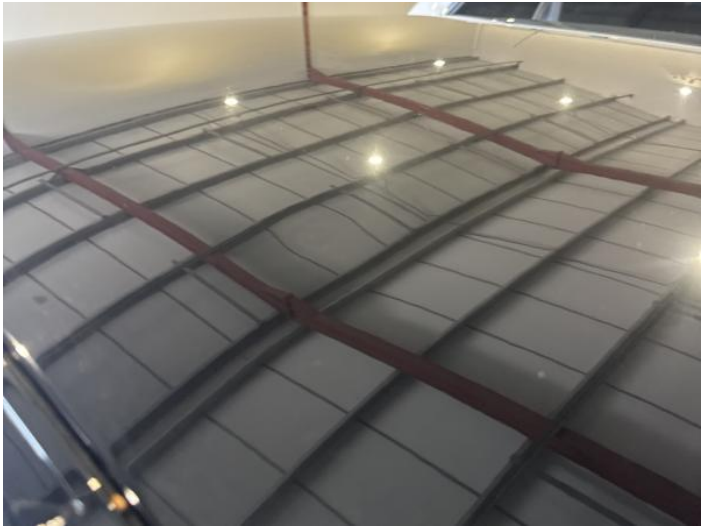
22: Roof
Dented
Between 10mm + 30mm
