VEHICLE INSPECTION REPORT

KN69YFK

Audi Q3 35 TFSI S Line 5dr S Tronic

nama
GRADE
3

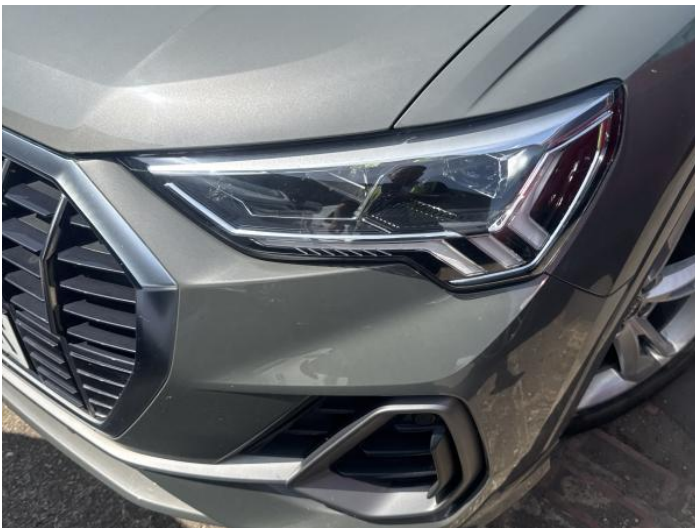
1: Bumper Front
Chipped
Multiple Chips

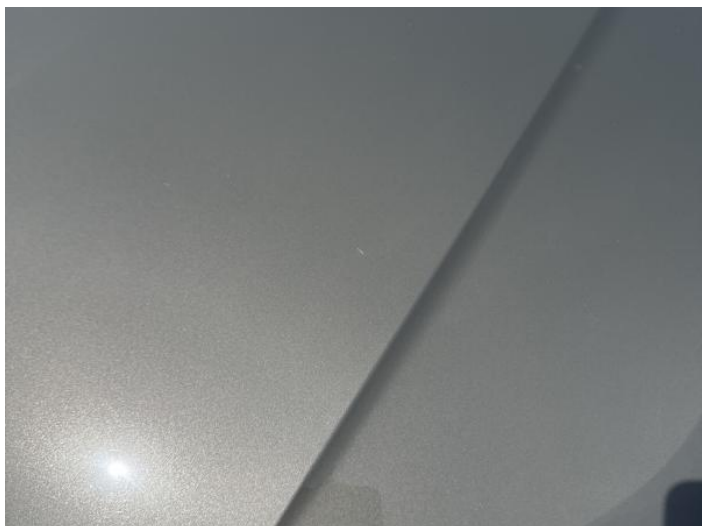
3: Bonnet
Chipped
1 To 5

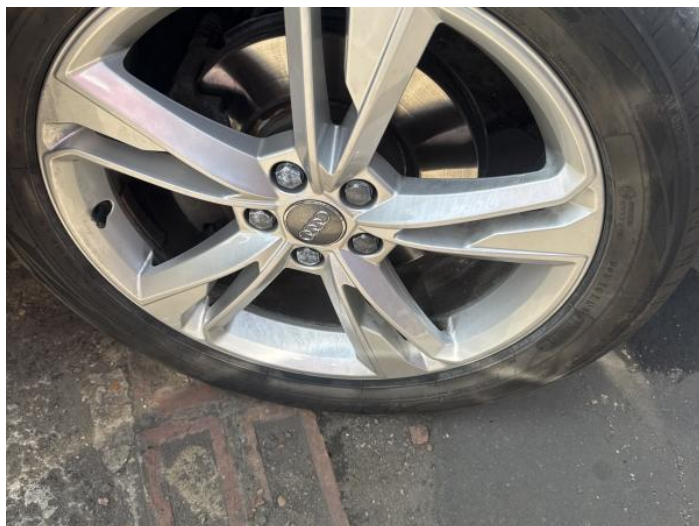
4: Wheel nsf
Scratched
Up To 50mm

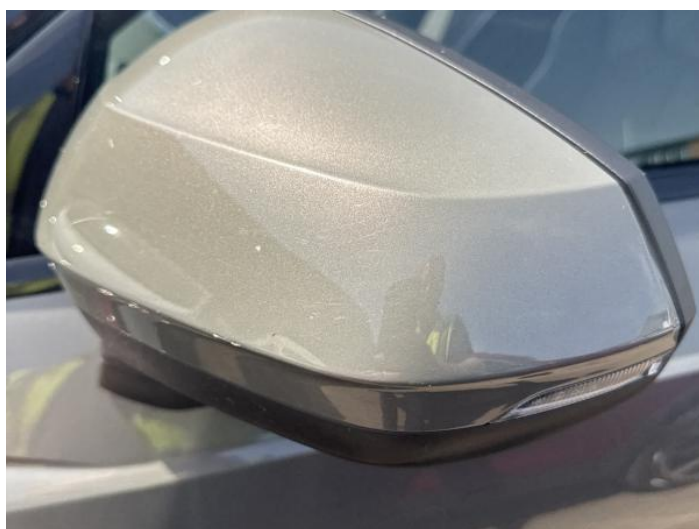
6: Door Mirror Assy nsf
Scratched (Painted)
UpTo 25mm Thru Paint

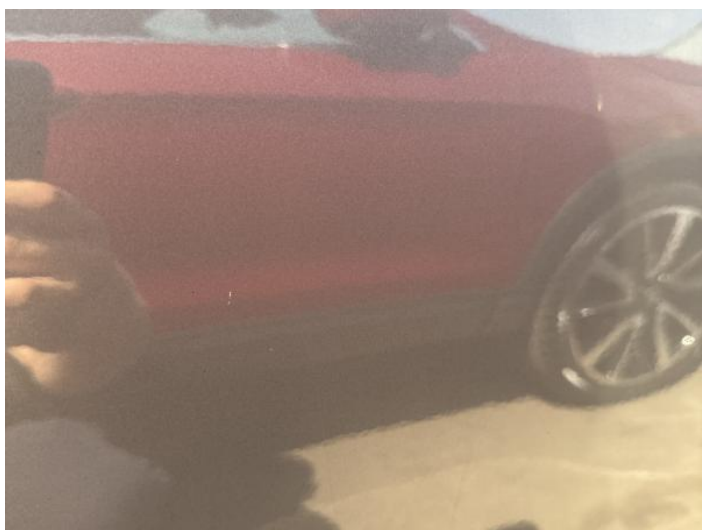
7: Door nsf
Chipped
1 To 5

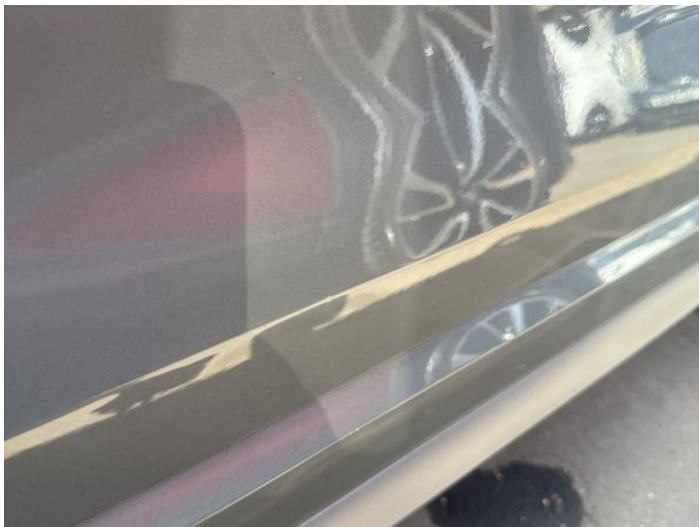
9: Door nsf
Dented
2 Or Less UpTo 10mm

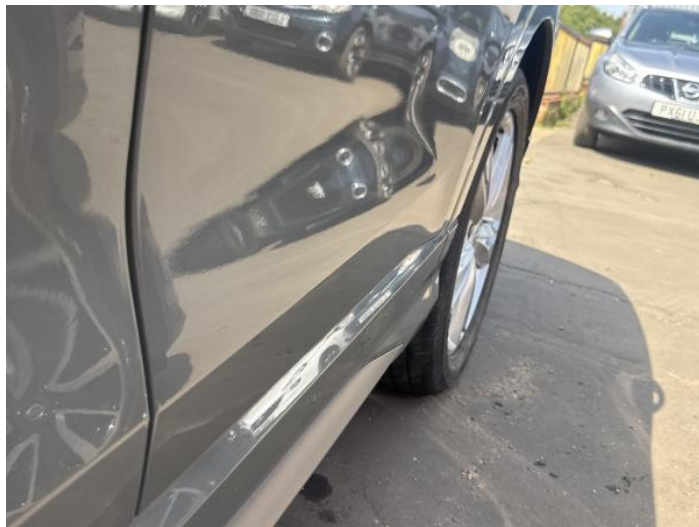
10: Door nsr
Dented
2 Or Less UpTo 10mm

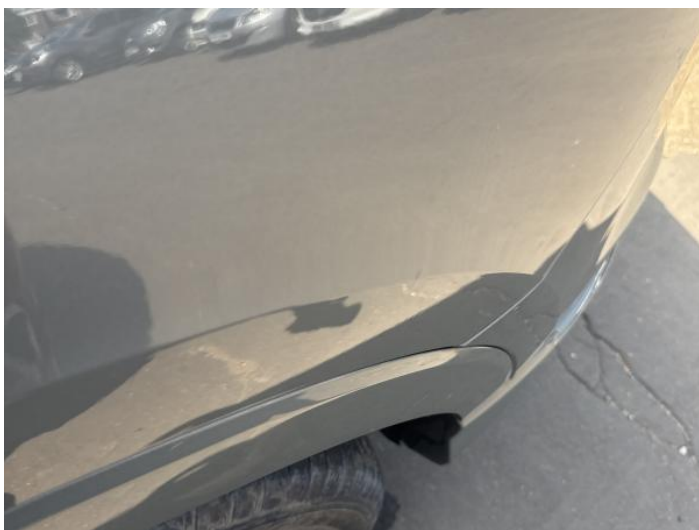
11: Qtr Panel nsr
Dented
2 Or Less UpTo 10mm

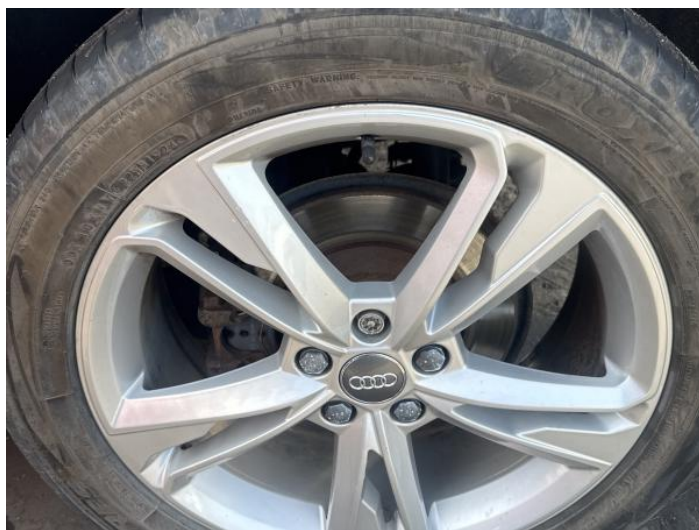
12: Wheel nsr
Scratched
Over 50mm

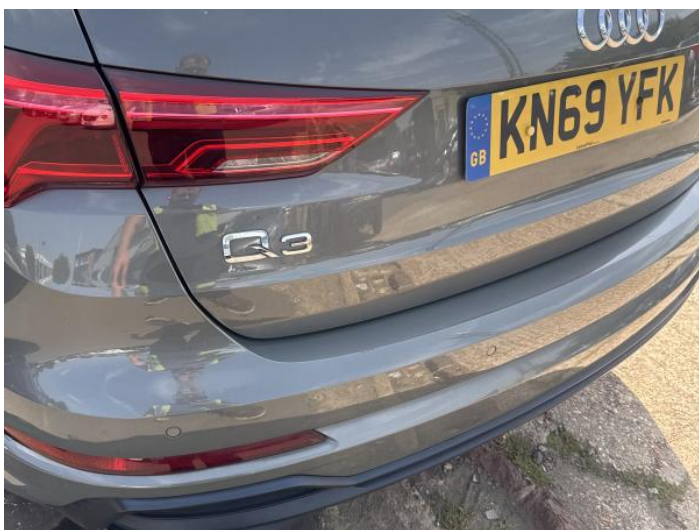
13: Bumper Rear
Scratched
25 to 100mm Thru Paint

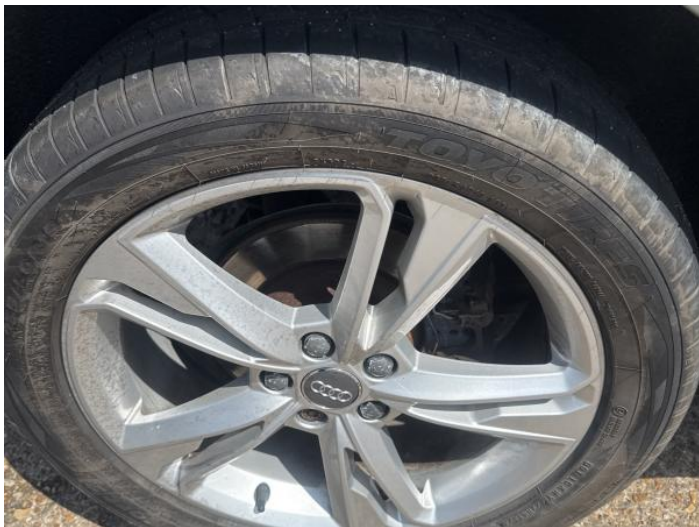
15: Wheel osr
Scratched
Up To 50mm

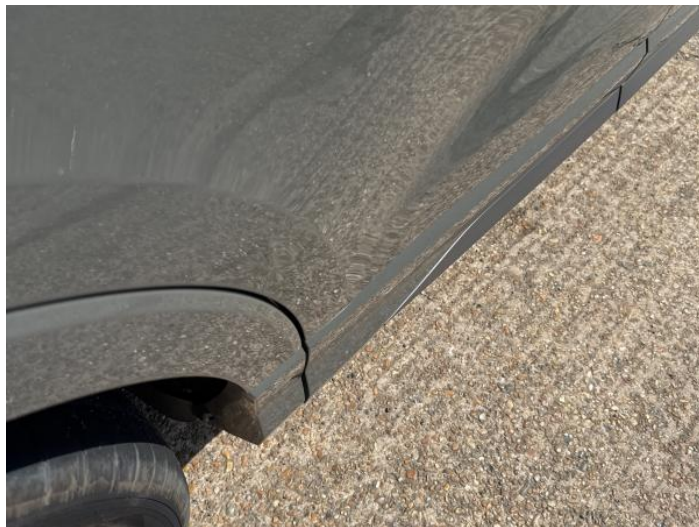
16: Door osr
Dented
Over 30mm

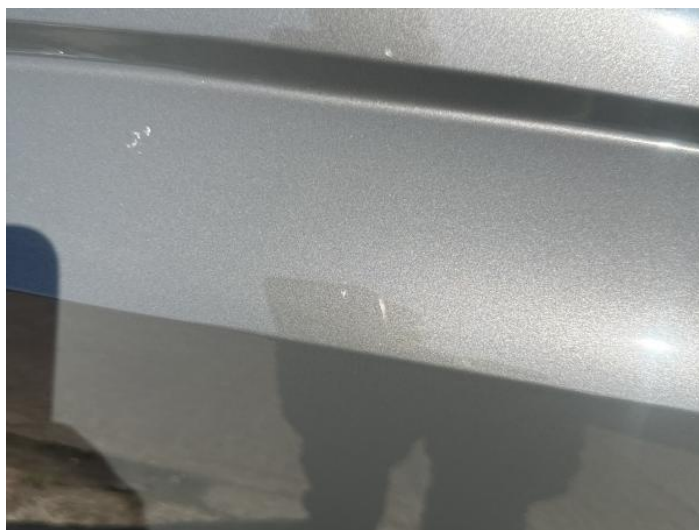
18: Wing osf
Chipped
1 To 5

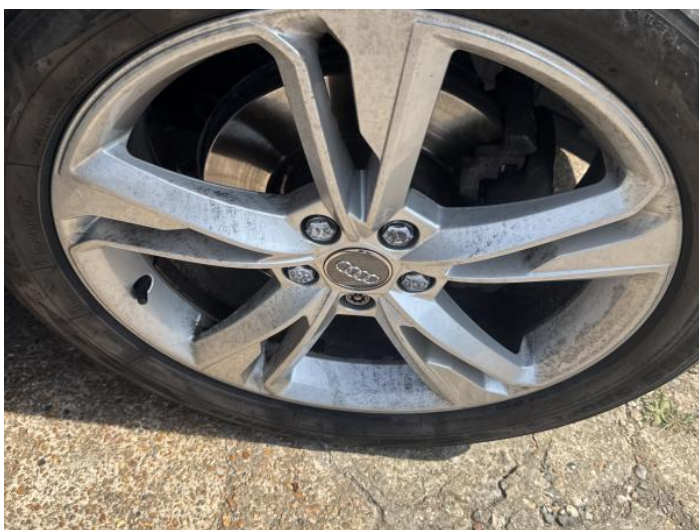
19: Wheel osf
Scratched
Up To 50mm
