VEHICLE INSPECTION REPORT

KM66KFT

BMW 1 Series 120d xDrive Sport 5dr [Nav] Step Auto

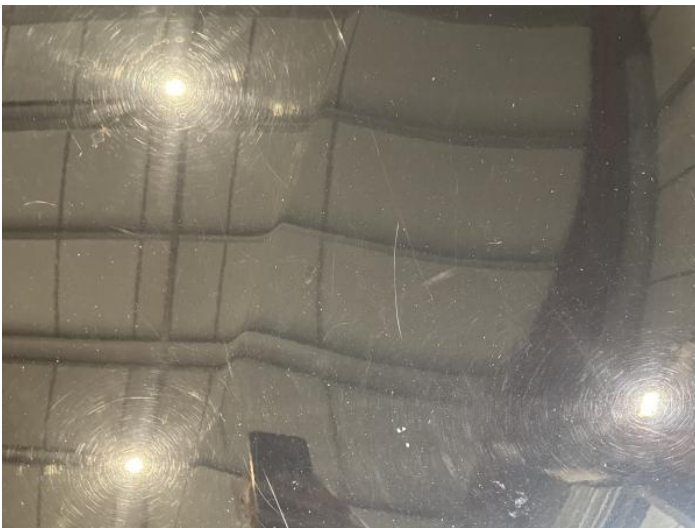
1: Bonnet
Chipped
Multiple Chips

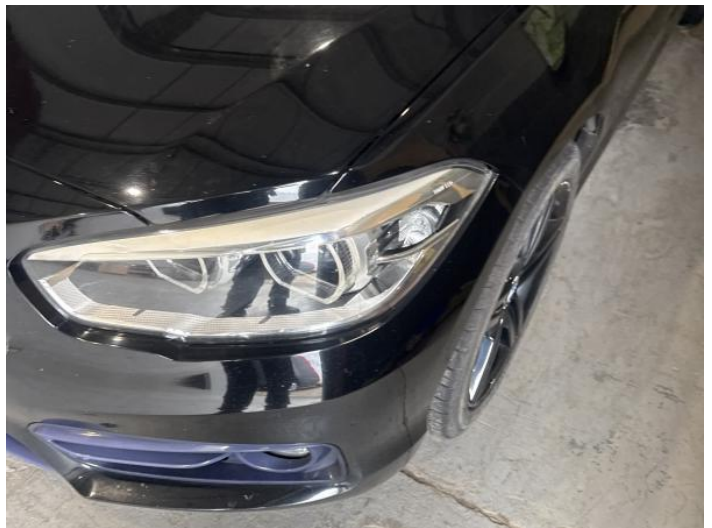
2: Bumper Front
Scratched
25 to 100mm Thru Paint

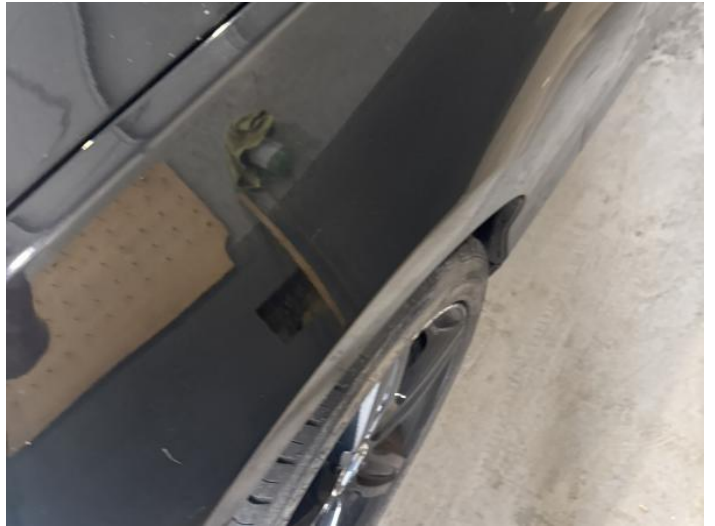
3: Bumper Front
Scratched
Over 25mm Not Thru Paint

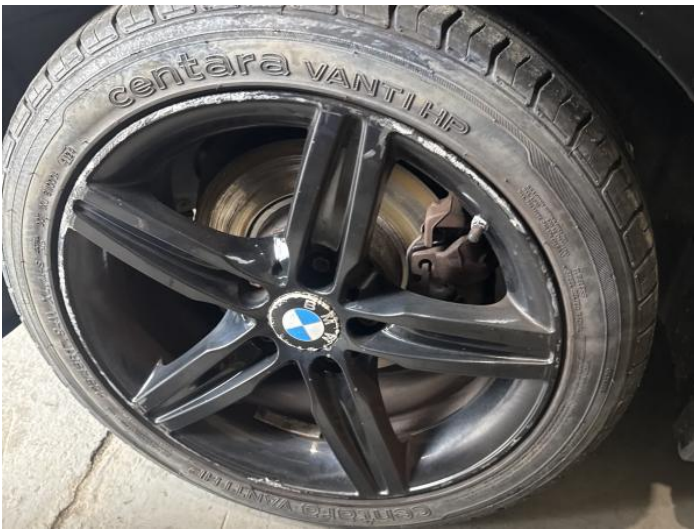
5: Wheel nsf
Scratched
Over 50mm

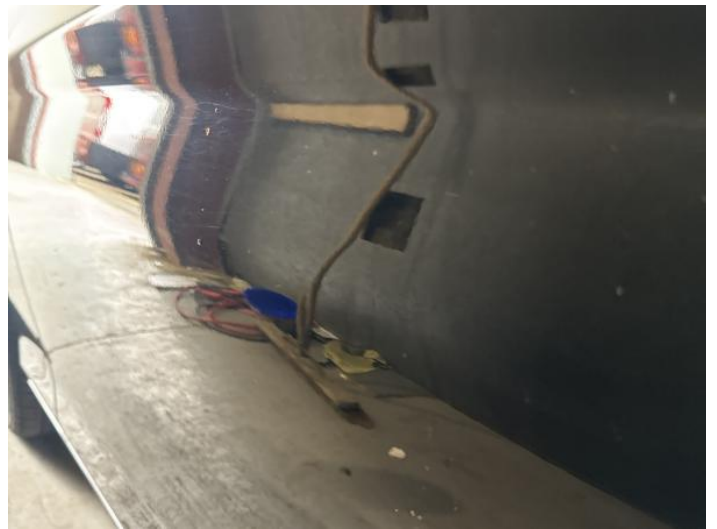
6: Door nsf
Dented
Over 2 UpTo 10mm

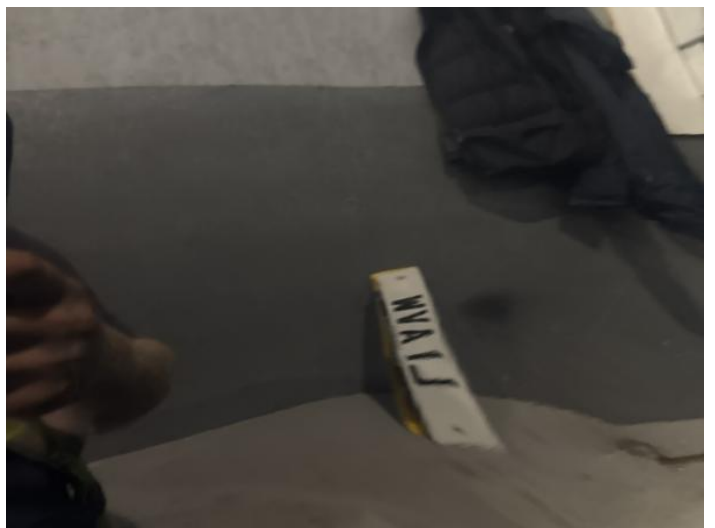
7: Door nsf
Scratched
Over 25mm Not Thru Paint

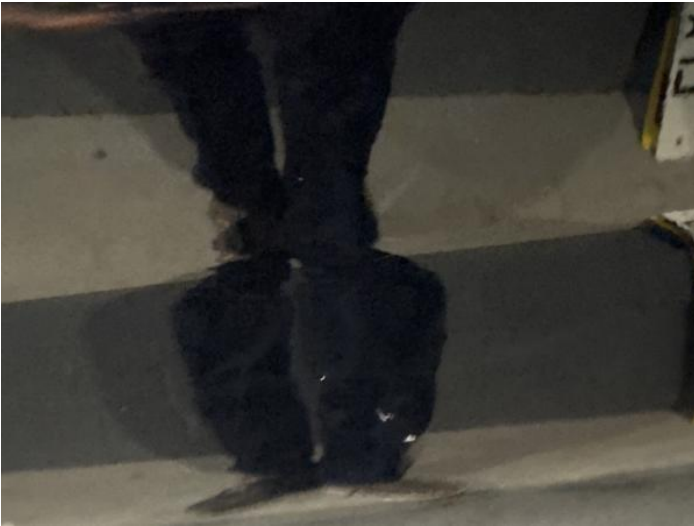
9: Door nsr
Chipped
1 To 5

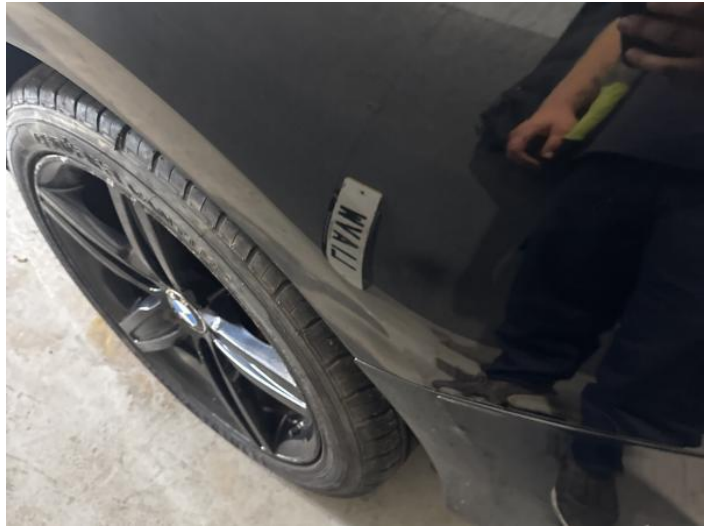
10: Qtr Panel nsr
Dented
Over 30mm

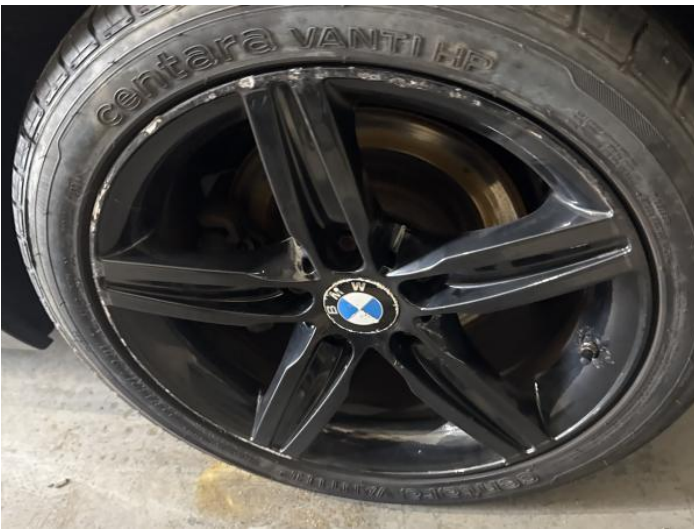
11: Wheel nsr
Scratched
Over 50mm

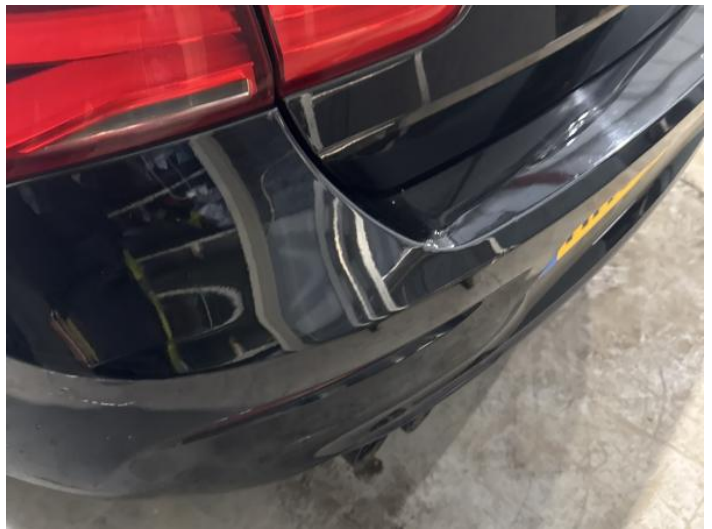
12: Bumper Rear
Poor Previous Repair
Rippled UpTo 30%

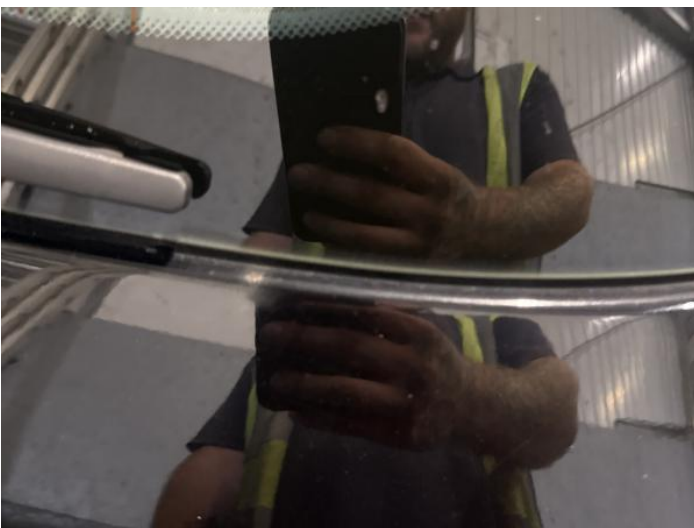
13: Boot Lid
Rusted
UpTo 5mm

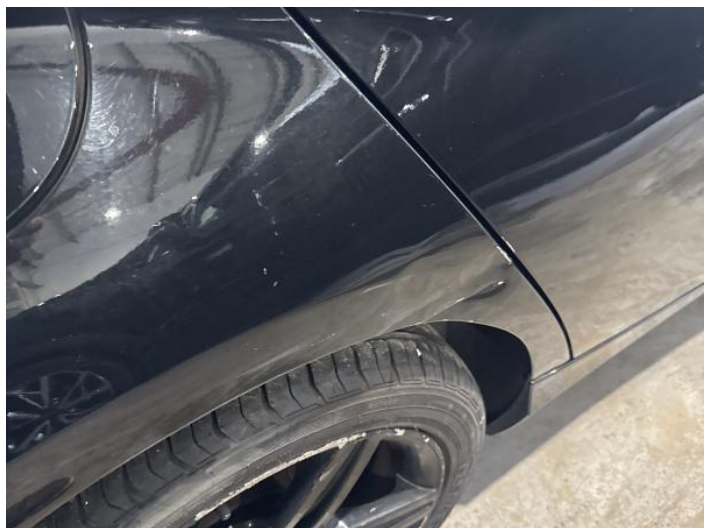
14: Qtr Panel osr
Dented
With Paint Damage

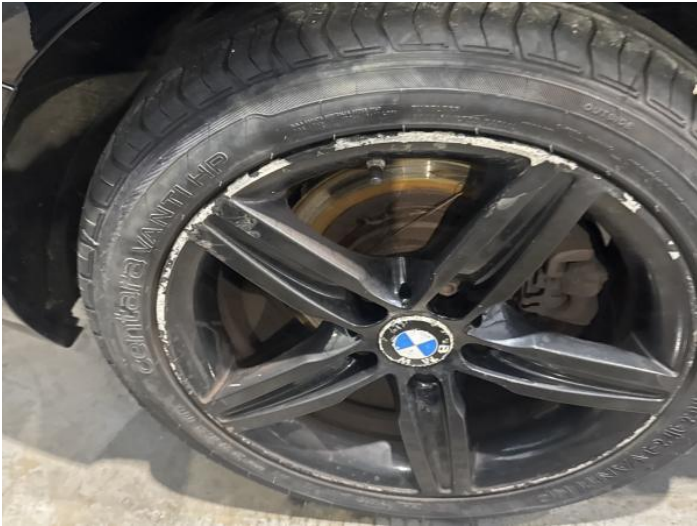
15: Wheel osr
Scratched
Over 50mm

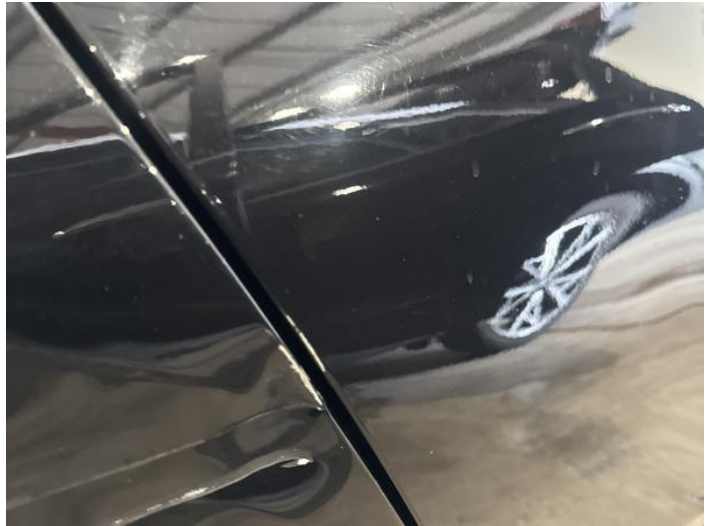
16: Door osr
Chipped
Edge Chip

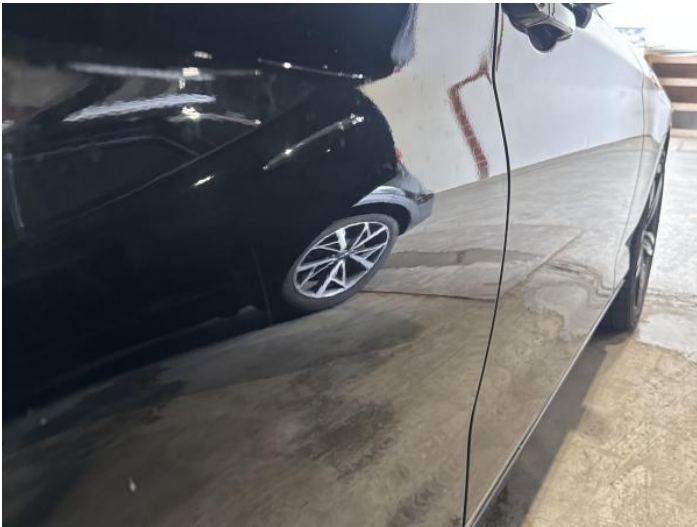
17: Door osr
Dented
Over 2 UpTo 10mm

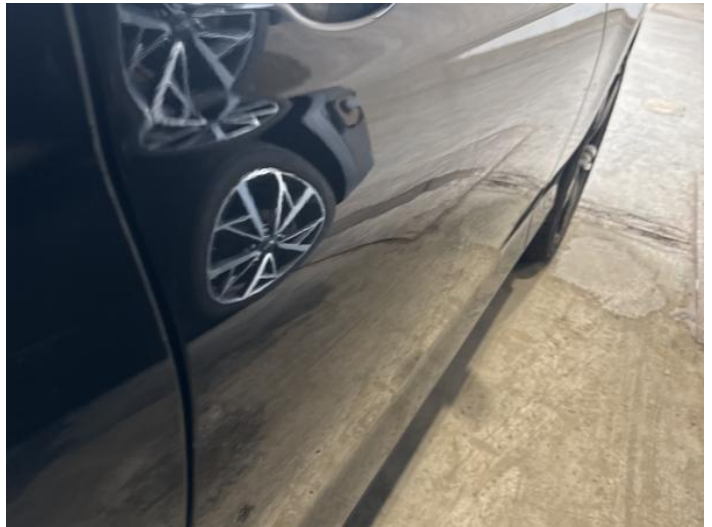
18: Door osf
Dented
Between 10mm + 30mm

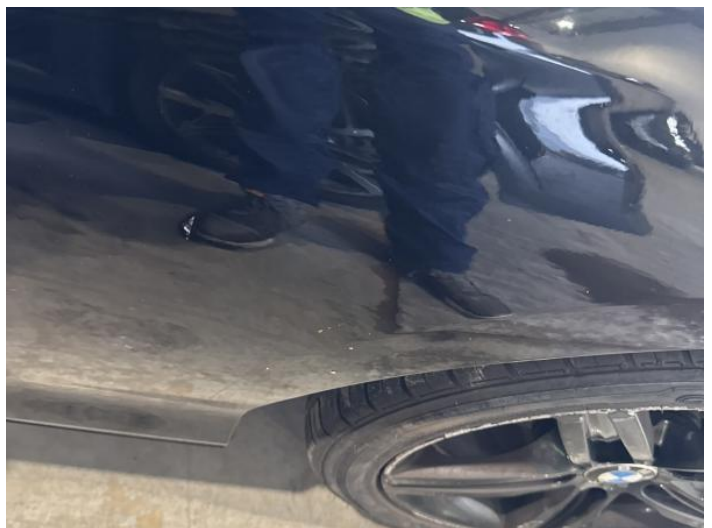
20: Wing osf
Chipped
1 To 5

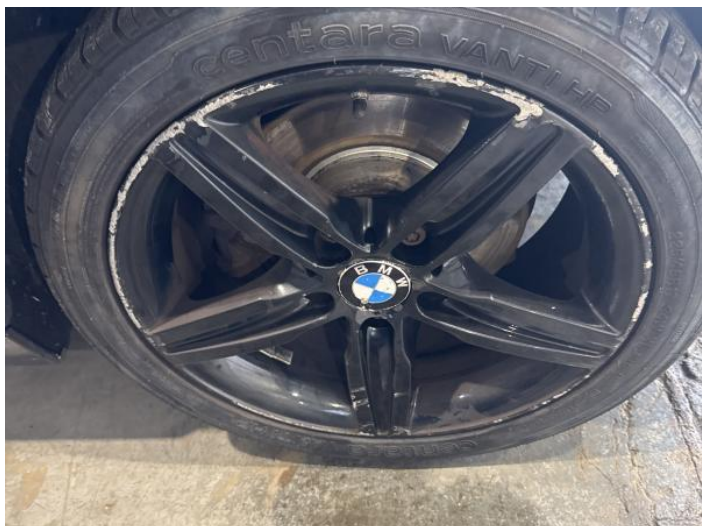
21: Wheel of
Scratched
Over 50mm
